# RUBBER SNOWPLOW BLADES AND LIGHTWEIGHT SNOWPLOWS USED FOR THE PROTECTION OF RAISED LANE MARKERS

Donald R. Anderson, Washington Department of Highways

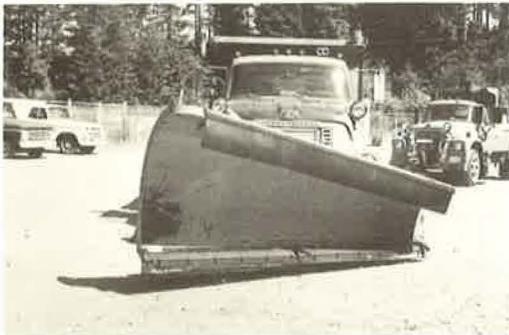
Figure 2. Washington standard power reversible moldboard with rubber snowplow blade.

In the spring of 1966, the Goodyear Rubber Company, through one of its local outlets, supplied the department with one hard-rubber snowplow blade. It measured 10 ft in length and was approximately  $1\frac{1}{2}$  in. thick and slightly over 10 in. wide (Fig. 2).

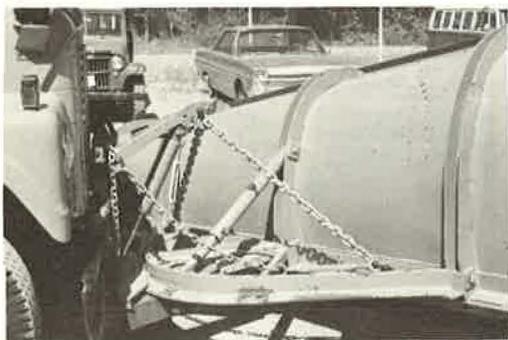
Figure 3. Washington standard moldboard with chain and turnbuckle assembly.

Our maintenance division, like those in many other states, does not have a surplus of equipment for use for experimental purposes during a snowstorm. It taxes our forces just to keep all available equipment working during a storm. Consequently, we determined that all equipment used during the study would remain in general use and would operate in a normal manner. The only change to the normal routine would be that each operator would report his daily activities on a special form developed for the study. Automatic recording devices were developed and used in the final phases of the test to ease the reporting burden and to remove as much of the "human element" as possible. A Hobbs hour meter (Fig. 5) was used to record the blade contact hours and an Engler electric speedometer/odometer (Fig. 6) recorded the blade contact mileage. Each of these devices was activated only when the moldboard was in a down position and plowing.

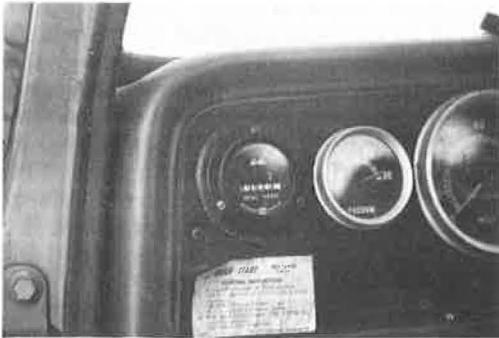
Figure 5. Hobbs hour meter mounting.

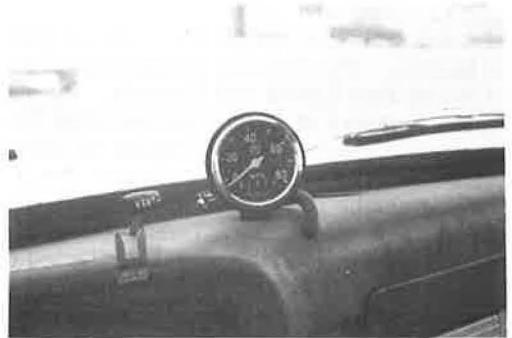
Figure 6. Engler electric speedometer/odometer.

Notes: All plowing was on portland cement concrete pavement. Engler Electric Speedometer/Odometer was added 1/26/69 to record automatically the time and distance the plow was in contact with the roadway surface.
