NATIONAL COOPERATIVE HIGHWAY RESEARCH PROGRAM
REPORT

115

**GUARDRAIL
PERFORMANCE
AND DESIGN**

HIGHWAY RESEARCH BOARD
NATIONAL RESEARCH COUNCIL
NATIONAL ACADEMY OF SCIENCES—NATIONAL ACADEMY OF ENGINEERING

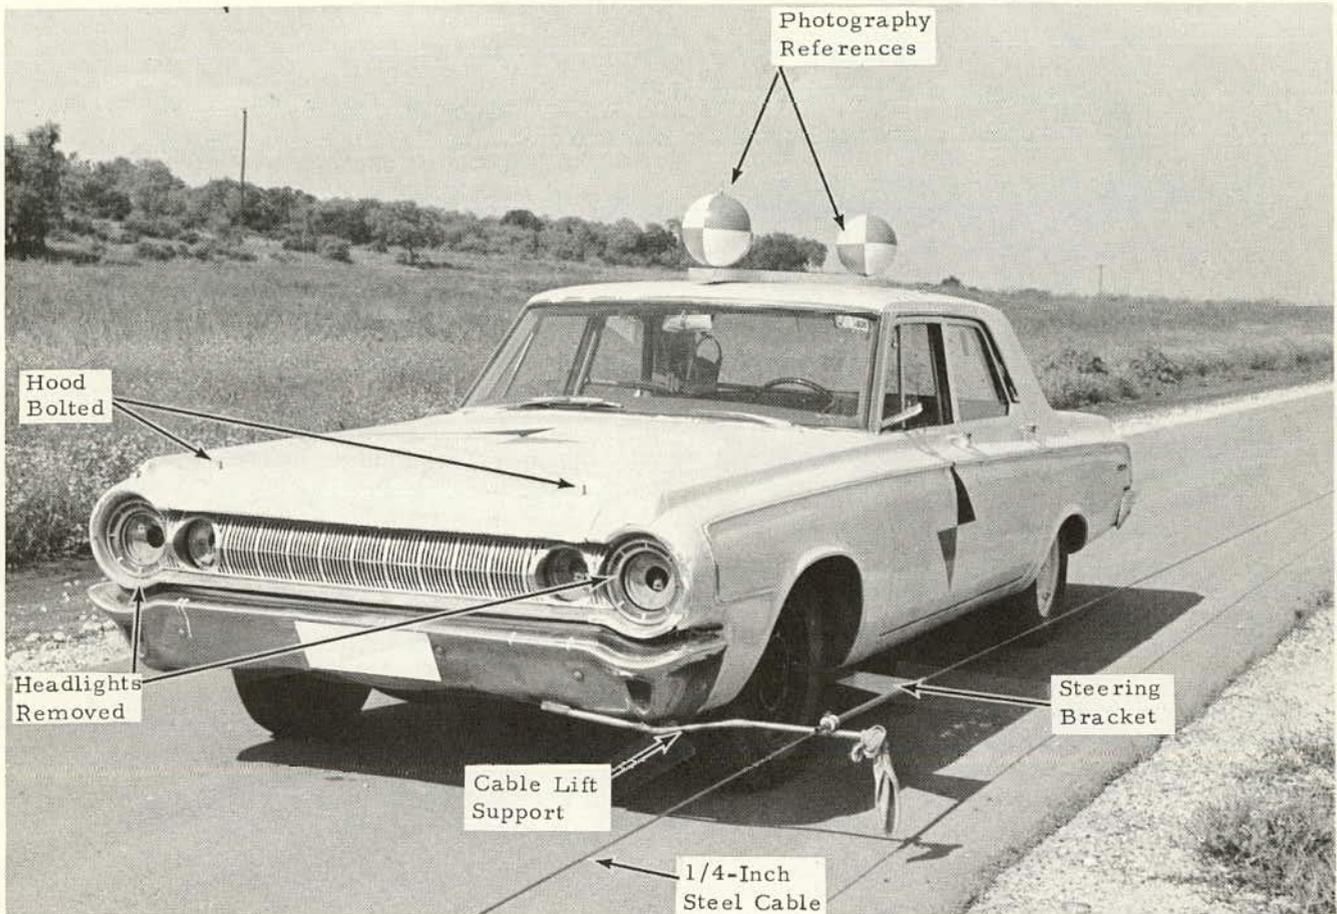
Figure A-2. Guide bracket on typical test vehicle.

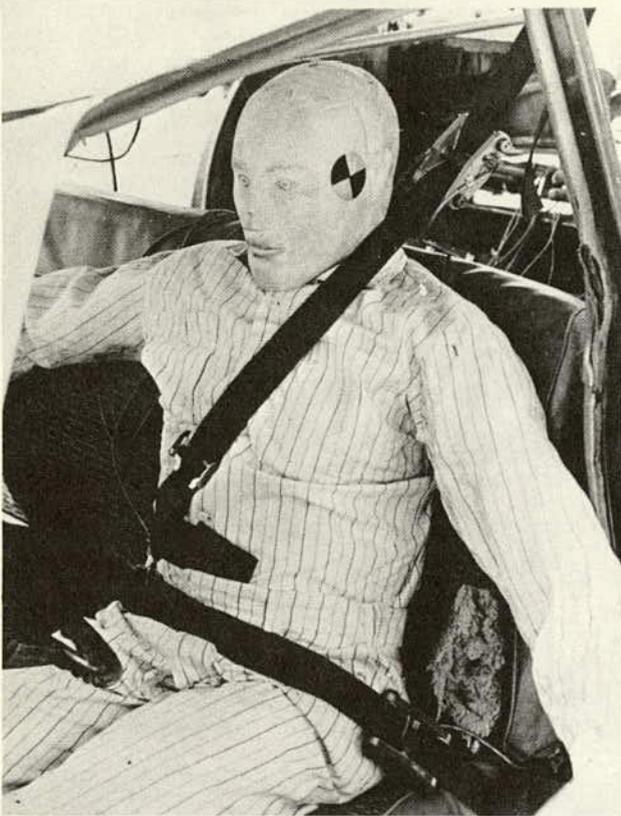
Figure A-3. Anthropometric test dummy.

The test subject was a 50th percentile Model 182 anthropometric dummy (Fig. A-3) manufactured by the Sierra Engineering Company. The dummy weighs 157.5 lb, has a standing height of 68.3 in., and a sitting height of approximately 34.1 in. The joints are articulated to simulate human motions, and the friction joint resistances can be varied from loose to tight. It is discontinuous at the joints to allow freedom of motion. The dummy has a resilient flesh covering over-all with the exception of the head. The head is an

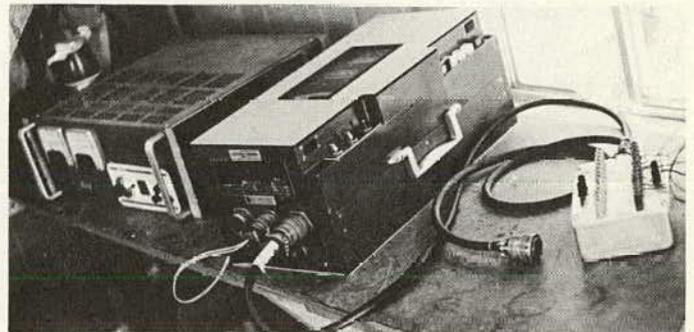
Figure A-5. Data acquisition equipment.

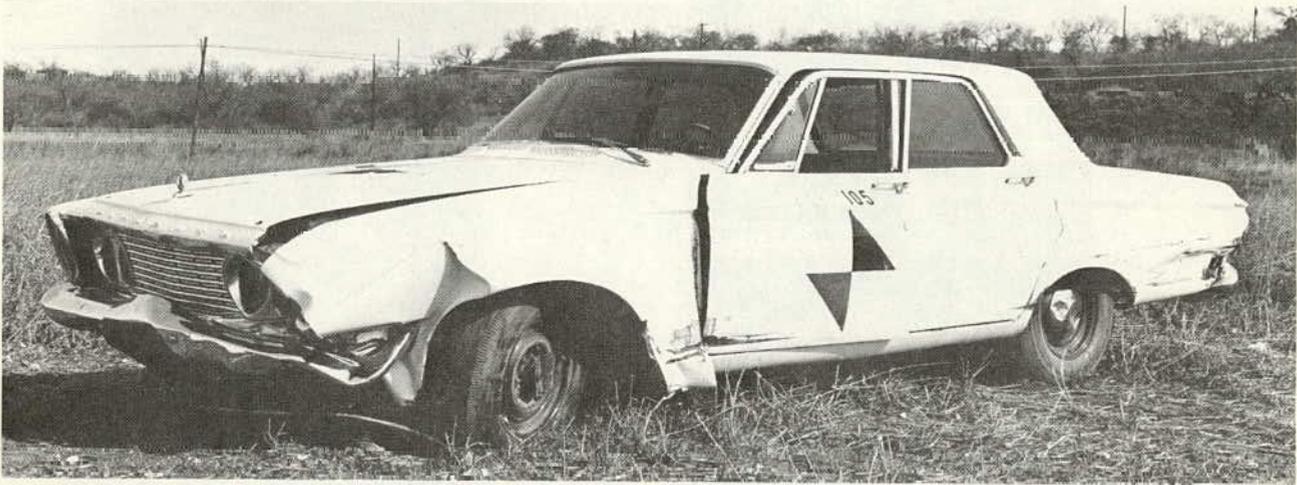
Figure A-10. Guardrail and vehicle damage, Test 105.

The test vehicle sustained relatively minor left front end damage, as shown in Figure A-10. The vehicle deformation index value was determined to be 11LDMW2.

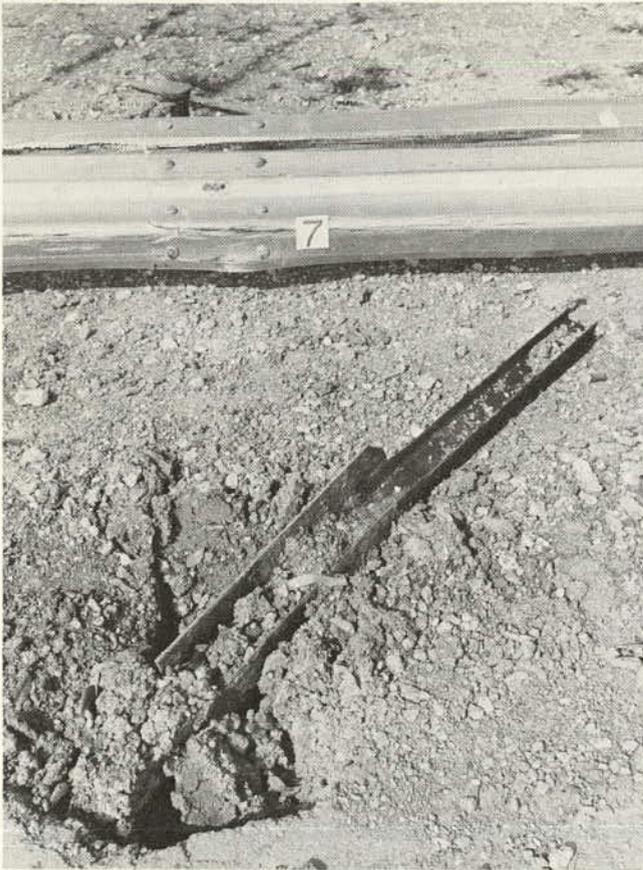
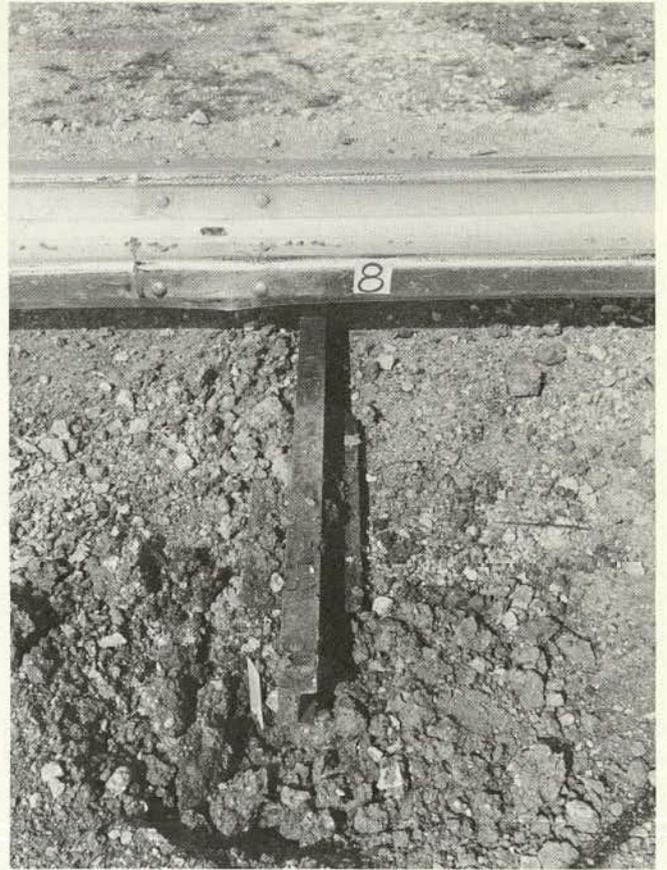
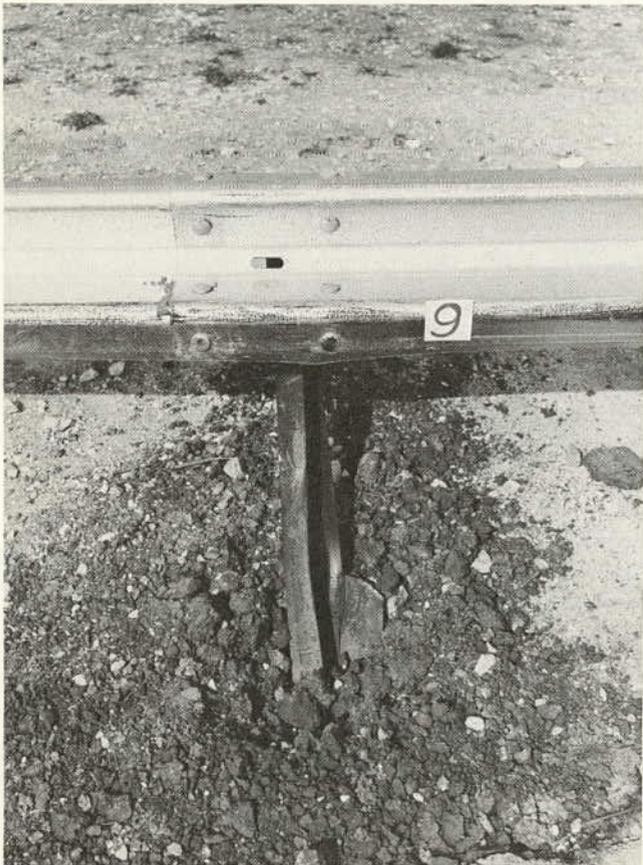
Figure A-16. Guardrail Posts 7, 8, and 9, and terminal end, after Test 105.

Only two posts were damaged significantly, although one undamaged post was pulled out of the ground (Fig. A-16). Two rail sections were bent beyond repair. Although other
