NATIONAL COOPERATIVE
HIGHWAY RESEARCH PROGRAM REPORT

227

**FATIGUE BEHAVIOR OF FULL-SCALE
WELDED BRIDGE ATTACHMENTS**

TRANSPORTATION RESEARCH BOARD 1980

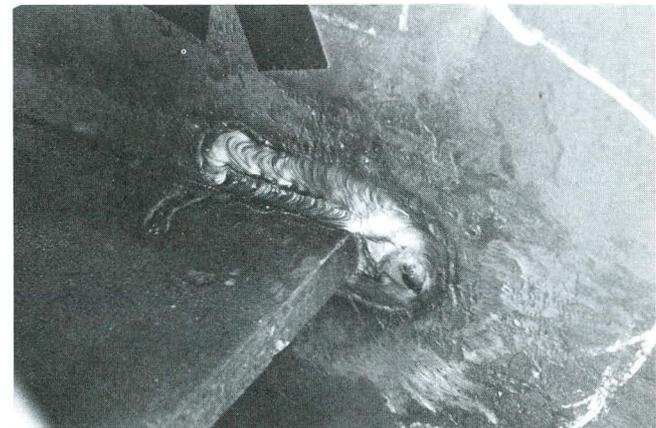
Figure 11. GTA remelted web gusset weld.

The depth of the remelting zone was critical to the success of this method. Insufficient depth of penetration will leave a crack buried below the surface, resulting in premature failure. Such failures, along with cracks initially deemed unsuitable because of a relatively large depth, were treated usually by drilling holes. Figure 11 shows a GTA-remelted weld toe.

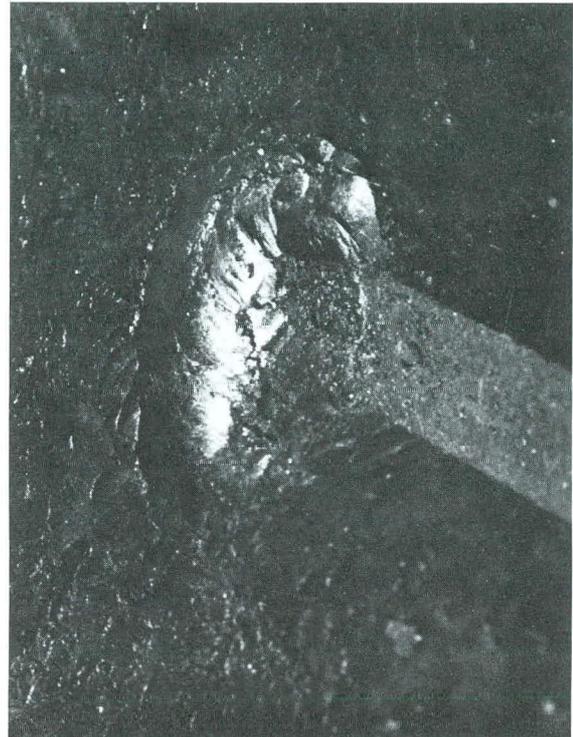
Figure 13. Peened weld.

Peening was performed with an Ingersoll-Rand model 1940 pneumatic air hammer operated at 25 psi (0.17 N/mm²). The peening tool is shown in Figure 12. When a crack was visually apparent (10X magnification) peening was continued until the crack was no longer visible and the weld toe became smooth. An example of a weld toe treated by peening is shown in Figure 13.

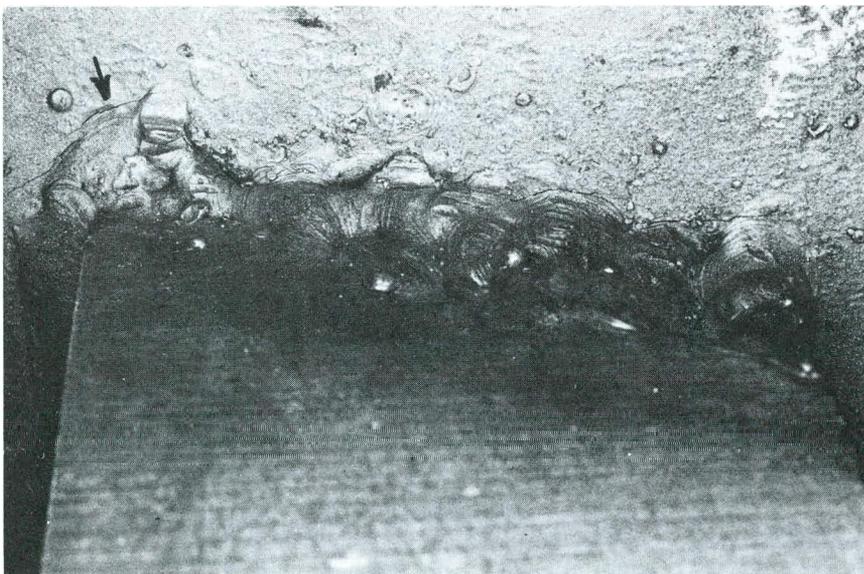
Figure 14. 0.25-in. (6-mm) crack at flange framed into web, groove welded.

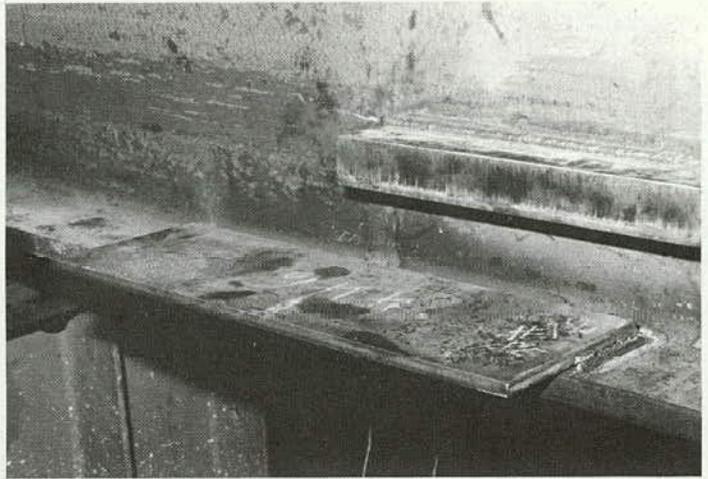
Figure 38. Flange surface gusset plate.

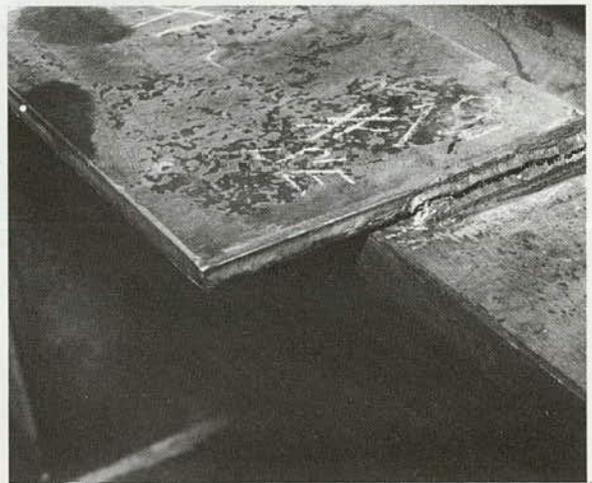
Figure 39. Weld crack through throat of fillet weld at root.

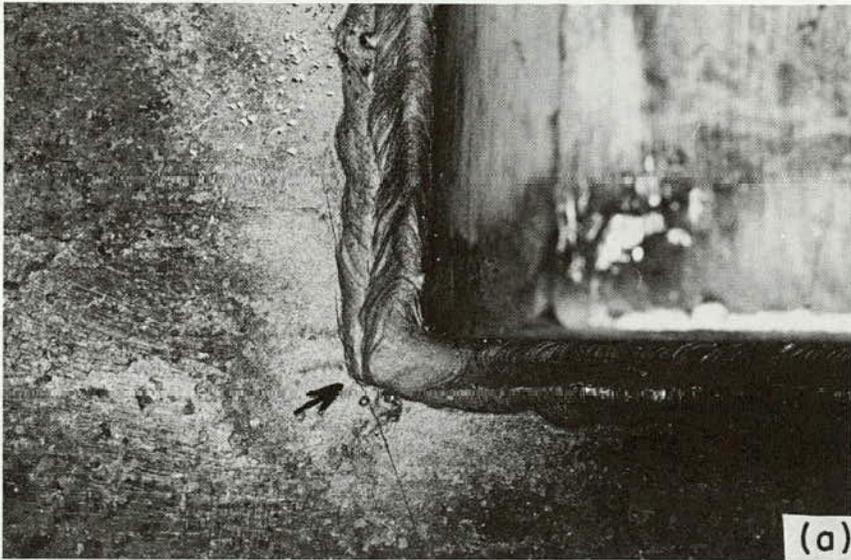
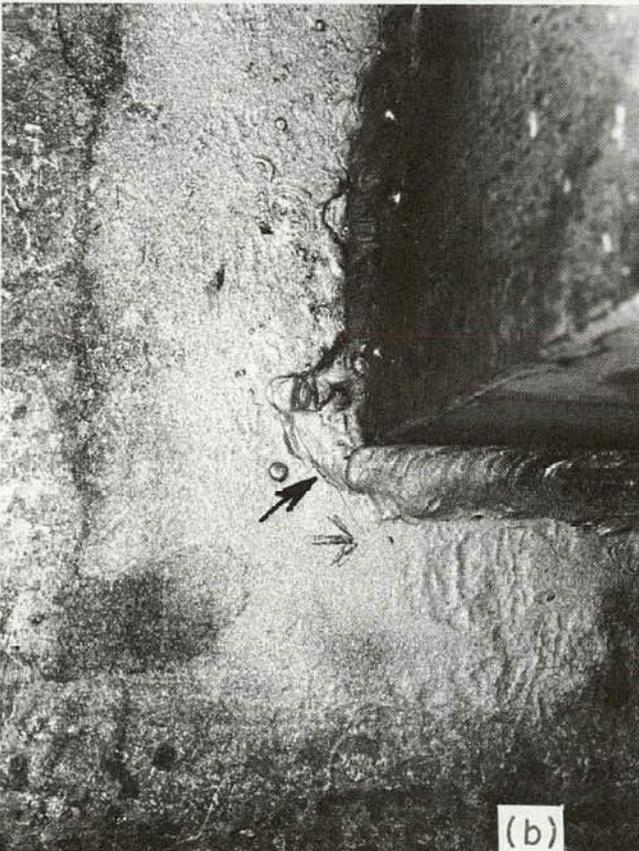
Figure 41. Cracks forming at ends of welded attachments: (a) crack at fillet weld toe; (b) cracks at groove weld toe.

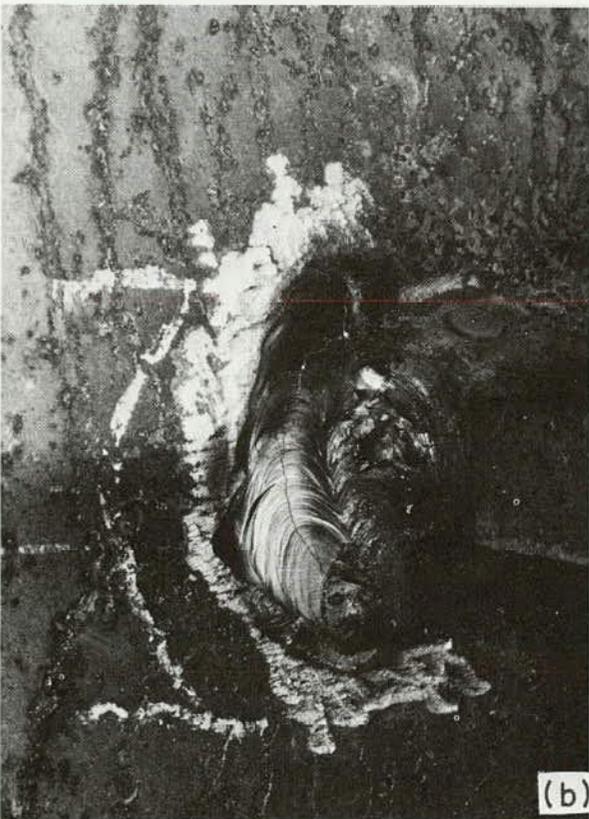
Figure 55. (a) Crack before GTA remelting; (b) crack after GTA remelting.
