# Synthesis of Highway Practice 220

## Waterproofing Membranes for Concrete Bridge Decks

DAVID G. MANNING, Ph.D., P.E.

Ministry of Transportation  
Ontario, Canada

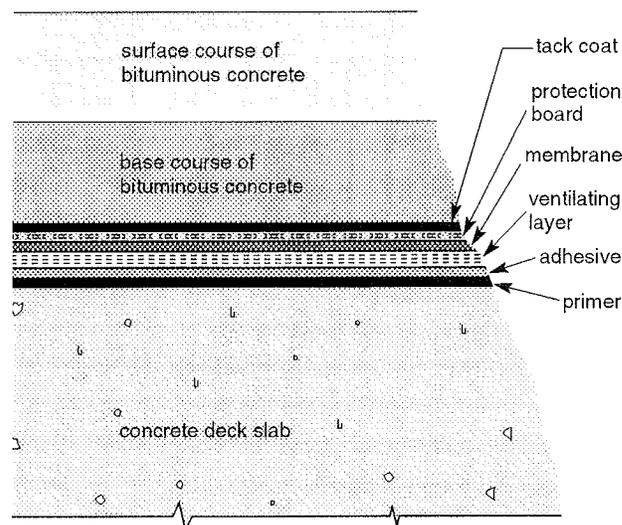
FIGURE 3 Schematic of possible components of a waterproofing system.

Primers are used to penetrate and coat the concrete deck surface to improve adhesion of the membrane to the deck slab. In the past, primers were usually bitumen dissolved in an organic solvent but, due to environmental and safety reasons, these have been largely replaced by emulsions. Synthetic rubber, sometimes combined with a resin and dissolved in a solvent, is used as a primer with some proprietary sheet membranes. Resinous primers are normally used with resin-based liquid systems.

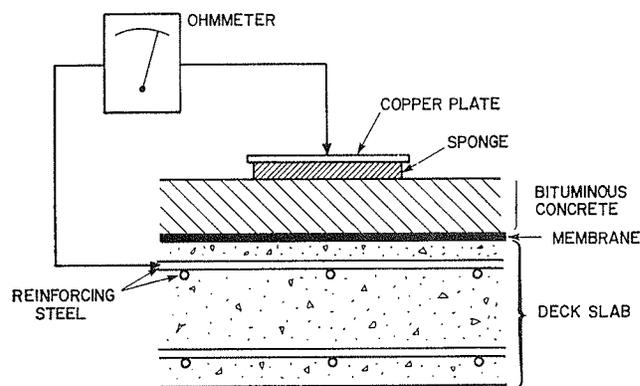
FIGURE 4 Circuit for measuring the electrical resistance of membranes.

The procedure consists of connecting one lead of an ohmmeter to the reinforcing steel and the other lead to an electrode on the deck surface, which consists of a copper plate and wet sponge (see Figure 4); the electrical circuit is not completed until wetting solution from the sponge percolates through the asphalt to the membrane. A full description of the equipment and a standard test procedure have been published by the American Society for Testing and Materials (ASTM D3633).

test locations before testing can begin. A representative, well-compacted test location is chosen as a checkpoint. Resistance readings are taken at intervals until the resistance stabilizes, which indicates that the wetting solution has reached the surface of the membrane. A wetting period of 30 minutes is often sufficient, but where the resistance readings remain infinite, measurements should continue for at least 4 hours.

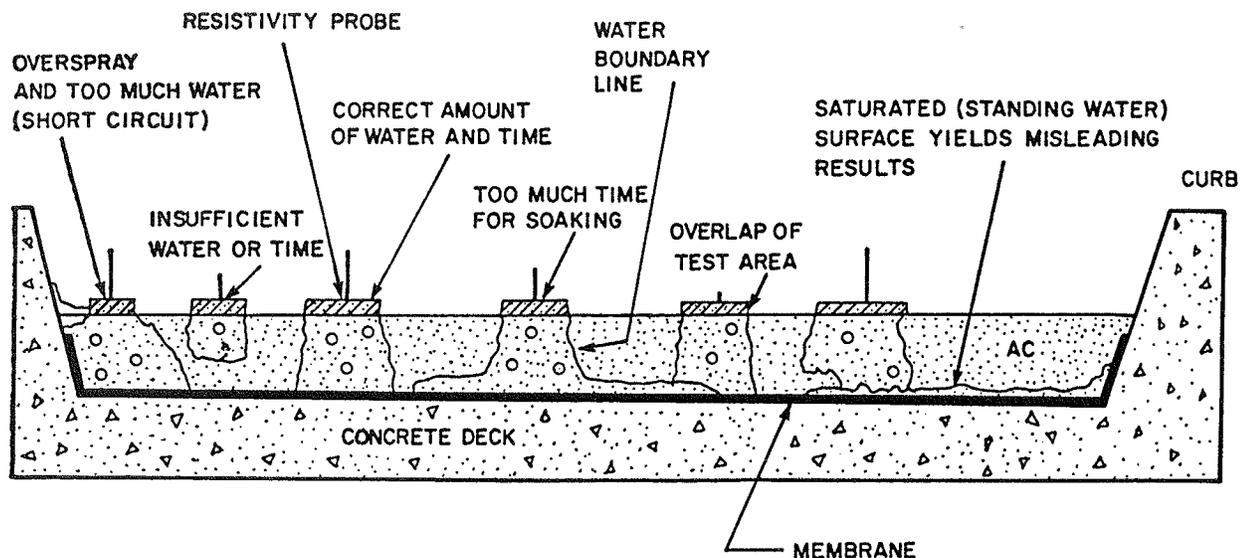
FIGURE 5 Possible problems in "resistivity" measurements (26).

A number of difficulties have been experienced in applying resistance measurements mainly because of variations in pavement porosity, moisture in the surfacing, and short circuits to the reinforcing steel (25–28). Some of the problems that can occur are illustrated in Figure 5. As originally conceived, the test method involved placing a sponge directly on a sealed concrete surface, in which case the contact area was known and the “resistivity” of the sealer could be calculated. (The units of electrical resistivity are ohm/m. The literature refers to the quotient of the resistance and the contact area of the sponge in ASTM D3633 as “resistivity,” which has the units ohm/m<sup>2</sup>.) When testing a membrane beneath a bituminous overlay, the area of contact between the wetting solution and the membrane is not the same as the area of the sponge but is a function of the time of soaking, the permeability of the asphalt, the moisture content of the asphalt, and the longitudinal grade and crossfall of the deck. If water is ponded on the top of the membranes, as is often the case, a short circuit to the reinforcing steel may occur through embedded hardware such as a deck drain or steel expansion joint. A note in ASTM D3633 suggests checking for excessive moisture in the asphalt by attaching the ohmmeter to the reinforcing steel and two probes on the deck surface. Immediate low readings (of the order of 10 000 Ω) indicate excessive moisture and further testing should be postponed.

When using a direct current ohmmeter, problems of drift and non-reproducible values resulting from the galvanic coupling of the copper plate to the reinforcing steel are often experienced. Approximate readings can sometimes be made by

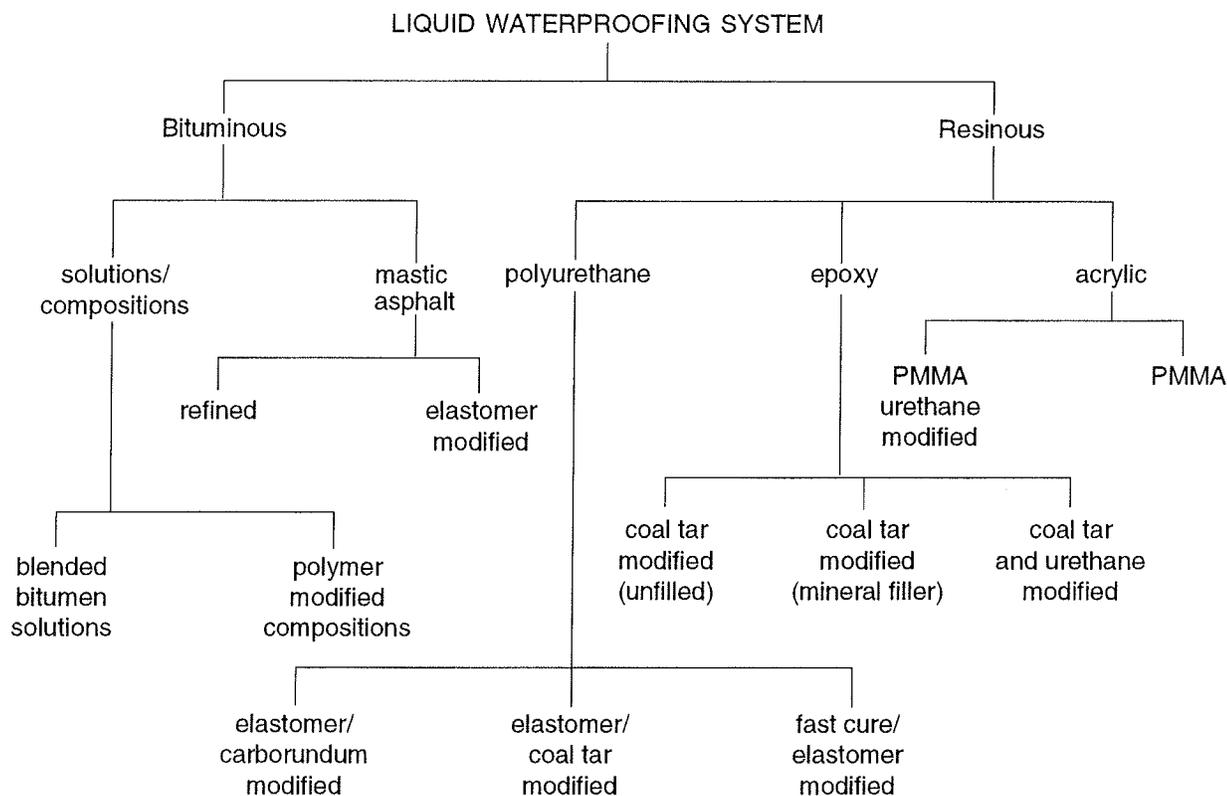
FIGURE 7 Liquid waterproofing systems (adapted from 9).

The resin-based systems were either one or two part mois-

ture curing or two part chemical curing, based on either urethane, epoxy, or acrylic resins.

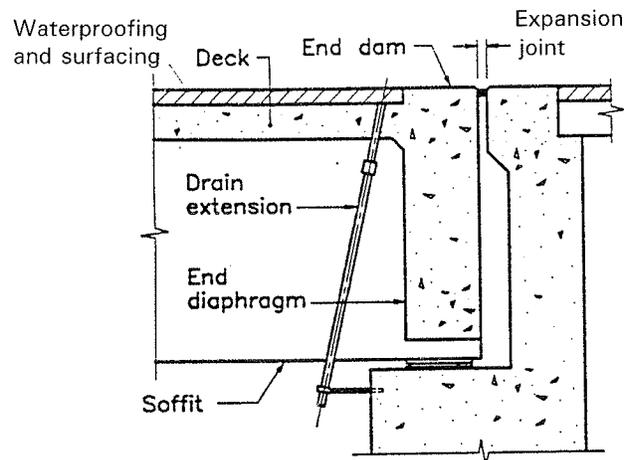
1. Top of drain to be installed flush with top of concrete deck.
2. Coupler and extension piece not to be installed until after removal of deck framework.
3. Drain to be 40 mm ID rigid PVC tube.
4. All metal parts to be galvanized.

FIGURE 8 Typical seepage drain detail.

Deck drains are often not located at the lowest points of the deck slab (in environmentally sensitive locations, there may be no deck drains), and seepage drains should be provided. The purpose of the seepage drains is to remove water from the surface of the membrane, and a typical detail is shown in Figure 8.

These drains are also sometimes called bleeder drains. To be effective, the top of the drain must be installed flush with the top of the concrete deck, and waterproofing material must not seal the tube. Figure 9 shows a deck (built without seepage drains) with water ponding on the membrane prior to application of the surfacing. In Europe, proprietary seepage drains that are attached to the formwork prior to placing the deck slab are sometimes used. Some models allow for the escape of vapors from a ventilating layer as well as drainage of the surface of the membrane. Although sometimes used in Europe, ventilating layers are not recommended because of the importance of bond to the overall performance of waterproofing systems. Other precautions, discussed elsewhere in this chapter, can be taken to prevent blistering.

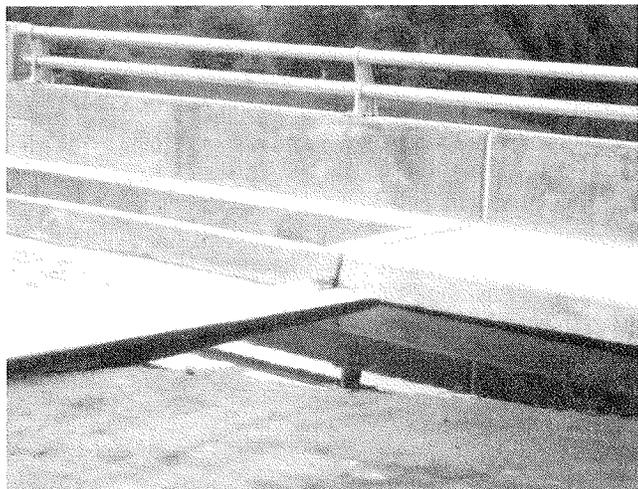
FIGURE 9 Water ponding on a membrane where a seepage drain is not provided.

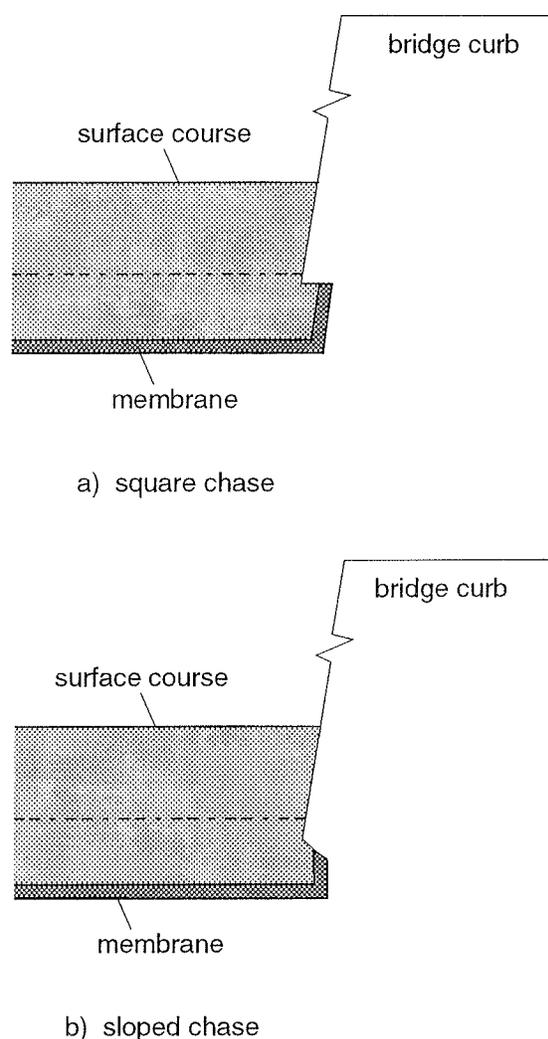
FIGURE 10 Typical chase details.

There is no agreement that a chase will improve membrane performance. The practice in Vermont is not to apply pre-

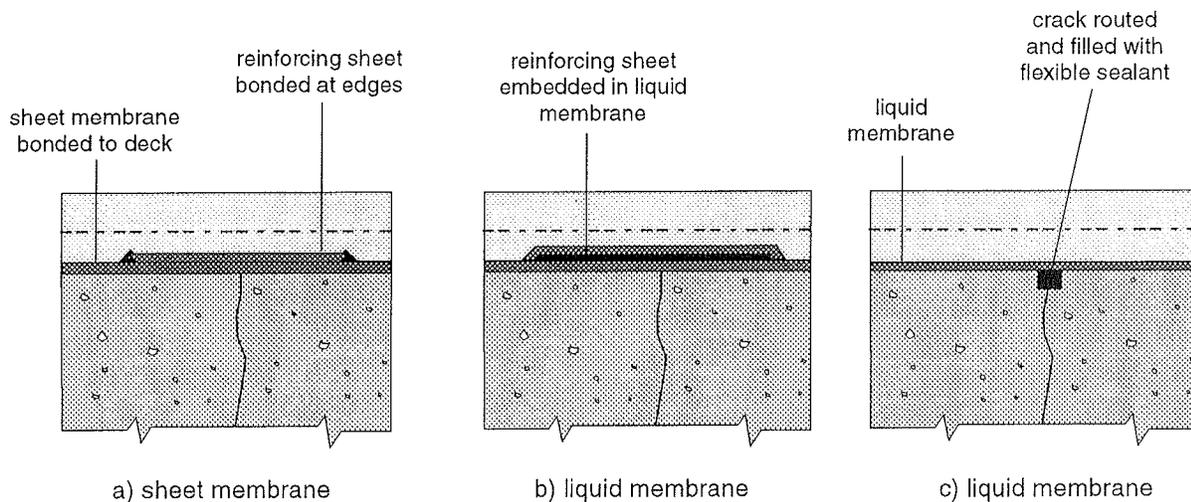
FIGURE 11 Waterproofing details at active cracks and construction joints.

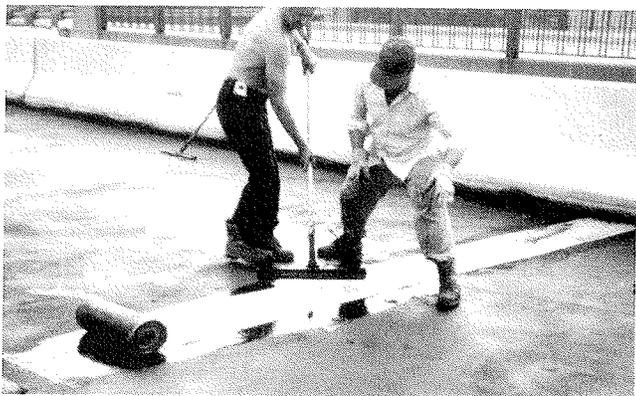
FIGURE 12 Use of a strip of preformed sheet embedded in liquid membrane at a construction joint in the deck.

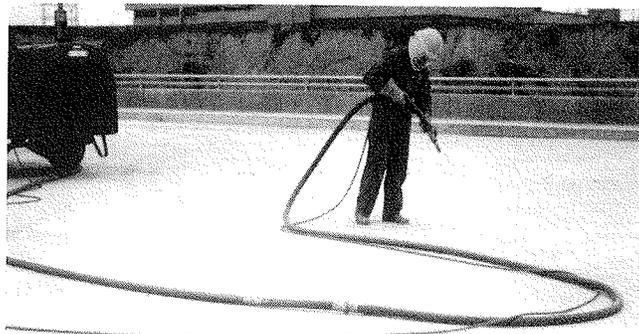
FIGURE 13 Sand blasting a bridge deck prior to waterproofing.

Where a curing compound was used on the concrete surface, it must be removed completely (66). This can only be done adequately by water or abrasive blasting. During field trials undertaken in California in the early 1970s, problems were experienced with two different systems because of reactions with

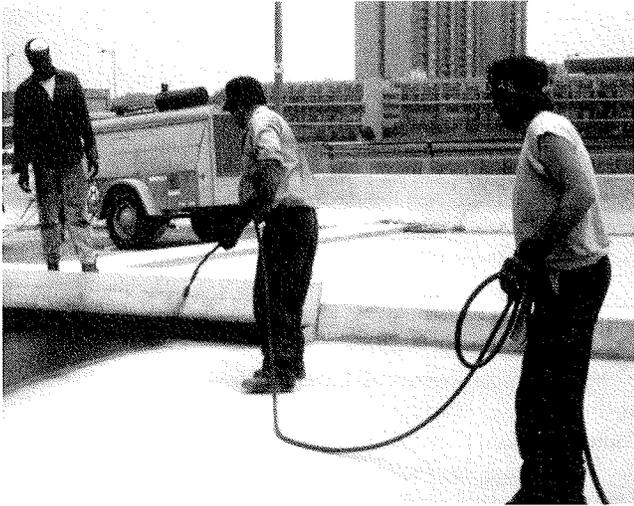
FIGURE 14 Application of an asphalt emulsion primer using a spray.

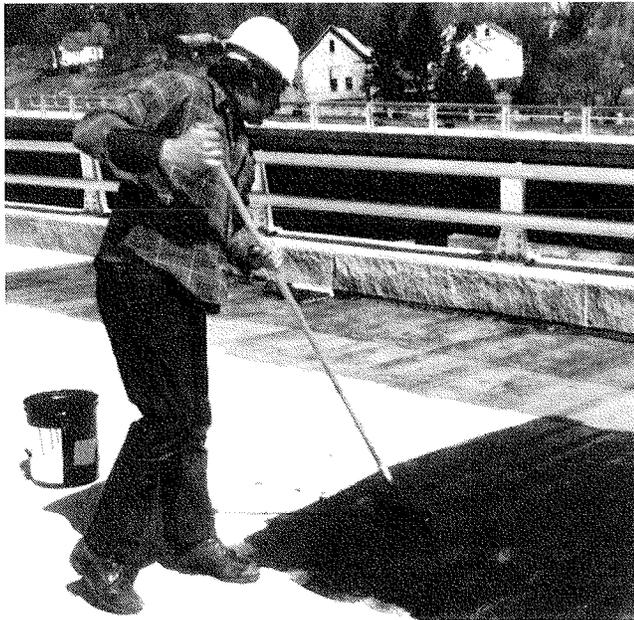
FIGURE 15 Application of a proprietary primer using a roller. (Courtesy of Vermont Agency of Transportation)

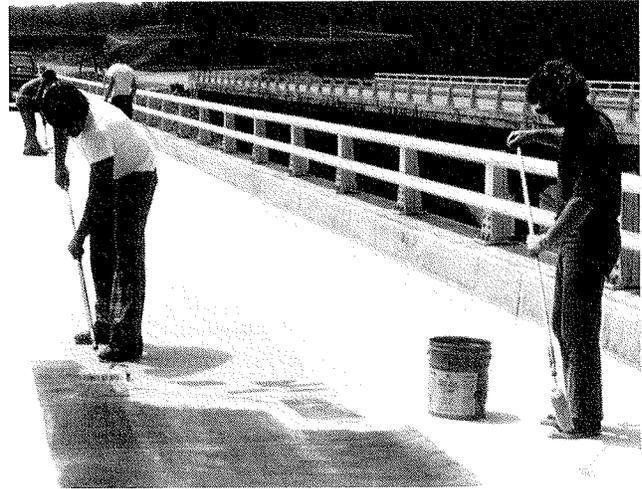
FIGURE 16 Applying adhesive to the deck and an EPDM rubber sheet. (Courtesy of Vermont Agency of Transportation)

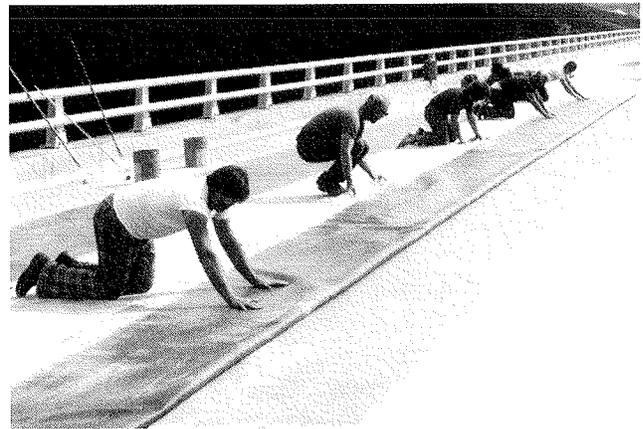
FIGURE 17 Rolling the EPDM rubber sheet on to the deck. (Courtesy of Vermont Agency of Transportation)

the deck in strips, with an overlap of approximately 100 mm (4 in.). The direction of unrolling is usually along the length of the bridge to avoid additional stresses on the lap joint during paving operations. Figure 18 shows a typical installation. Sometimes deck geometry or site conditions dictate laying across the width of the deck. In such cases, the installation should begin at the low end if the deck is on a grade, the analogy being with shingles on a roof. The adhesives are pressure sensitive and a heavy hand roller should be used. The bond strength is also a function of temperature, and the temperature at the time of installation should be 10°C (50°F) or more.

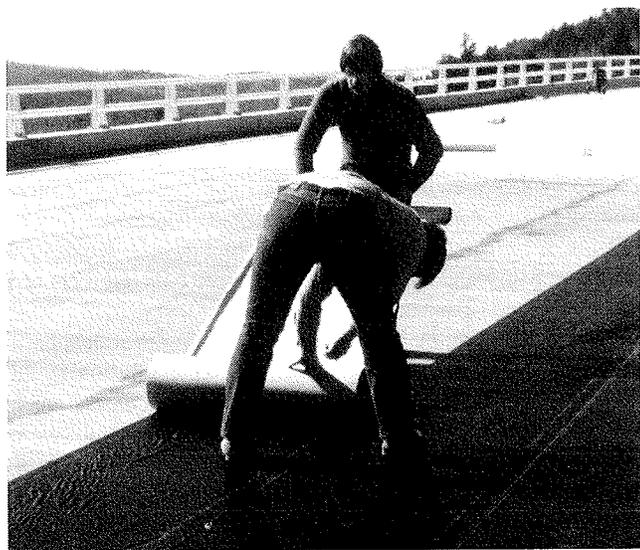
FIGURE 18 Application of a self-adhesive preformed membrane. (Courtesy of Vermont Agency of Transportation)

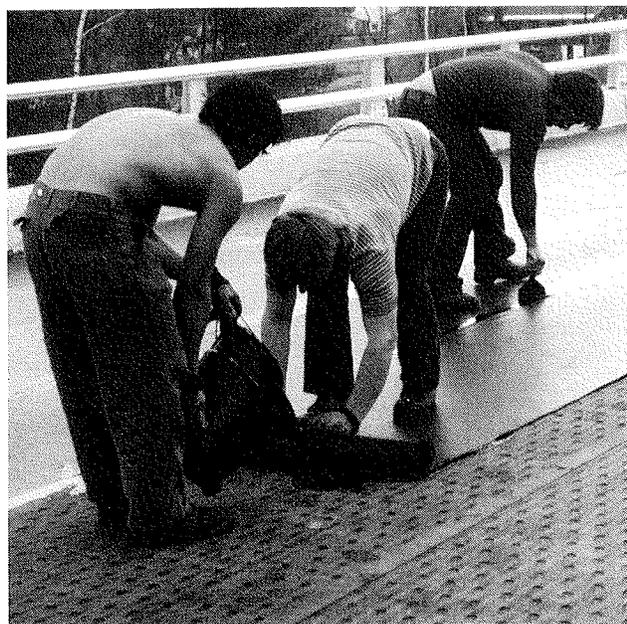
FIGURE 19 Application of a preformed membrane into hot bitumen. (Courtesy of Vermont Agency of Transportation)

Sheet systems that are not self-adhesive are usually bonded by the pour and roll method. Hot oxidized bitumen is poured on the deck in front of the sheet as it is unrolled and pressed into the bitumen. This is shown in Figure 19, which illustrates another of the membranes installed as a field trial in Phase II of

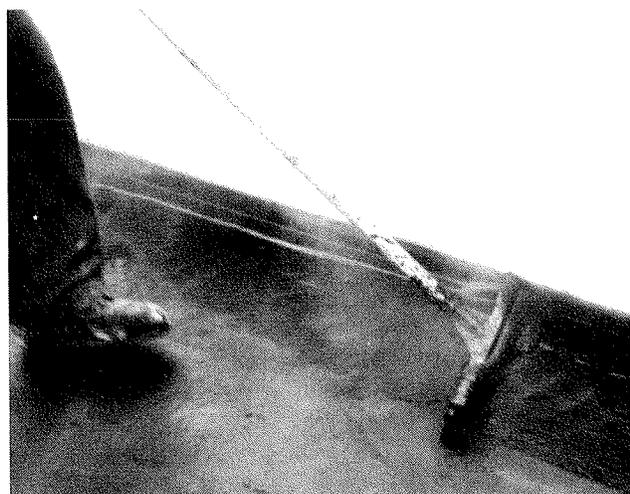
FIGURE 20 Application of a hot-applied rubberized asphalt by squeegee showing extension of membrane up the face of the curb.

Hot material is drawn from the kettle, poured on the deck, and spread to the specified thickness (typically  $5 \pm 1$  mm or  $0.2 \pm 0.04$  in.) in a continuous operation, usually by a squeegee. The membrane is also extended up the face of curbs (as shown in Figure 20), barrier walls, and deck drains as specified, usually terminating at the top of the surface course, or in a chase where this has been provided. Where the placing operation is interrupted, by weather or equipment failure for example, the membrane is lapped approximately 150 mm (6 in.) when placing resumes.

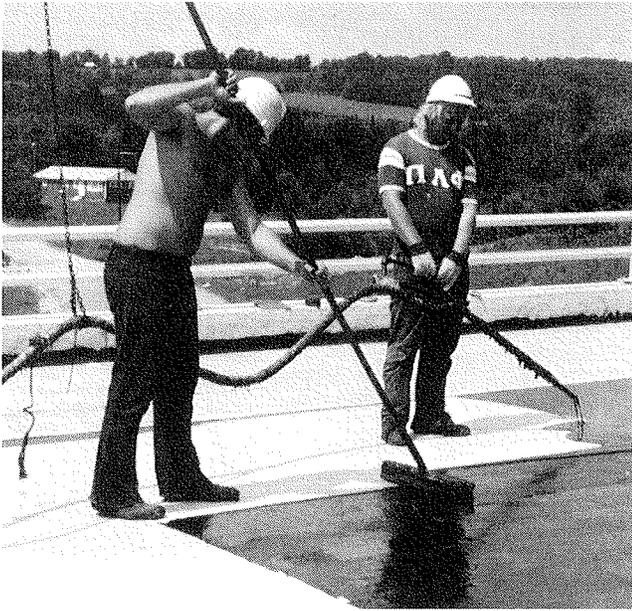
FIGURE 21 Extrusion and application by squeegee of a hot-applied PVC membrane. (Courtesy of Vermont Agency of Transportation)

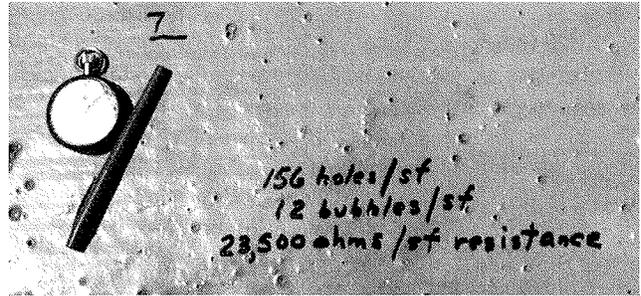
FIGURE 22 Numerous pinholes and blisters in a two-component polyurethane membrane. (Courtesy of Vermont Agency of Transportation)

A distinction is sometimes drawn between blisters and blowholes (2,5). Blowholes, which have the characteristic appearance of small craters, occur at the time of installation of

liquid membranes; blisters may develop in any kind of membrane several hours after installation. Blowholes may be formed by the rapid expansion of vapors in the concrete during installation of hot-applied products or during the curing of cold-applied products because of rising ambient temperatures, decreasing atmospheric pressure, or the increase in deck temperature caused by increased absorption of solar radiation upon application of a black or dark-colored membrane. The possibility of blisters or blowholes occurring in any situation is determined by the porosity and moisture content of the concrete (71) and the atmospheric conditions during and after installation.

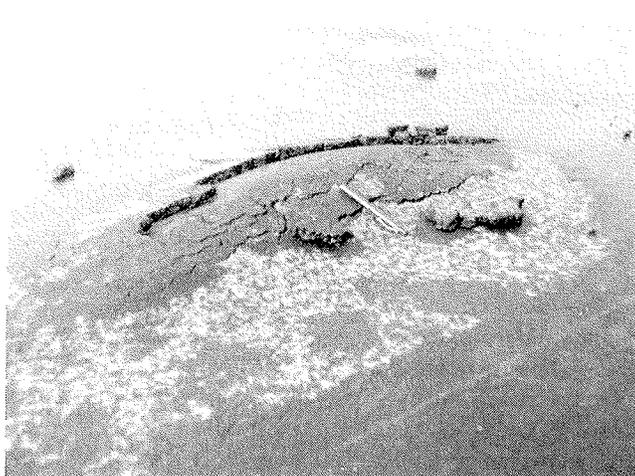
FIGURE 23 Blisters in membrane and base course. (Courtesy of Vermont Agency of Transportation)

The rapid expansion of vapor during placement of the hot mix can also result in blister formation. Unless the asphalt cracks, these blisters are difficult to detect and even more difficult to repair. Air pockets trapped beneath a protection layer will also have the same effect.

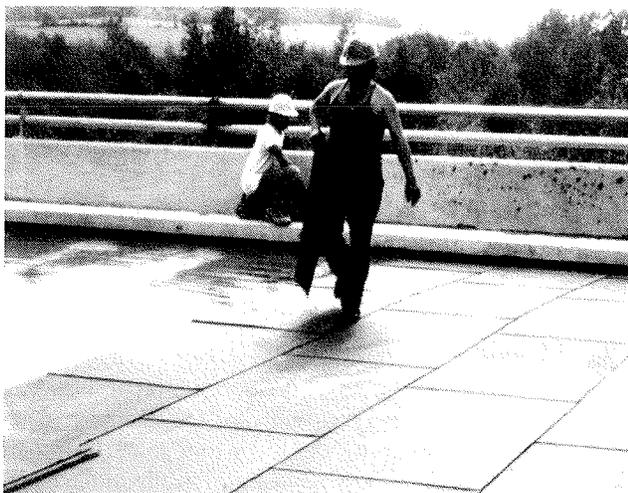
FIGURE 24 Protection boards applied over a rubberized asphalt membrane.

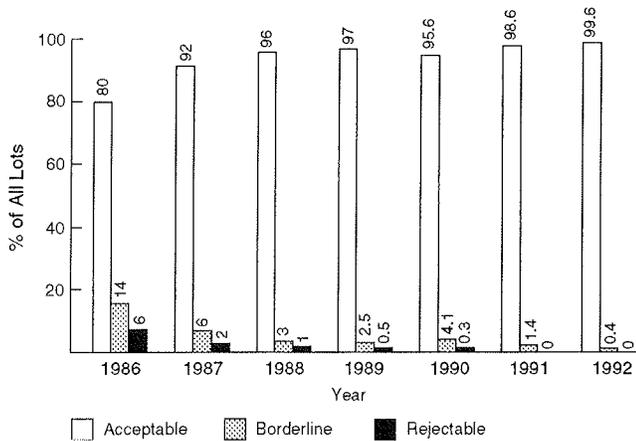
FIGURE 25 Annual thickness compliance for liquid membranes.

Figure 25 shows improvement in compliance with the thickness requirements from the introduction of the specification in 1986 to 1992. In 1986, only 80 percent of the lots were accept-

able, and 6 percent were rejectable. In 1992, a total of 94 890 m<sup>2</sup> (1,021,000 ft<sup>2</sup>) was installed by eight contractors. Of the 257 lots reported, there was only one borderline lot and no rejectable lot. The borderline lot received a price adjustment factor of 0.93.

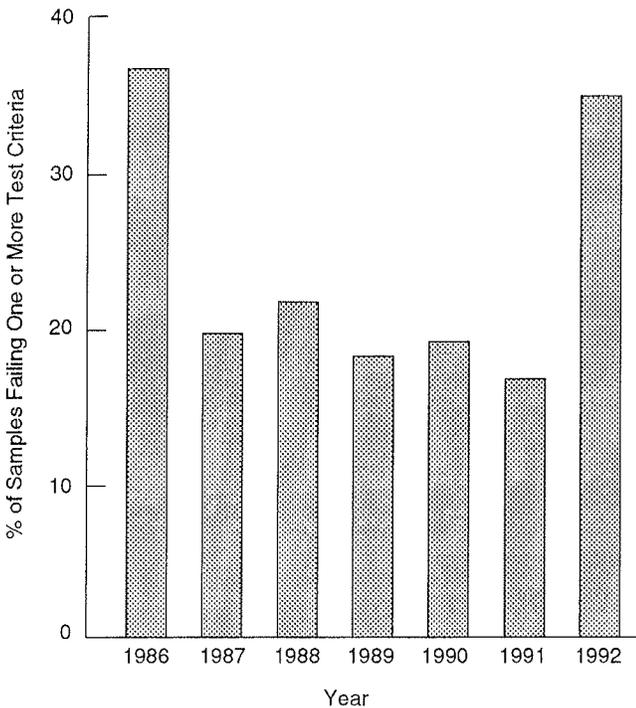
FIGURE 26 Annual material non-compliance for liquid membranes.

Figure 26 shows the history of quality tests for the period 1986 to 1992. The requirements were changed in 1986 and the price adjustment for quality was not implemented until 1987. Quality improved steadily until 1991, but in 1992 problems arose that had not been experienced previously. In 1992, 35 percent of samples failed one or more of the six quality criteria.

All of the samples that failed, failed the toughness/peak load ratio and some samples also failed other criteria. The poor performance was traced to an oil used in the manufacture of the products.

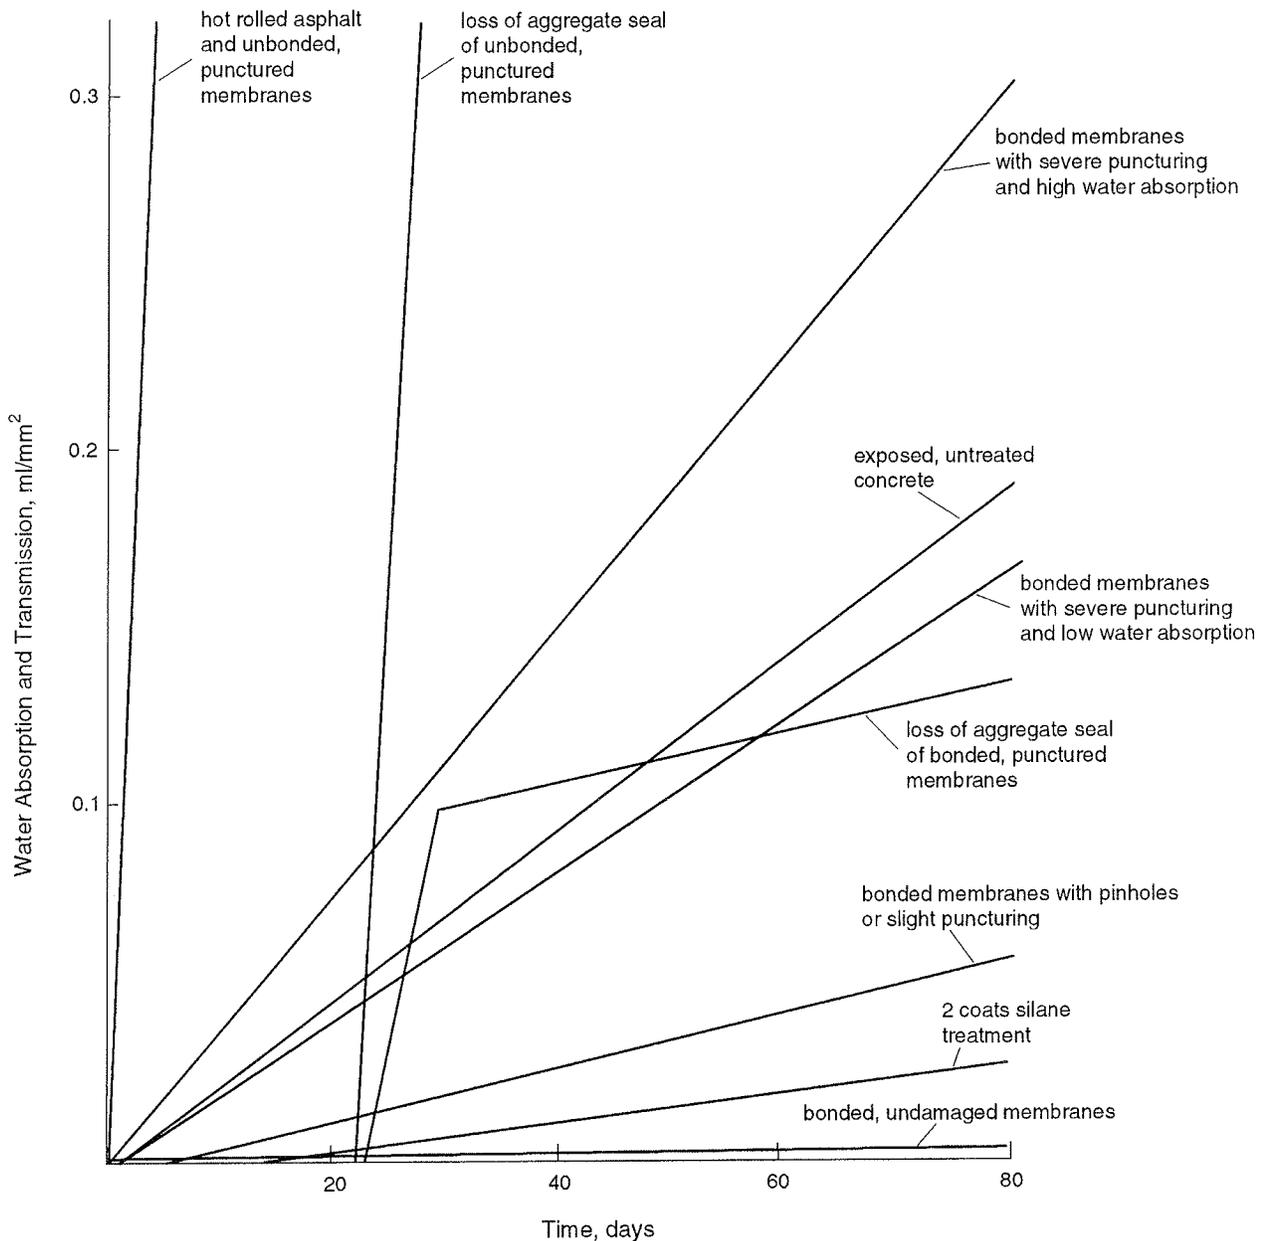
FIGURE 27 Absorption and transmission of water through membranes and surfacing (adapted from 21).

The results showed that where a membrane was fully bonded, undamaged, and had low water absorption, there was little or no transmission of water over the 80-day test period. At the other extreme, punctured membranes, which were either unbonded or exhibited high water absorption, were very permeable and passed more water than the untreated concrete because the spread of water was not contained.

For other conditions, the amount of water transmitted through the membrane was determined by its water absorption, the amount of damage, and the degree of bond. Even badly punctured membranes slowed the flow of water provided they were well bonded. Some punctured systems had aggregate particles embedded in the puncture, effectively sealing the hole. As the bitumen surrounding the aggregate particle embrittled, the aggregate was loosened and water transmitted through the membrane. This condition was common and likely often occurs in practice.

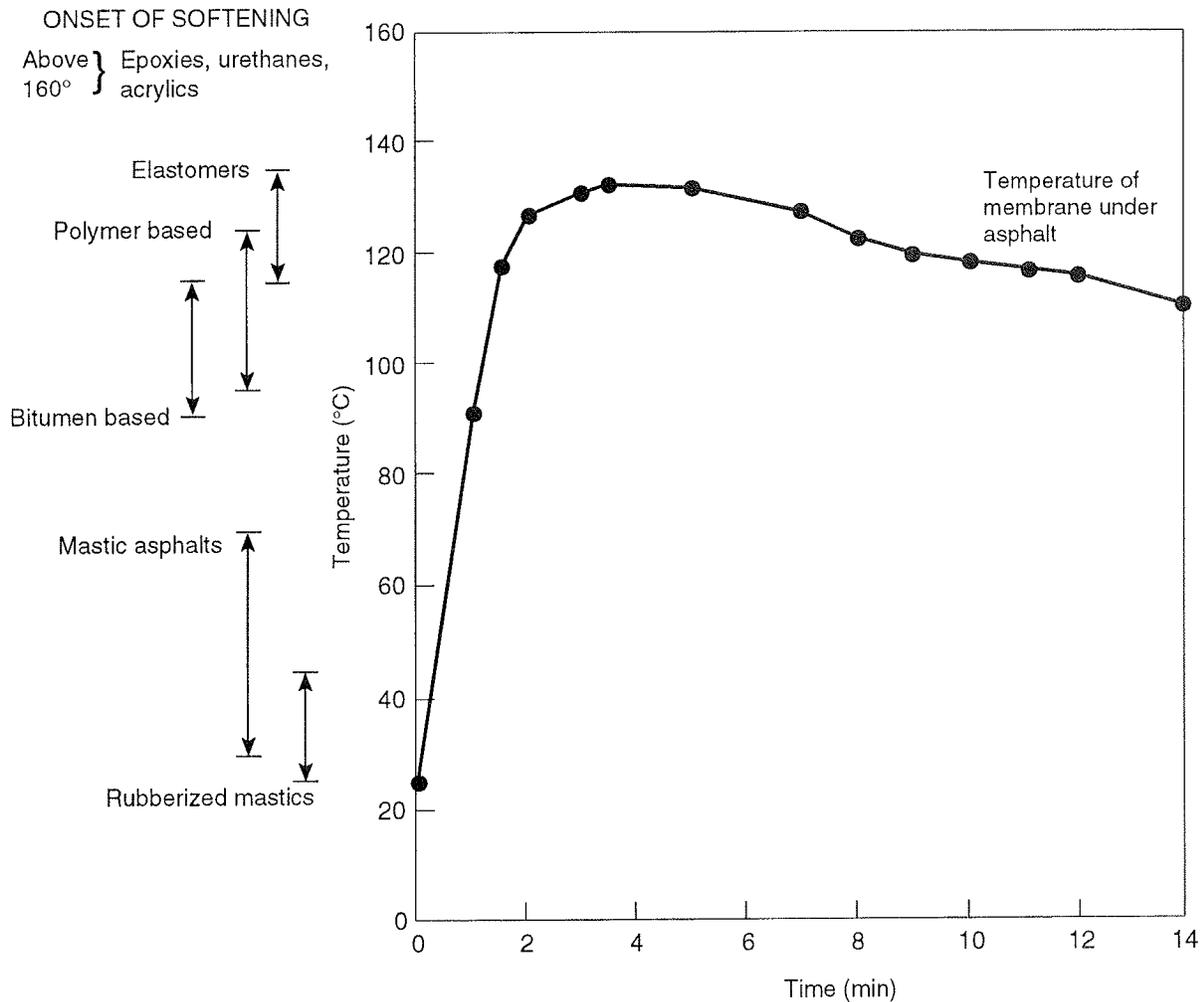
FIGURE 28 Typical asphalt application temperature on membranes, and softening temperatures of generic membranes.

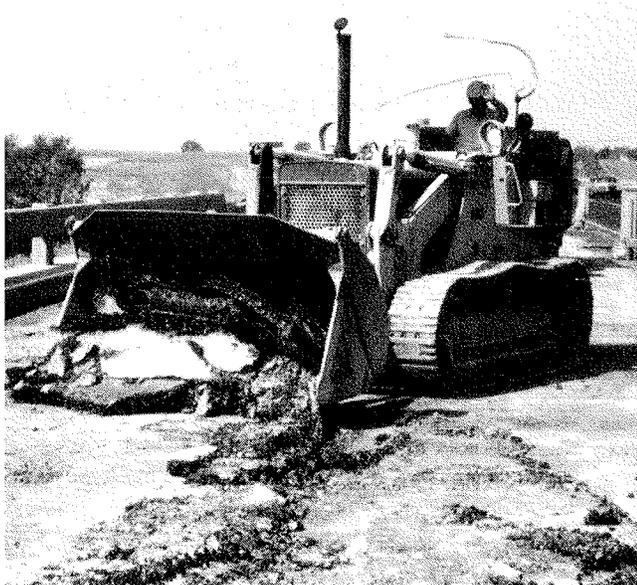
FIGURE 29 Use of a bucket to remove surfacing and poorly bonded membrane.

Where there is an existing membrane on the deck, the difficulty of removal is a function of the bond to the deck. If the bond is weak, the membrane can be planed, sometimes in the same operation as removing the asphalt surfacing as illustrated in Figure 29. In situations where the membrane is tightly adhered to the concrete, removal can be very difficult. Eleven responding agencies reported that they had experienced difficulties in removing existing membranes and eight agencies reported experiencing no difficulties. Other agencies reported no experience because it had not been necessary to remove membranes. The methods of removal varied, although planing or scraping, often followed by abrasive or water blasting, were most common. Some agencies use milling equipment, and Colorado reported using heat to soften the membrane so that it

can be removed by scraping. The softer, liquid membranes are especially difficult to remove because they remain tacky; they are also not easily removed by blasting. Recognizing these difficulties, several agencies reported that the contractor is allowed to leave remnants of membrane in place provided that they are tightly bonded to the deck surface. This does not appear to have caused problems in North America because of the limited range of membranes used. The issue of compatibility of materials is much larger in Europe because of the greater diversity of materials used in waterproofing systems. Where a bituminous system is being replaced by a resinous waterproofing system, very thorough preparation is necessary because of the incompatibility of many bitumens and resins (22). The deck also needs to be examined for evidence of applications of a sealer. Some silane treatments have been found to reduce the adhesion of membranes (66).

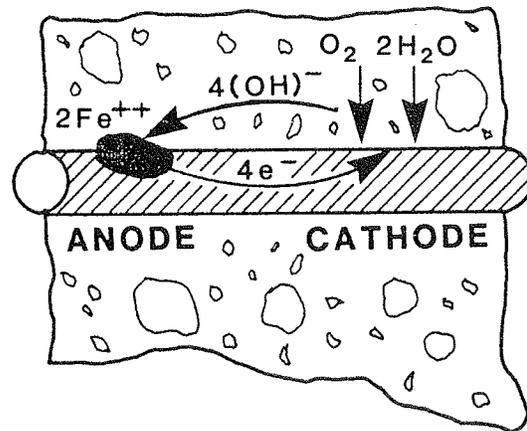
FIGURE 30 Simplified model of steel corrosion in concrete (101).

When repairs are made, the delaminated concrete is removed. Future corrosion activity is determined by the amount of concrete removed and the extent to which corrosion products are cleaned from the reinforcing steel. If the concrete is re-

moved from around the perimeter of the bars, and the corrosion deposits removed from the bars before (chloride free) patching material is placed, the steel in the patch area will become cathodic with respect to the steel outside the patch. Thus, a former anodic area becomes a cathode. In many cases, a greater potential difference exists across the perimeter of the patch than before the original concrete was removed. The steel outside the patch becomes the anode, and rapid corrosion of the steel surrounding the patch may occur.
