Evaluation of Metal-Tensioned Systems in Geotechnical Applications, Phase I

Interim Report

Prepared for:
National Cooperative Highway Research Program
Transportation Research Board
National Research Council

March 2001

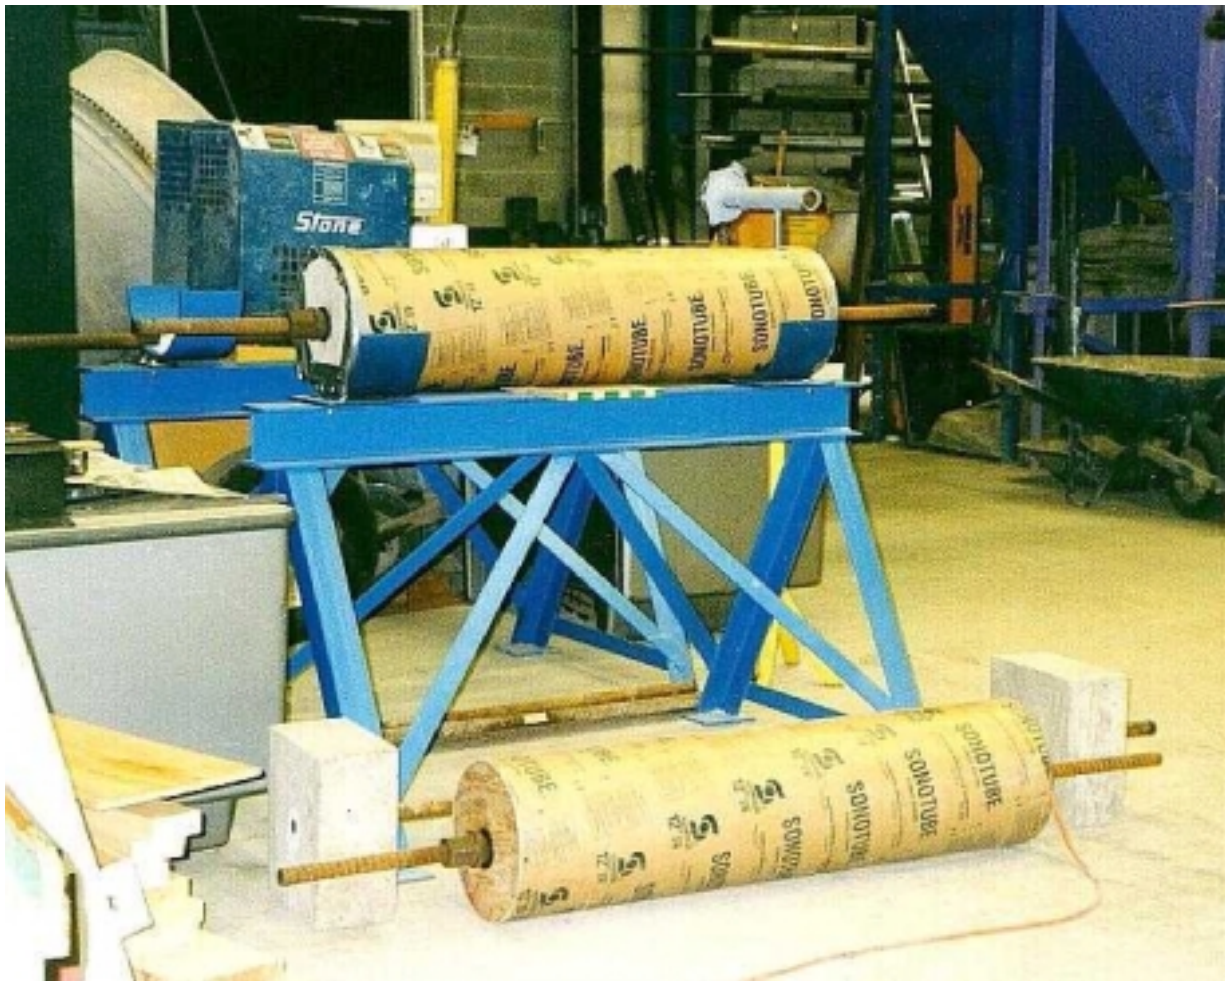
Figure 3-1: Bench-Scale Test Facility.

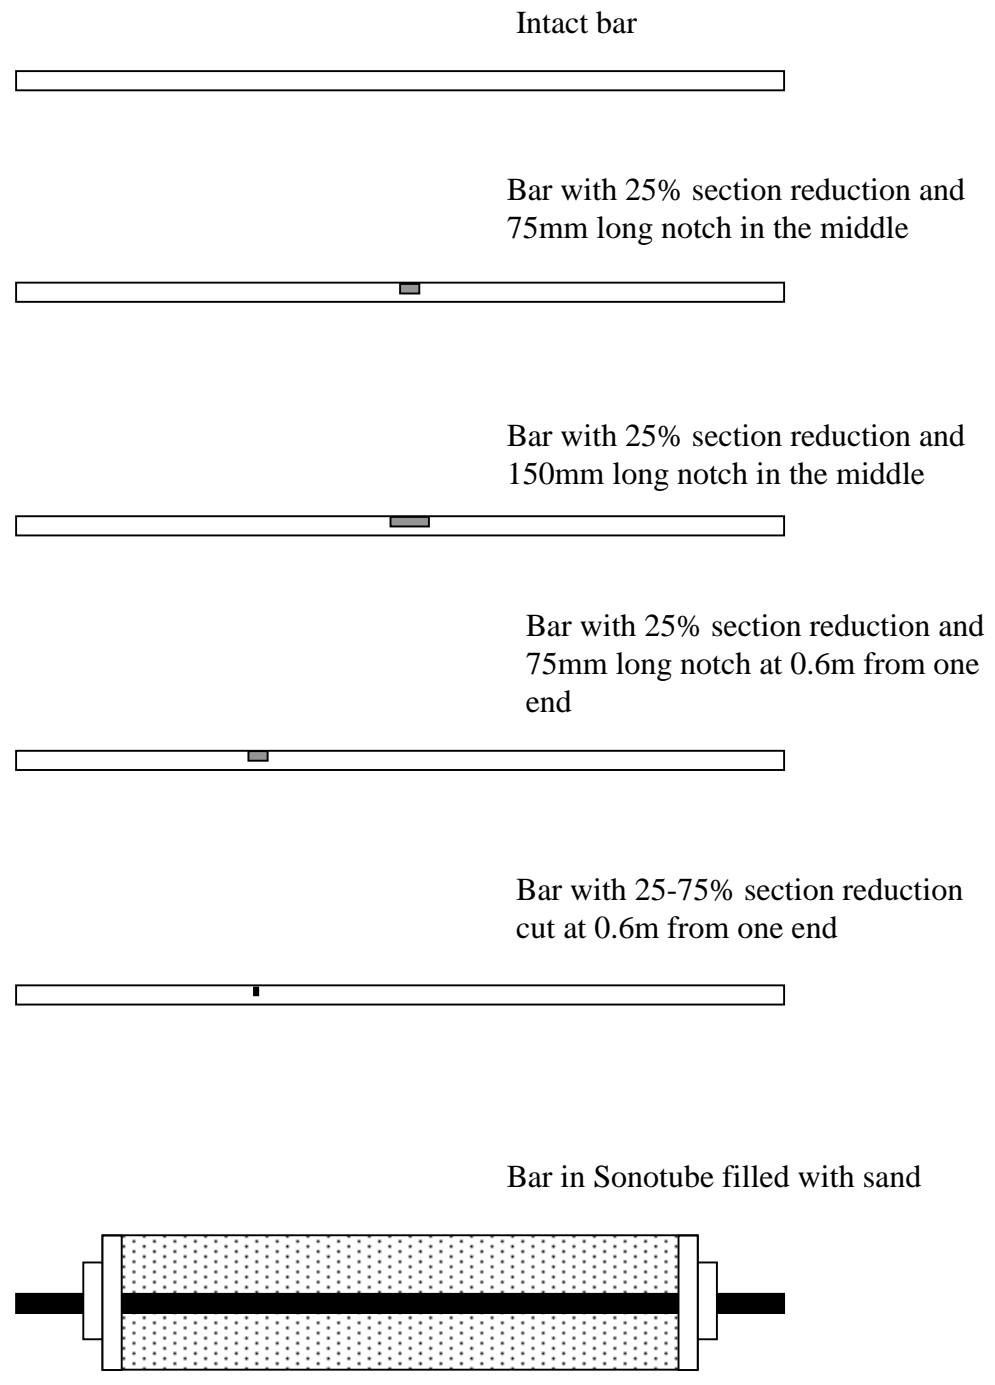
Figure 3-2: Bench-Scale Specimens- 2.0 m Long Plain Dywidag Bars.

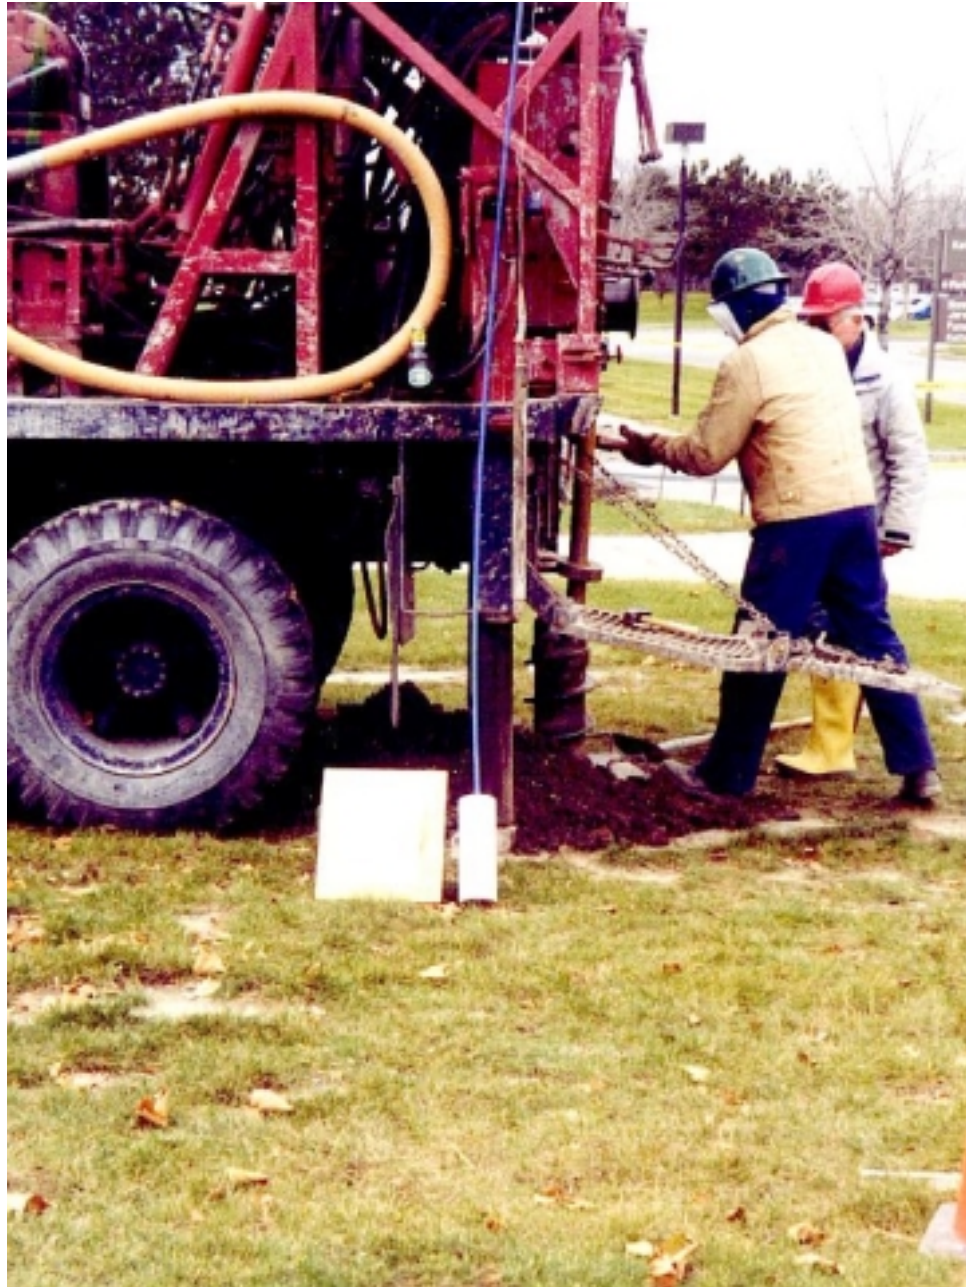
Figure 3-3: Installation of In-Situ Specimens.

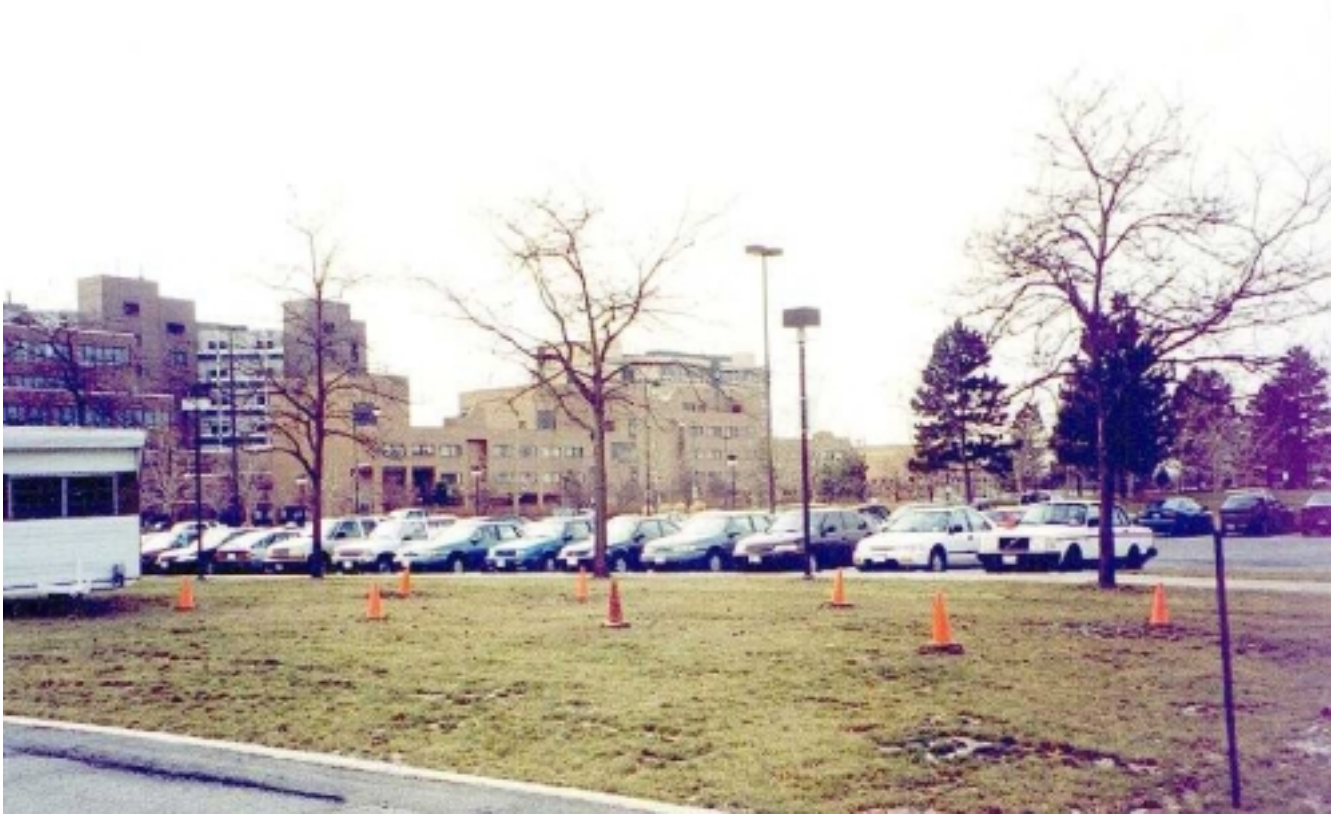
Figure 3-4: In-Situ Metal Specimen Testing Facility at U.B.

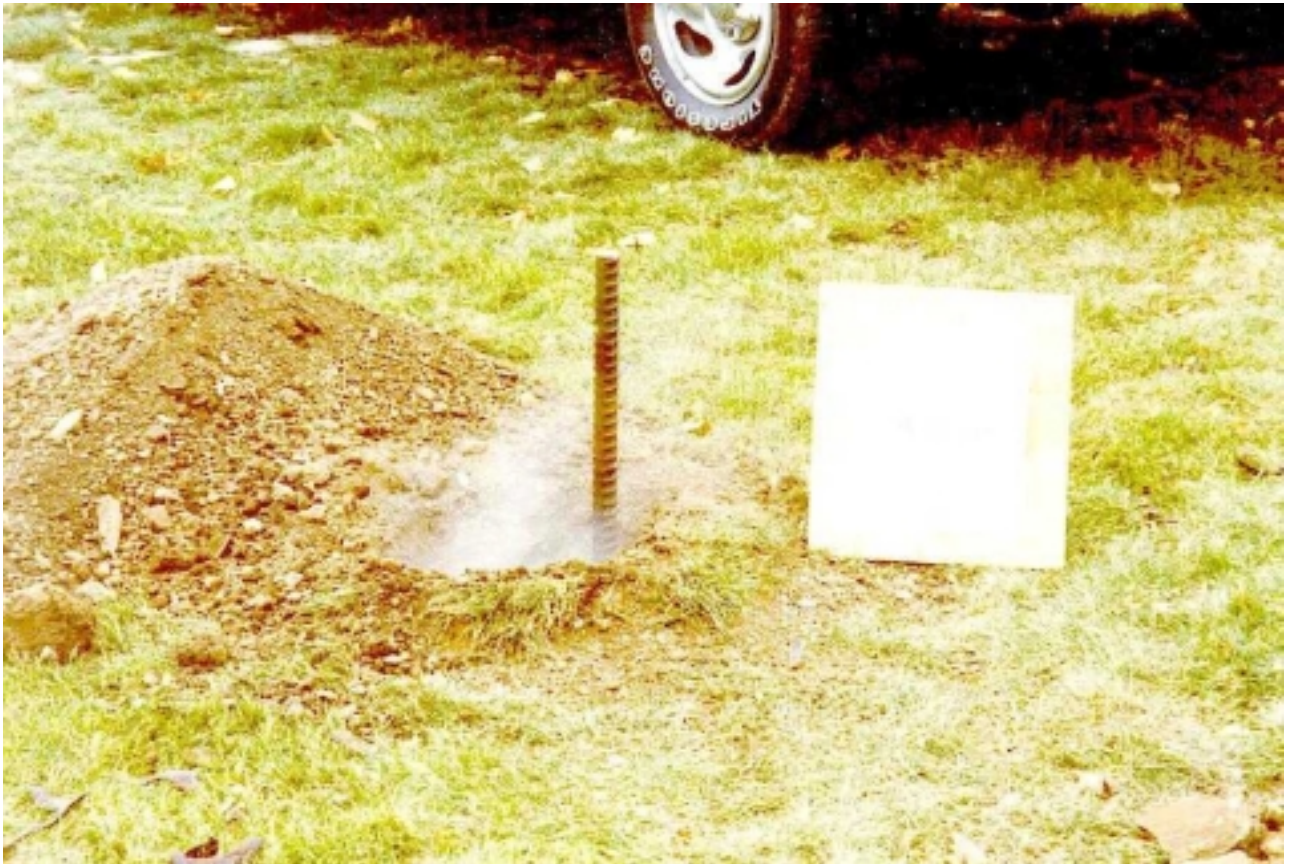
Figure 3-6(a): Installed In-Situ Specimen #1: Plain Bar.

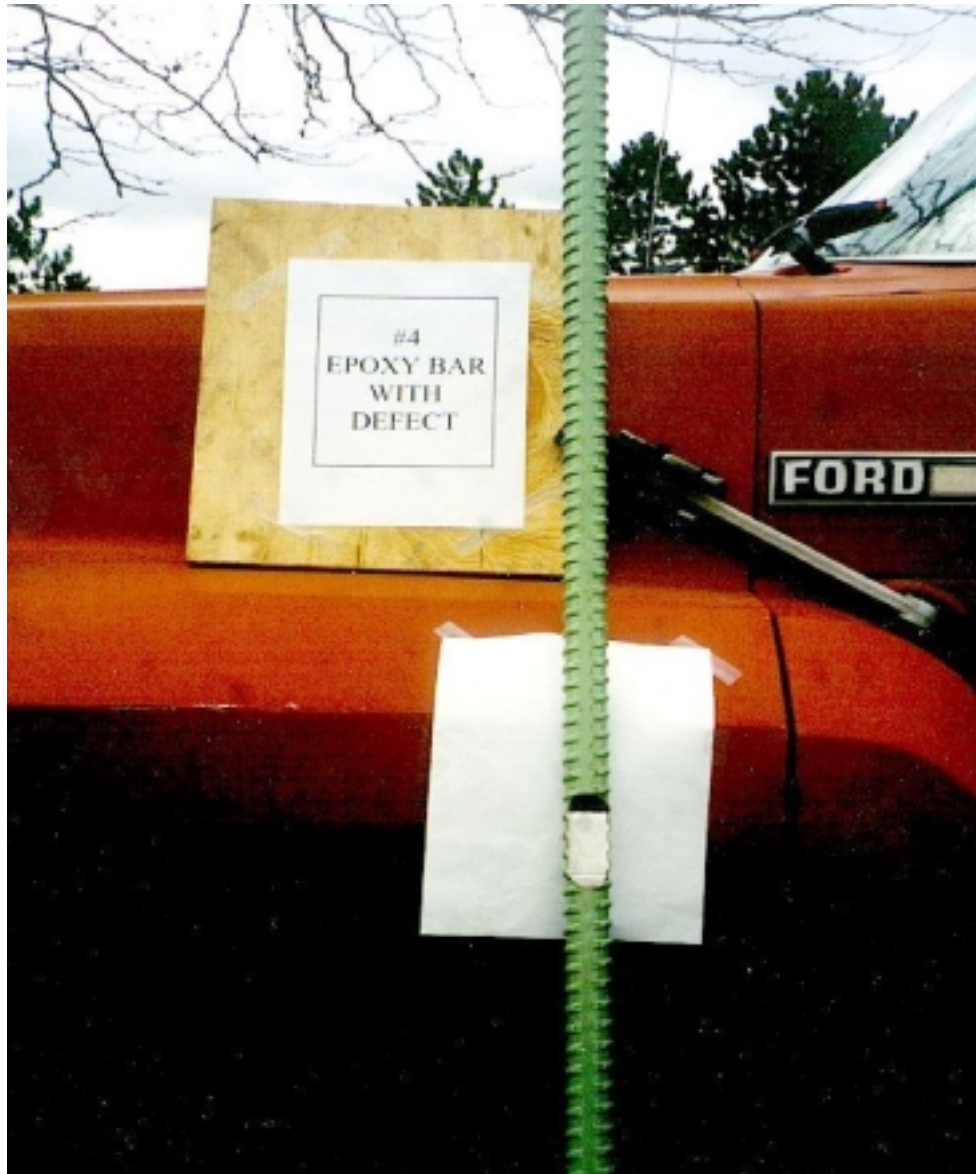
Figure 3-6(c): In-Situ Specimen #4: Epoxy Bar With Defect.

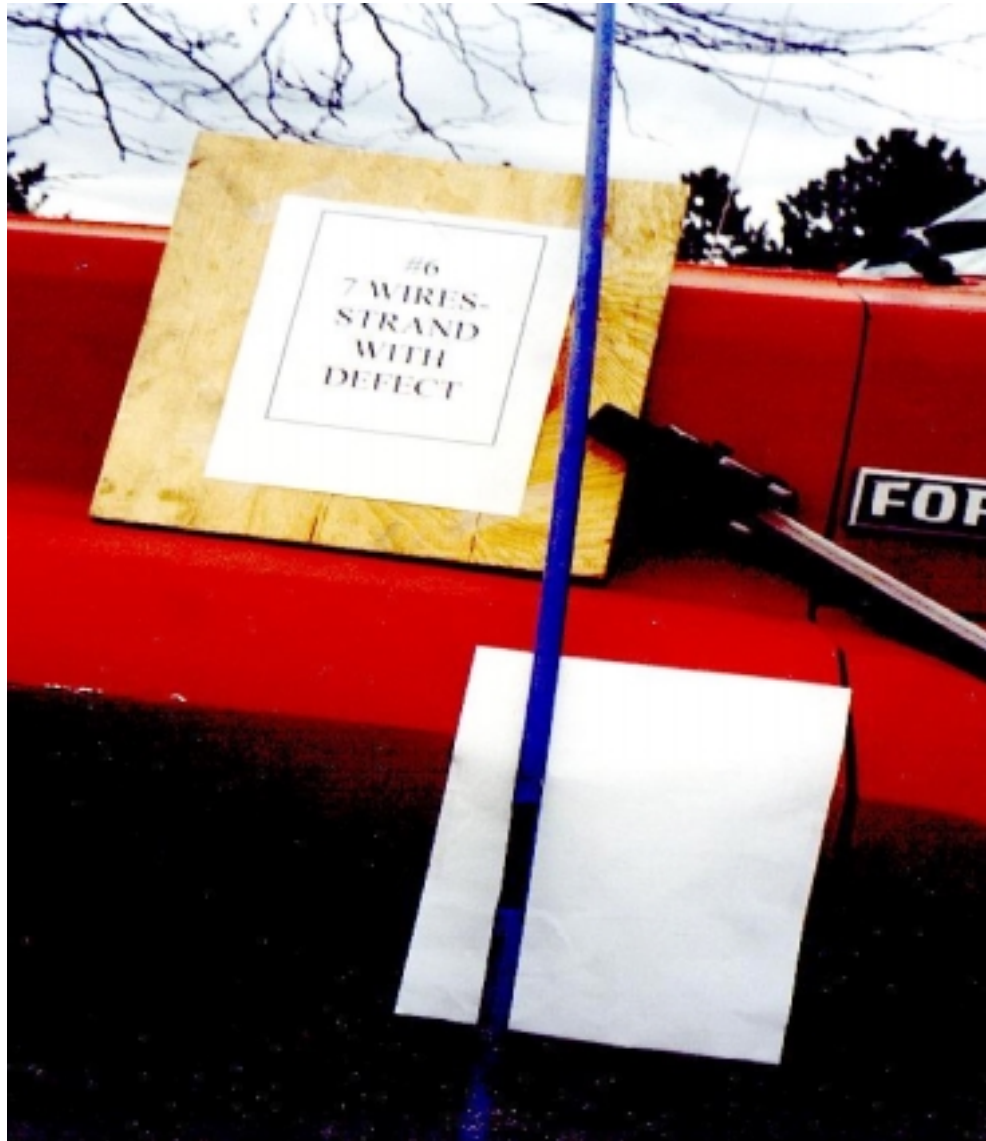
Figure 3-6(d): In-Situ Specimen #6: Seven-Wire Strand With Defect.

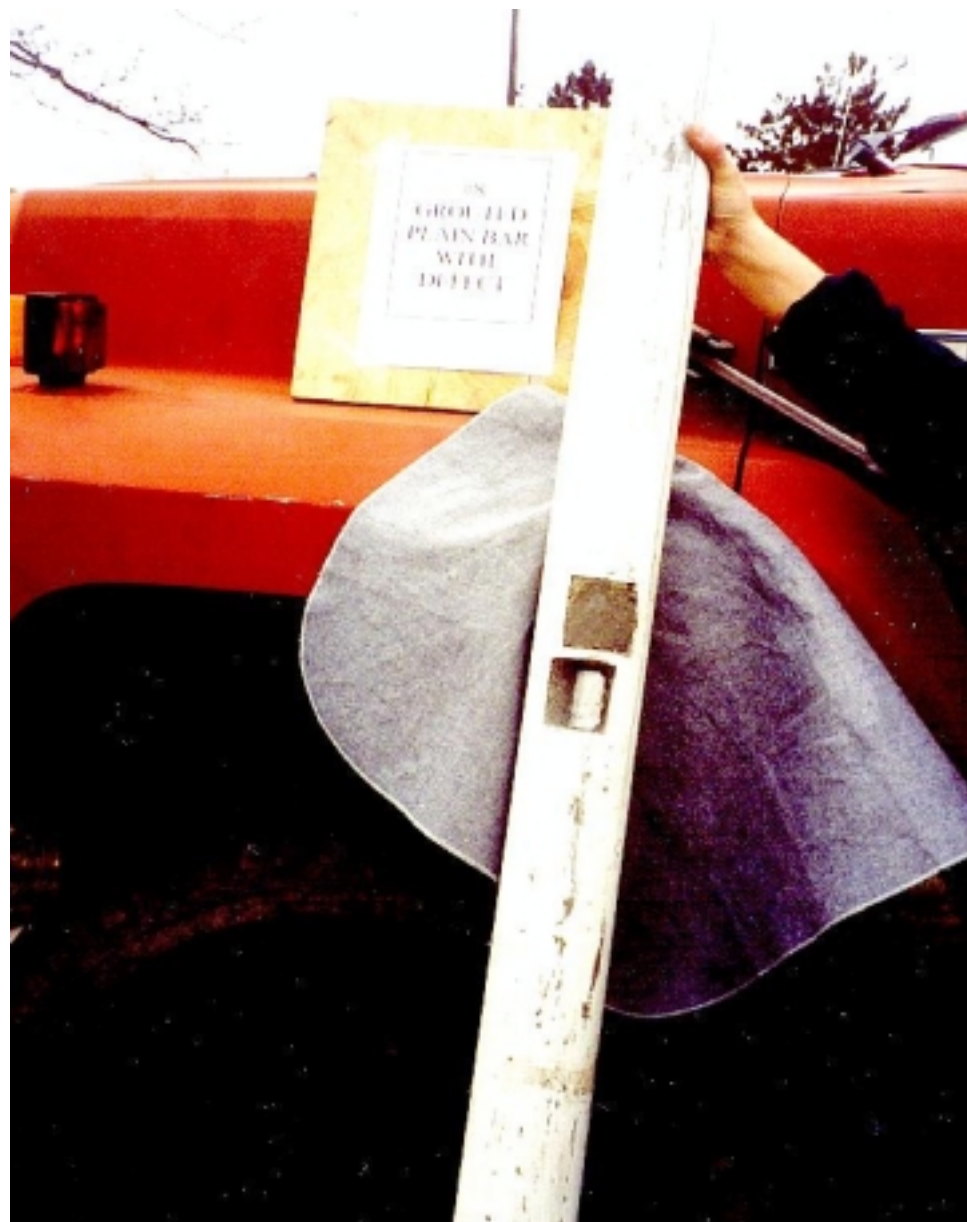
Figure 3-6(e): In-Situ Specimen #8: Grouted Bar With Defect.

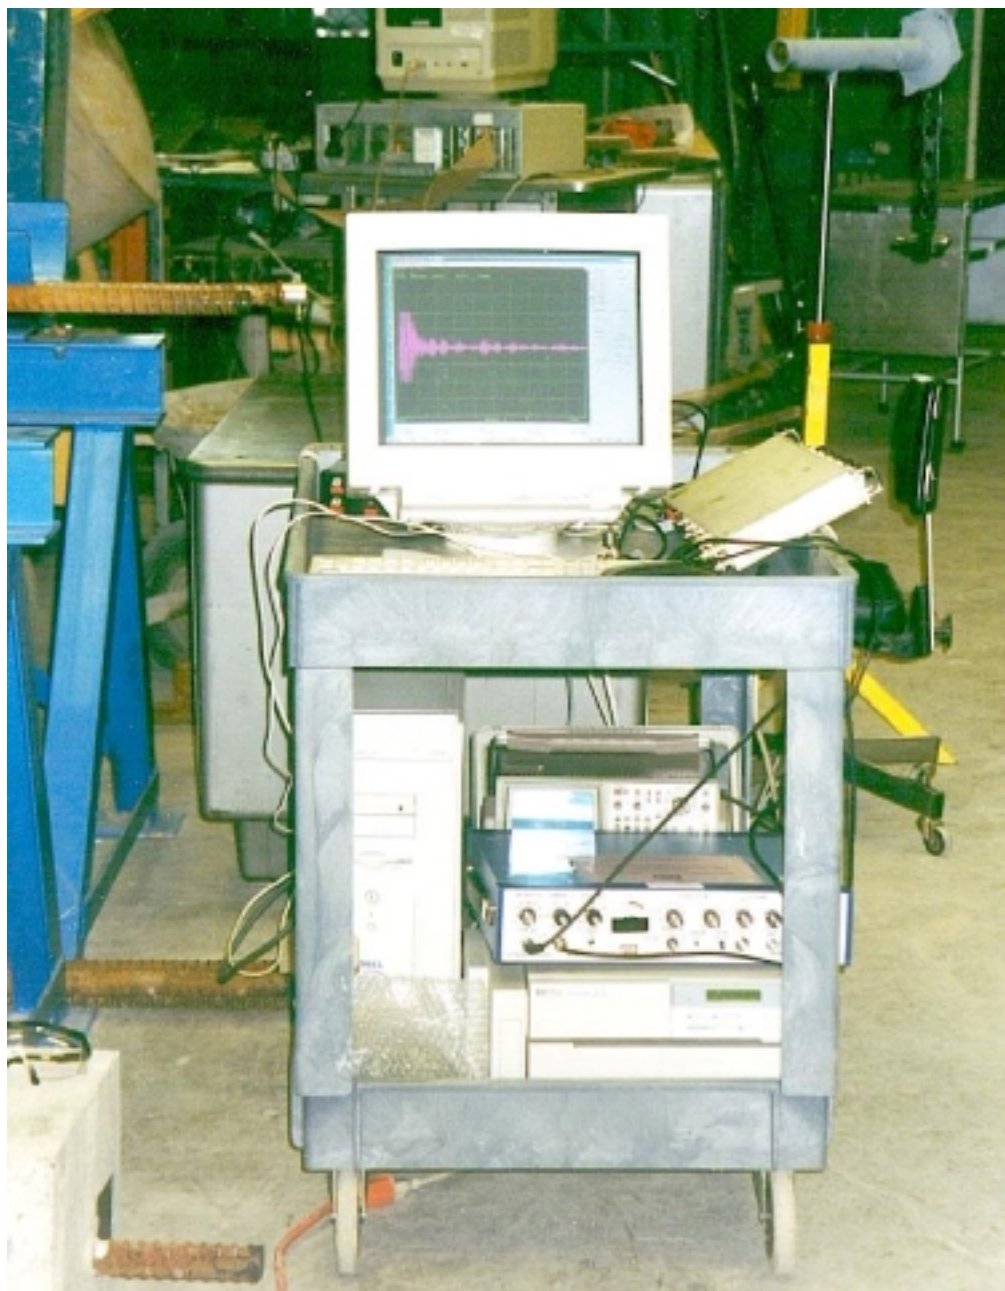
Figure 3-8. Computerized Data Acquisition System Placed on Cart.

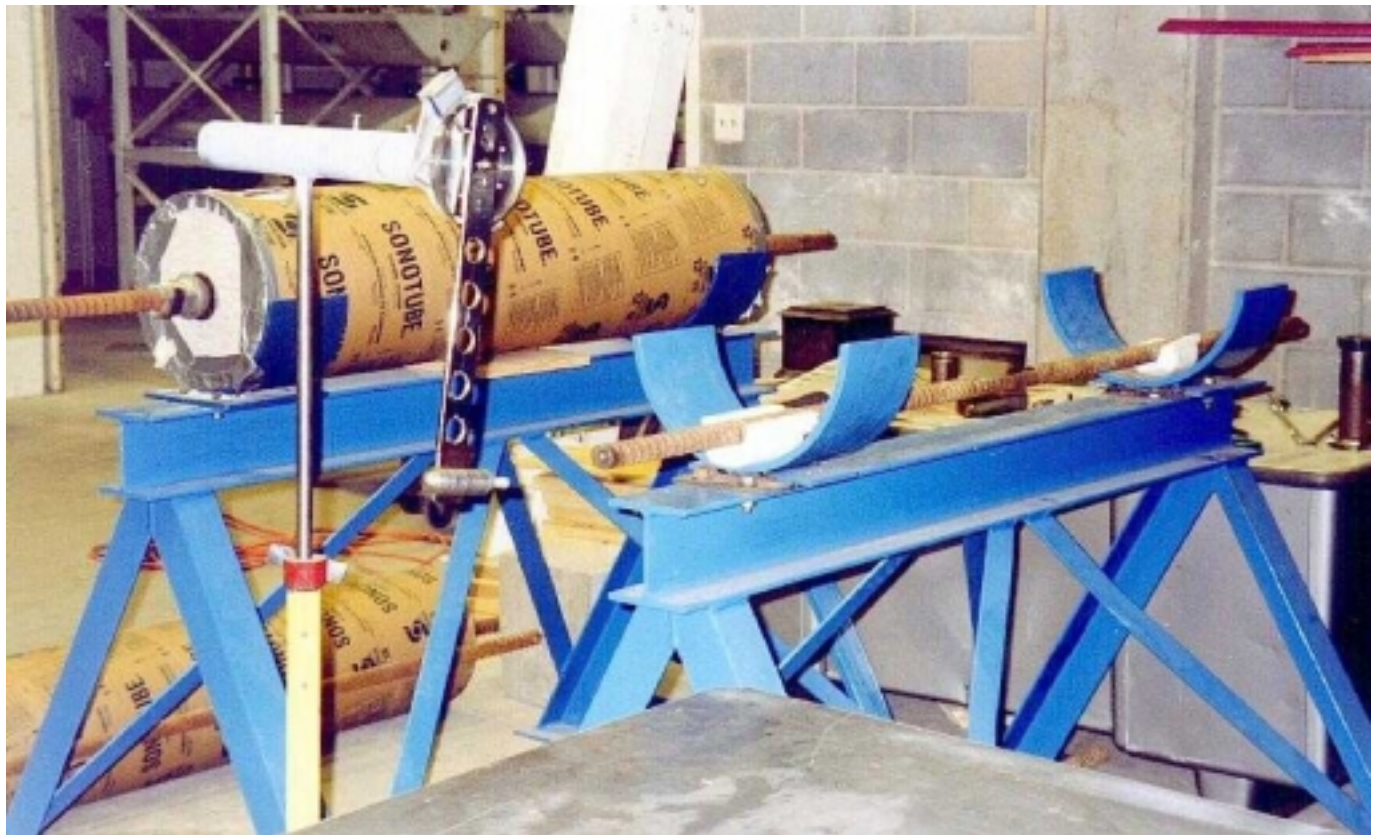
Figure 3-9: In-House Manufactured Pendulum With Ball Peen Hammer.

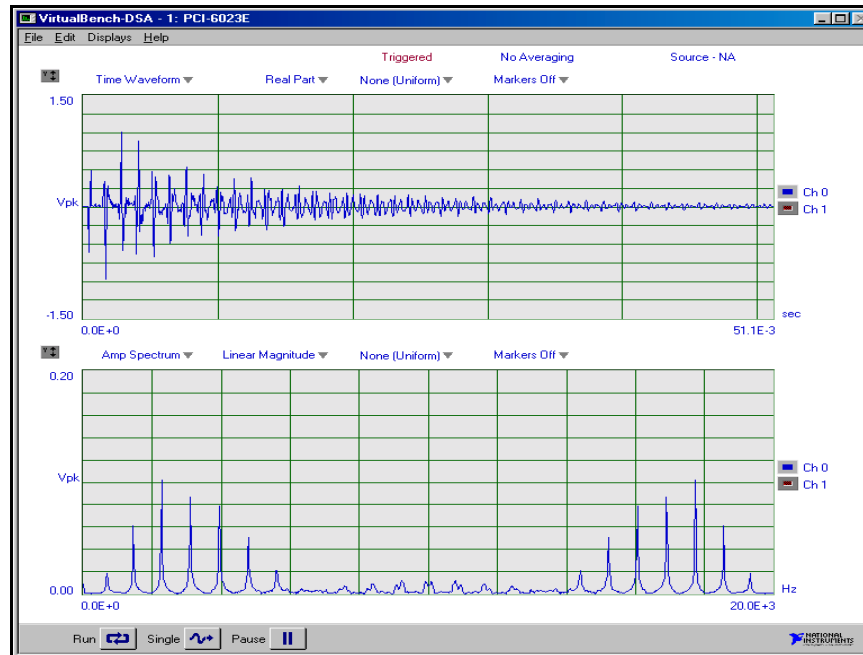
Figure 3-11(a): Impact Test Response for In-Situ Specimen #1- 3.0m Long Plain Bar; Impacted with Ball Peen Hammer.

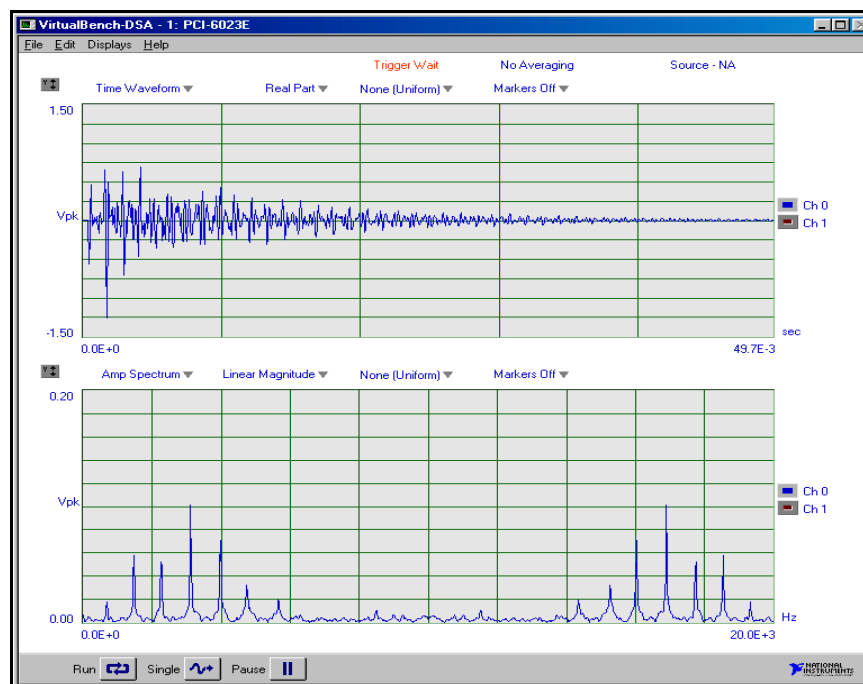
Figure 3-11(b): Impact Test Response for In-Situ Specimen #2- 3.0m Long Plain Bar with Defect; Impacted With Ball Peen Hammer.

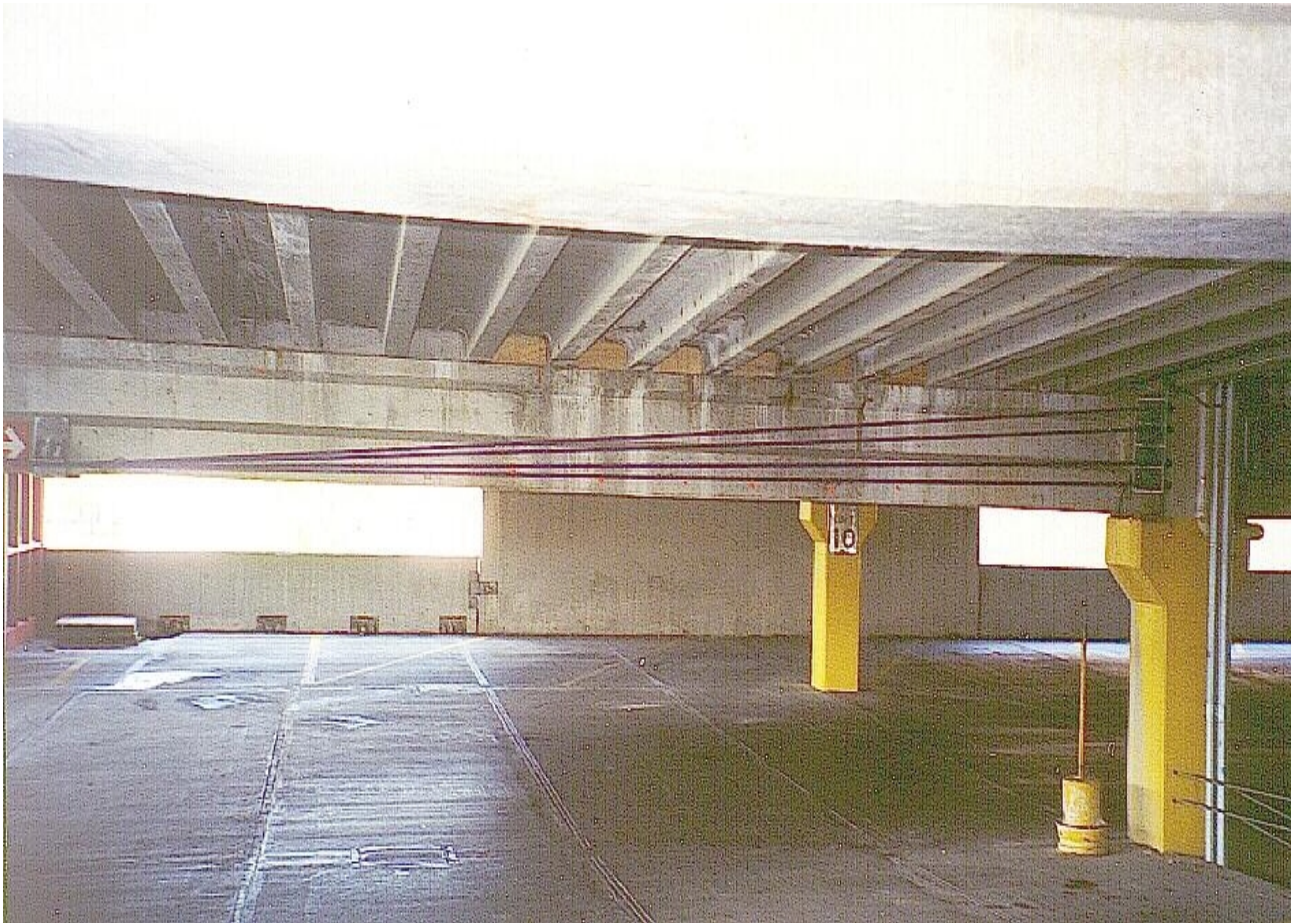
Figure 3-12(a): Retrofitted Beam at Niagara Falls Parking Garage.

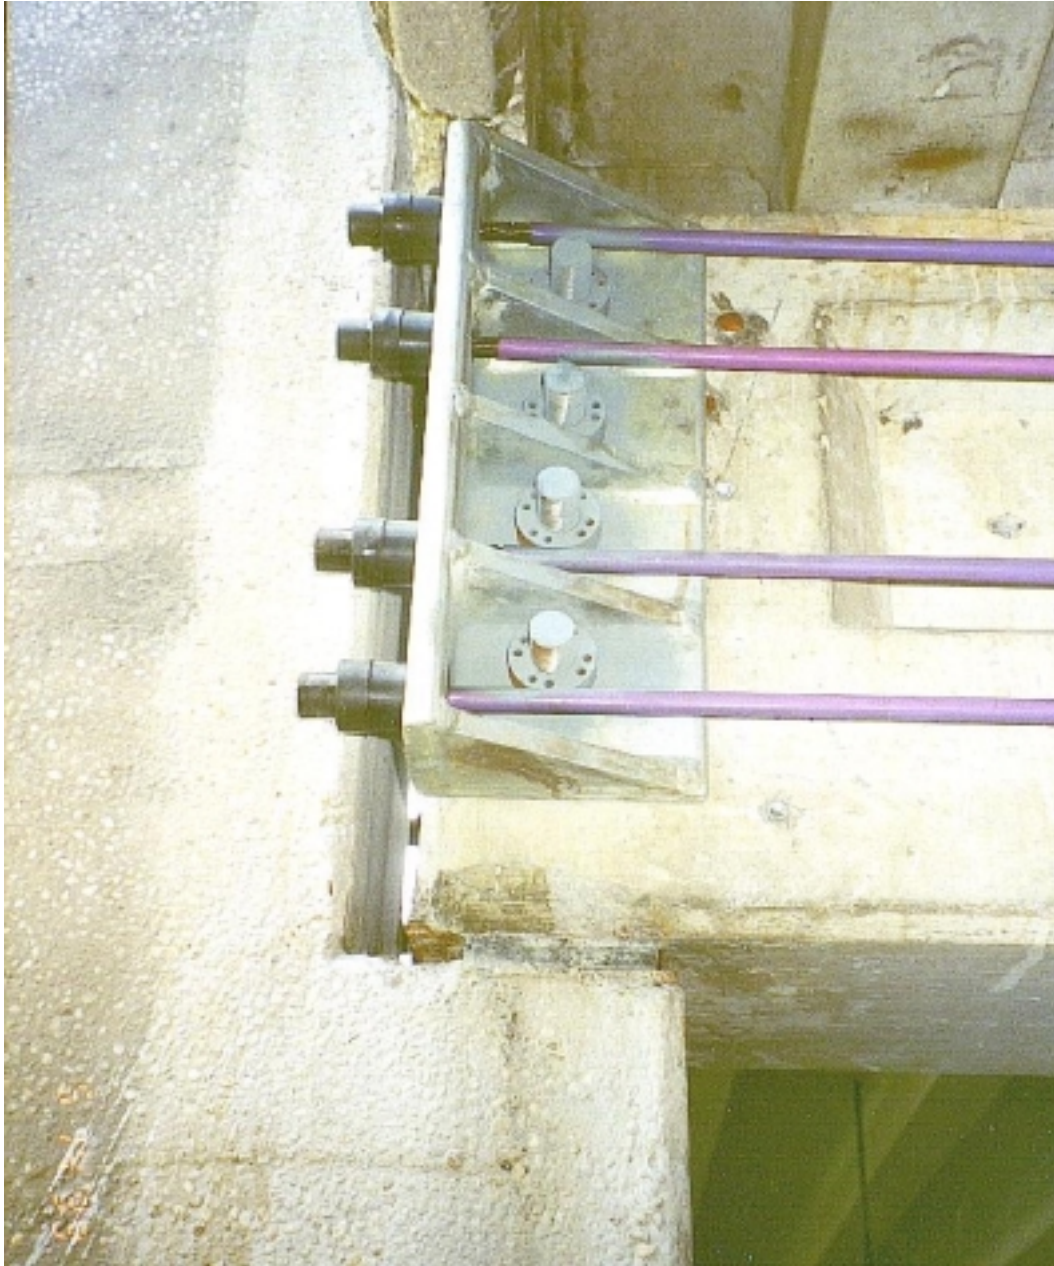
Figure 3-12(b): Tendon Anchorage at Niagara Falls Parking Garage.

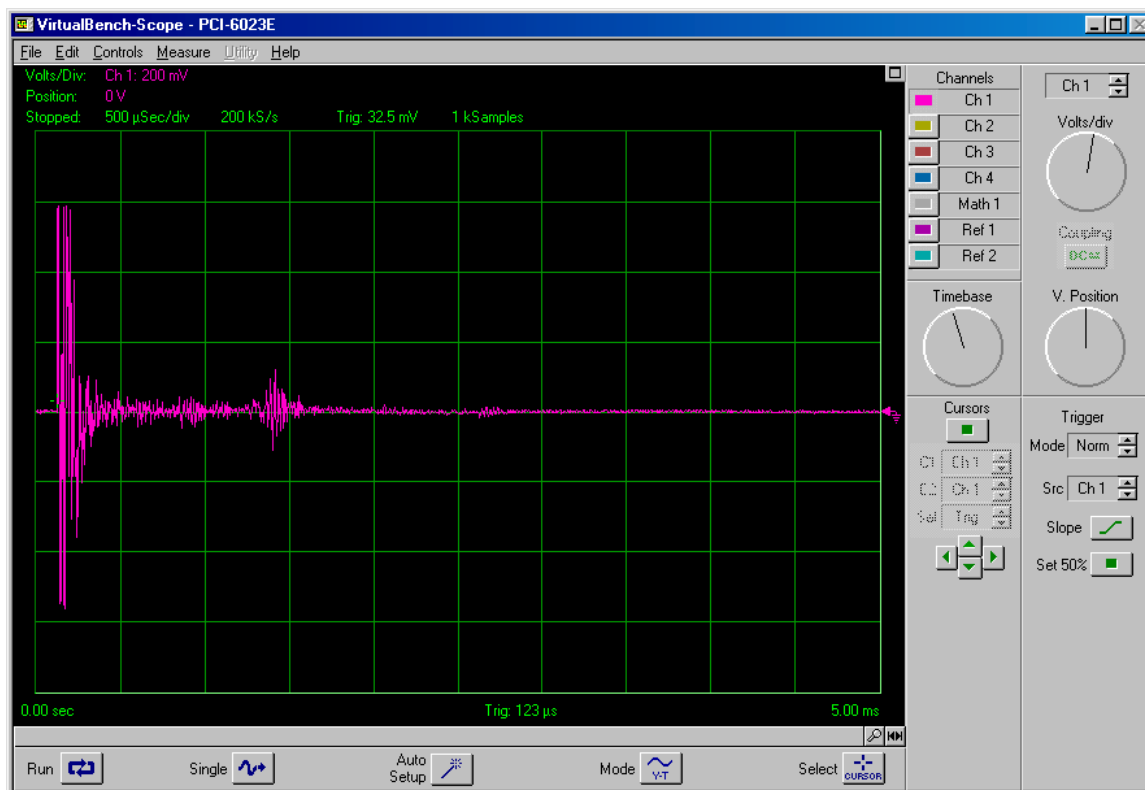
Figure 3-15 (b): Ultrasonic Test Results (100 kHz Transducer) for In-Situ Specimen #4; Epoxy-Coated Bar With Defect.

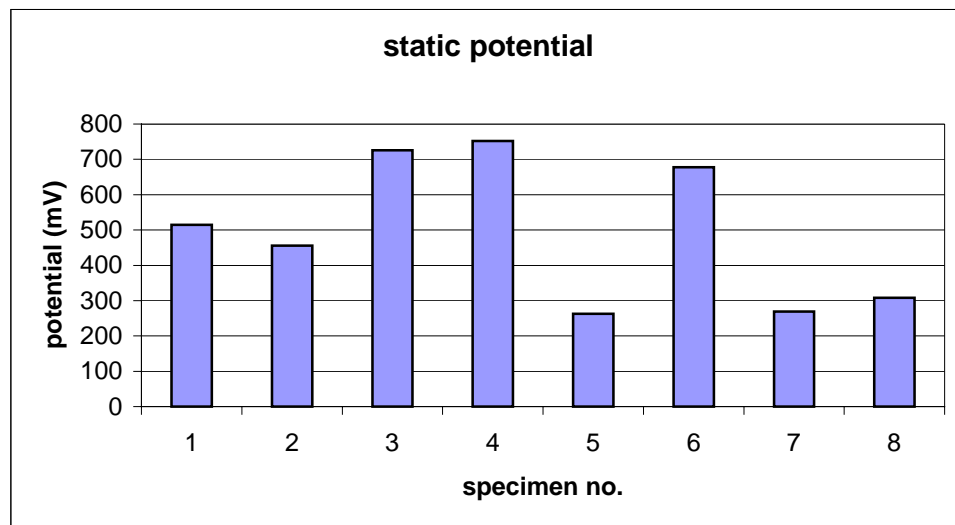
Figure 3-17: Half-Cell Potential Measurements for In-Situ Specimens.

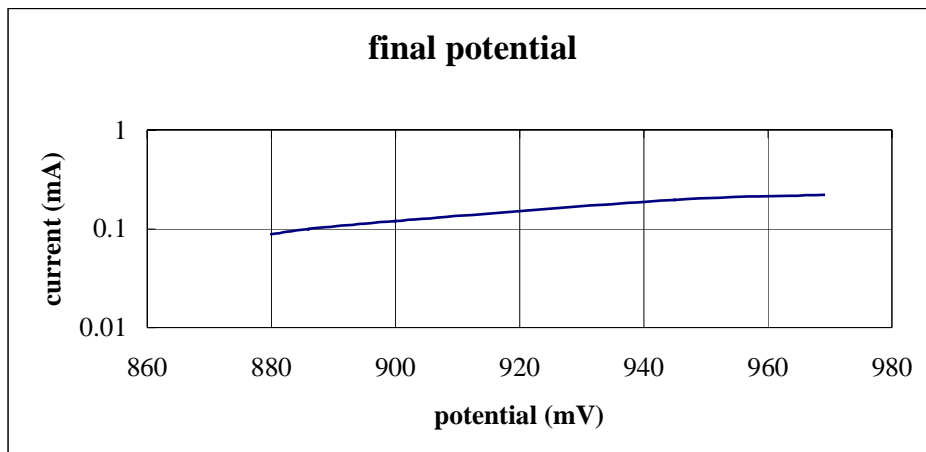
Figure 3-19(a): E Vs. Log I Measurement for In-Situ Specimen #3; Epoxy Bar Without Defect.

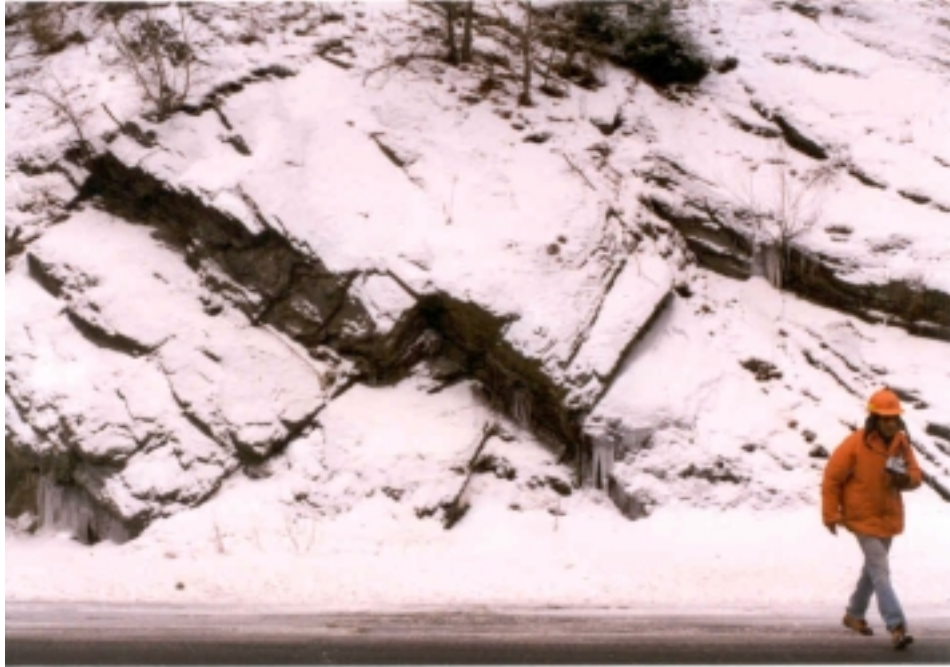
Figure 6-1: Rock Bolts Observed Along NYS Route 22.

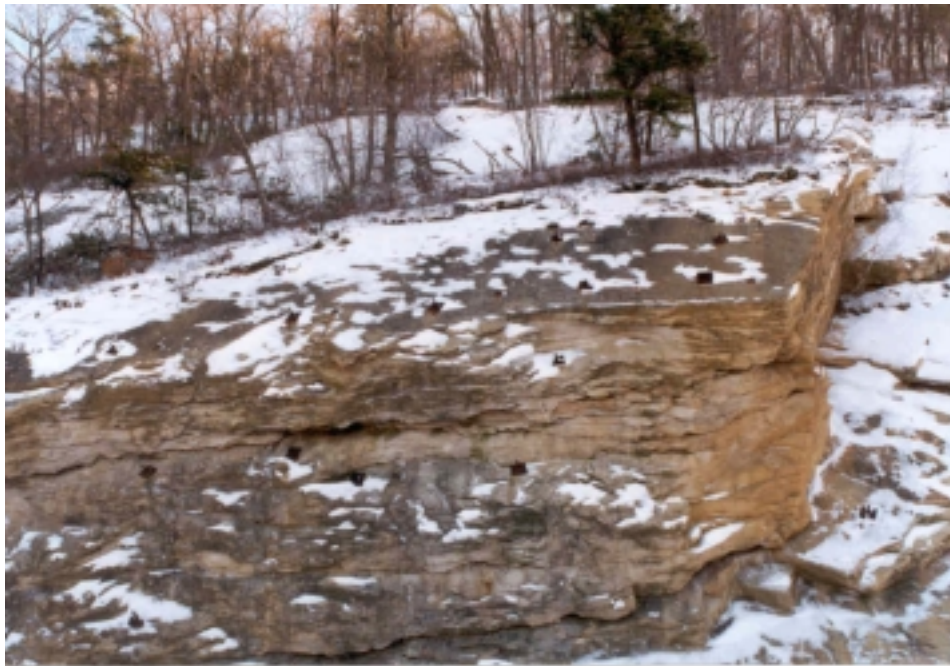
Figure 6-2: Rock Bolts Observed Along NYS Route 52 in Ellenville, NY.

Eight of the sites are ground anchors and one site is a rock bolt site. The rock bolt site in Ellenville, NY was selected based on the presence of different types of rock bolts, the density of the rock bolt pattern, the rock conditions, and the access available at the site. In 1992, a rock-slide occurred at this location and some information is already available from a study conducted by NYSDOT after the slide.

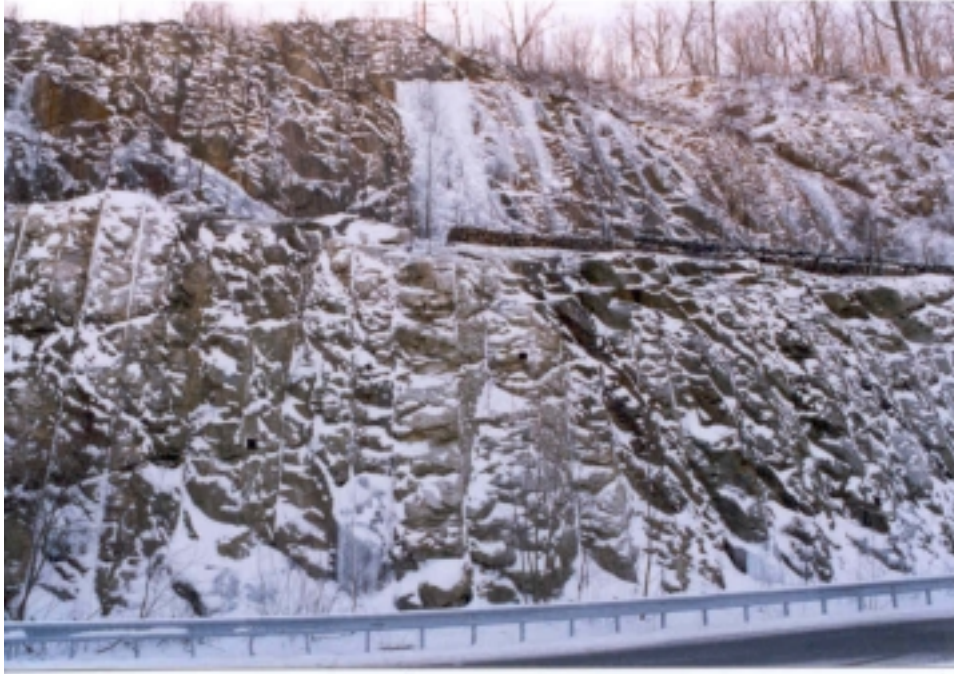
Figure 6-3: Rock Bolts Observed Along NYS Route 9W, Hudson Highlands.

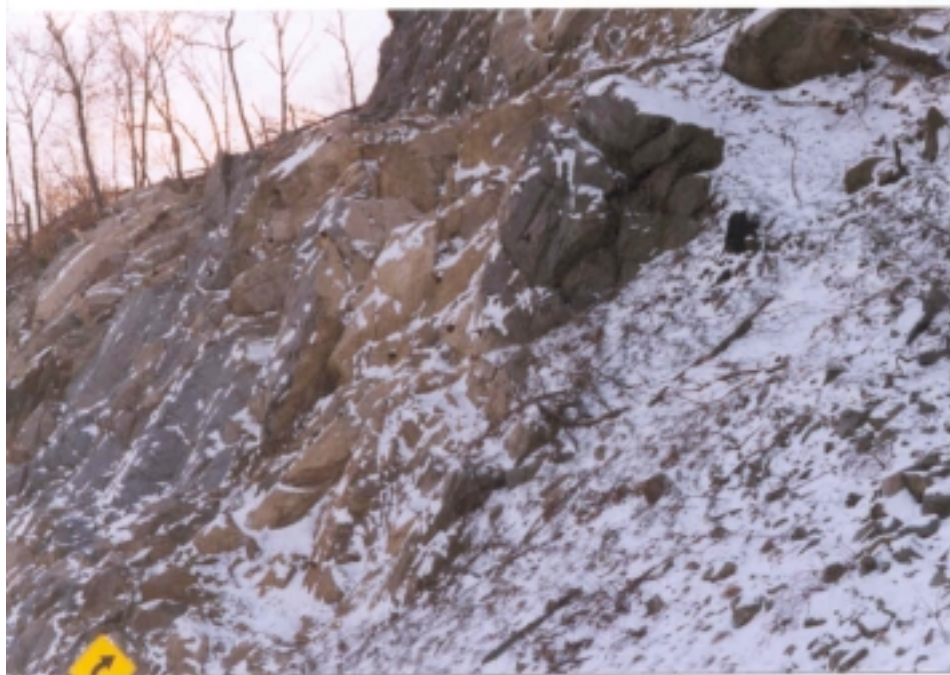
Figure 6-4: Rock Bolts Observed in Bear Mountain State Park, NY.

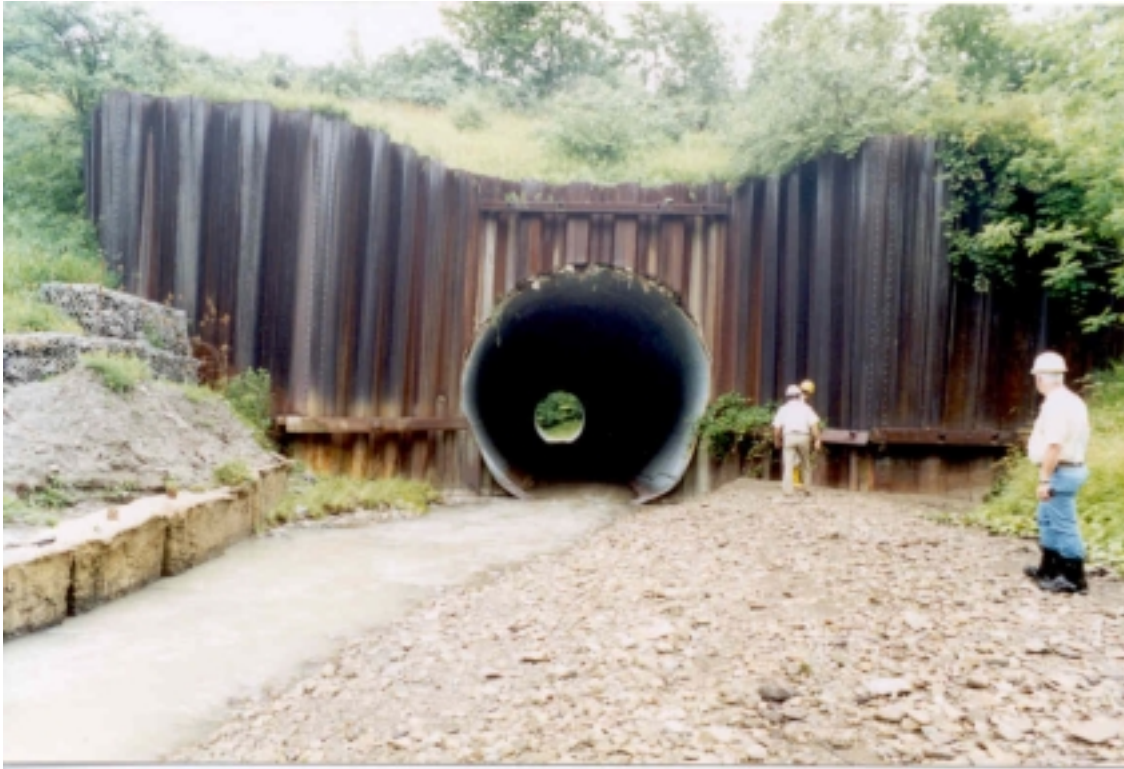
Figure 6-5: Tied-Backs Observed for Culvert Wing Wall, West Valley, NY.

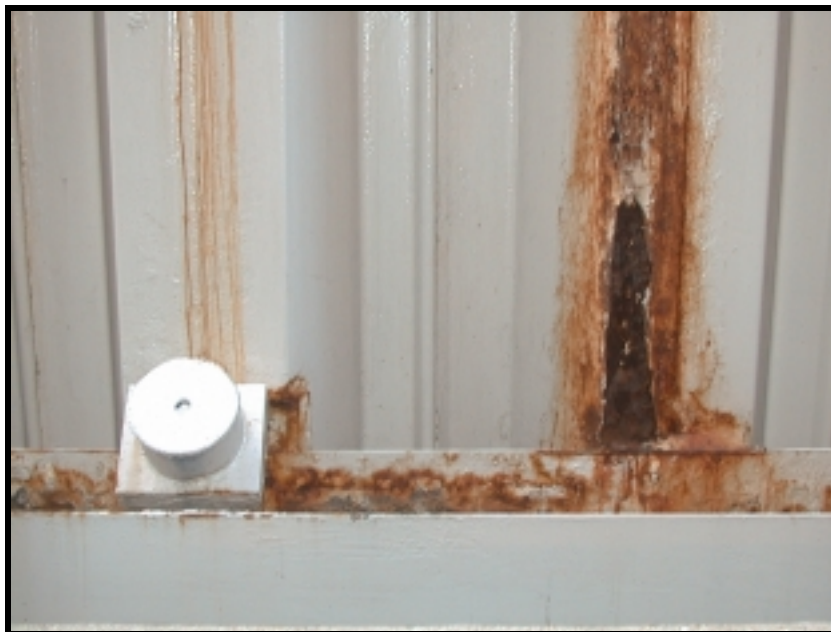
Figure 6-6: Corroded Sheet Pile Section of Anchored Wall, Pittsburgh, Pennsylvania.

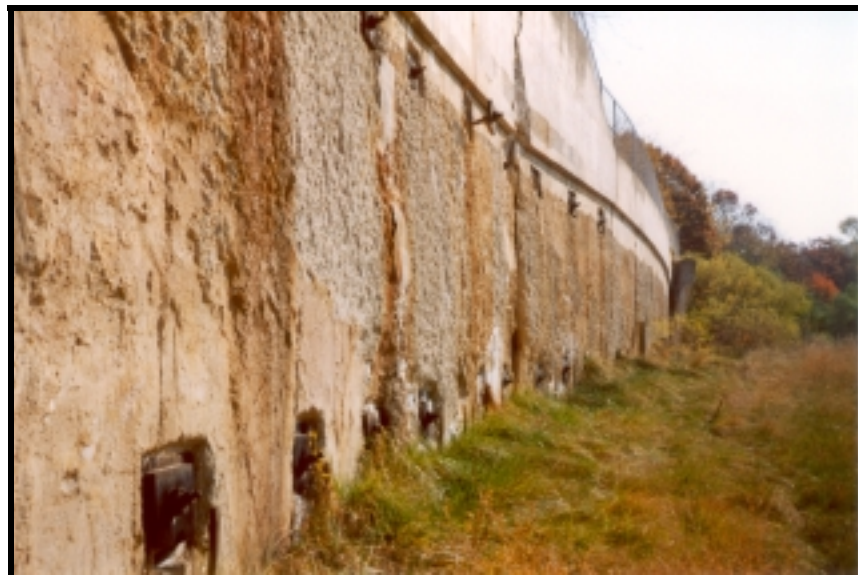
Figure 6-7: Anchored Concrete Diaphragm Wall, Washington, DC.

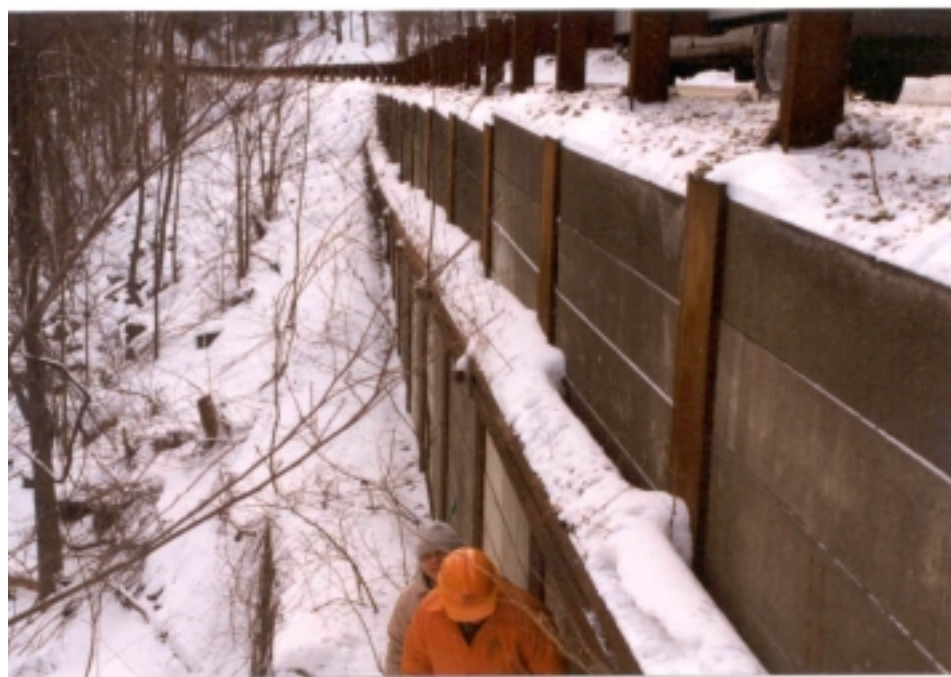
Figure 6-8: Soldier Pile and Lagging Wall, Palenville, NY.
