Evaluation of Metal-Tensioned Systems in Geotechnical Applications, Phase I

Interim Report

Prepared for:
National Cooperative Highway Research Program
Transportation Research Board
National Research Council

March 2001

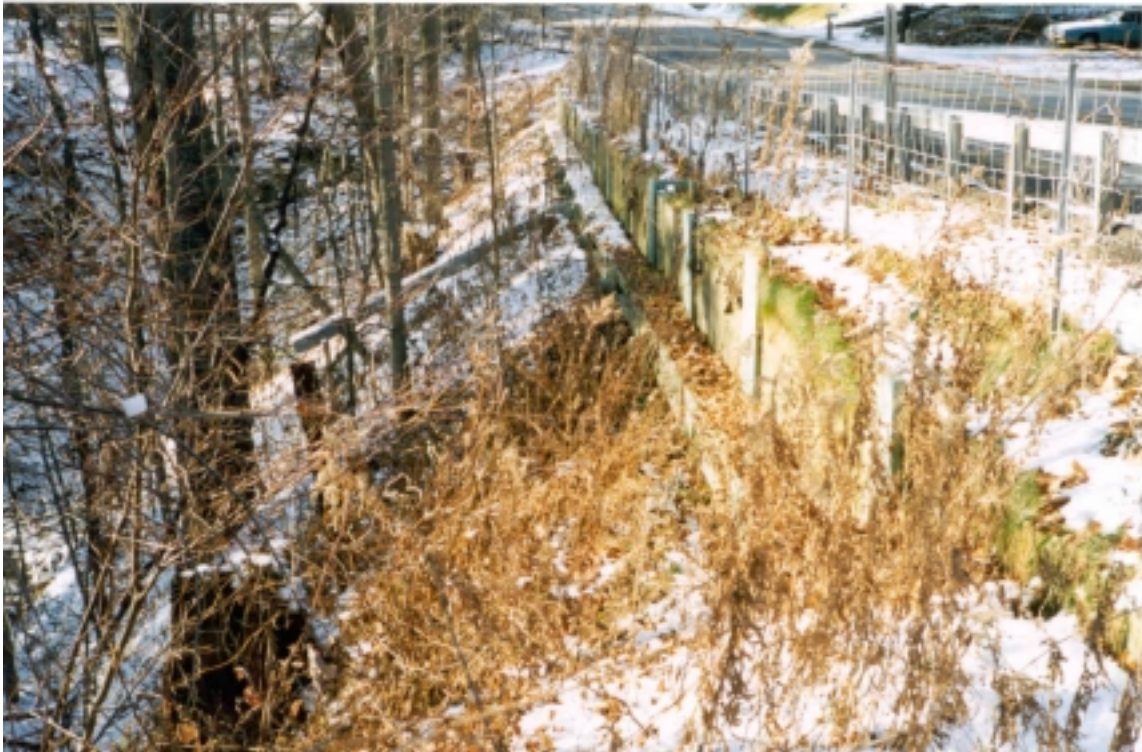
Figure 6-9: Soldier Pile and Lagging Wall, Gawanda, NY.

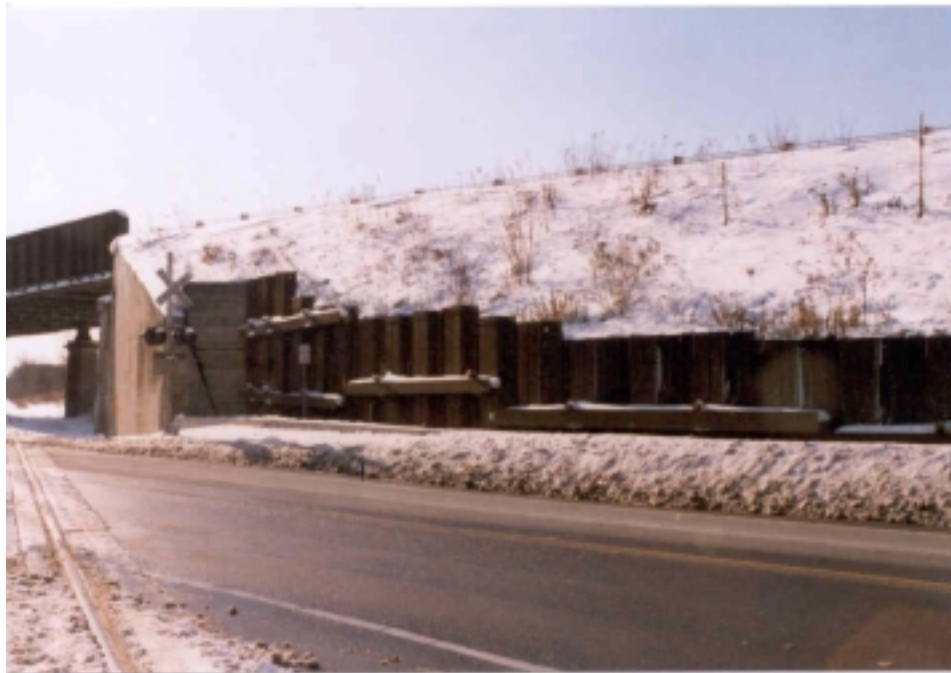
Figure 6-10: Tied-Back Wall for Embankment, Conrail Over NYS Route 5.
