Extended Exposure and Monitoring of Epoxy-Coated Reinforced Concrete Test Slabs

**National Cooperative Highway Research Program
Transportation Research Board
National Research Council**

May 2001

EXTENDED EXPOSURE AND MONITORING OF EPOXY-COATED REINFORCED CONCRETE TEST SLABS

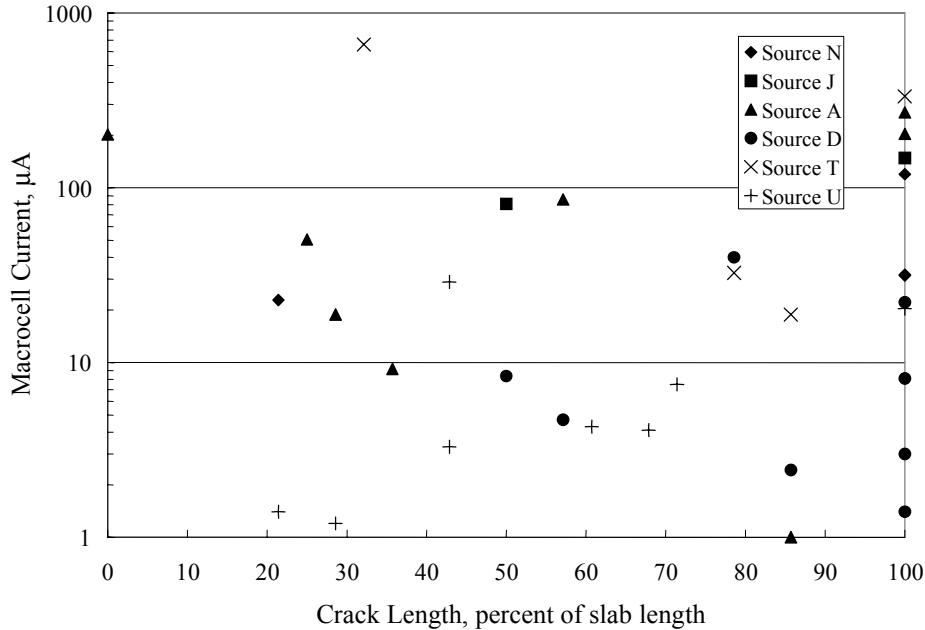
Figure 1: Plot of macrocell current versus crack length as of November, 1999.

Figure 1 presents a plot of crack length above individual ECRs that remained for the final autopsy versus macrocell current with each bar source identified. No dependence is apparent between crack length and either macrocell current or bar source. The same result was obtained for the natural weathered slabs. This supports the conclusion that the cracking source was other than corrosion related.

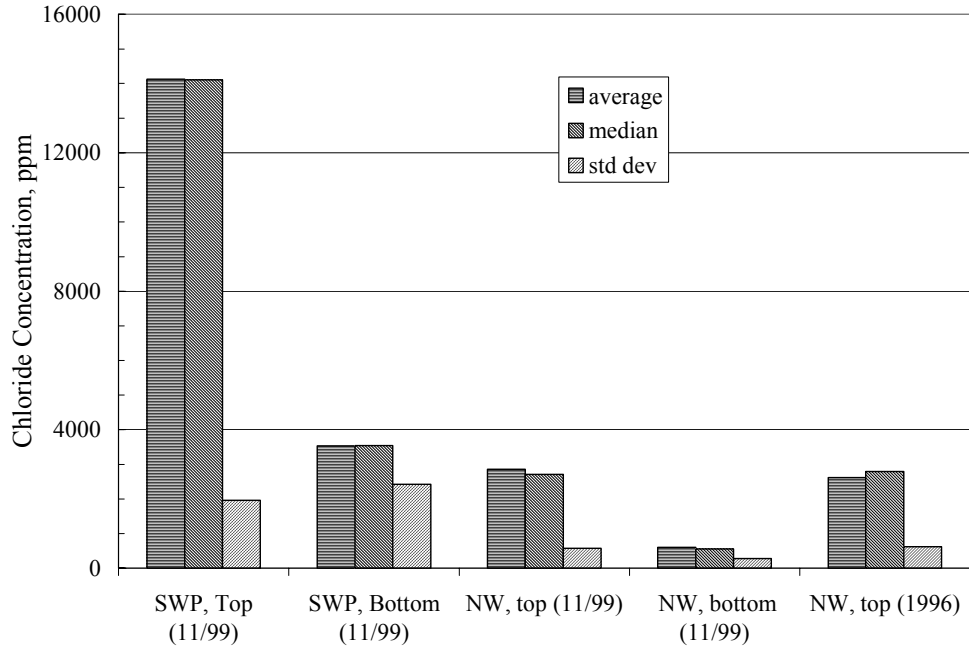
Figure 5: Chloride concentration at the top and bottom bar depths at the time of the third and fourth autopsies.

Figure 5 shows the values for chloride concentration that were measured at the trace of both top and bottom bars at the time of the third and fourth autopsies (see also Tables 1 and 2). These data indicate that there was little difference between the chloride concentration at the two times for the natural weathering (NW) slabs, as should be expected; but the salt water ponding (SWP) resulted in an increase by approximately a factor of five. The cracks above the ECR trace on many of the specimens undoubtedly contributed to this. The data also show that chlorides had migrated into the bottom portion of the slabs, which were cast without admixed chlorides, and had reached levels in excess of the chloride threshold (250-500 ppm) in most cases.

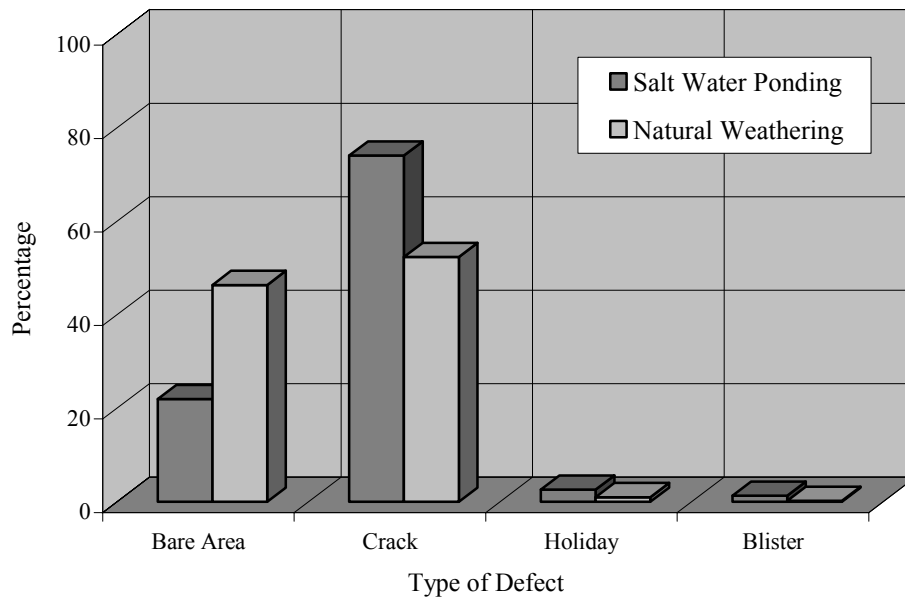
Figure 9: Percentage of each defect type for the two exposures.

progressed and the coating became brittle. Also, while the percentages of bare areas and coating cracks were comparable for the NW exposed specimens (46 versus 52 percent, respectively), these percentages were 22 and 74 (bare areas and coating cracks, respectively) for the SWP exposure, which is indicative of greater tendency for the latter to form under this exposure condition (SWP) compared to the former. Also, although the percentage of pin holes (holidays) was relatively low for both exposures, this defect type developed to a greater extent on bars with cross deformations and on bars for which the coating was relatively thin. However, the average coating thickness was within specification in all cases, as noted above.

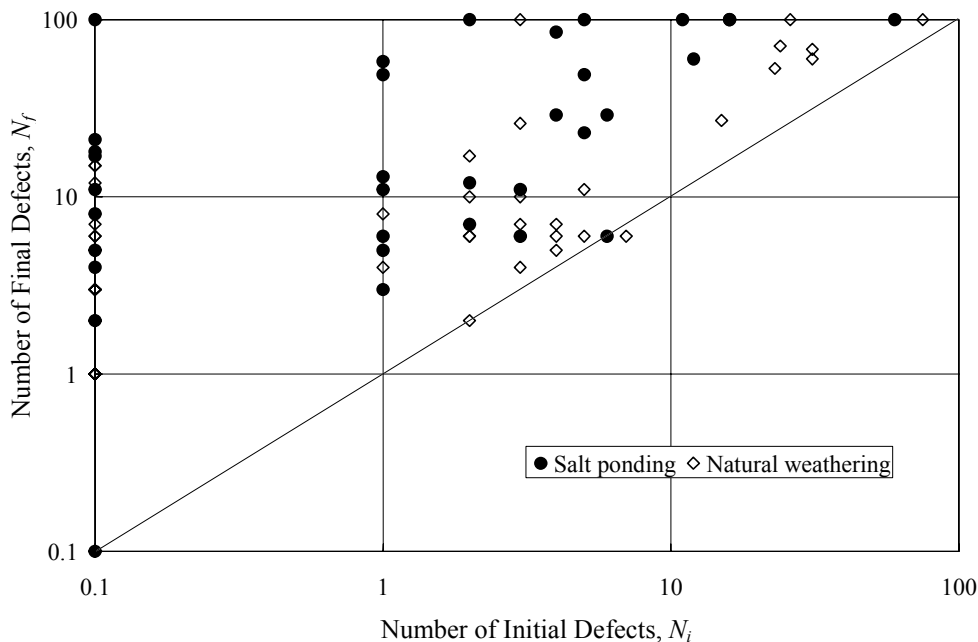
Figure 10: Plot of the initial number of coating defects versus the final number for specimens of the fourth autopsy.

Figure 10 plots the number of initial defects versus the number of final ones for bars that were analyzed during the fourth autopsy with the data being partitioned according to the type of exposure (natural weathering versus salt water ponding). Cases of no initial defects are represented as 0.1. In instances where the final number of defects was excessive, due to coating cracks in most cases, a value of 100 was assigned. If no defects developed for a particular bar subsequent to the initial count, then the corresponding datum lies along the sloping line. The fact that most data are above this line indicates that additional defects formed in the great majority of

cases. In some instances, this increase was by more than an order of magnitude and was greater for the more severe exposure (salt water ponding compared to natural weathering). The latter observation (greater increase in the number of defects for the salt water ponded specimens) indicates that at least some of the increase was a consequence of exposure as opposed to damage during specimen fabrication. Coating cracks were mainly responsible for this increase, as discussed above. While 16 salt water ponded and 18 naturally exposed bars that had no initial

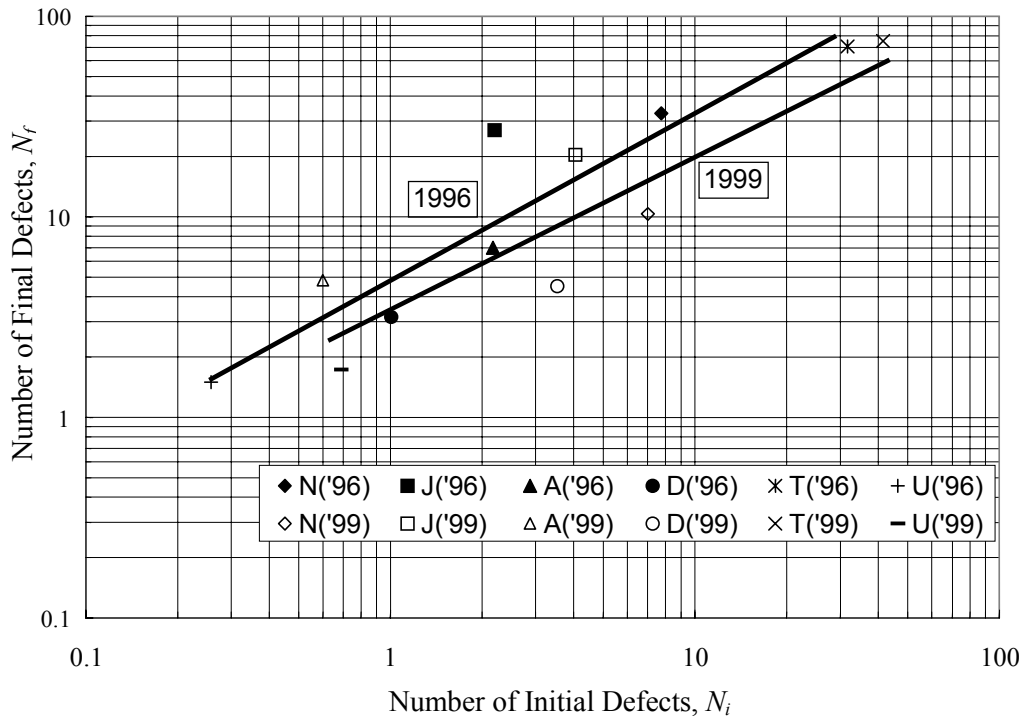
Figure 11: Replot of the natural weather exposure data from Figure 10 (1999 autopsy) along with results from the 1996 autopsy with data for each bar source averaged.

Figure 11 replots data for the natural exposure specimens in Figure 10 but with each bar identified according to source. Results from the third autopsy (1996) are included also; and it is apparent that the number of coating defects approximately doubled between these two times (1996 and 1999). Also, while more additional coating defects formed for bars with a high number of initial defects compared to bars with few, Table 4 indicates that the ratio of these two (number of final defects to the number of initial) was roughly constant. In developing the data in Table 4, specimens with excessive coating defects were not included.

The data in Figures 11 and 12 indicate that U source bars were one of the, top performers, if not the top performer, with regard to number of defects. As noted earlier, these bars were chromate conversion coated. While this surface treatment may have been responsible for the lesser number of coating defects, there is no way of confirming this.

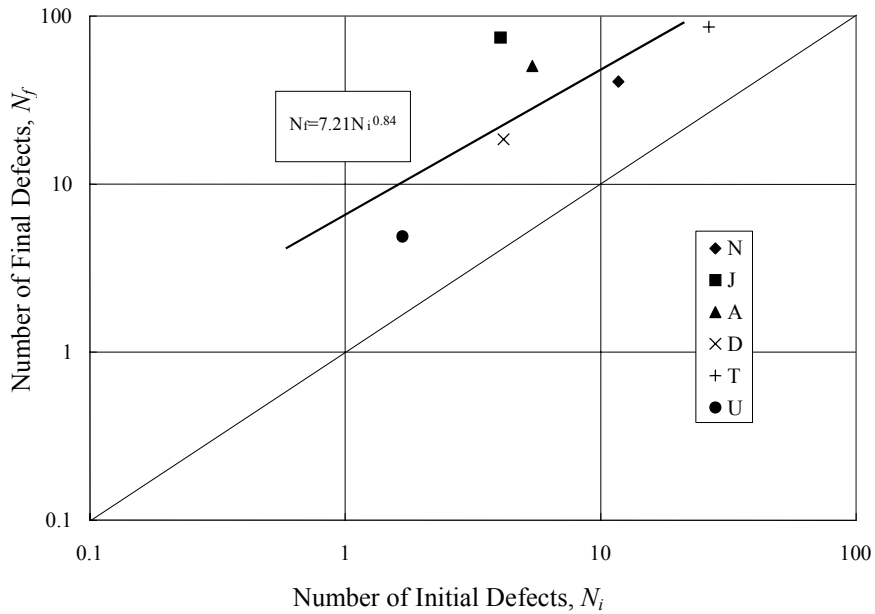
Figure 12: Plot of the number of final defects versus the initial number for salt water ponded specimens (1999 autopsy) with the data averaged according to bar source.

Correspondingly, Figure 12 shows a plot similar to the one in Figure 11 but for the salt water ponded exposure specimens. Assuming that a power law expression adequately represents the data, although the fit is not as good as in Figure 11, and recognizing that the slope of this best fit line is near unity, then the number of final defects exceeded the initial by a factor of approximately seven. On this basis, the number of defects that developed during the 13 months of salt water ponding was almost twice what occurred during six years of natural weather/potable water ponding exposure. Table 5 tabulates the ratio of final-to-initial defect numbers according to bar source and shows that on average a seven fold increase in the number of defects occurred for these specimens. Presumably, the difference for these, compared to the fourth autopsy NW

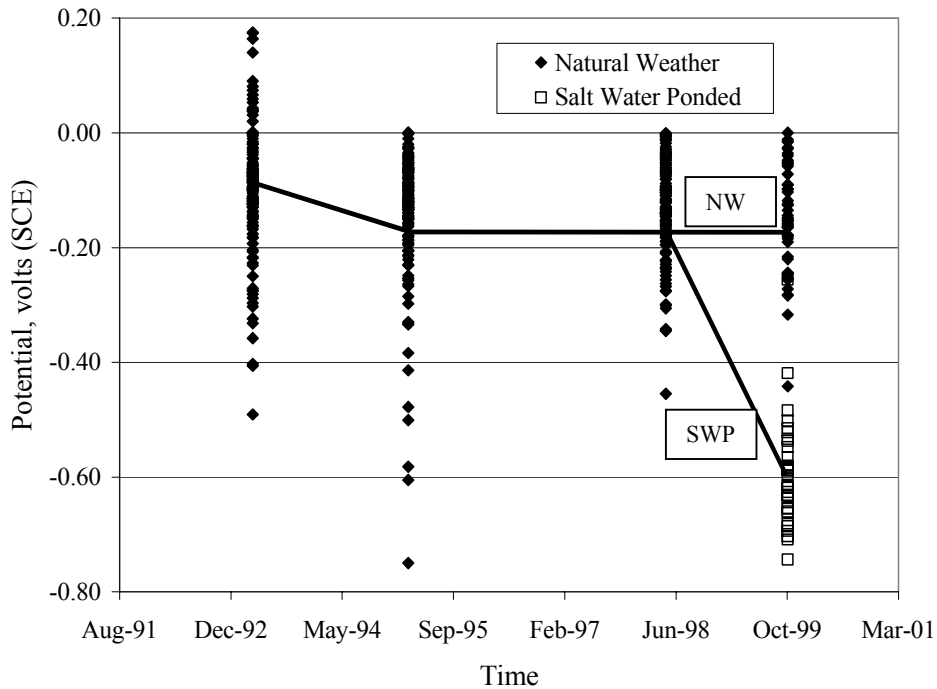
Figure 14: Open circuit potential data for the test slabs at select times during the exposure.

Epoxy-coated bars that exhibited a relatively low macrocell current and positive potential generally showed minimal corrosion and vice versa, as determined visually when the slabs were broken apart. Figure 14 shows corrosion potential for individual bars at select times during the exposure with the data partitioned according to natural weathering versus salt water ponding. The two curves are plotted according to the average potential at each time. Thus, there was relatively little change in potential with time for the natural weather exposed specimens, whereas a negative potential shift of 450 mV resulted from the 13 months of salt water ponding. This suggests a much more active corrosion state for the latter compared to the former.

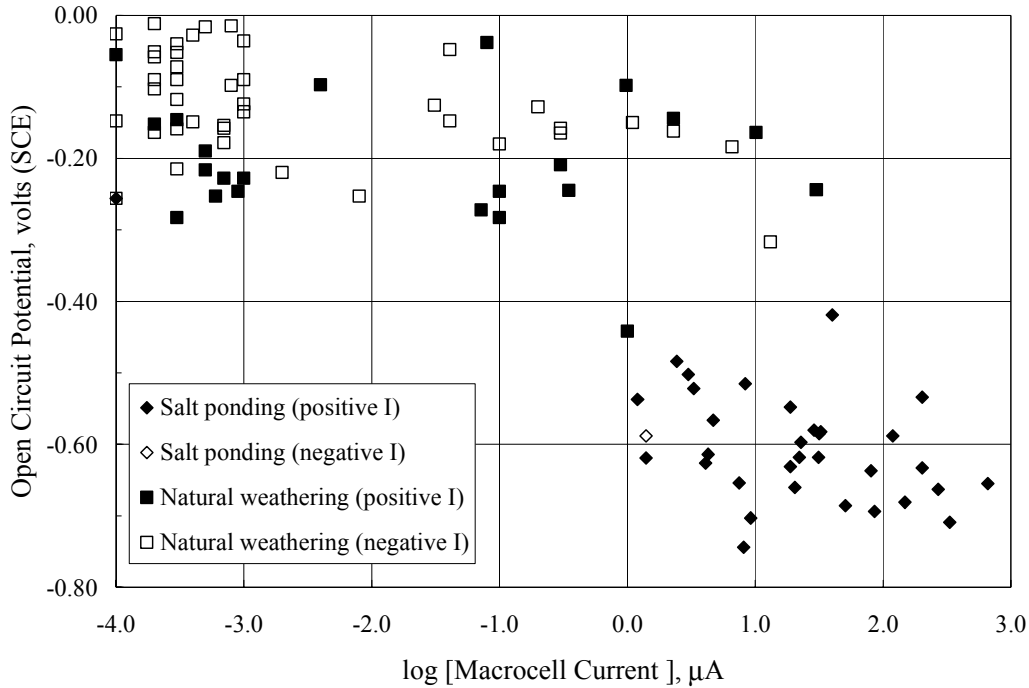
Figure 15: Plot of macrocell current versus open circuit potential for slabs just prior to the final autopsy.

Likewise, Figure 15 plots potential versus macrocell current for all specimens that remained for the final autopsy. This shows a general relationship where current increased with decreasing

(more negative) potential with the natural weathering specimens occupying the low current, relatively positive potential regime and the salt water ponded ones the high current, negative potential regime. Some currents were negative, particularly for the natural weathering specimens, indicating that the bottom black steel was anodic to the upper mat ECR. However, in the majority of cases where this occurred, potential was positive to the threshold value below which atmospherically exposed steel in concrete is considered to be active (OCP was positive to -0.28 volts (SCE)), suggesting that both steel mats were passive. Chloride intrusion into the bottom mat, as noted above, combined with protective action of the epoxy coating is thought to have been responsible for this. Table 6 shows that the percentage of ECRs that exhibited such a current reversal increased with exposure time. Consistent with this, bars with negative currents typically had relative few coating defects (bars from sources U, D, and A).

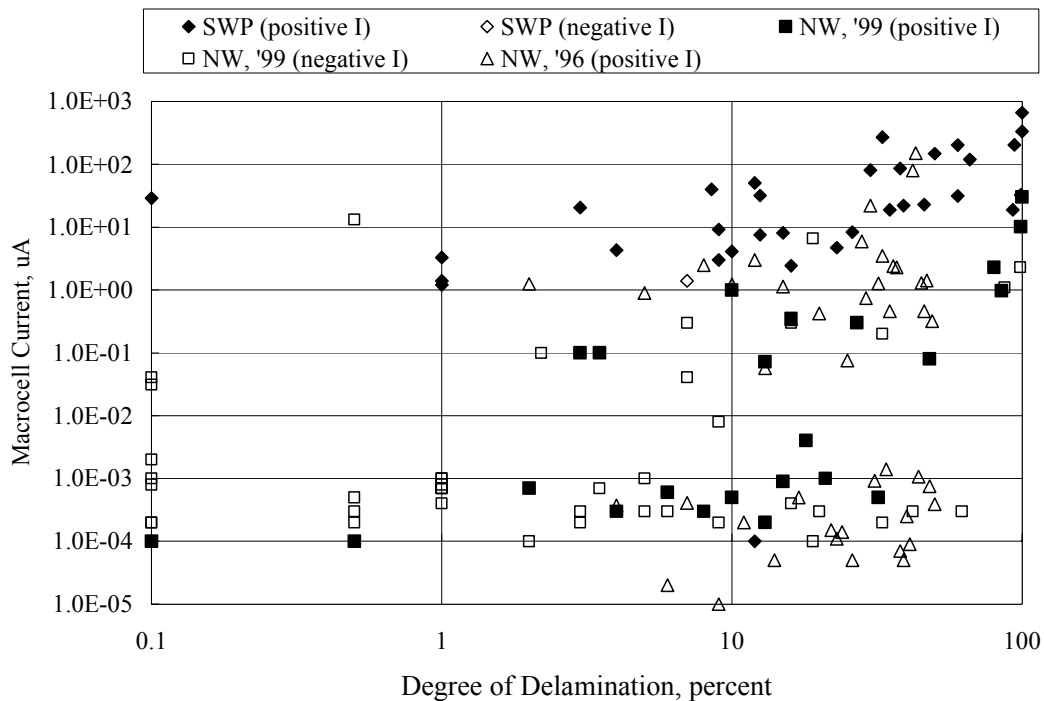
Figure 17: Plot of percent coating disbondment versus macrocell current for ECRs recovered from the third and fourth autopsies.

The extent of coating disbondment was measured for individual ECRs that were recovered from the third and fourth autopsies by using a utility knife to peel back and remove loose coating beginning at coating defects and estimating the percent of the entire bar area that became exposed. Figure 17 plots these data versus macrocell current. Results for bars from the third autopsy (1996 natural weather (NW) exposure) fell into two groups, one at relatively low current (essentially zero to a fraction of a microamp) and one at high (0.1 to 200 μA) with percent disbondment for both sets being independent of current. Data for the SWP specimens tended to be displaced toward higher current for a given percent displacement than for the NW ones. Also, the percent disbondment for the SWP specimens increased with increasing current for percent disbondments in excess of about ten, although the effect is somewhat obscured by the relative scaling of the axes. The cause and affect here is uncertain in that high current may have caused disbondment or vice versa. Also, the percent disbondment was roughly independent of whether ECR current was anodic (positive) or cathodic (negative). A likely explanation for the current-disbondment relationship is that coatings with a high density of defects developed greater disbondment and this, in turn, led to higher current.

A high quality coating with few or no defects is expected to provide a resistive barrier to flow of macrocell current, either to or from ECR. However, local microcell action beneath any disbonded areas of the coating can result in further disbondment. In situation where current is positive (anodic), disbondment results from cathodic processes at or near the front between the intact and disbonded coating (the farthest distance beneath the disbonded coating from the active site (coating defect)). If, on the other hand, the current is negative, then the entire ECR becomes a cathode; and disbondment occurs locally at a rate proportion to the magnitude of this current. This may explain the low macrocell current (either positive or negative) – large coating disbondment data in Figure 17.

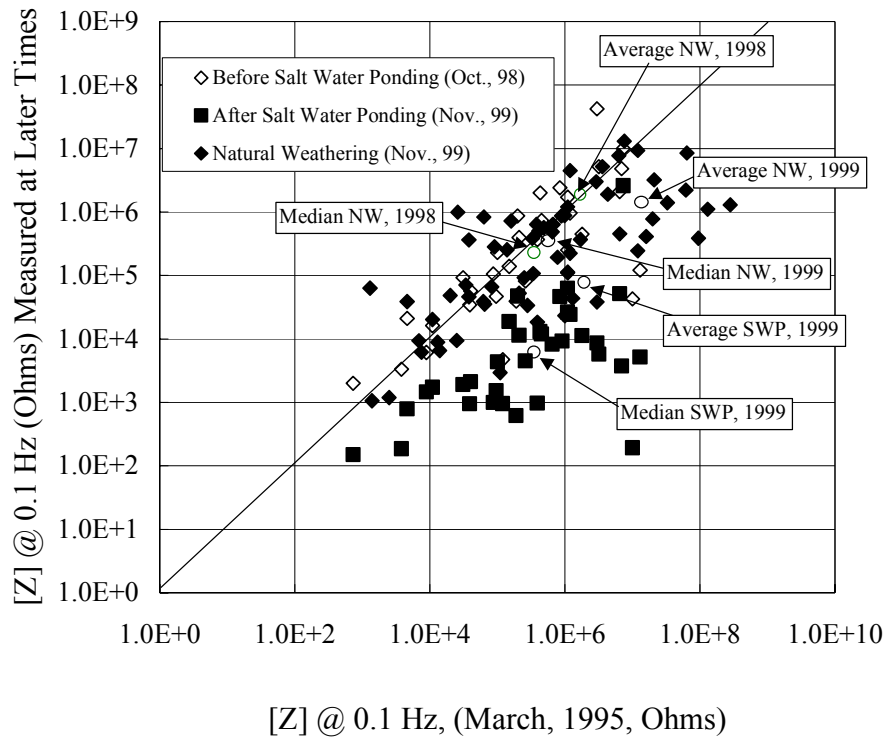
Figure 21: Comparison of impedance of individual ECRs as recorded at different times.

Impedance for the individual ECRs fluctuated with time, particularly in cases where the magnitude of this parameter was relatively high. The variations were, however, typically within an order of magnitude. Impedance for some bars increased with time, possibly due to buildup of corrosion products at coating defect sites or clogging of coating pores (or both), as discussed previously (9). Figure 21 presents a plot of impedance that was measured for individual ECRs in March, 1995 versus the value at subsequent times before and after salt water ponding. This shows that the NW data are evenly distributed to either side of the one-to-one line and that the 1998 average and the 1998 and 1999 medians fall close to the one-to-one line, indicating that these parameters did not change during the times considered (1995 to either 1998 or 1999). The fact that the average for the NW 1999 specimen data is about an order of magnitude below the one-to-one line probably reflects a relatively large Z decrease for a few bars. The SWP data, on the other hand, are all below the one-to-one line with the average and median lying below the corresponding values for the NW specimens by a factor of 20 and 69, respectively. Again, the fact that the average is less than the median in each case reflects an influence from a few bars with relatively high impedance.

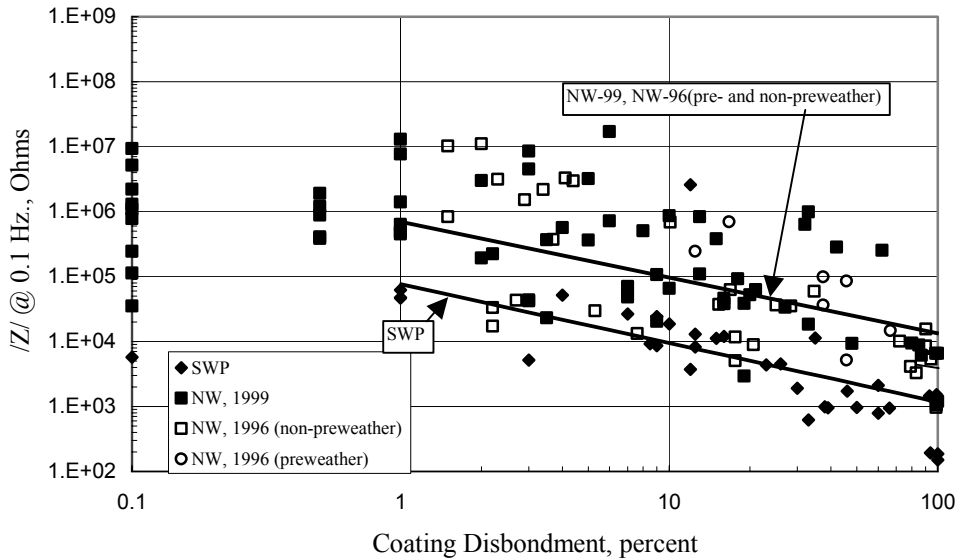
Figure 22: Plot of percent impedance at 0.1 Hz. versus percent coating disbondment.

Figure 22 plots impedance for specimens that remained at the end of the third and fourth autopsies versus percent coating disbondment. The salt water ponded data are represented here to one percent disbondment by one power law expression, whereas the natural weathered specimens

(1996 (preweathered and non-preweathered) and 1999) are represented in terms of a second, albeit in spite of relatively large scatter. This shows that impedance decreased with increasing disbondment such that a one order of magnitude change in one parameter resulted in an order of magnitude change in the second. Also, the 13 months of salt water ponding decreased impedance by approximately one order of magnitude at a particular percent disbondment compared to the natural weather exposure. Alternatively, an order of magnitude greater disbondment was required to affect a given impedance in the NW compared to SWP ECRs. Considering that ten percent disbondment corresponds to approximately ten coating defects per 14 inch specimen length (Figure 18), Figure 22 indicates the corresponding $\log/Z/$ for natural weather exposure was about five and for salt water ponding four (specific impedances of 1.8×10^7 and $1.4 \times 10^6 \Omega\text{cm}^2$, respectively).

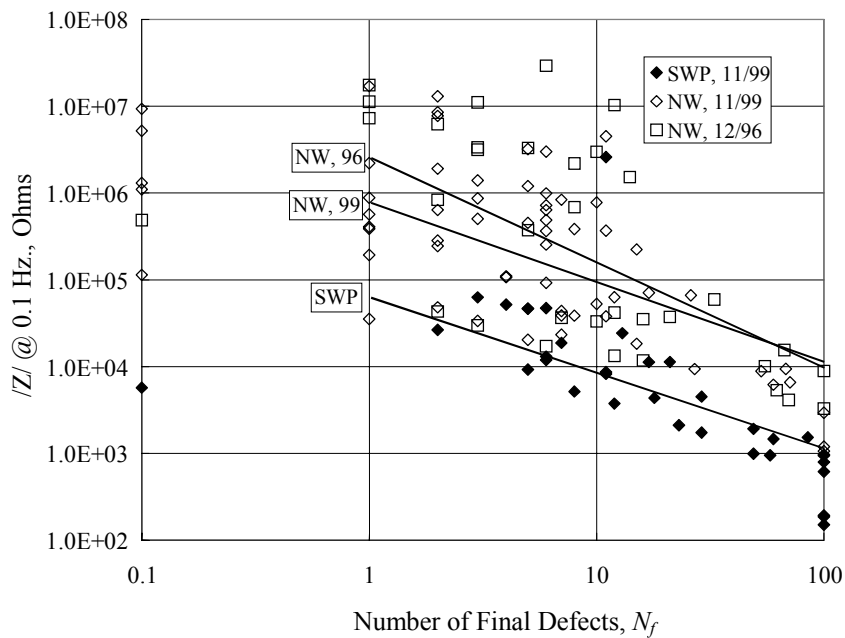
Figure 24: Plot of impedance versus the number of final defects for specimens from the third and fourth autopsies.

Figure 24 plots impedance versus the number of final defects for bars from the third and fourth autopsies. Each of the three sets of data has been fitted by a power law relationship considering only cases of one or more coating defects per bar. These show that both sets of NW data conform to essentially the same trend curve, albeit with a relatively large amount of scatter, whereas results for the SWP exposure are displaced toward lower impedance by about one order of magnitude; that is, a ten-fold greater number of defects was required to affect a particular impedance in the NW compared to SWP exposure. range. Such a projection is consistent with the

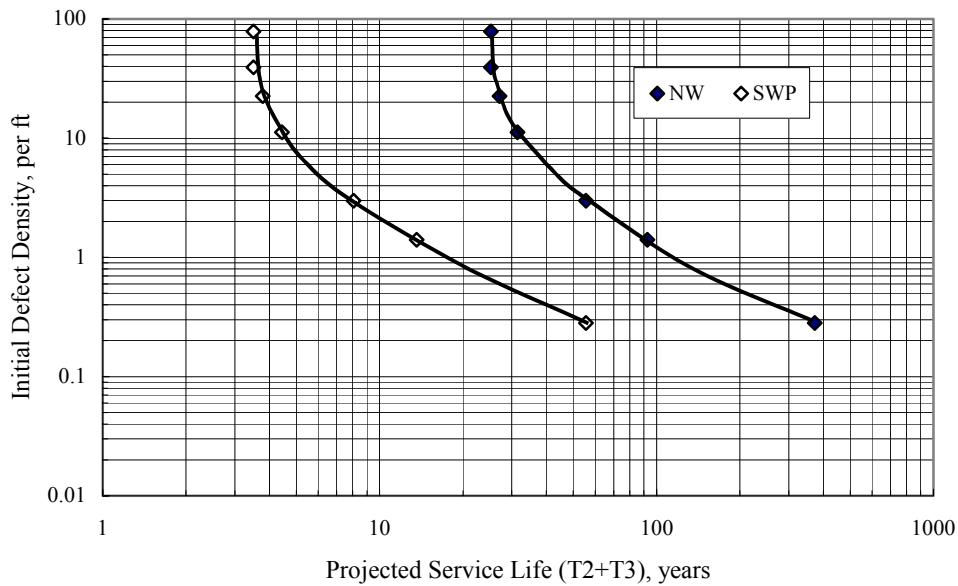
Figure 26: Plot of T_2 plus T_3 service life versus the number of coating defects for the NW and SWP exposures.

conditions moderate, however, performance should improve and perhaps even exceed that represented by the NW exposure. It must be kept in mind, however, that the above analysis (Tables 14 and 15 and Figure 26) disregards any contribution from the T_1 component of service life. On the other hand, T_1 is likely to be adversely affected (minimized) by deck cracking above ECRs, which is commonly observed on actual structures, as discussed above.

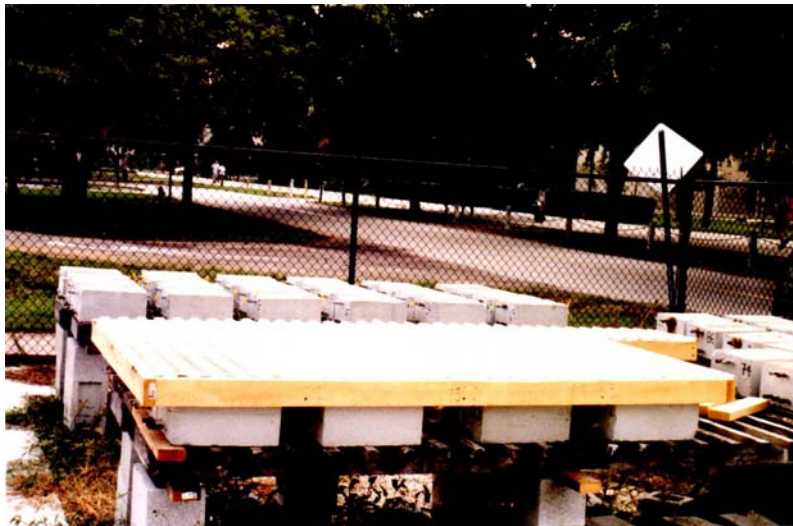
Figure A-2: Photograph of specimens under exposure. The plastic cover is to protect cyclically ponded specimens from rain.

The slabs were exposed in an outdoor Florida Atlantic University test yard in Boca Raton, Florida approximately two miles (three km) inland from the Atlantic Ocean beginning in March, 1993. Figures A-2 and A-3 show photographs of specimens under exposure. For the initial 2.7 years, the slabs experienced natural weathering in conjunction with one of four different wet-dry cycles, as listed in Table A-3. During the summer, 1995 hairline cracks were detected upon the top slab surface of some specimens. The width and number of these cracks increased during the course of the exposure, as discussed subsequently. Based upon the observation that slab

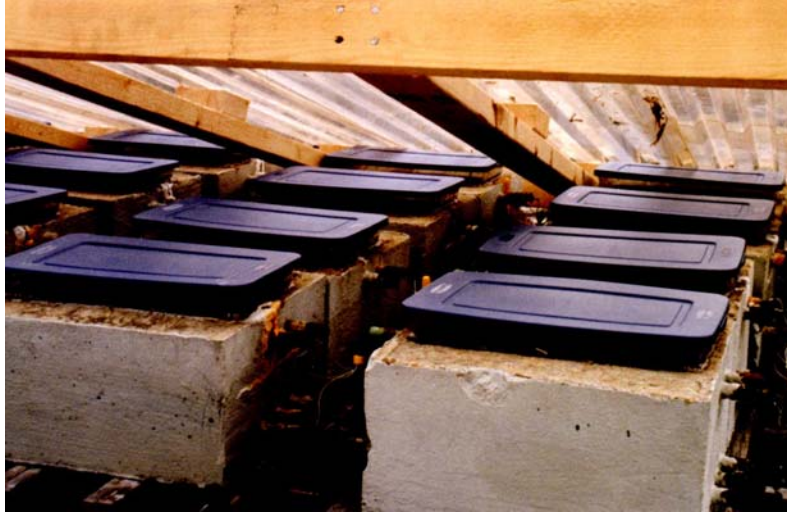
Figure A-3: Close-up photograph of specimens in Figure A-2.

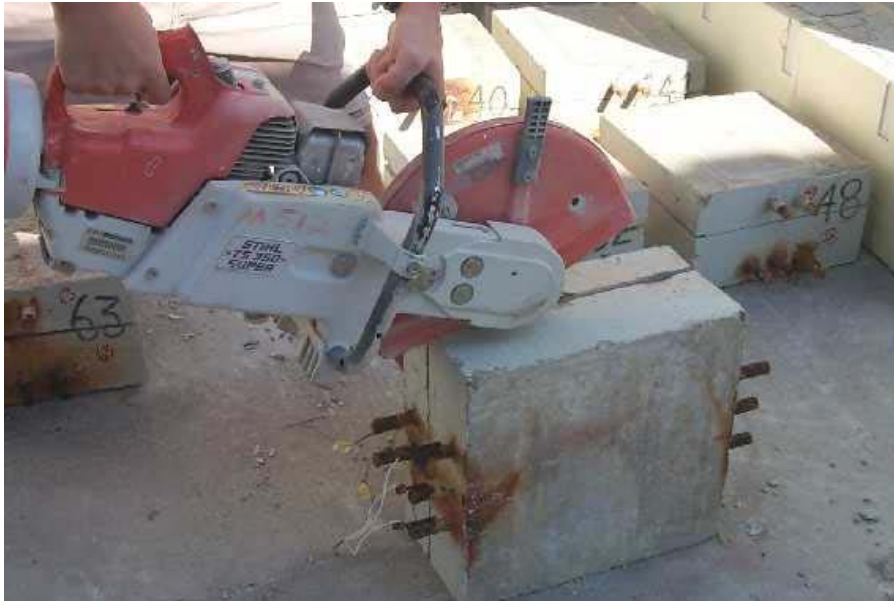
Figure A-4: Photograph showing the initial step in autopsy of a specimen where a saw cut was made along the lift line.

Figure A-4 is a photograph of the first autopsy step where the ECRs were extracted by cutting along the joint between the top and bottom lifts using a gas powered masonry saw. Figure A-5 shows a specimen subsequent to this saw cutting where the two specimen halves have been physical separated along the concrete lift, and Figure A-6 illustrates the method for cracking open the upper lift along the ECR length using a chisel. The ECRs were then removed from the concrete and examined for coating defects and corrosion. Also, the bar traces in the concrete were examined for presence of corrosion products and for cracks. During autopsies 3 and 4, concrete powder samples were taken from the ECR/concrete and black bar/concrete interface of

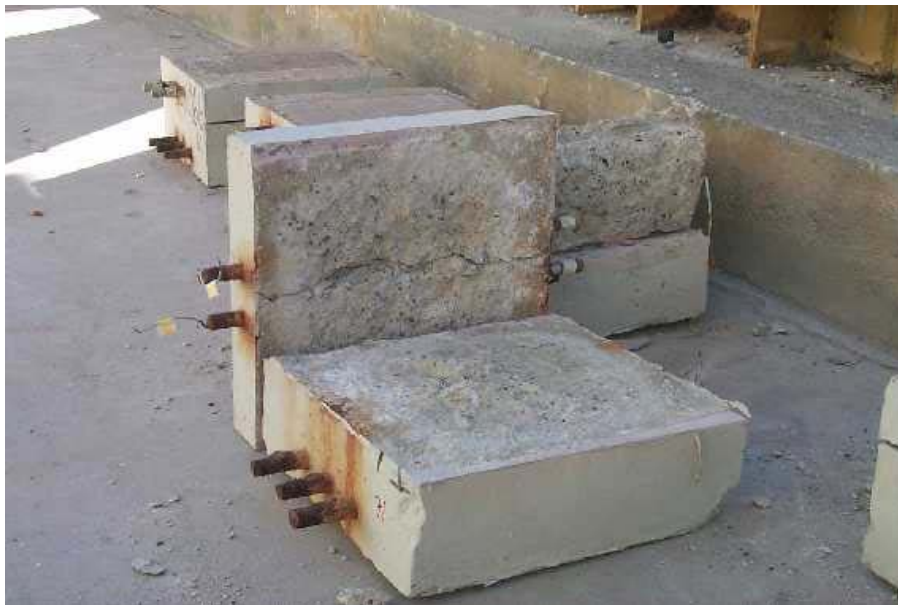
Figure A-5: Photograph of specimen after breaking apart along the lift line.

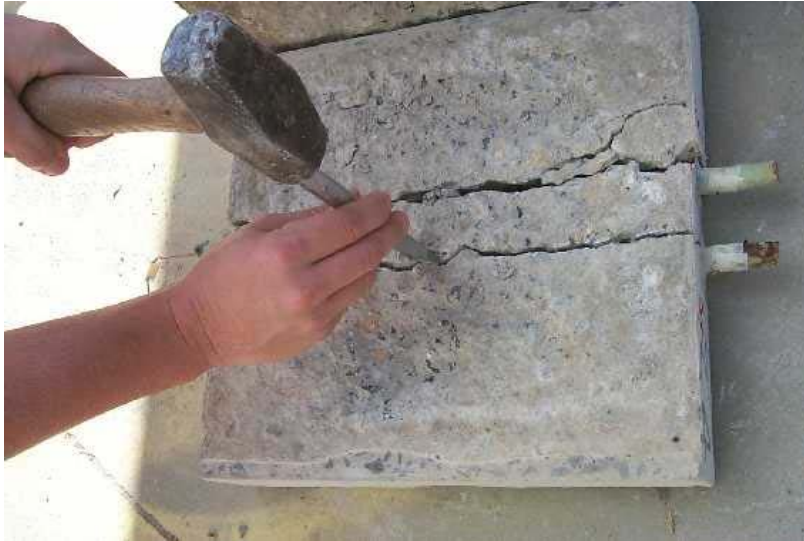
Figure A-6: Photograph of the upper lift containing two ECRs being broken open.

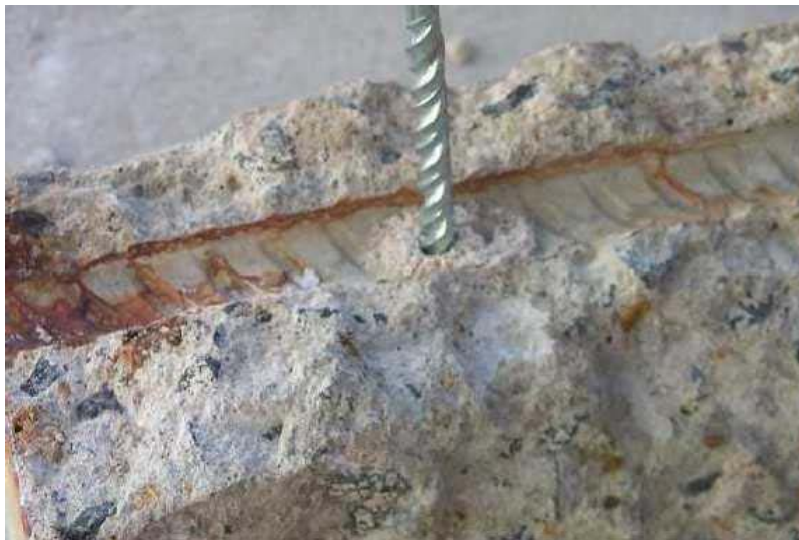
Figure A-7: Photograph of a concrete powder sample being taken by drilling at the reinforcement trace of a fractured specimen.

some of the slabs by drilling with a 6.4 mm diameter masonry drill bit. A photograph of this step is shown in Figure A-7. These samples were used for determination of the water-soluble chloride content according to ASTM C-1218 (A2).
