Measurement of Volume Changes of Concrete in Service

CALVIN C. OLESON, Consulting Engineer, Northbrook, Illinois;
formerly Portland Cement Association

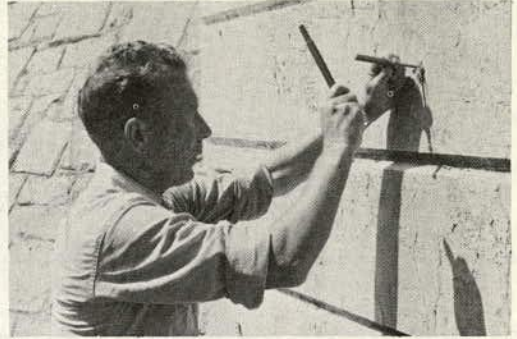
Figure 4. Setting brass insert with lead wool. This concrete is expanding at 0.03 percent per year.

location being in the gutter at 6 to 12 in. from the face of the curb. Other locations were on the top of the curb or safety walk, or on a wing wall or abutment. The concretes included a wide range of cements and aggregates, and the structures were new bridges in most cases, although a few were several years old. After 2 years of observation and measurements with no appreciable change in any of the concretes, another bridge, in which the concrete was definitely pattern-cracked, was added to the program (Figs. 3 and 4).

For the bridge that was added to the program because it was already cracked, two installations in the abutments have revealed expansion at an annual rate of about 0.03 percent for a total of 0.185 and 0.171 in. between the reference points. This example provides the assurance needed to show that the precise measurement program does indeed measure expansion or contraction in concrete if it is present.

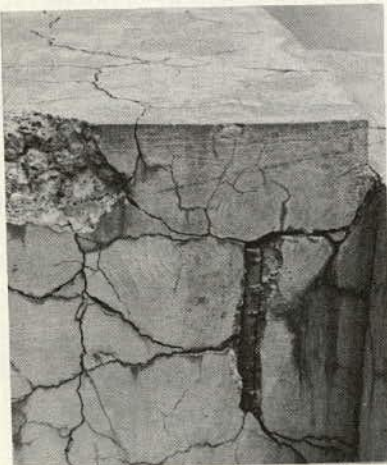
Figure 6. Hand rail post in 1956 (left) and 1964 (right) vertical expansion is $1 \frac{3}{16}$ in. in spite of reinforcing.

Another example of expansion of a reinforced concrete is shown in Figure 6. This post was observed to be severely cracked in 1956, with one of the heavy vertical bars being partially exposed. By 1964, the concrete had expanded vertically $1\frac{3}{16}$ in. This is the clear distance between the top of the bar and the concrete that originally was in contact with the top end of the bar. In this case, the reinforcement had no significant effect in preventing expansion.
