Special Report 106

Observations of the Performance of Concrete in Service

HIGHWAY RESEARCH BOARD
NATIONAL RESEARCH COUNCIL NATIONAL ACADEMY OF SCIENCES NATIONAL ACADEMY OF ENGINEERING

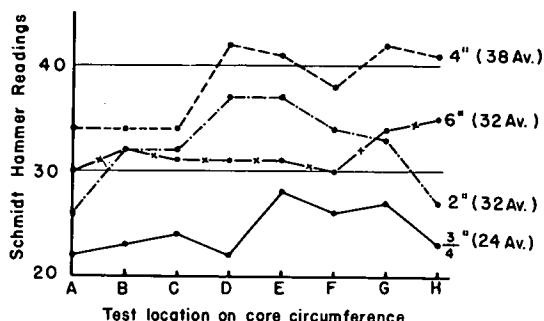
Figure 1. Variation of strength within 8 1/2-in. pavement core.

To illustrate these points as well as to show how the Schmidt hammer can be used to gain information not readily obtainable by other methods, data obtained during the course of an investigation of a concrete pavement failure are shown in Figures 1 and 2. This pavement was showing surface raveling after only 2 weeks of use. Figure 1 shows the variation in impact readings in one of the cores representing concrete still in good

condition. Not only did the indicated strengths vary around the core at the same depth, but the average level of strength varied greatly at various depths, being lowest near the surface of the pavement. Figure 2 shows comparison data on cores taken both from raveled and adjacent sound areas. In addition to showing variability, the several comparisons indicate that surface raveling was associated with an impact reading of 24 or less.

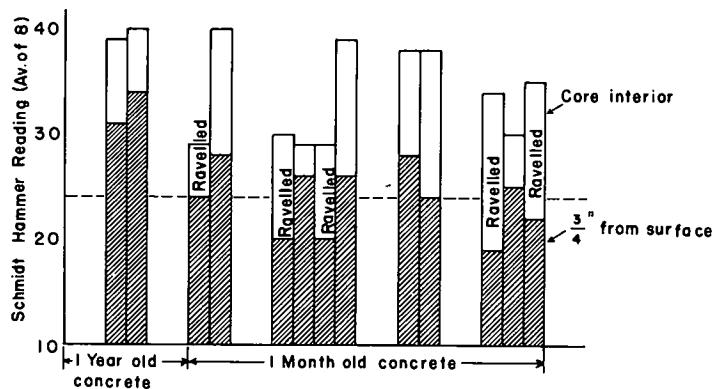
Figure 2. Strength vs raveling of pavement.

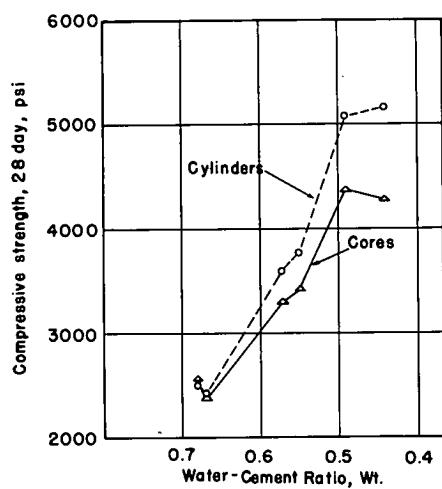
Figure 3. Relation of compressive strength of 6 by 12-in. cylinders and cores similarly cured.

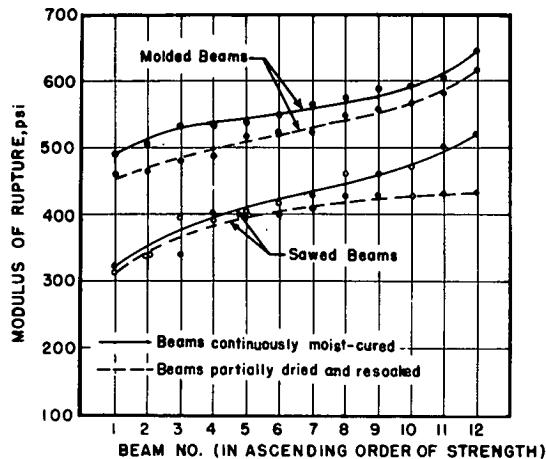
Figure 4. Relationship between flexural strengths of sawed and molded beams of same concrete.

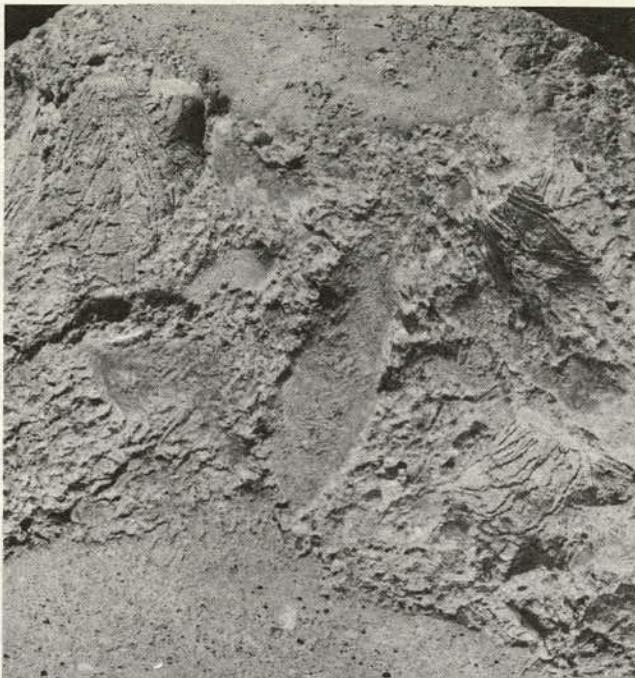
Figure 1. Formerly present ice crystals were responsible for the patterned imprints in aggregate sockets (magnification 1.8 \times).

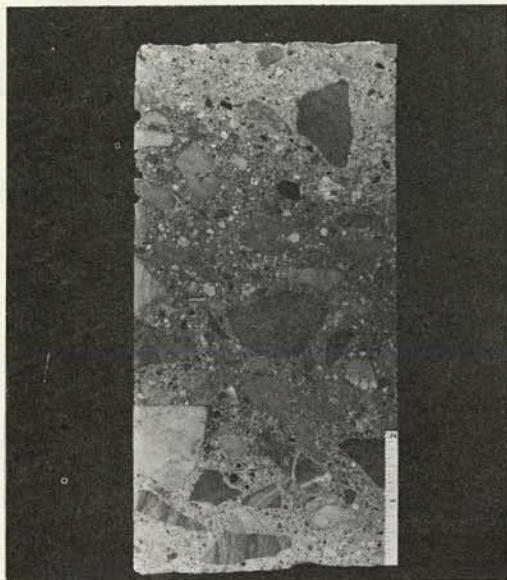
Figure 4. Cross section of a core from a pavement where surface raveling occurred. The dark area in the central portion was treated with wax to facilitate processing and is shown enlarged in Figure 5. Scale is in inches.

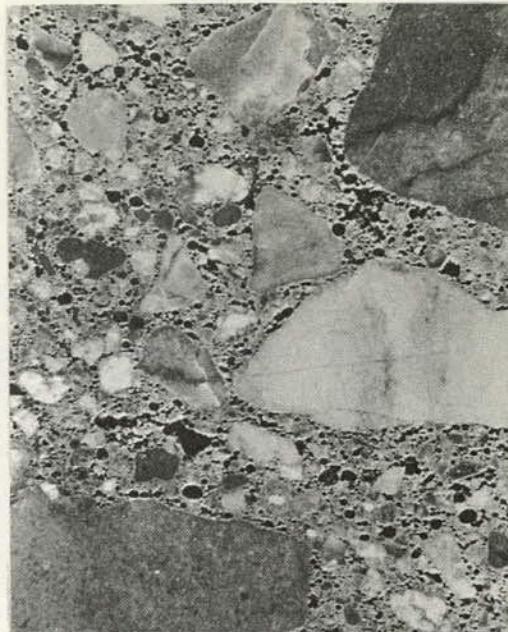
Figure 5. Magnified portion of the central area shown in Figure 4. The air content was determined to be 15 percent (magnification 3X).

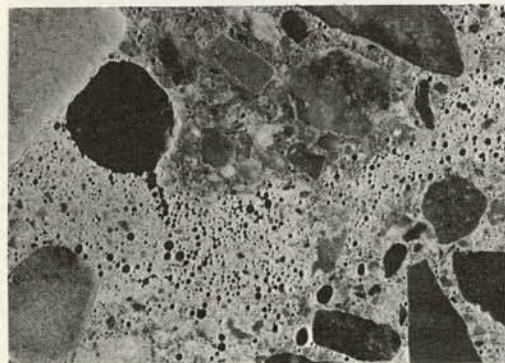
Figure 6. Cross section of a portion of a core from a pavement where a nonuniform distribution of entrained air occurred (magnification 3X).

Figure 6 shows a cross section of a core taken from a pavement that contained a nonuniform distribution of entrained air. The localized concentration of entrained air shown occurred in a small stringer of essentially neat paste that was flanked by non-air-entrained mortar.

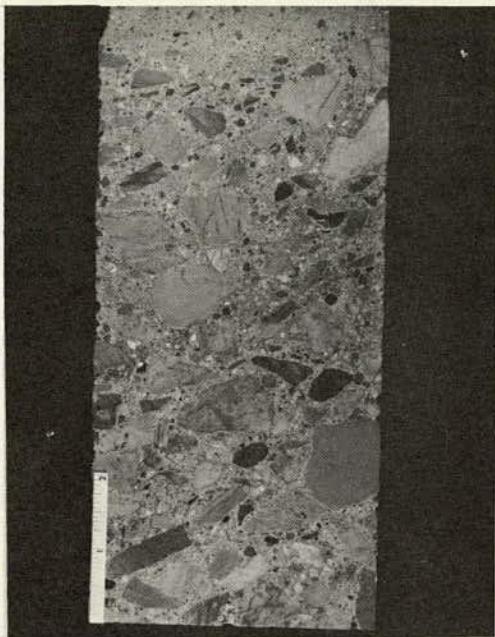
Figure 7. Cross section on a core taken from a pavement. A $\frac{1}{2}$ -in. thick zone at the wearing surface is devoid of coarse aggregate. Scale is in inches.

Figure 7, a cross section of a core taken from a pavement, shows a $\frac{1}{2}$ -in. zone that is devoid of coarse aggregate and is located at the wearing surface. The proportions of air, aggregate, and paste in this zone and in the remaining concrete can be determined by use of linear traverse or point-count methods of measurement.

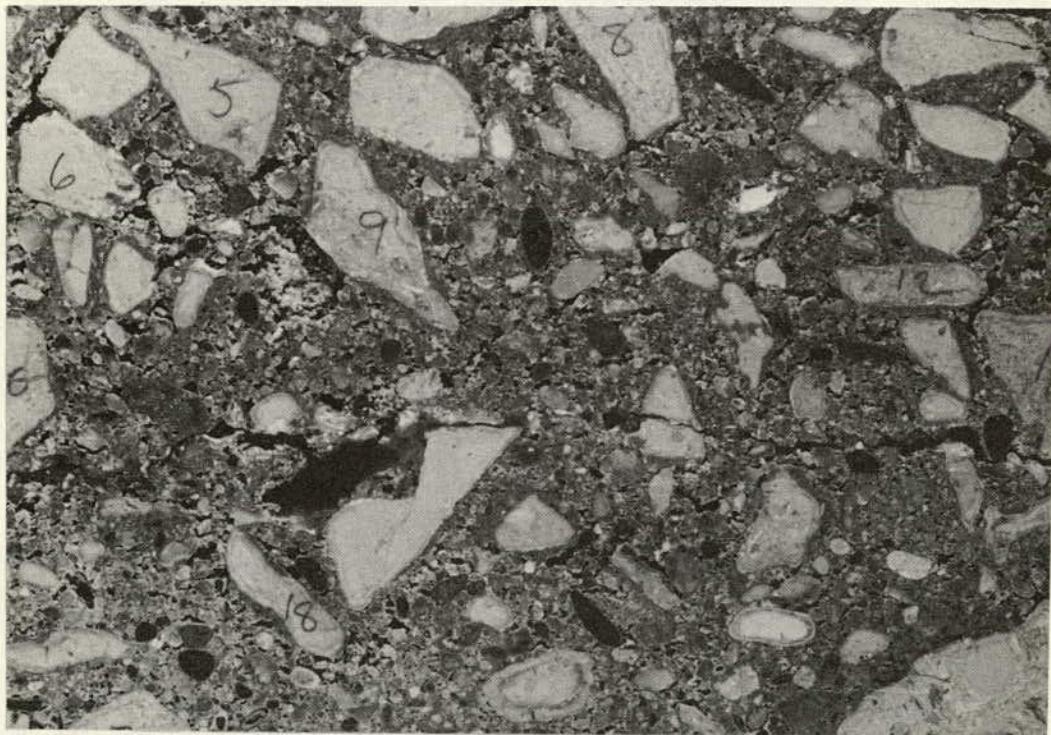
Figure 8. Enlargement of the central portion of a core taken from a pavement placed using two-course construction. An abnormal concentration of entrapped voids is present (magnification 1.5 \times).

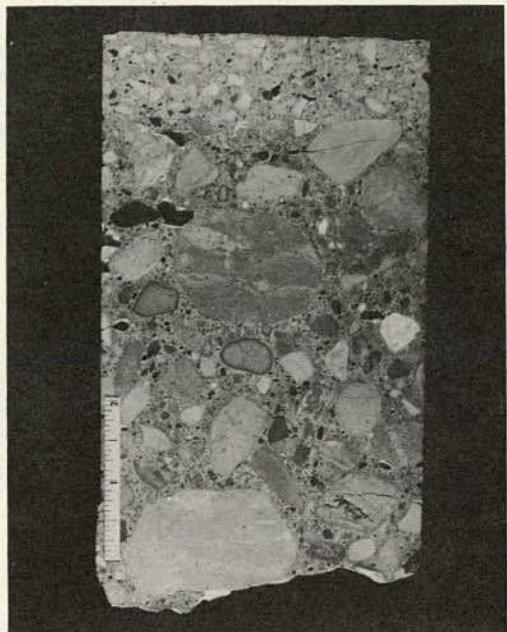
Figure 9. Cross section of a core taken from a resurfaced airport runway. Cracking in the 1-in. resurfacing is a reflection of continuing distress in the base concrete. Scale is in inches.

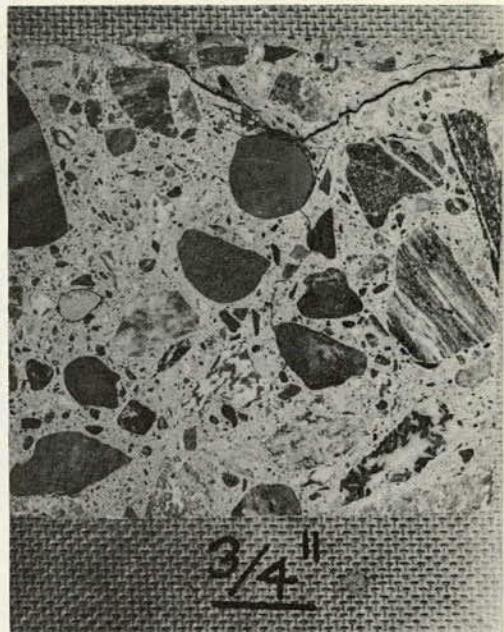
Figure 10. Cross section of a core taken from a bridge deck. An incipient spall, radial cracking, and rusting are associated with the reinforcing bar.

Figure 10 shows an upper cross section of a core from a bridge deck. Associated with the reinforcing bar, which is located $\frac{5}{8}$ in. below the wearing surface, are two prominent fractures that angle obliquely and intersect the surface. Minor fractures that extend radially into the mortar are also visible. The steel is corroded along its

upper periphery and corrosion products have migrated into the fractures. The major cracks define an incipient spall. Relationships between the thickness of cover over the steel, the cracking patterns, the disposition of the corrosion products, and other features were useful for interpreting the mechanism responsible for the cracking.

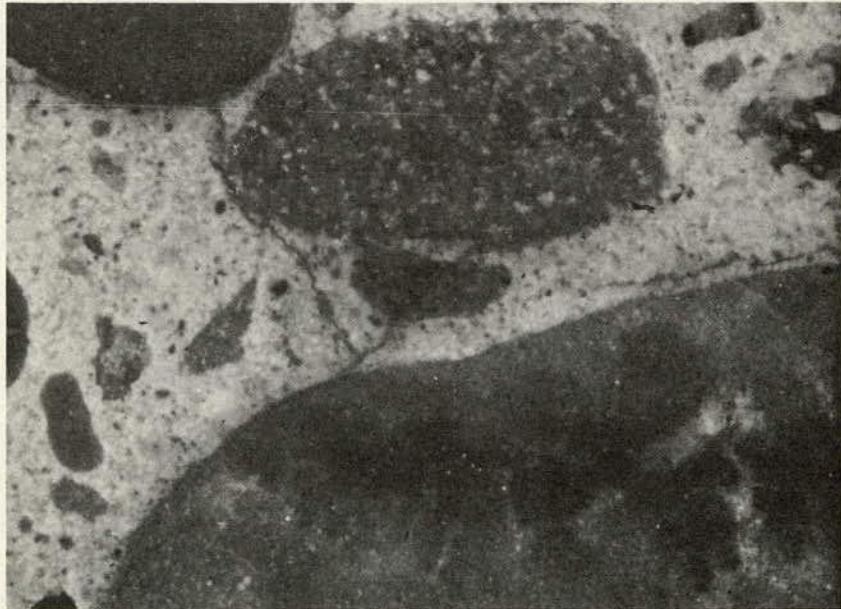
Figure 11. Enlargement of an area from a cross section of a prism made with a coarse aggregate that shrank excessively. Peripheral cracking was associated with the coarse aggregate particles (magnification 57.4X).

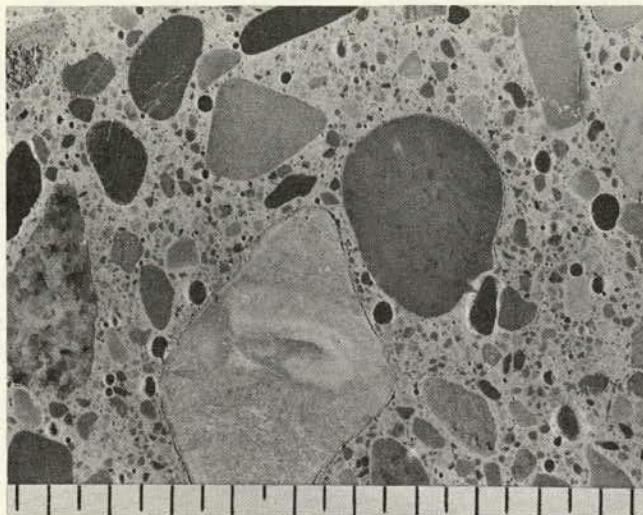
Figure 12. Enlargement of an area from a cross section of a prism made with a paste designed to expand. Peripheral cracking was associated with coarse aggregate particles. Scale is in $\frac{1}{16}$ -in. increments.

Figure 12 shows part of a cross section of a laboratory prism that contained a paste designed to expand. Peripheral separations occurred at coarse aggregate-paste interfaces. Unfortunately, the cracking patterns in this figure and in the preceding figure were similar. Thus, when encountering field concretes, the unstable component must be determined through supplementary tests. For example, one might make measurements of dimensional

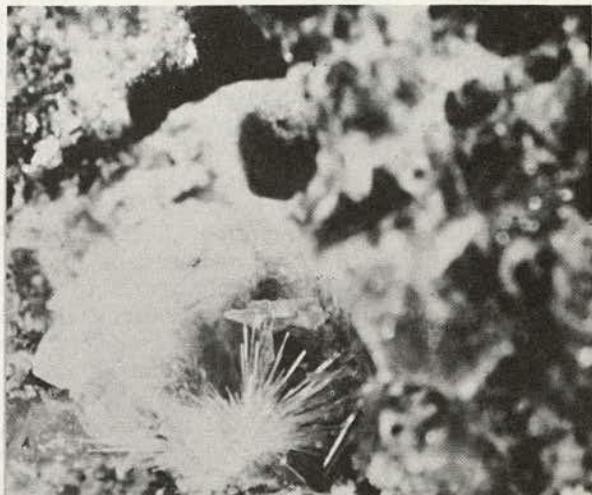
Figure 15. Entrapped air void containing needles of ettringite and platelets of calcium hydroxide (magnification 7.5 \times).

Figure 15 shows an entrapped air void that contains fine needles radiating from a common center, plus two thin hexagonal platelets. Although there is not much of these materials present, the two phases can be identified as ettringite and calcium hydroxide. Figure 16 shows material, selectively picked from a soft area of paste, identified as ettringite and altered paste. The location of the ettringite, as shown in the preceding figure, would be normal for many concretes exposed in a moist environment. In Figure 16, however, its occurrence typifies concrete damaged through sulfate attack. Figure 17 shows

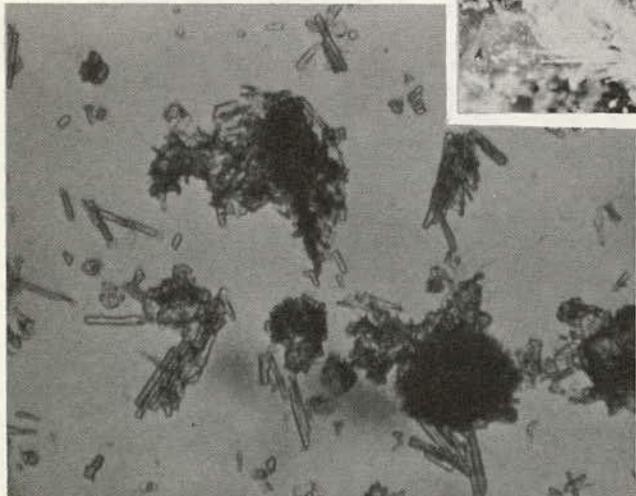
Figure 16. Powder mount of altered paste containing ettringite (magnification 375 \times).

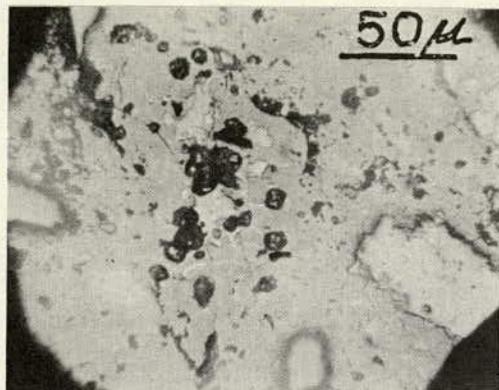
Figure 17. Polished section that shows residual and relic cement particles and microcracking.

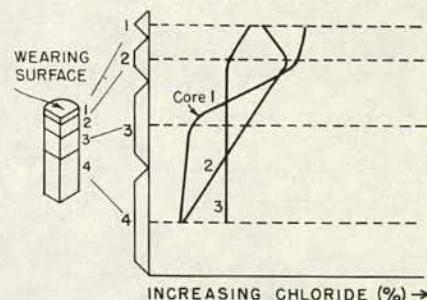
Figure 18. Analysis for chlorides in selected areas in cores may be useful for correlating particular types of deterioration and chloride ion concentrations.

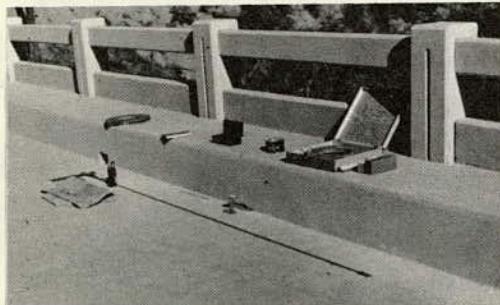
Figure 1. Precise measurement equipment showing typical installation in gutter line.

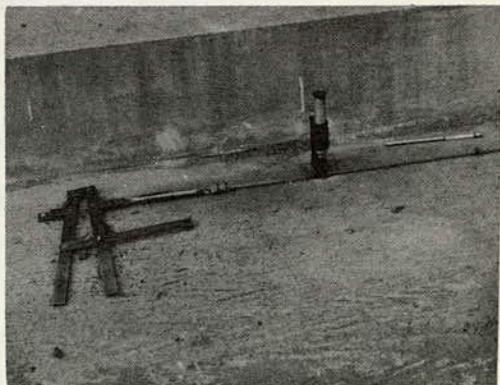
Figure 2. Tensioning device and shop microscope reading to thousandths of an inch.

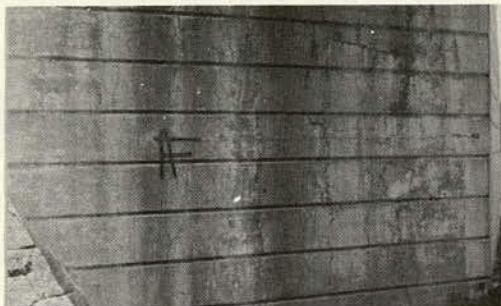
Figure 3. Precise measurement installation in severely cracked abutment.

location being in the gutter at 6 to 12 in. from the face of the curb. Other locations were on the top of the curb or safety walk, or on a wing wall or abutment. The concretes included a wide range of cements and aggregates, and the structures were new bridges in most cases, although a few were several years old. After 2 years of observation and measurements with no appreciable change in any of the concretes, another bridge, in which the concrete was definitely pattern-cracked, was added to the program (Figs. 3 and 4).

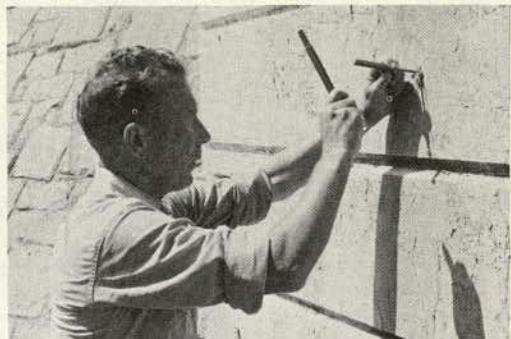
Figure 4. Setting brass insert with lead wool. This concrete is expanding at 0.03 percent per year.

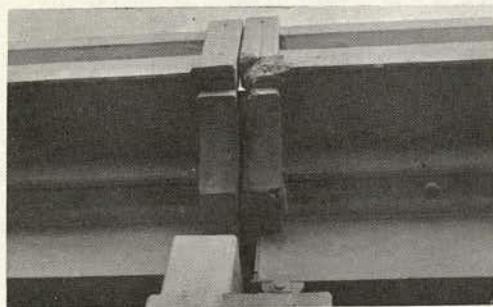
Figure 5. Expansion in bridge deck results in tight joint and broken end web.

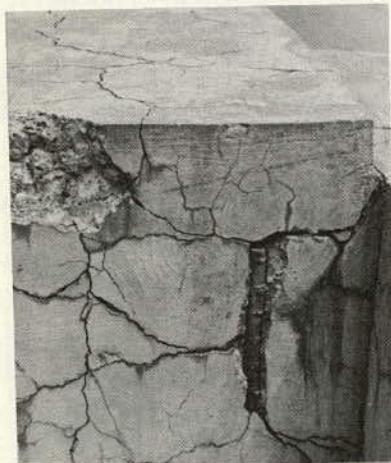
Figure 6. Hand rail post in 1956 (left) and 1964 (right) vertical expansion is $1 \frac{3}{16}$ in. in spite of reinforcing.

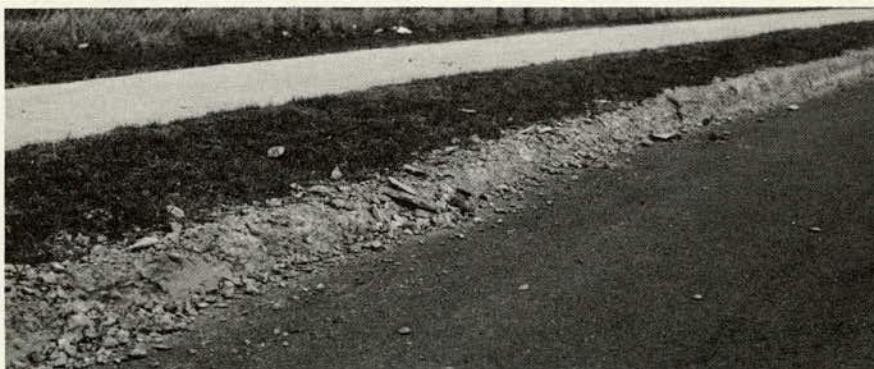
Figure 1. Close-up of section of a deteriorated concrete curb, affected area.

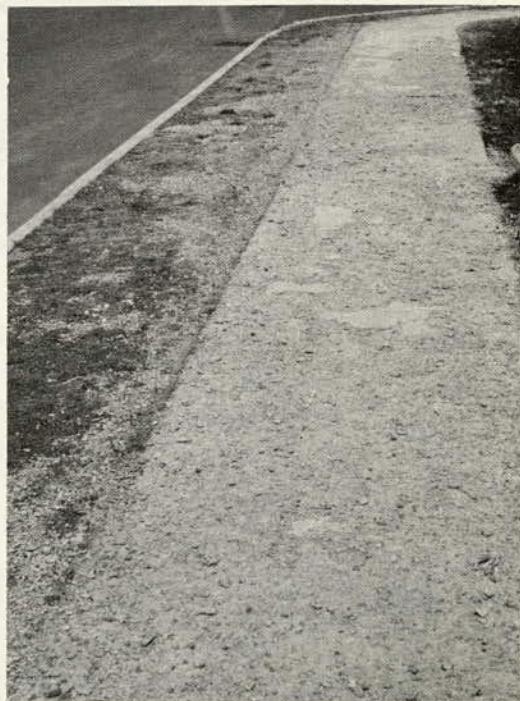
Figure 2. Deteriorated concrete sidewalk, affected area.

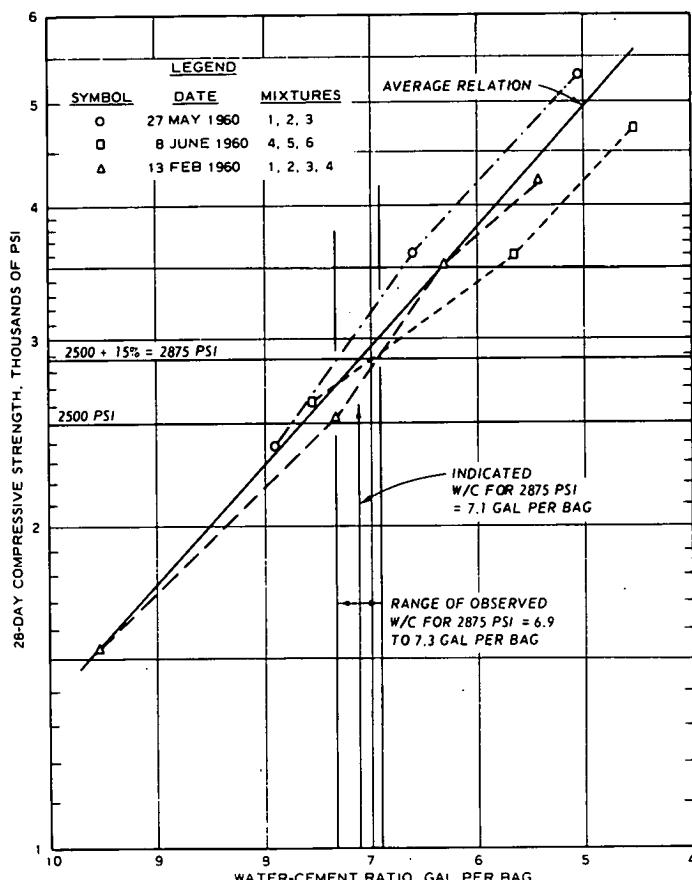
Figure 3. Relationship of water-cement ratio to compressive strength based on data submitted for Contracts A, B, C, and D.

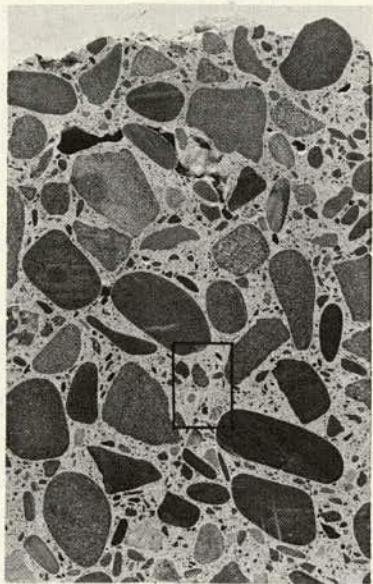
Figure 4. Sawed surface of top half of core CON-20, $\frac{1}{2}$ natural size. From $\frac{3}{4}$ to 1 in. of top surface has scaled off. The section outlined is magnified in Figure 5.

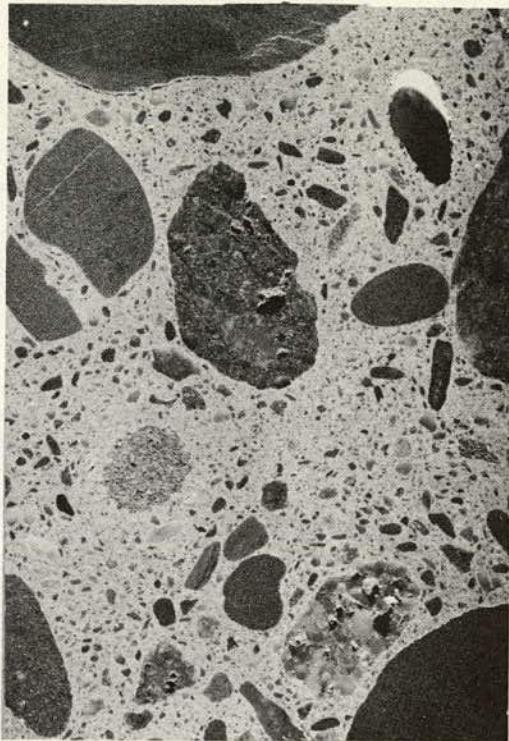
Figure 5. Sawed surface of core CON-20. This is the area outlined in Figure 4. The actual magnification is 4.4 times natural size.

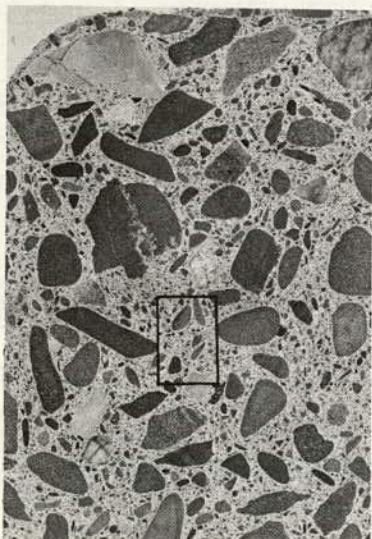
Figure 6. Sawed surface of top half of core CON-24, $\frac{1}{2}$ natural size. Curbing was in good condition with formed and finished surfaces intact. The section outlined is magnified in Figure 7.

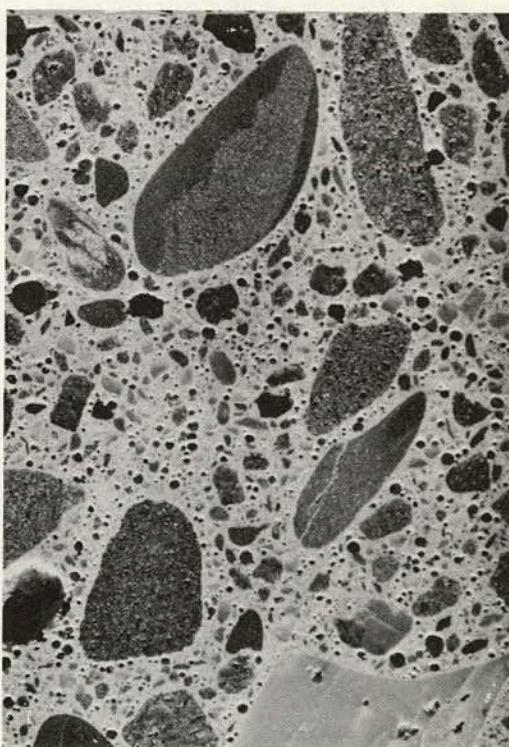
Figure 7. Sawed surface of core CON-24. This is the area outlined in Figure 6. The actual magnification is 4.4 times natural size.

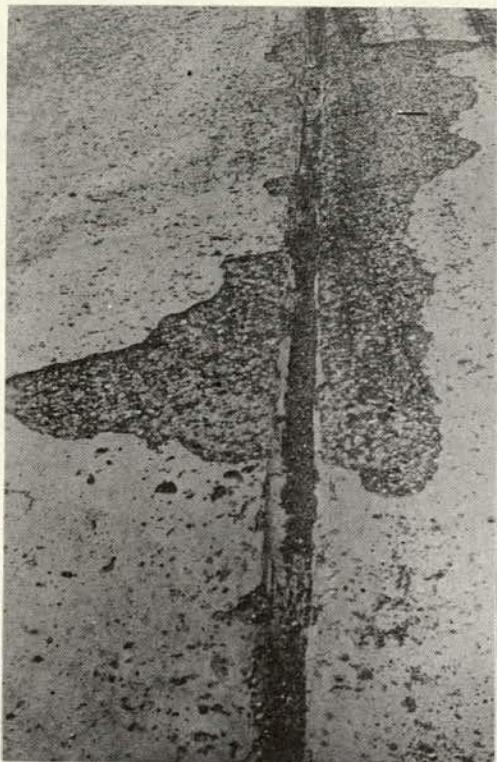
Figure 1. Typical scaling of concrete as it had occurred in areas 92, 93, and 98. Note localized pitting and spalling of the finished surface in advance of general scaling.

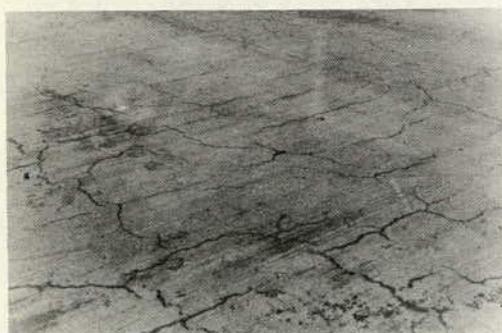
Figure 1. Random cracking in span 4 (surface damp).

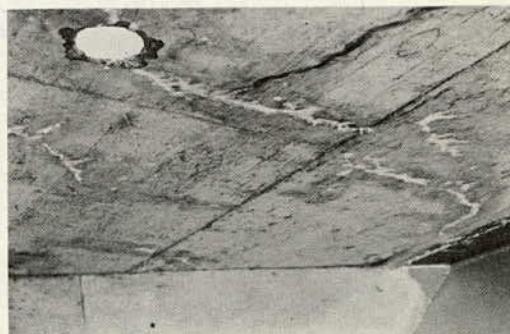
Figure 2. Underside of span 4 showing leaching through cracks and corrosion of longitudinal stringer. Core was removed from hole at upper left.

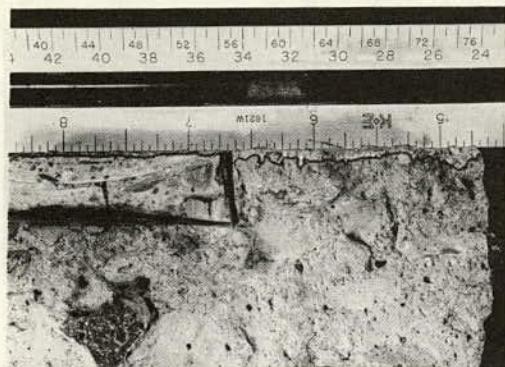
Figure 3. Top of core removed from a bridge showing random cracking. The right side shows penetration of curing compound into crack to a depth indicated by the dark line. The normal depth of curing compound is indicated on the sawed left section of core.

To accomplish this, two 4-in. diameter cores were removed from the cracked area for petrographic examination. Examination of these cores indicated that the cracks traveled around rather than through aggregate particles. Considering this finding and the fact that the strength of the concrete was high based on information from construction records and the petrographic examination, it was possible to conclude that the cracking occurred when the concrete was relatively green and perhaps fresh. This conclusion was supported by an earlier investigation (4) of a similar though less severe occurrence in which it was shown, from a petrographic examination of cores, that the curing compound actually penetrated into the crack as shown in Figure 3, thus proving that formation of the crack preceded or very closely followed the application of curing compound. Results from an earlier, unpublished laboratory study of similar quality concrete suggested that the absence of broken aggregate associated with the crack indicates that the crack occurred during the initial 24 hours.

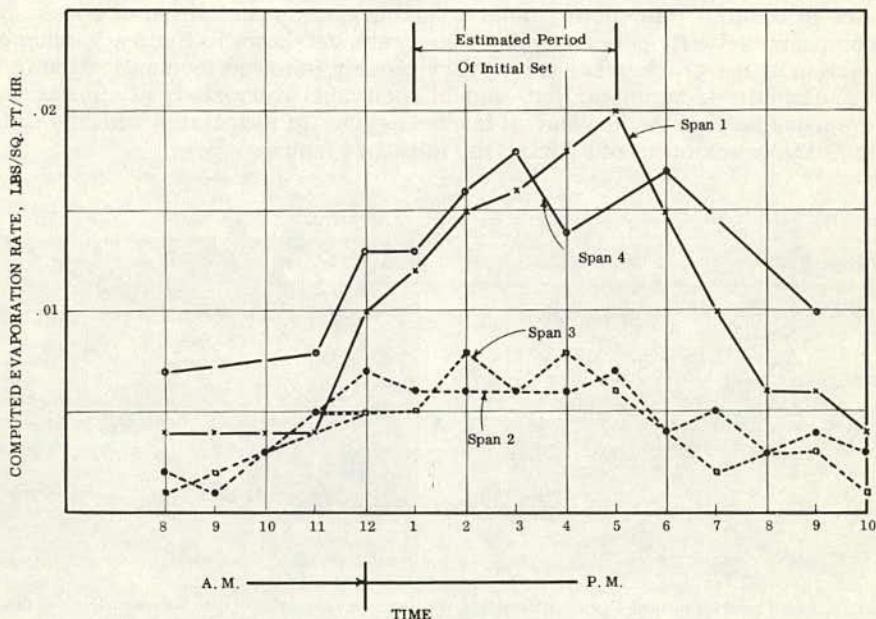
Figure 4. Variation with time of computed evaporation rates for spans 1 and 4 (cracked) and 2 and 3 (uncracked).

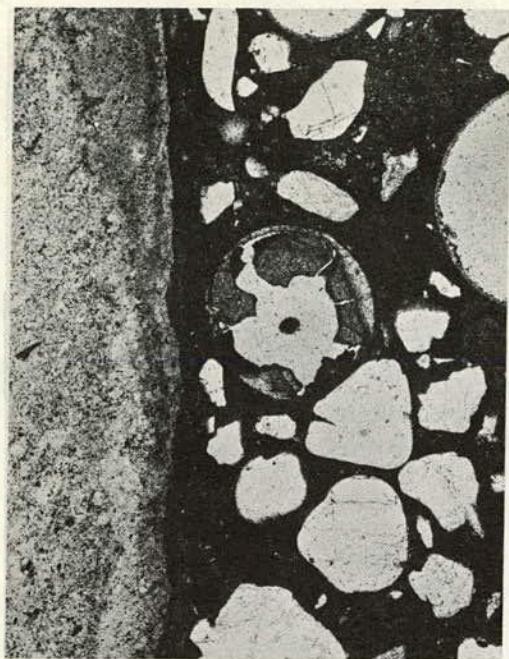
Figure 1. Thin section of concrete from factory chimney near the Mediterranean Sea. Flint pebbles to the right have darkened rim caused by partial solution resulting from alkali-aggregate reaction. Air bubble in center of picture is partly filled by alkali-silica gel, fractured during drying.

A concrete specimen from the top section was examined by chemical analysis, X-ray diffraction analysis, and a thin-section investigation. The concrete proved to have undergone leaching and carbonation along with the corrosion of the reinforcement. On the outer surface of the specimen, a coating of the mineral syngenite $[K_2Ca(SO_4)_2 \cdot H_2O]$ was observed (Fig. 3), while a coating consisting of the hemihydrate $CaSO_4 \cdot \frac{1}{2}H_2O$ was found on the inside of the chimney and situated in a crack in the structure.

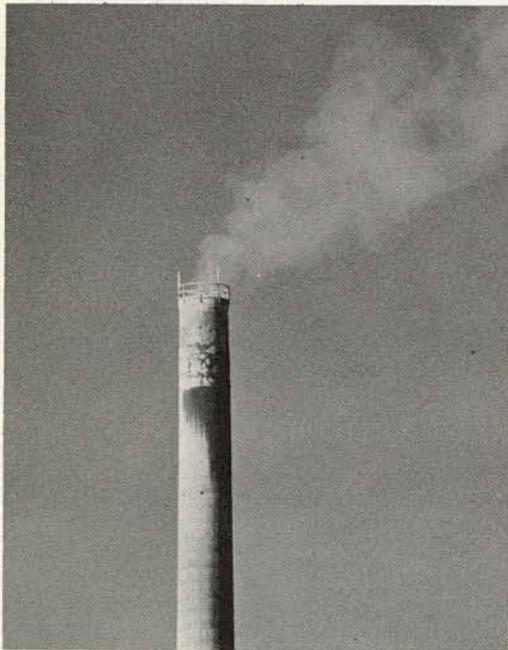
Figure 2. Top section of concrete chimney showing disintegration.

1. The content of carbon dioxide in the smoke accelerates the carbonation of the concrete. The ability of the concrete to protect the reinforcement against corrosion is thereby reduced and formation of rust may result in spalling of the covering layer.
2. The temperature variations, presumably most pronounced at the top of the chimney, cause unequal thermal deformation of the concrete, possibly accompanied by crack formations.
3. The content of sulfur gases in the smoke condenses on the sides of the chimney, thereby developing sulfuric acid that deteriorates the concrete. The reaction products formed are gypsum and other calcium-sulfates.

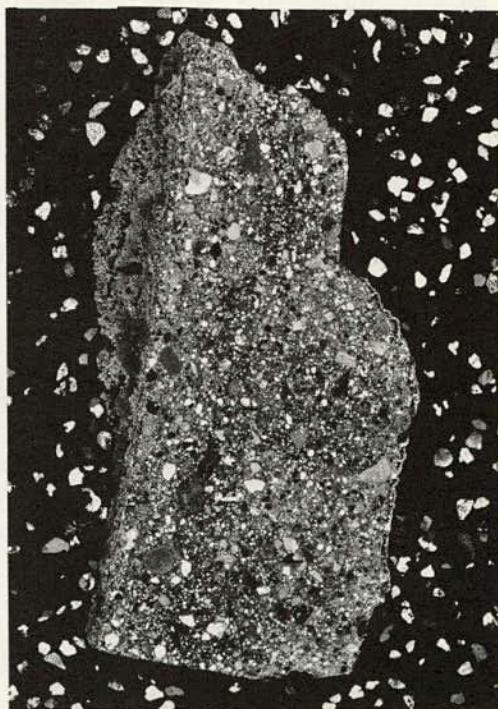
Figure 3. Total photo of a thin section prepared from a deteriorated piece of concrete taken from the outside upper part of a chimney (crossed nicols, 1.26x magnification).

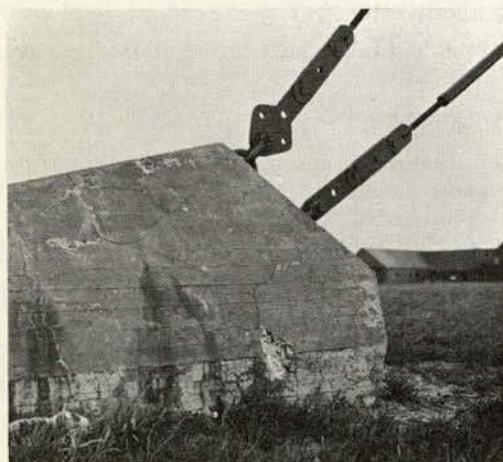
Figure 1. Anchorage block 8 (Fig. 2) with coarse cracks and map-cracking.

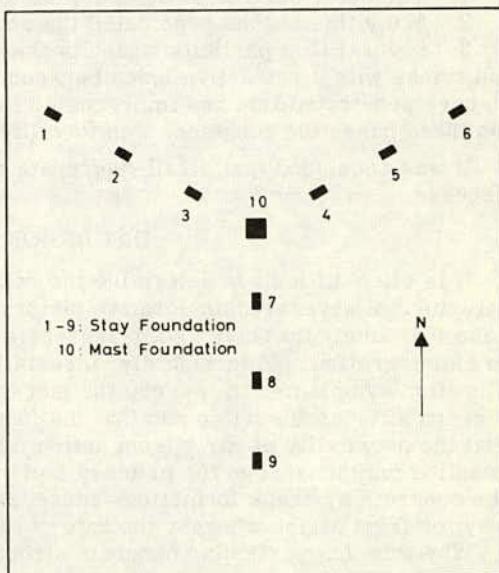
Each anchorage block is about 3 m long, 1.5 m wide, and 2.5 m high with about 1 m visible above ground level.

Figure 2. Arrangement of anchorage blocks and foundation (not in scale).

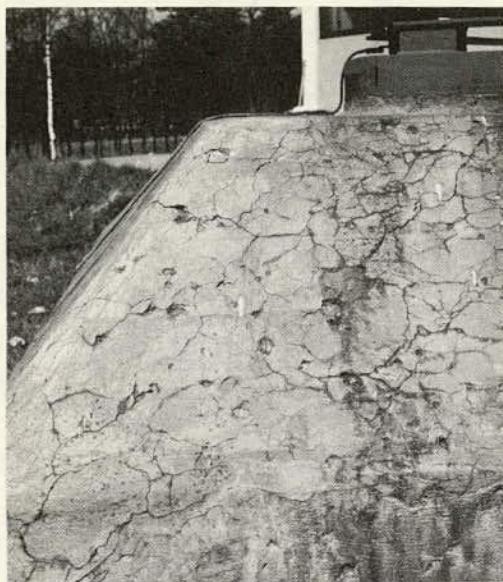
Figure 3. Close-up of mast foundation (10 in Fig. 2) showing extensive map-cracking and pop-outs.
