# The Use of a Screen to Subdue Gale-Force Winds on a Mountain Bridge

ERIC F. NORDLIN and LOUIS BOURGET, Materials and Research Department,  
California Division of Highways

This is a study to determine the feasibility of employing wind screens as a means for preventing vehicle accidents caused by high-velocity crosswinds. An experimental wind screen was installed on a mountain bridge where truck trailers had been overturned by sporadic gale-force crosswinds. The 10-ft-high screen was made of 9-gage galvanized steel chain-link mesh fencing with all of the apertures filled with crimped aluminum slats vertically placed. The spaces between the slats resulted in a porosity of 20 percent. The screen has been completely successful in preventing either the overturning of vehicles or loss of driver control during a 2-year test period. This paper suggests other types of locations that may benefit from wind protection and offers basic design considerations.

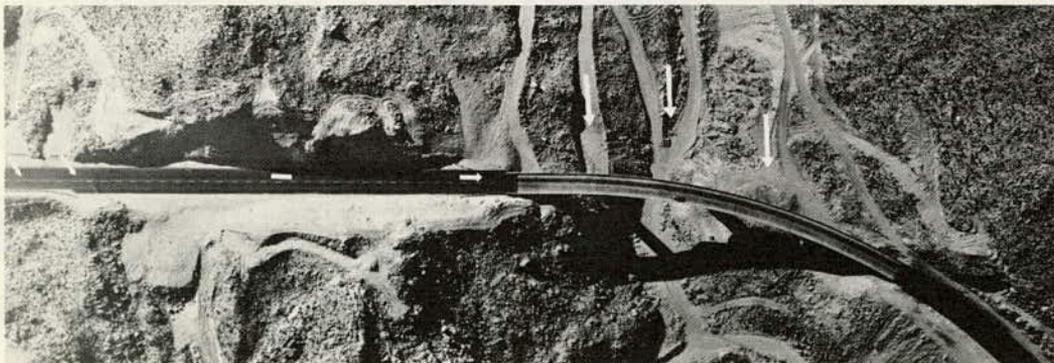
Figure 9. Effect of terrain in reducing and deflecting crosswinds on bridge.

Some of the strong west winds over the entire area find a spillway beyond the south gap of the bridge. The contours of the terrain at this location reduce and deflect the west wind to a half velocity head wind that filters through the south gap and travels north on the bridge (Fig. 9). This head wind was readily turned by the predominant west crosswind on the bridge before the screen was installed, and no evidence of a head wind appeared on the wind instruments mounted near the center of the bridge (Fig. 10). After
