# **Snow and Ice Control in California**

Carl E. Forbes, Carl F. Stewart, and Don L. Spellman

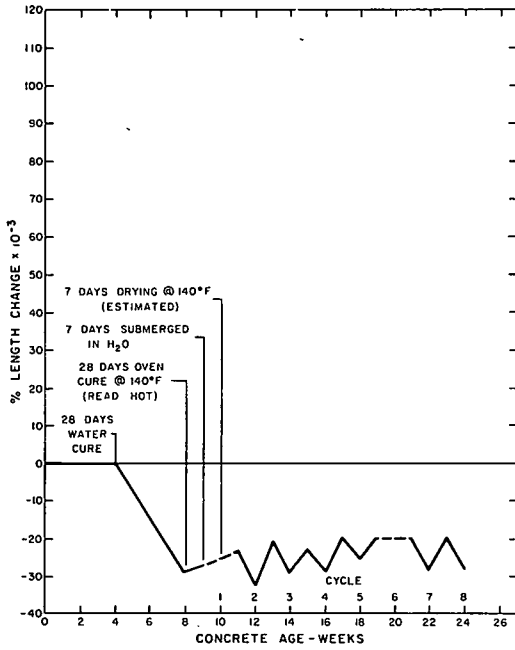
Figure 1. Alternate immersion tests of 4½-sack concrete in tap water.

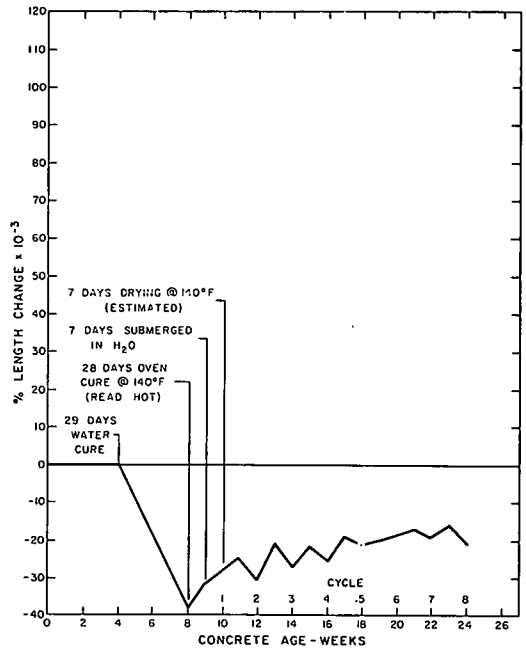
Figure 2. Alternate immersion tests of 7-sack concrete in tap water.

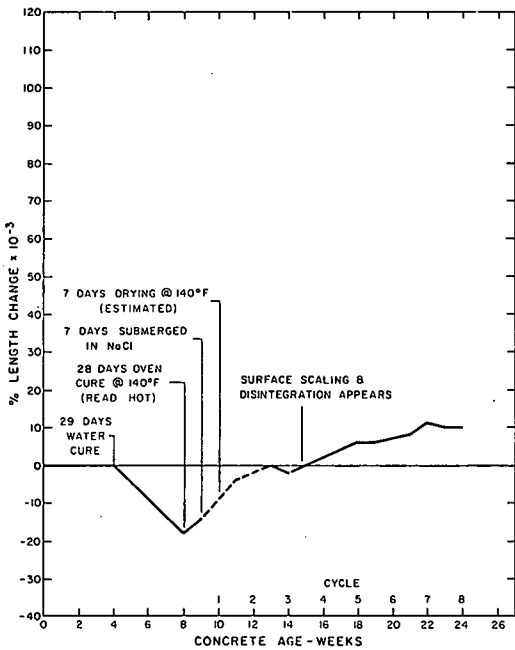
Figure 3. Alternate immersion tests of 4½-sack concrete in sodium chloride solution.

3. Concrete cylinders cycled in a saturated sodium chloride solution were first observed to have scaling of the surfaces of all cylinders after the third cycle. This scaling did not become severe through 7 cycles and is believed to be primarily confined to the surface area and not of major concern yet to the structural strength of the concrete. The distress observed is similar to that occurring in normal air-entrained concrete exposed to similar salt concentrations.

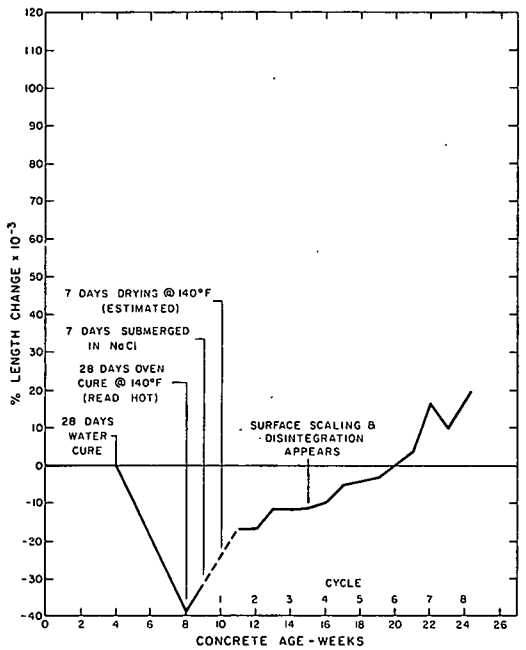
Figure 4. Alternate immersion tests of 7-sack concrete in sodium chloride solution.

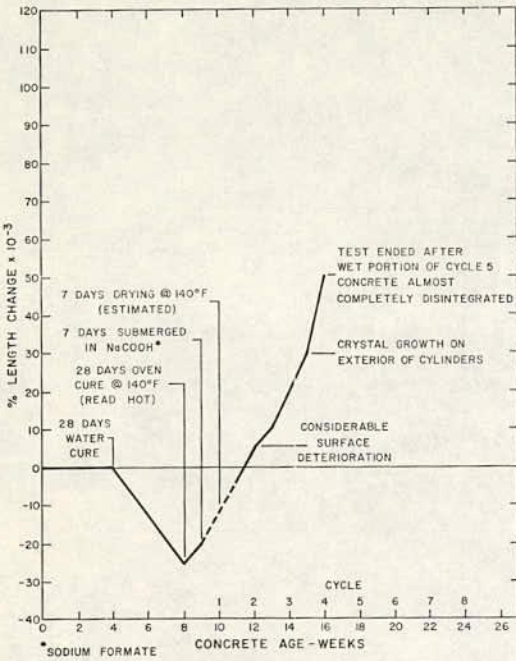
Figure 5. Alternate immersion tests of 4½-sack concrete in sodium formate solution.

2. Sodium formate caused severe deterioration of both  $4\frac{1}{2}$ - and 7-sack concrete specimens. Visible surface scaling was evident after only 2 cycles. Figure 7 shows the condition of  $4\frac{1}{2}$ -sack concrete specimens after removing them from solutions at the completion of the wet portion of the fourth cycle. Crystal growth and severe disintegration are obvious. Only one more cycle was possible before terminating tests employing sodium formate because of the extreme disintegration of the concrete.

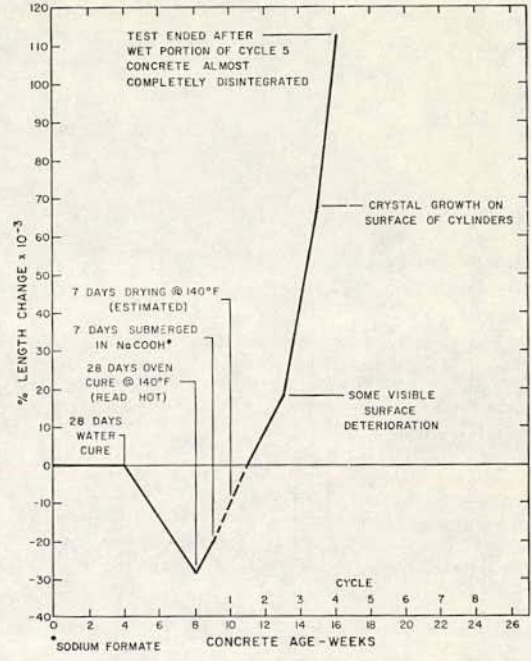
Figure 6. Alternate immersion tests of 7-sack concrete in sodium formate solution.

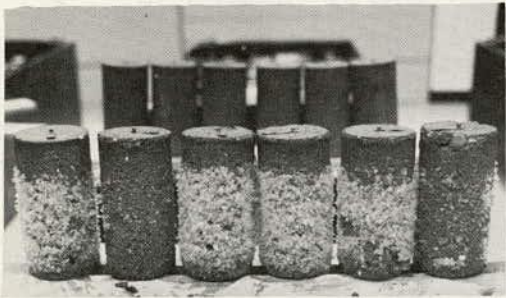
Figure 7. Condition of 4½-sack concrete after 4 cycles of alternate immersion in sodium formate and oven-drying.

Figures 7, 8, and 9 show the appearance of  $4\frac{1}{2}$ -sack concrete after 4 cycles of alternate immersion and oven-drying. Figures 10 and 11 show the amount of concrete disintegration after 5 and 6 cycles of alternate immersion in sodium formate for the  $4\frac{1}{2}$ - and 7-sack concrete.

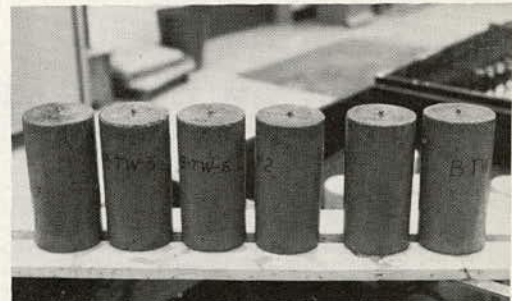
Figure 8. Condition of 4½-sack concrete after 4 cycles of alternate immersion in tap water and oven-drying.

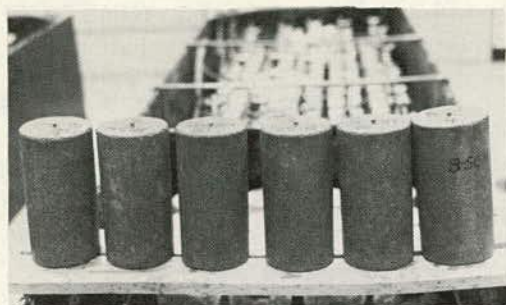
Figure 9. Condition of 4½-sack concrete after 4 cycles of alternate immersion in sodium chloride and oven-drying.

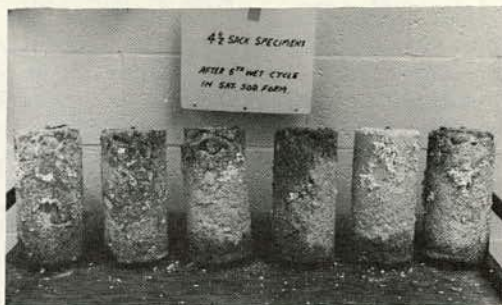
Figure 10. Condition of 4½-sack concrete after 5 and 6 cycles of alternate immersion in sodium formate.

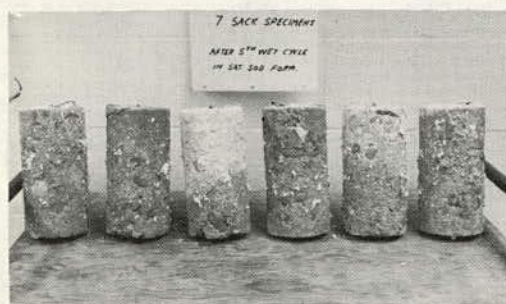
Figure 11. Condition of 7-sack concrete after 5 and 6 cycles of alternate immersion in sodium formate.

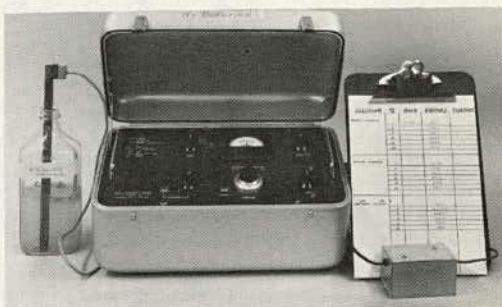
Figure 12. Corrosimeter testing apparatus.

One of the most important properties of any de-icing chemical considered as a substitute for sodium chloride is that it be noncorrosive to reinforcing steel in bridge decks, or at least only slightly corrosive. A simple corrosion screening test was chosen to evaluate the corrosivity of the various concentrations of chemical solutions. The method used was to immerse mild steel corrosion probes in the solutions and measure the corrosion rate of the steel by means of the change in the electrical resistance of a thin metal strip. The resistance change is caused by any loss in metal cross section as corrosion proceeds. The equipment used is shown in Figure 12.
