An Approach to Concrete Pavement Replacement That Minimizes Disruption of Traffic

R. F. Grimsley and B. G. Morris
Florida Department of Transportation

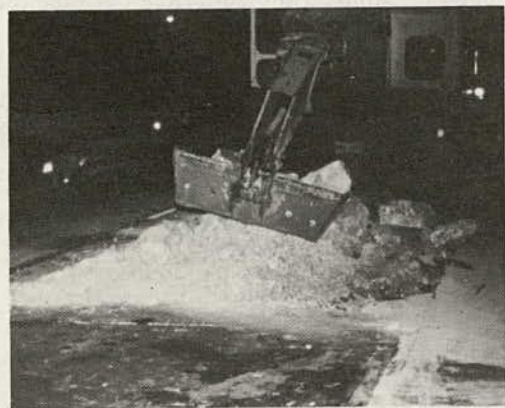
Figure 3.

The next operation was to break up the damaged concrete slab. This was accomplished with a $\frac{1}{2}$ -ton (450-kg) mobile dragline and a headache ball. The operator positioned the dragline so the headache ball could be dropped on the designated slab and break it into pieces small enough to allow easy removal from the work area. Approximately 45 min is usually required to break a slab into pieces small enough to be loaded into dump trucks by a gradall (Fig. 3). Extreme care in dropping the headache ball is required to prevent damage to adjacent slabs.

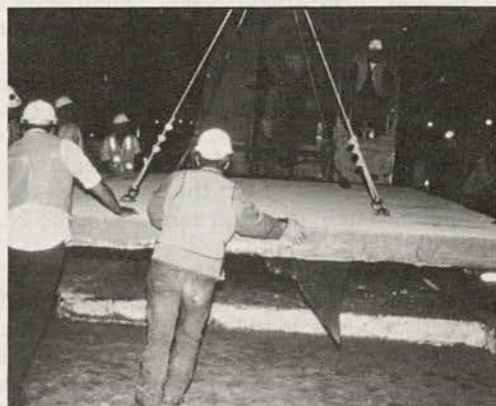
Figure 4.

The next operation consisted of placing the slabs in the prepared location (Fig. 4). A crane was used to lift the slab from the transport onto the roadway base. Heavy equipment such as the crane should be kept off newly placed slabs until the final grade is established.
