Chapter 8

Design and Construction of Soil Slopes

David S. Gedney and William G. Weber, Jr.

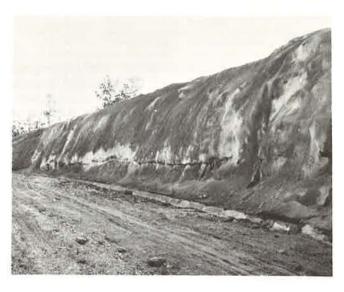
Figure 8.5. Slope protected by pneumatically applied mortar.

Slope treatment per se may involve a number of alternatives, all designed to promote rapid runoff and improve slope stability. Some of these measures are (a) seeding or sodding and (b) using gunite, riprap, thin masonry or concrete slope paving, and rock fills. Gunite and thin masonry or concrete slope paving have been used successfully to protect weak shales or claystones from rapid weathering (Figure 8.5). The use of asphalt paving to prevent infiltration of surface water is also common in some areas. These methods of controlling surface runoff are effective when used in conjunction with various subsurface drainage techniques. Surface drainage measures require minimal design and offer positive protection to slopes along transportation facilities.

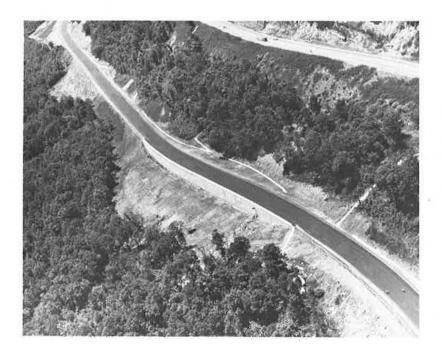
Figure 8.27. Aerial view of final correction to fill failure using reinforced earth, I-40 near Rockwood, Tennessee (8.26).

Final design plans called for careful excavation of the failed portion of the fill to a firm unweathered shale base, installation of a highly permeable drainage course approximately 10 m (33 ft) wide below the wall area, placement of the reinforced earth wall, and final backfill operations behind the reinforced earth mass (Figure 8.26). The wall was designed for a minimum safety factor of 1.5 against failure. The 253-m long by 10-m high (830-ft by 3.3-ft) wall was completed in approximately 60 d (Figure 8.27).

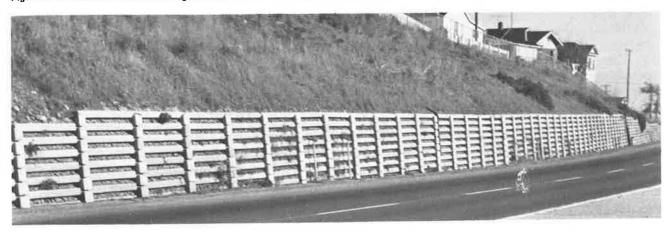
Figure 8.28. Concrete crib wall and gravel backfill installed to prevent movement in Arcata, California (8.24).
