## FROST DAMAGE TO ROADS IN GREAT BRITAIN\*

D. Croney, Road Research Laboratory, Harmondsworth, Middlesex, England

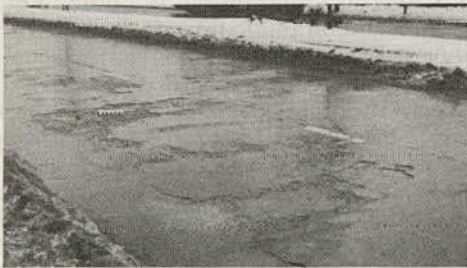
Figure 1. Surface Spalling Due to Frost (Concrete Construction).

The most common form of frost damage to concrete when used as a road surfacing, is spalling arising from the expansion on freezing of the water contained in the upper voids of the concrete. An example of this type of damage is shown in Figure 1. Spalling is most likely to occur in concrete made with a high water to cement ratio (above 0.7 by weight), which favors the formation of a surface laitance.

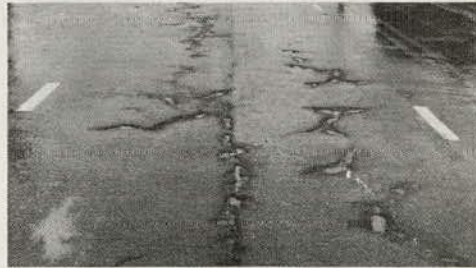
Figure 2. Separation of Two Courses of 2-Coat Asphalt Due to Frost Action.

periods. Frost can also cause the separation of the upper layers of compound bituminous surfacings. This also leads to failure of local areas under traffic (Fig. 2). Freezing of water at the interfaces between the layers is probably the original cause of separation.

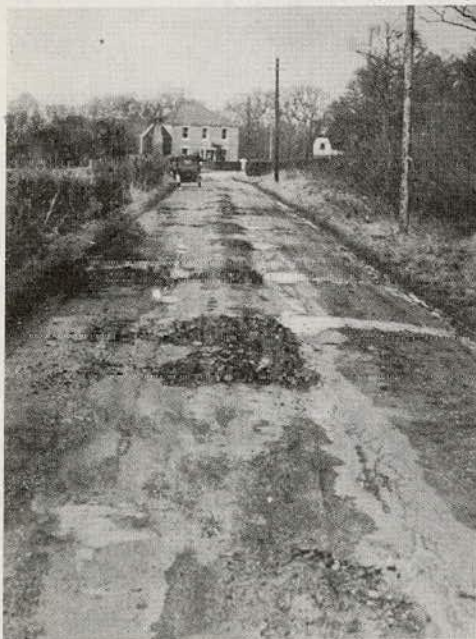
Figure 5. Frost Heave on Country Road in Southern England.

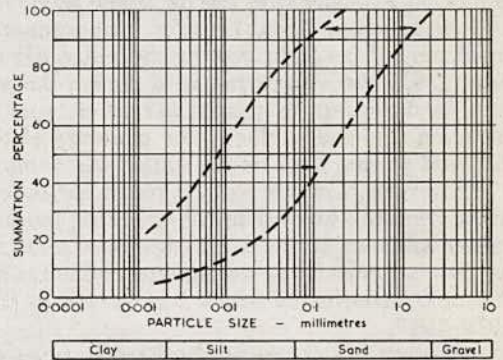
Figure 4. Particle-Size Limits Within Which Soils are Likely to be Frost Susceptible (Based on Investigations in So. England.)

Figure 4 shows the approximate limits of particle-size distribution for soils which are frost susceptible under British climatic conditions. These curves are based on a number of subgrade investigations carried out during the very cold winters of 1940 and 1947. It will be seen that the upper curve indicates a total clay and silt content much greater than is usually associated with frost susceptible soils. In fact, the particle-size distribution of most of the soils tested were close to the lower limiting curve. In a few cases, however, where the free-water table was close to the surface of the subgrade, soils having a clay content approaching 30 percent were found to exhibit appreciable heave. In such soils it is probable that lowering the water table would have entirely prevented heave. In the case of many of the coarser subgrades investigated, the water table was at a considerable depth and it was clear that the water required to promote ice segregation was being drawn from the soil immediately beneath the frozen zone rather than directly from the water table. Figure 5 shows typical damage to an unclassified road in southern England. For generations prior to the advent of the tar surfacing, such roads were kept open in winter by the tipping of any available granular material into the deep ruts caused by iron-tired vehicles. There tends therefore to be a considerable thickness of frost-resistant material near the edges and only a comparatively thin layer at the center of the road. This accounts for the heave and subsequent breakup being confined largely to the crown of the road.

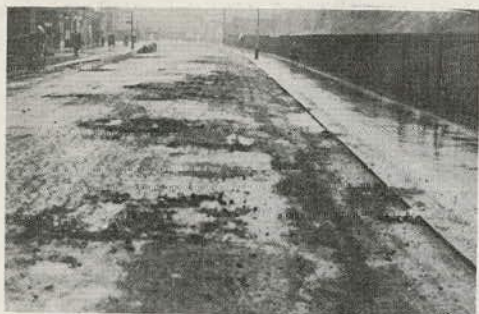
Figure 6. Damage Caused by Frost Heave in Chalk Fill.

Chalk, which occurs near the ground surface over considerable areas of S. E. and E. England, is a particularly troublesome subgrade material from the point of view of frost heave. The upper few feet of the chalk are generally intersected by weathering and temperature cracks between which ice lenses form when freezing occurs, the necessary water being drawn from the chalk beneath. When the subgrade of a road consists of compacted chalk fill the heave is likely to be much greater than in the case of natural (undisturbed) chalk subgrades. Figure 6 shows the breakup subsequent to thawing to a suburban road where a compacted chalk subbase about 8 in. in thickness was used on a heavy clay (non-frost susceptible) soil. The road structure in this case consisted of a tar-macadam surfacing on a base of compacted brick rubble 8 in. thick.
