Chapter Five

Airphoto Interpretation

Ta Liang and Donald J. Belcher

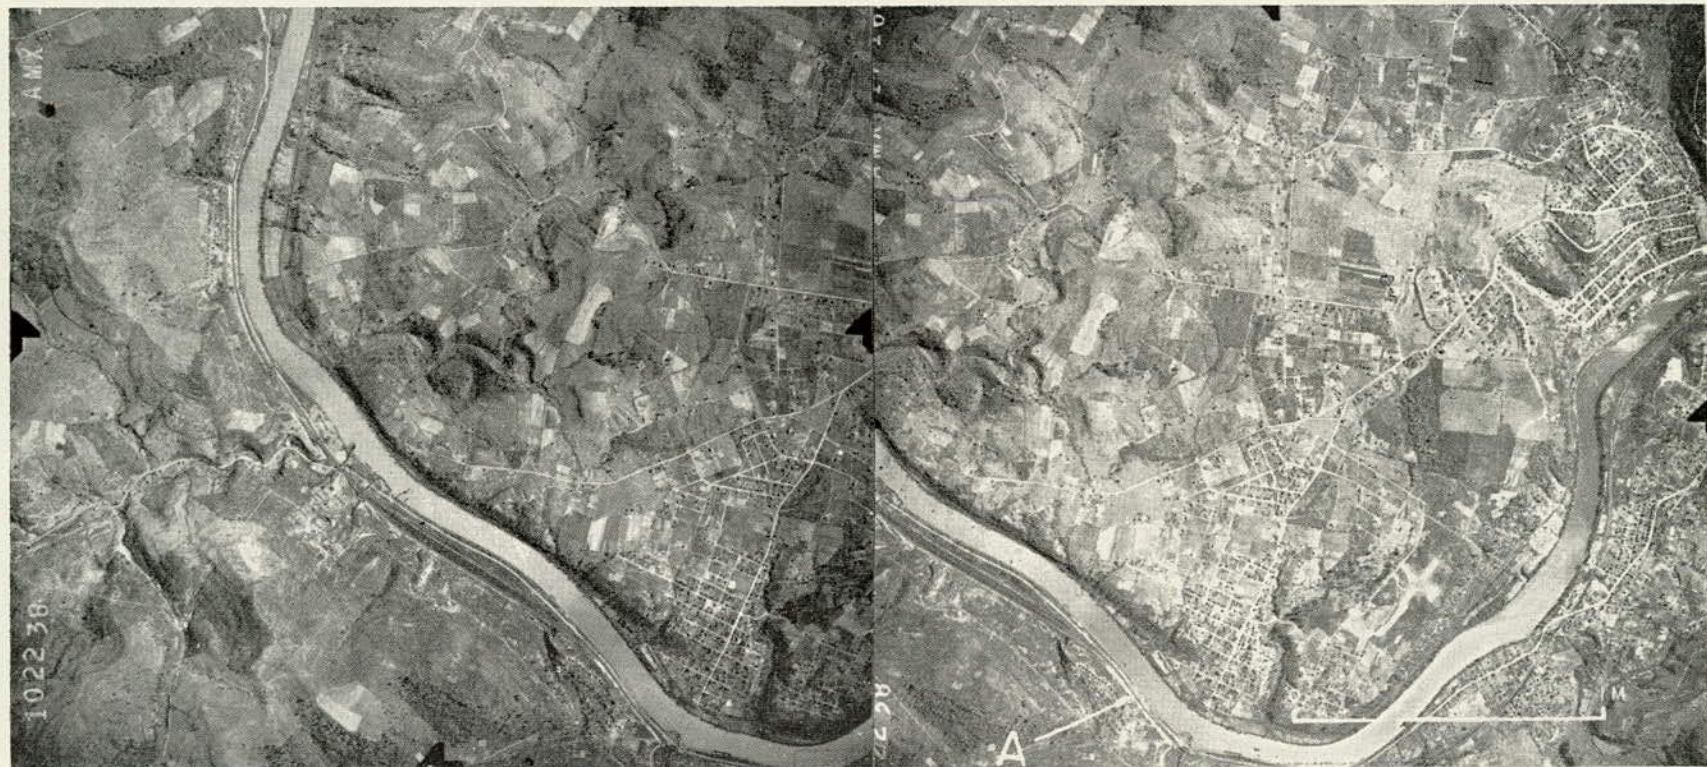
Figure 48. Clay shale, Monongalia County, W. Va. This stereo pair shows an area where clay shales predominate and landslides are active. There are very few competent beds in the general area as evidenced by the rounded, soft slopes and dull, uniform, gray tones. Minor irregularities as signs of movement are seen in most of the steep slopes. Even without artificial disturbances, nature is actively reducing the relief of the area by creeps, flows, and slides. At area (A), both the railroad and highway have experienced continuous landslide troubles. The irregular outline of the bank along the river and the patchwork on the road pavement are clearly seen in the photos. The steep slope and active attack by the river provides a favorable condition for landslides. Furthermore, surface drainage in the back of the slope is blocked by a hill and water is seeping through the hill toward the river. Such a circumstance is conducive to slides.

In horizontal positions, massive sandstone is little likely to slide. Clay shale, especially if interbedded with sandstone or limestone, is highly susceptible to landslides (Figs. 48, 49, 50, and 51). Landslides are uncommon in thickly bedded limestone unless it is interbedded with shale or other soft rocks. In steeply tilted positions, any sedimentary rock may fail by sliding (Fig. 52). Depending on the dip angle, joint system, and climate, slides may take one or a combination of the forms of rockfalls, rockslides, debris falls, debris slides, and earthflows. River undercutting and artificial excavation are important factors in initiating landslides in both horizontal and tilted rocks.

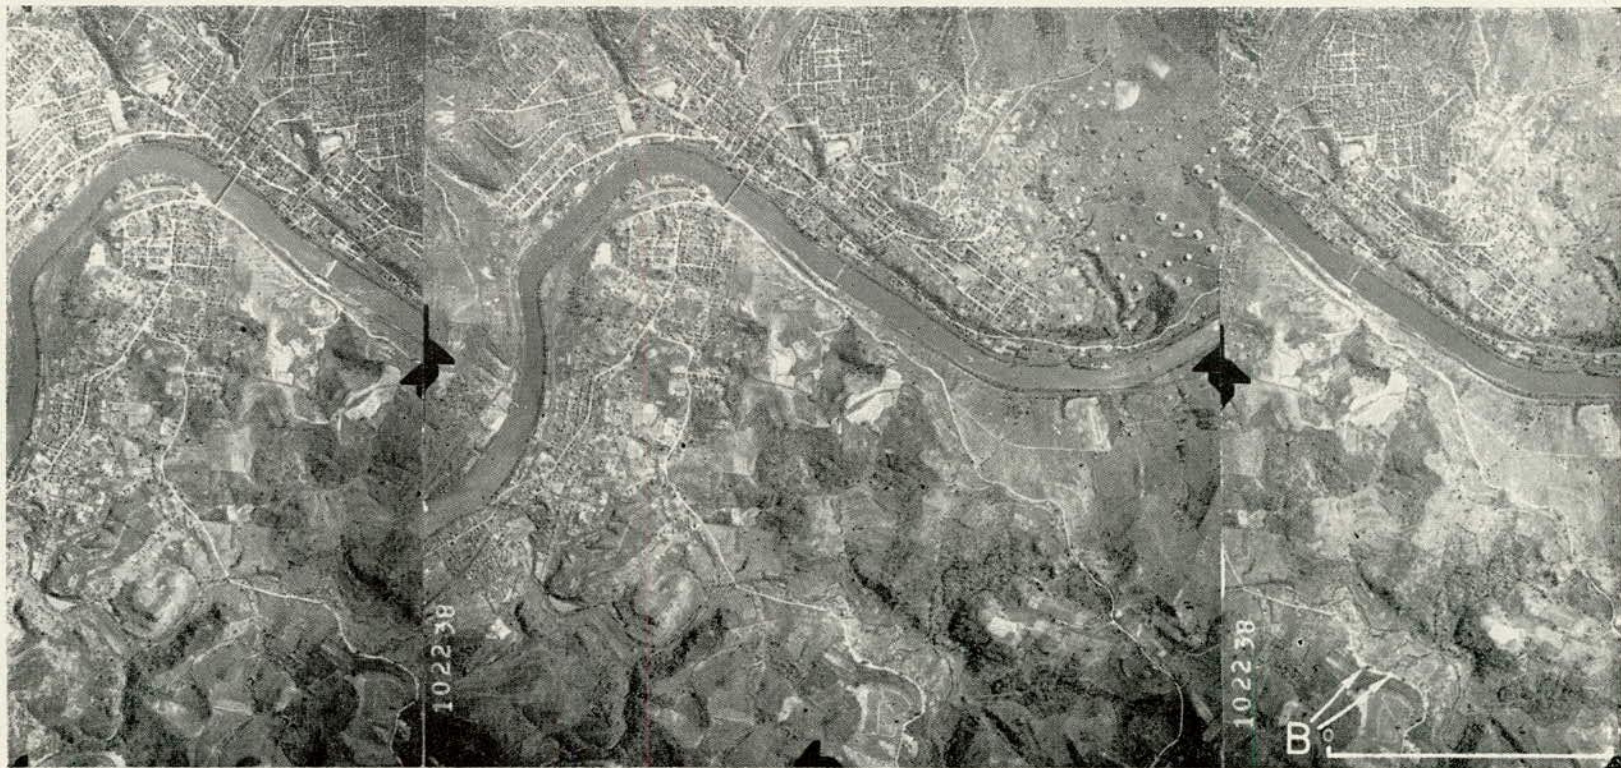
Figure 49. Shale in same general area as shown in Figure 48, Monongalia County, W. Va. Area (B) shows one of the most unstable slopes in the area. The disordered, hummocky forms on the hillside indicate that flows and slides are active. The irregular outlines of the road is a sign of continuous refilling and repatching because of slides. Slide scars are also prominent on the opposite side of the valley, particularly on the steeper slopes. (Aerial photograph by U. S. Department of Agriculture)

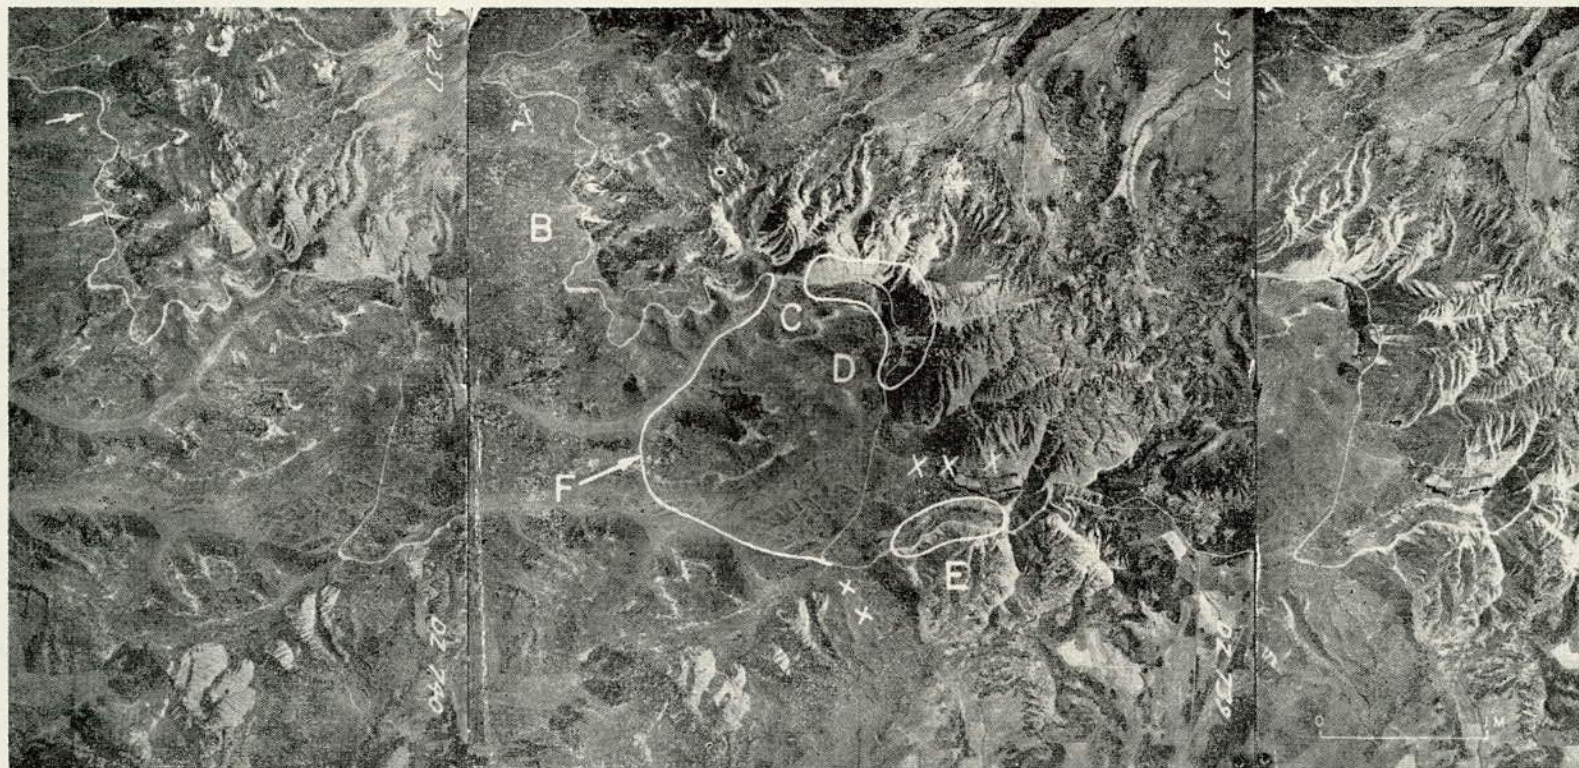
Figure 50. Flat-lying sedimentary rocks, Mesa Verde National Park, Montezuma County, Colo. The interbedded competent sandstones and soft shales are nearly horizontal, as indicated by the contour-like stratification lines on hills. The numerous landslides and erosional scars, seen as white patches, are striking throughout the area. Serious slides are marked (A), (B), (C), (D), and (E). (C) indicates where caprock fails, (D) indicates slumps where shale is primarily involved. Drainage condition in back of (C) helped to promote the mass movement.

It is difficult to maintain the highway on the shale slopes because they are already oversteepened and do not provide a good foundation; further disturbance would hasten the slide. Because of the difficulty in maintaining the roads on the steep slopes, several routes (X) have been abandoned in the general area. A plan of relocating the scenic highway that passes the hazardous area (C) and (D) is now under consideration. The new route will follow the valleys and go through a 1,400-foot tunnel (F). (Aerial photograph by U. S. Department of Agriculture)

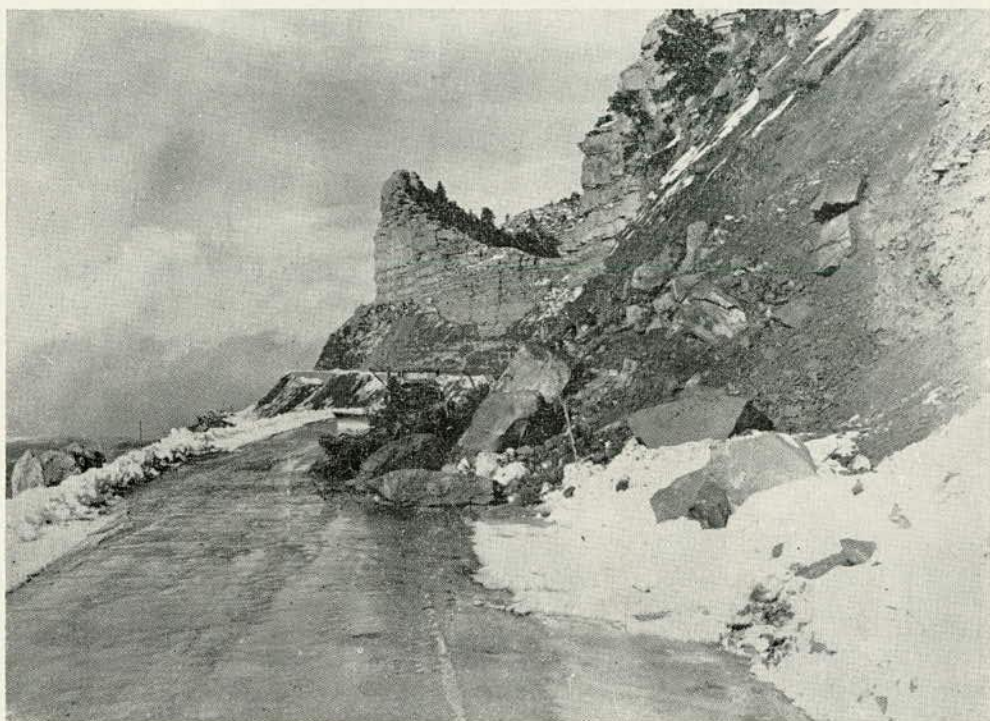
Figure 51. Ground view of rockslides and rockfalls in shale and sandstone, shown in Figure 50. (Photograph by National Park Service)

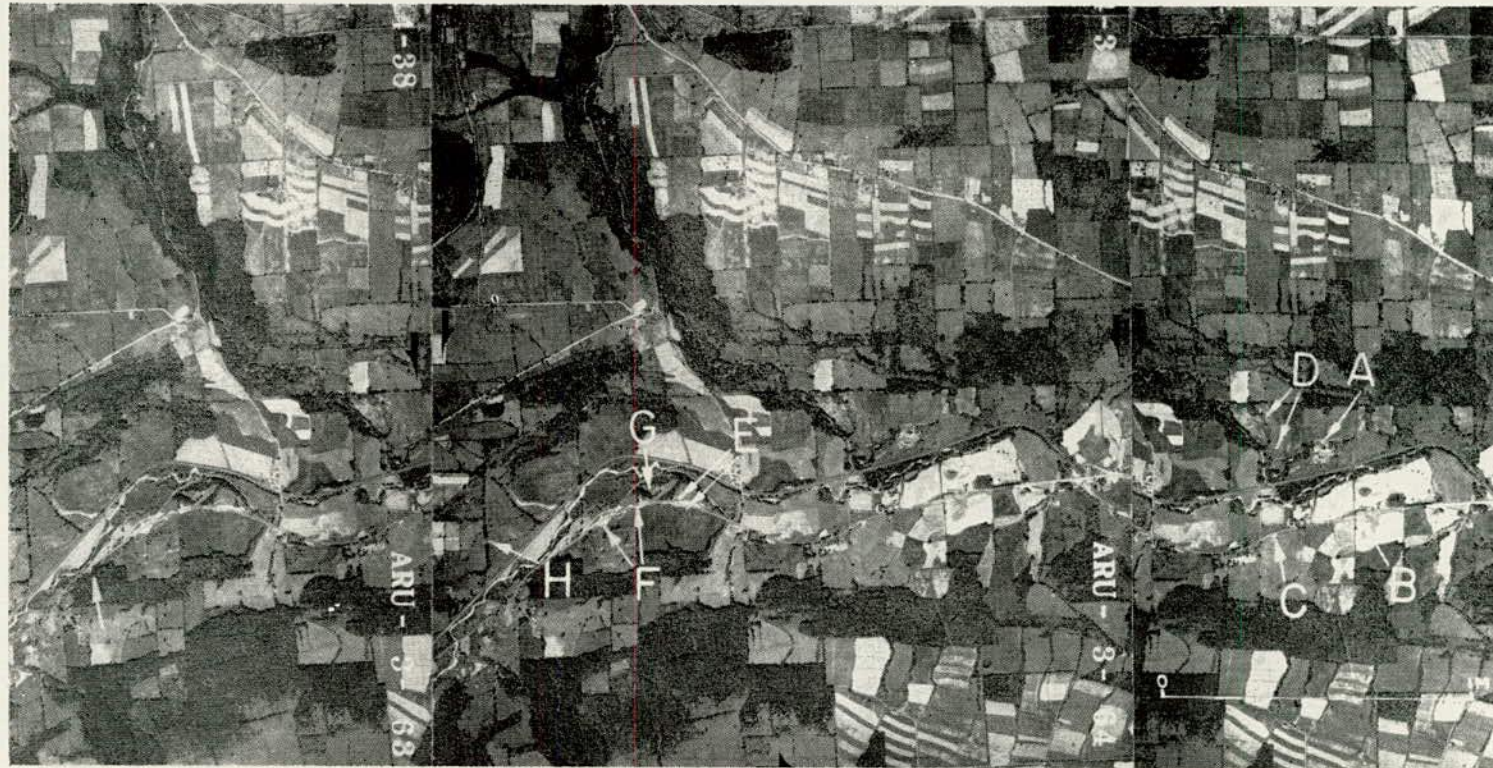
Figure 54. Moraine and lake bed, Tompkins County, N. Y. New slumps and debris slides, as well as old slide scars, are common occurrences in this glaciated valley where post-glacial erosion has dissected the moraines and the overlying lake deposits. Morainal areas are recognized by their hummocky topography. Lake deposits are usually distinguished by their flat, horizontal disposition. However, when lake clays are dissected, such a criterion no longer holds. Rather, the clues for clay identification, such as the characteristic smooth slopes, high degree of dissection, and gradual change of color tones, are more applicable.

A close inspection of the photo reveals that there are many old landslides, (A) being a prominent example. Other old slides, such as (D), (G), and (H), are common throughout the valley. All of them have been more or less stabilized, as indicated by the established vegetative pattern. Most highway cuts of moderate depth have experienced landslides, as in (B), (C), (E), and (F). Although deep-seated and large-scale slides are not likely to occur in such an area, continuous maintenance work in clearing the sliding material and in protecting slopes from erosion is necessary. (Aerial photograph by U. S. Department of

Minor slumps, debris slides, and earthflows are common in cut slopes in moraines as the result of the presence of undrained depressions and seepage zones in the mass. Because morainic hills are usually small, these slides are not very extensive. They are, nevertheless, large enough to cause continuous trouble to many highway maintenance engineers (Figs. 54 and 55).

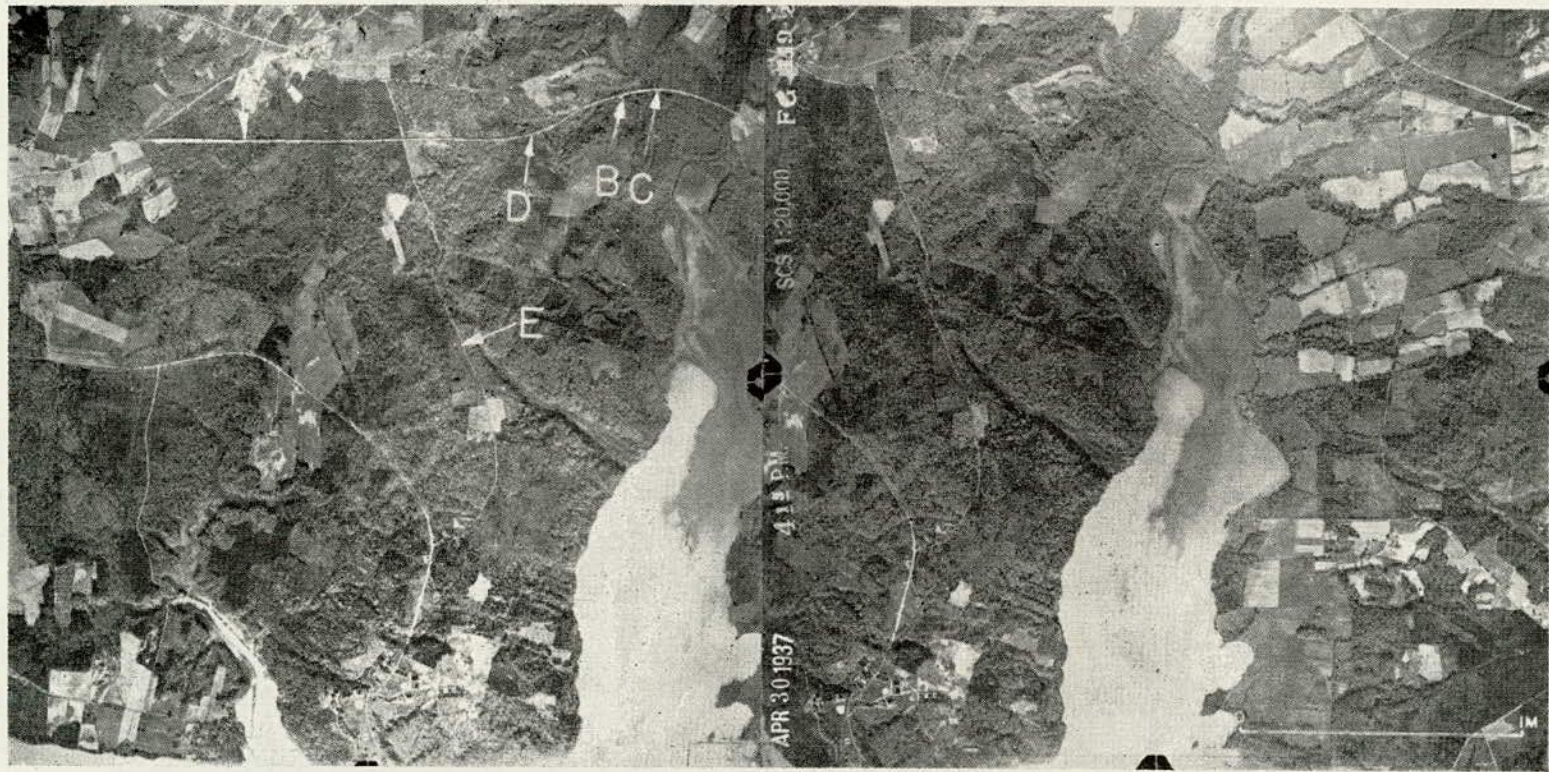
Figure 57. Coastal plain, Prince Georges County, Md. The stereo pair shows a proposed road (white line on left photo). The dissected plain is identified by its low, soft hills and the associated tidal channels. Cut slopes steeper than the natural slopes are susceptible to slides unless adequate precautions are taken. In highway location in an area like this, it would be better to set the grade line below dangerous clay layers so that even if a slide occurs, it would not affect the foundations of the road. At (A), a road constructed after the photos were taken was located above the clay. The subsequent slide not only damaged the upper slope but took away part of the pavement as well. At (B) and (C), the road cut into the toe of the natural slopes. Since the road was located below the clay layer, slides in both places occurred on the cut slope only. The cut slope at (D) also failed, but the drainage and topographic situation was more favorable there and the slide was stabilized shortly. At (E) is an old slide that can be easily recognized in the photograph; it is hidden by vegetation when inspected on the ground. (Aerial photograph by U. S. Department of Agriculture)

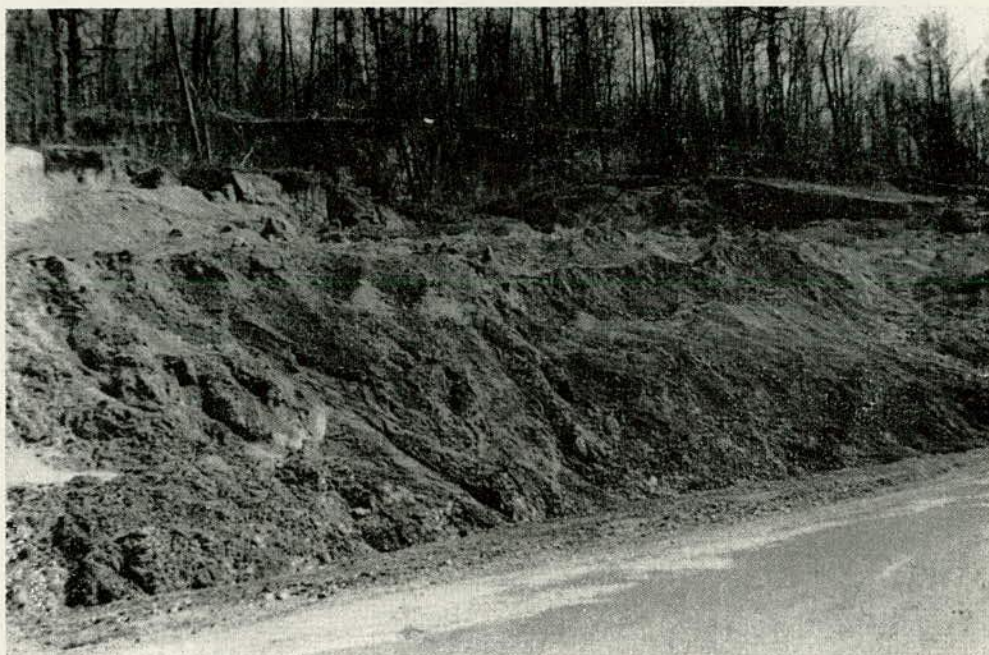
Figure 58. Ground view of landslide at point (A) shown in Figure 57. Here, the gray clay layer lies underneath the pavement, which is damaged by the slide. (Photograph by Ta Liang)

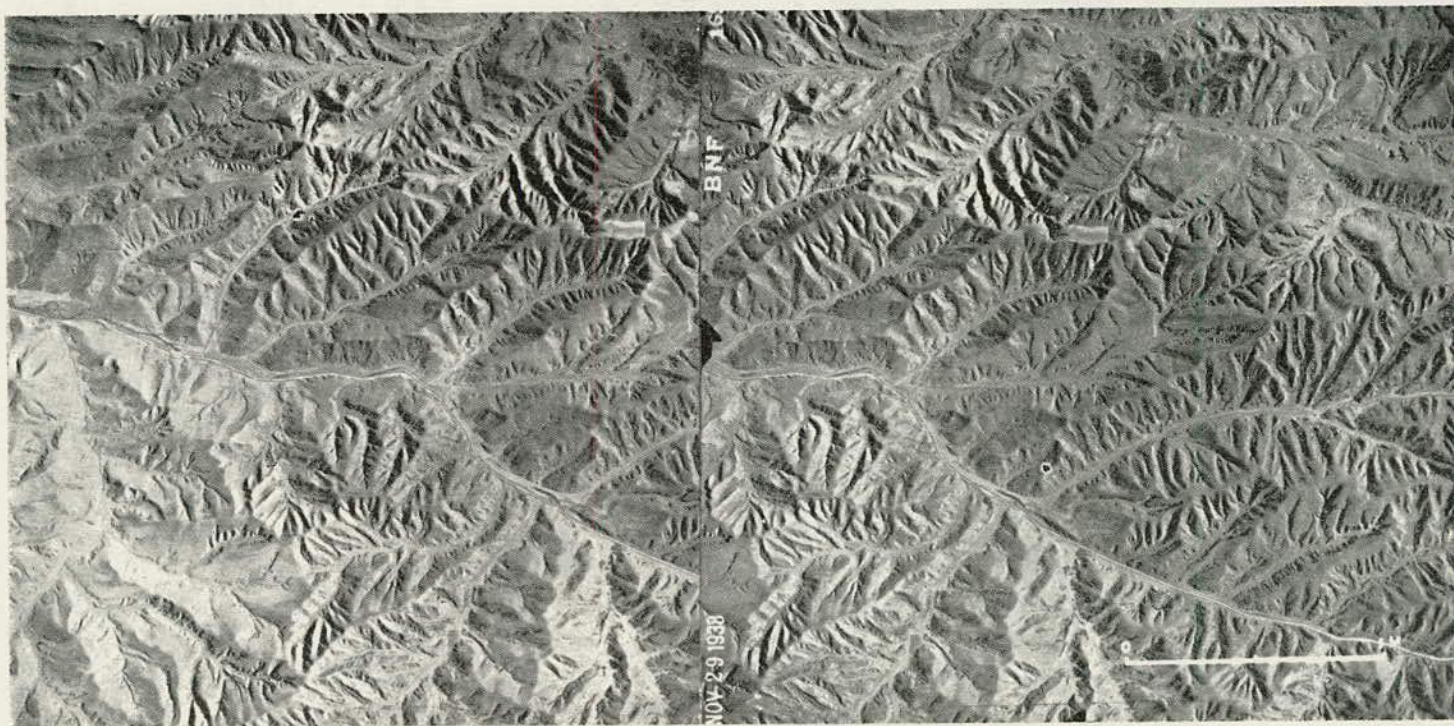
Figure 60. Loess, Lincoln County, Nebr. This stereo pair shows loess of great depth which is identified by steep-sided, flat-bottomed gullies, equal slopes in hills and valleys, and soft tones. The catsteps — small slumps — are seen as light fine contours all over the area. (Aerial photograph by U. S. Department of Agriculture)

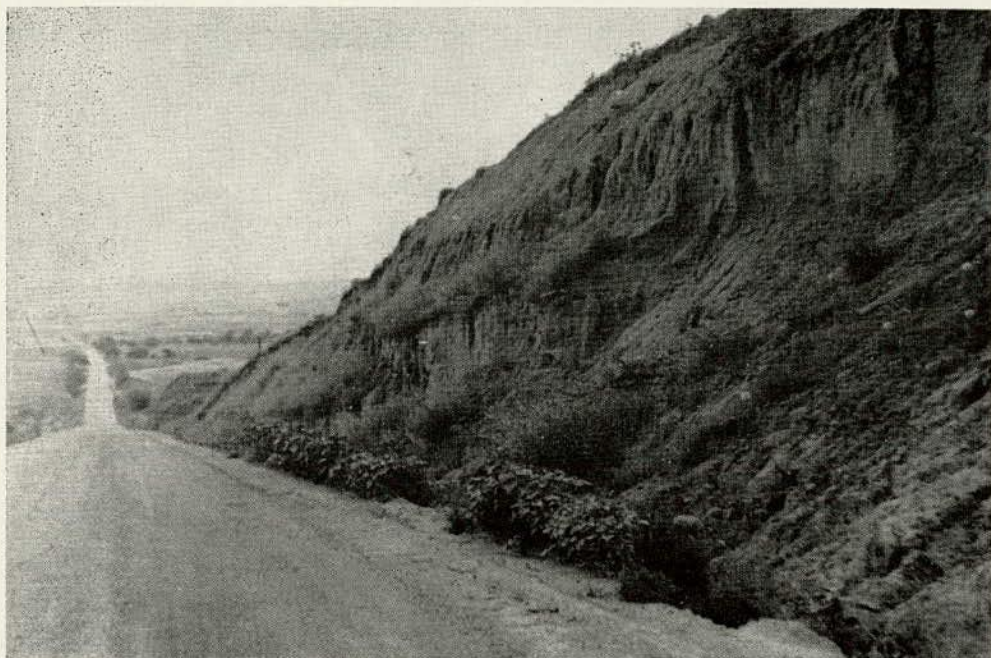
Figure 61. A ground photo showing catsteps in loess, such as those shown in Figure 60. (Photograph by Ta Liang)
