VII — Papers Presented by the American Exchange Delegation in the USSR

Floating Caisson Foundations

JOHN LOWE, III, Associate Partner, Tippetts, Abbett, McCarthy, Stratton

Steel Piles with Attachments

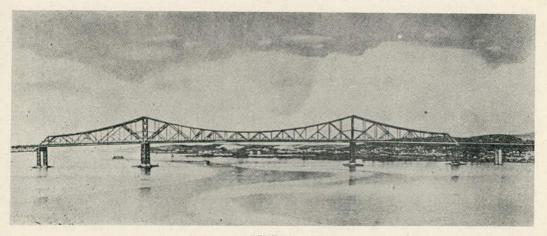
FIGURE 3 Main spans of Tappan Zee Bridge.

approach spans each of which is approximately 250 ft in length; from Nyack on the west shore, toward the center of the river is a trestle type structure approximately 8,000feet in length and having 50-ft spans. A closer view of the main spans is given (Fig. 3). The 1,212-ft main span was dictated by clearance requirements. The 602-ft anchor spans are structural adjuncts of the main span; the trestle spans were dictated by foundation conditions.

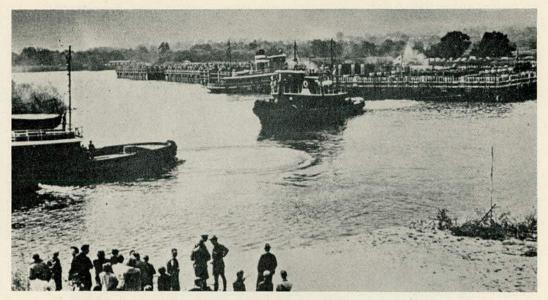
FIGURE 15 Towing first foundation caisson from construction basin.

(Fig. 15) is the first box being towed out of the basin. Shown (Fig. 16) is the box en route to the bridge site and illustrated (Fig. 17) is the box held in position by clusters of timber piles.
