TRANSPORTATION RESEARCH

CIRCULAR

STATE OF THE ART: PERMANENT BRIDGE DECK FORMS

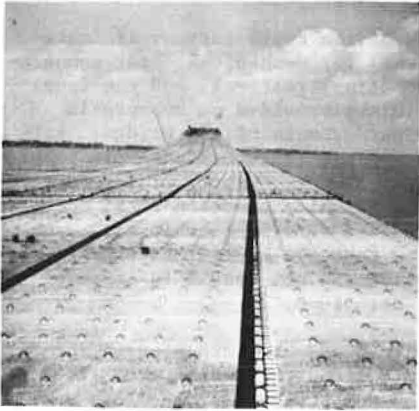
Figure 1. Prestressed panel subdecks in place on a bridge deck in Texas.

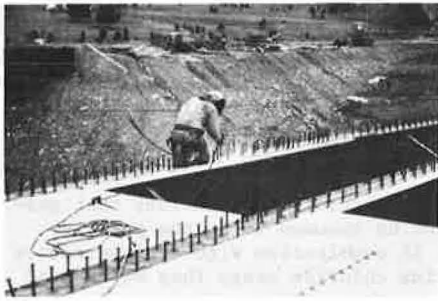
Figure 1. Permanent steel forms being installed on a steel girder bridge.

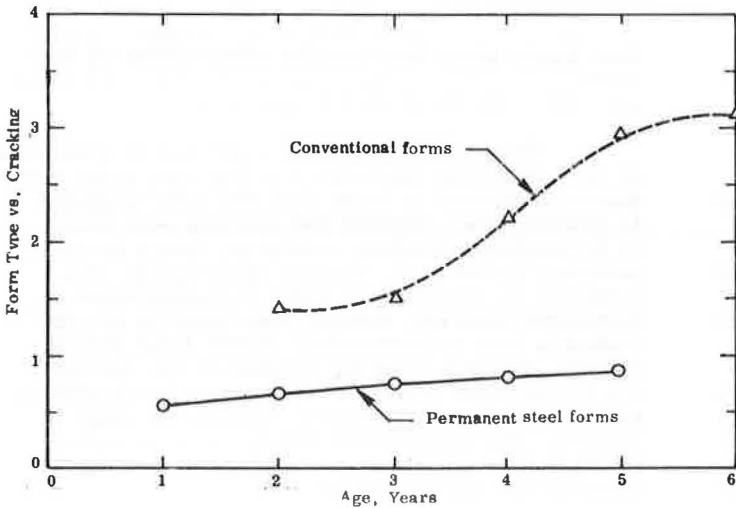
Figure 3. Relationship of rate of deck cracking to type of deck forming used (5).

The deterioration of 7 concrete bridge decks was observed by Cady et al.⁵ for periods of at least 5 years subsequent to construction. Three of these decks were built with conventional removable forming, whereas 4 were built with permanent steel forms. The decks built with removable forms exhibited higher rates of cracking but lower rates of surface mortar deterioration than the decks built with permanent steel forms. The average rate of cracking on the bridge decks is shown in Figure 3, which indicates that after 5 or 6 years of service, the conventionally formed decks exhibited roughly 3 times more cracking than did the permanently formed decks. The authors suggested that the reduced cracking on the latter decks could be attributed to two factors. First, as indicated earlier in the work conducted by Barnoff et al.³ permanent forms produce decks that are stiffer than conventionally formed decks and thus their use might reduce cracking precipitated by dynamic loads. Secondly, the steel forms would aid moisture retention for longer periods of time and thus reduce shrinkage cracking resulting from early moisture loss in the newly placed concrete.

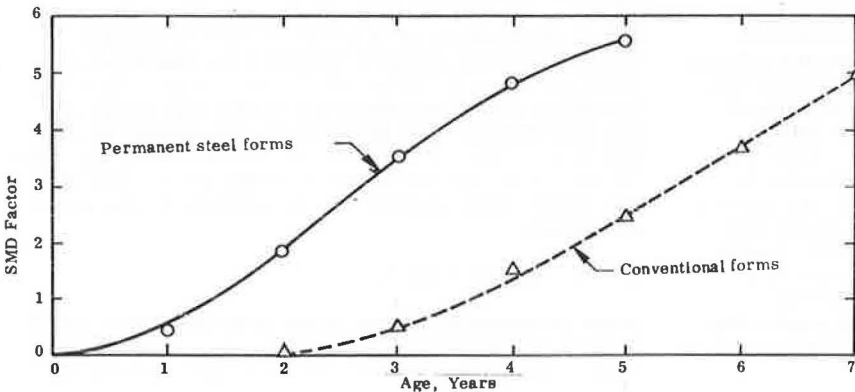
Figure 4. Relationship of rate of deck SMD to type of deck forming used (5).

Figure 4 shows the relationship between the form type used and the mean rates of surface mortar deterioration (SMD) found on the bridge decks. As indicated in Figure 4, the SMD on the permanently formed decks after 1 year was roughly equal to that developed after 3 years on the conventionally formed decks. The trend of the conventional form curve, however, suggests that the SMD may only be lagging by several years the deterioration noted on the permanently formed decks.
