CIRCULAR

Epoxy-Coated Reinforcement in Highway Structures

Committee on Corrosion

TRANSPORTATION RESEARCH BOARD
NATIONAL RESEARCH COUNCIL

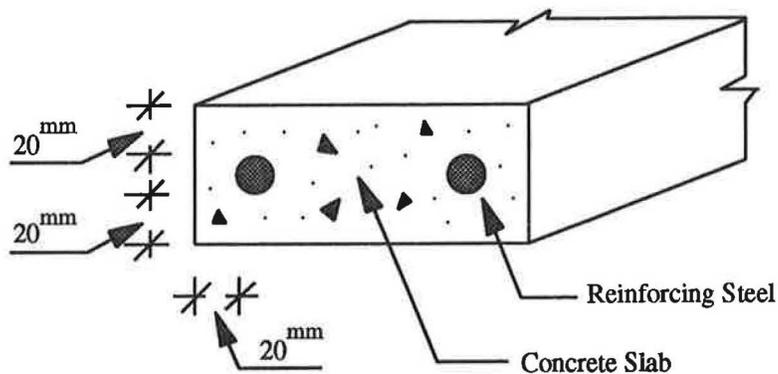
Figure 1 Location of the U-shaped rebar in concrete slab.

The slabs were 55 x 200 x 300 mm (2.2 x 8 x 12 in.). The concrete cover over the rebar was 20 ± 2 mm (0.8 ± 0.1 in) in all directions as shown in Figure 1. To keep concrete cover the same in all directions for all concrete slabs, the U-shaped rebars were adjusted so the legs of the bar were parallel to each other and in one plane. For corrosion rate measurements, a 100 mm (4 in) stainless steel rod (303 SS) was centrally located in each slab as a counter electrode. Wires were connected to the stainless steel rod and the rebar prior to casting the concrete. The electrical connections were coated with an epoxy compound.

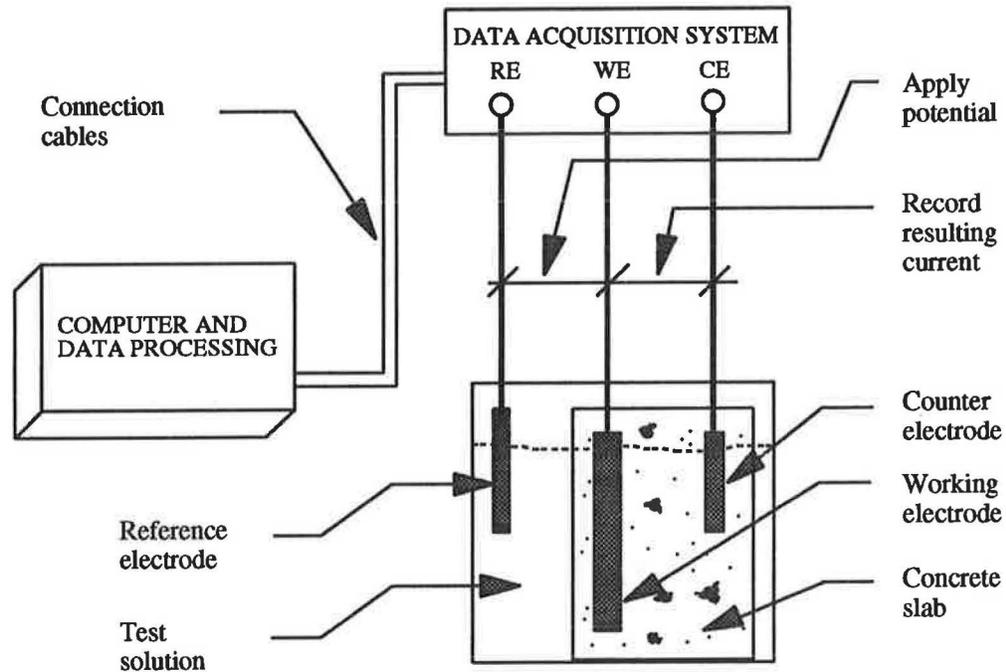
Figure 2 Schematic layout of corrosion rate measuring instrument.

The system is able to polarize the rebar (working electrode) in concrete by impressing a voltage through a counter electrode. The impressed voltage causes current to flow between the working electrode and the counter electrode. A schematic layout of the setup is illustrated in Figure 2.

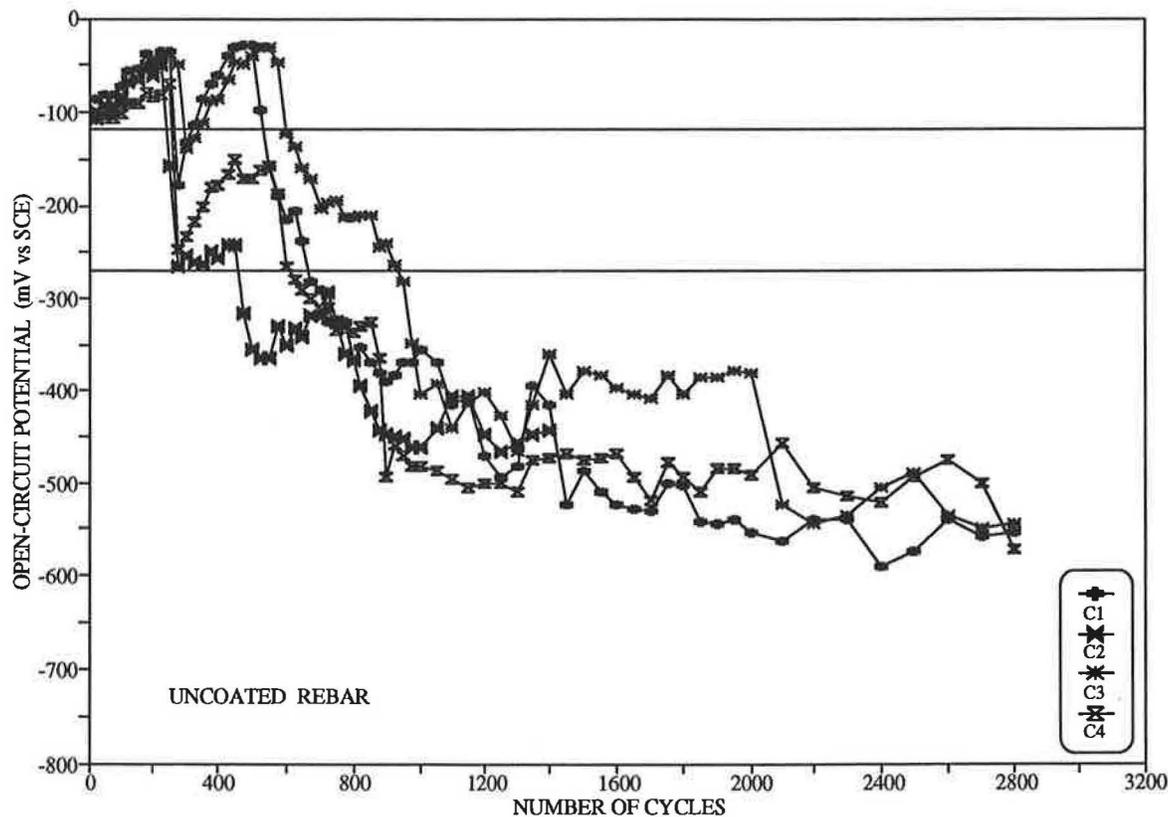
Figure 3 Potential of the uncoated rebar in concrete slabs exposed to simulated seawater.

the open-circuit potential of the rebars began to increase. The potential drop was greater for rebars in concrete slabs C2 and C4 than those slabs C1 and C3. Repassivation continued for about 200 cycles, then, a sudden drop in potential was observed for all bars. Following this depassivation, active corrosion started and continued for the remainder of the test with a consistent potential trend. The first drop in potential is indicative of the arrival time of chloride ions at the steel surface.

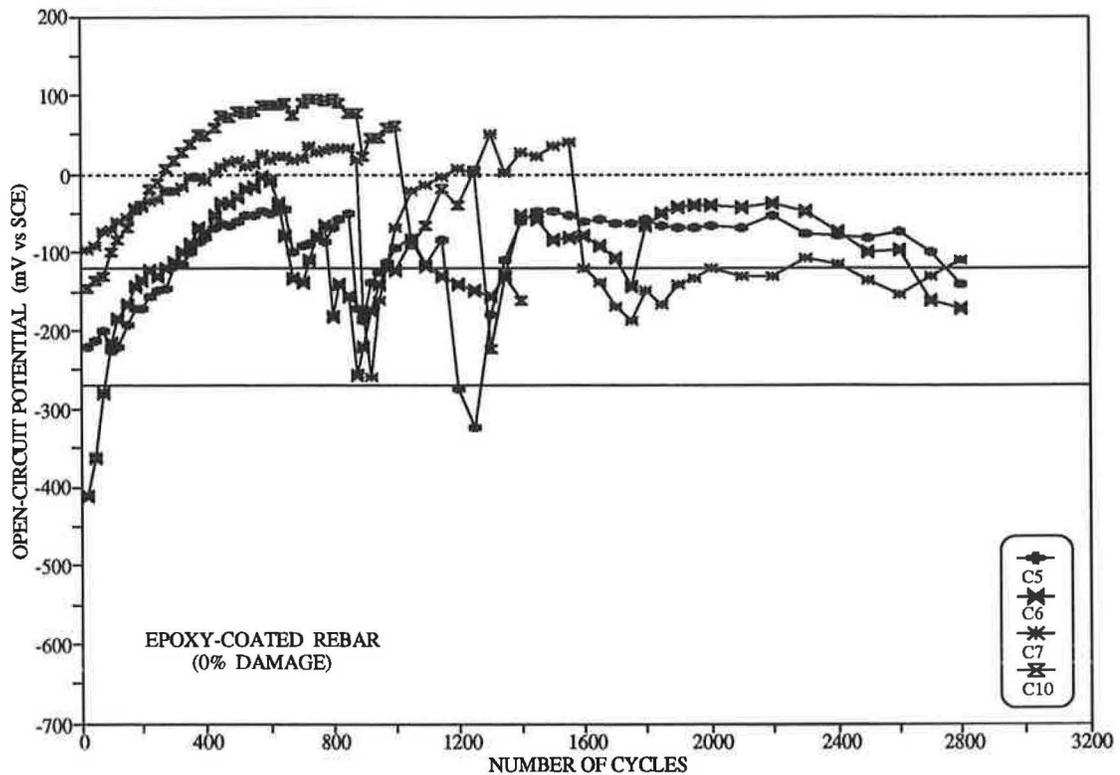
Figure 4 Potential of the undamaged epoxy-coated rebar in concrete slabs exposed to simulated seawater.

Figure 4 shows the potential variation of the undamaged epoxy-coated reinforcing steel in the slabs. Initially, all bars showed a gradual increase in potential. This increase continued up to 650 cycles for the bars in the concrete slabs C5 and C6, and 900 cycles for bars in slabs C7 and C10. Following a period of fluctuation in potential, all bars showed a consistent potential variation thereafter. This is a good example the fact that properly coated steel in concrete remains passive in the absence of cathodic areas where reduction of oxygen is supposed to take place.

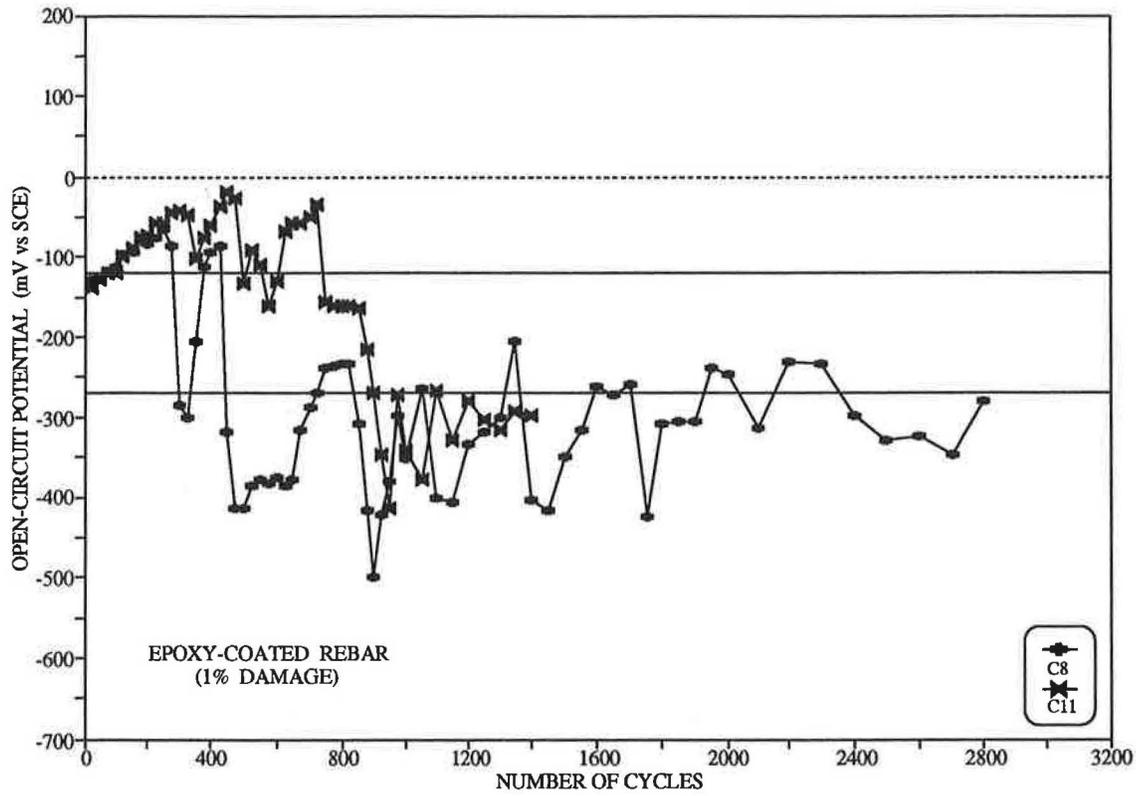
Figure 5 Potential of 1% damaged epoxy-coated rebar in concrete slabs exposed to simulated seawater.

Figure 5 shows the thermodynamic behavior of 1% damaged epoxy-coated reinforcing steel in the concrete slabs. Up to 300 cycles, a continuous increase in the potential of both rebars was observed. Then, following a fluctuation period, both rebars displayed

consistent potential variation. The fluctuations indicate that the corrosion activity was controlled by the oxygen necessary for cathodic reaction and the amount of chloride ions available at the steel surface to break down the passivity.

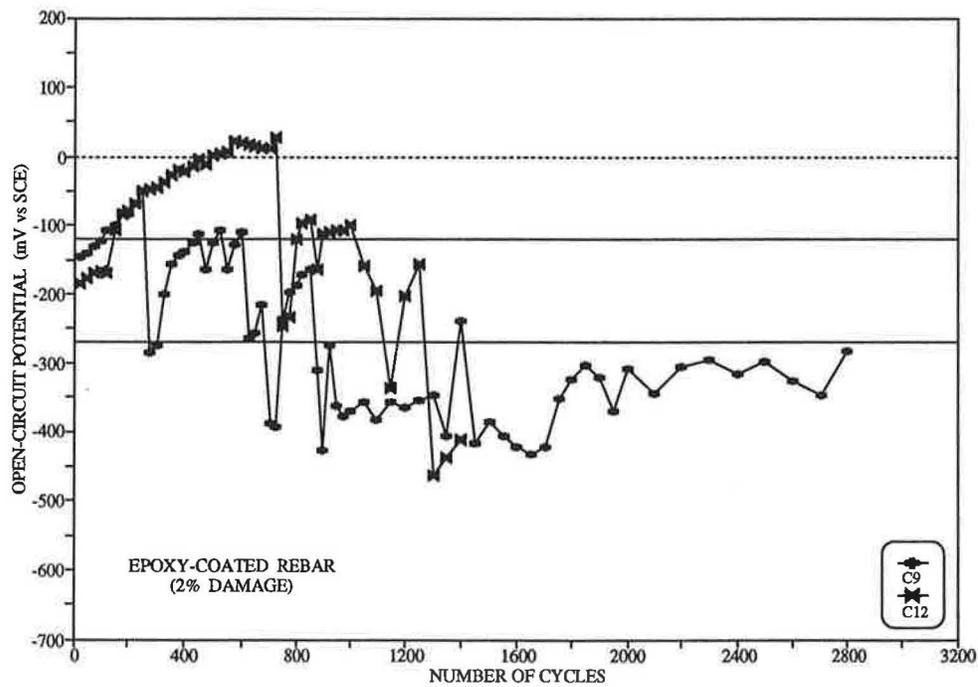
Figure 6 Potential of 2% damaged epoxy-coated rebar in concrete slabs exposed to simulated seawater.

Figure 6 illustrates the thermodynamic behavior of 2% damaged epoxy-coated rebar in concrete slabs with time. The potential variation is similar to that obtained from 1% damaged epoxy-coated bars. Following an initial increase in potential, both bars went from a passive to an active state by a series of intermediate steps depending on the availability of chloride ions at the reaction front. Then, both bars remained active for the remainder of the test. This indicates there were sufficient amounts of chloride ions available at the damaged areas of the steel surface to break down the passivity. As a result, the potential of the bars remained active without microcathode polarization owing to the presence of oxygen at the damaged areas of the steel.

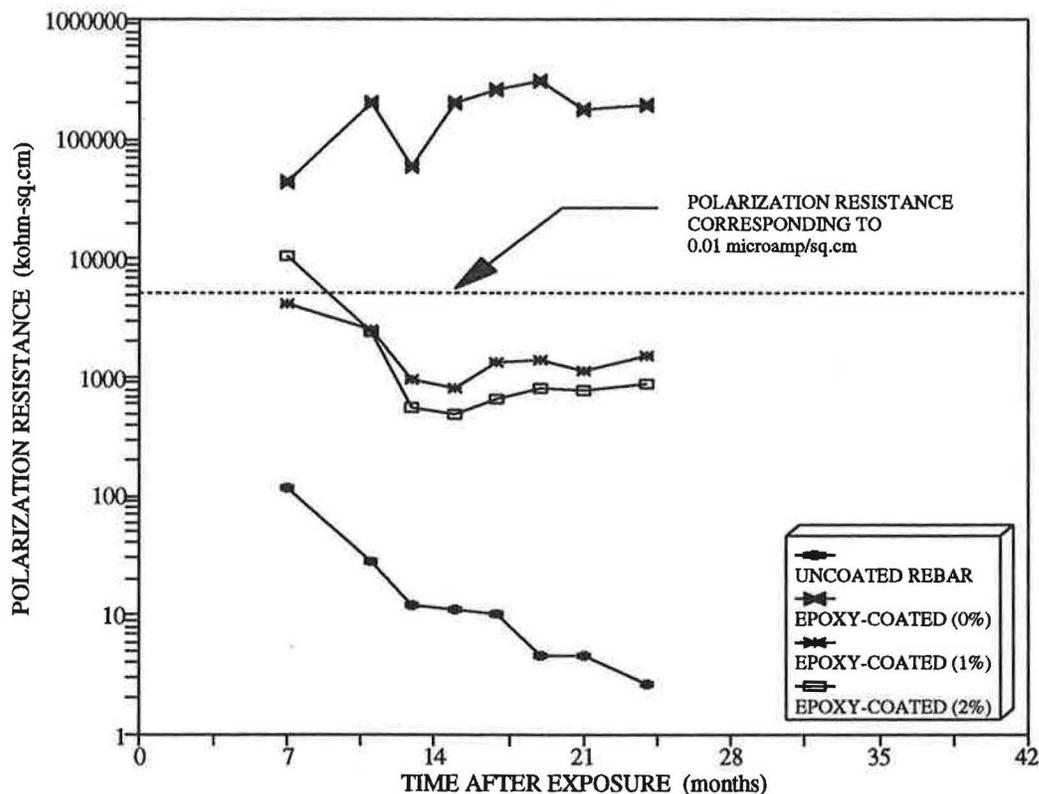
Figure 7 Polarization resistance of reinforcing steel in concrete slabs exposed to simulated seawater.

The average polarization resistances and current densities obtained from bars are summarized in Table III. The corresponding illustration is given in Figure 7. Although it differed from rebar to rebar, the magnitude of the average current density increased with time. There was a slight increase in the resistance of the undamaged epoxy-coated bars exposed to the same environment. The average polarization resistances (ohm-area) were over 10,000 k Ω -cm² (1,550 k Ω -in²) for the entire test period. This resulted in negligibly low

From Figure 7, 1% and 2% damage epoxy-coated bars showed similar corrosion trends over time. There was an increase in the average polarization resistance measured for both groups of rebars. The magnitude of corrosion current density was higher than the $0.01 \mu\text{A}/\text{cm}^2$ ($0.01 \text{ mA}/\text{ft}^2$) which is recommended as the maximum current density normally considered for long-term maintenance-free performance.

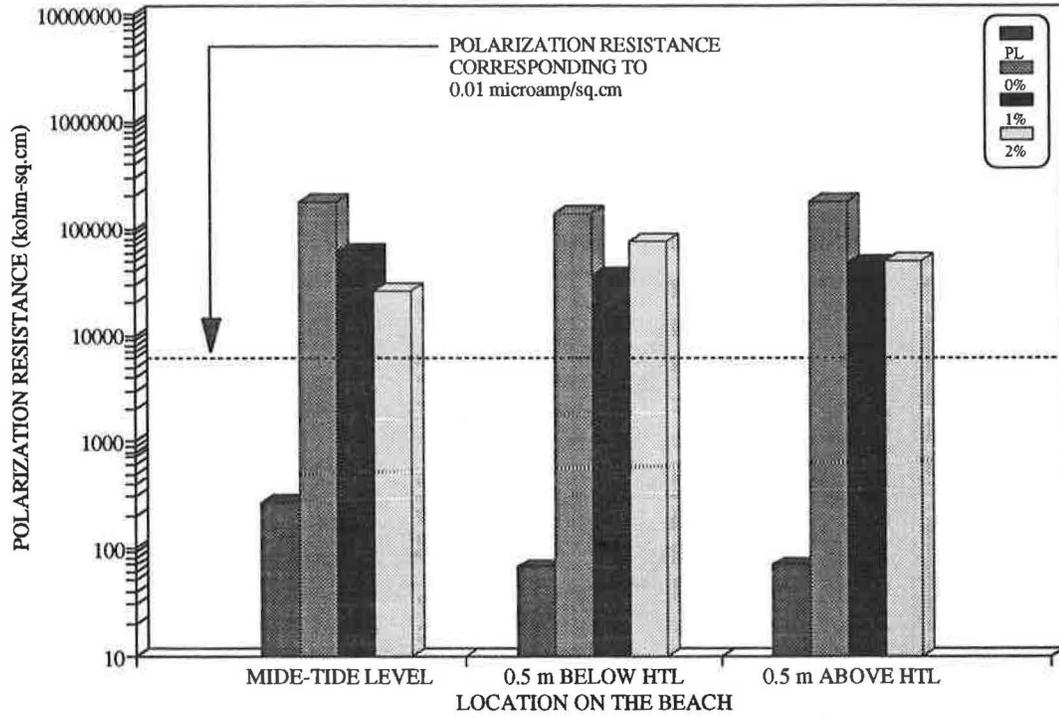
Figure 8 Polarization resistance of reinforcing steel in concrete slabs exposed to natural marine environment for one year.

The average polarization resistances obtained from rebars in the concrete slabs exposed to natural marine environment using the linear polarization technique are presented graphically in Figures 8 and 9. They illustrate the average polarization resistances measured at the end of one and two years of exposure. These graphs allow comparisons between the polarization resistance of rebars with regard to location at the exposure site. At the end of one year, the difference in polarization resistance of the damaged and undamaged epoxy-coated rebar, was not discernable re-

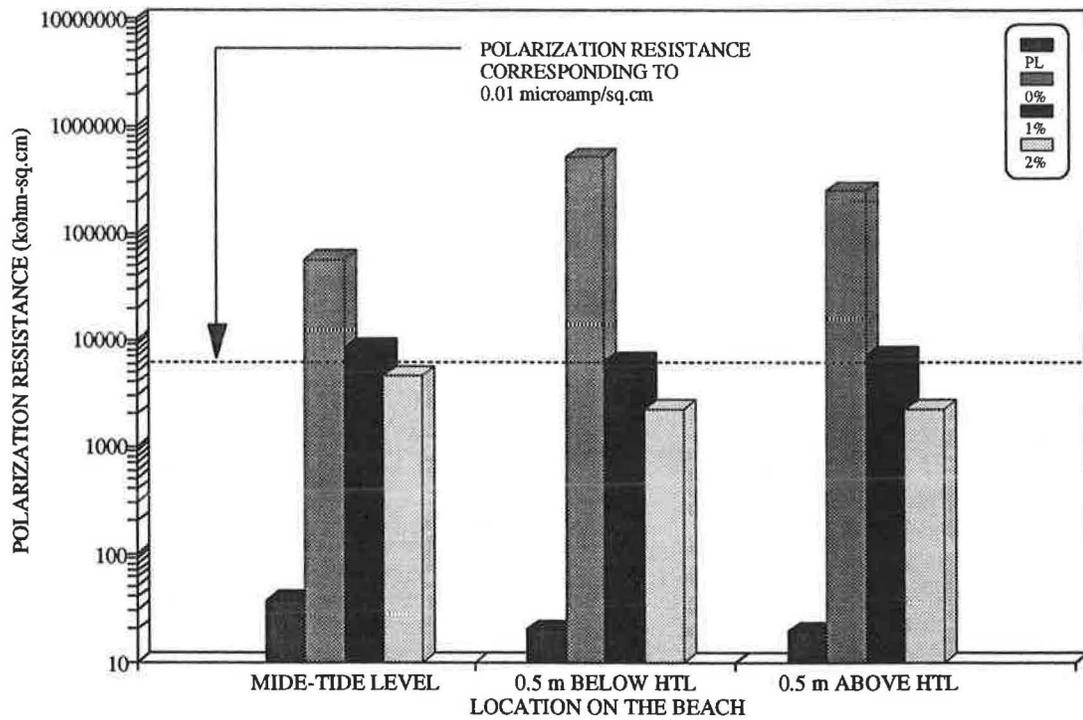
Figure 9 Polarization resistance of reinforcing steel in concrete slabs exposed to natural marine environment for two years.

gardless of location within the exposure site. The magnitude of current density was negligible. However, at the end of two years, the damaged rebars showed high current densities with respect to those obtained at

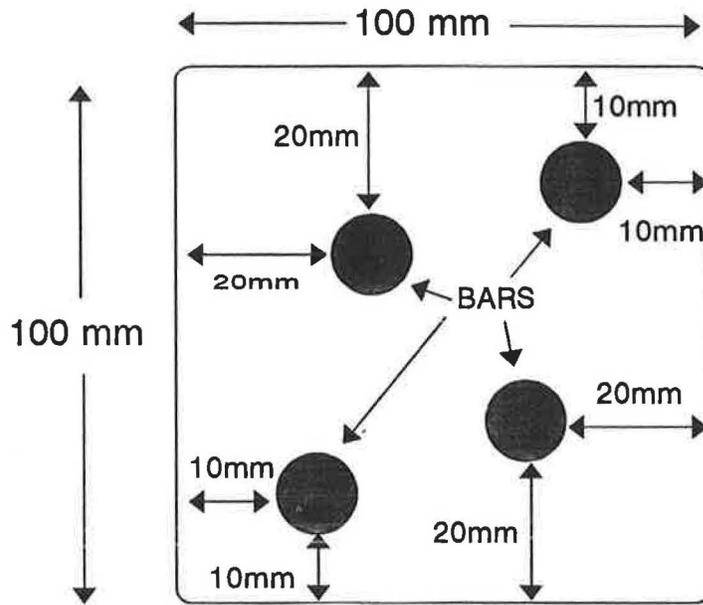
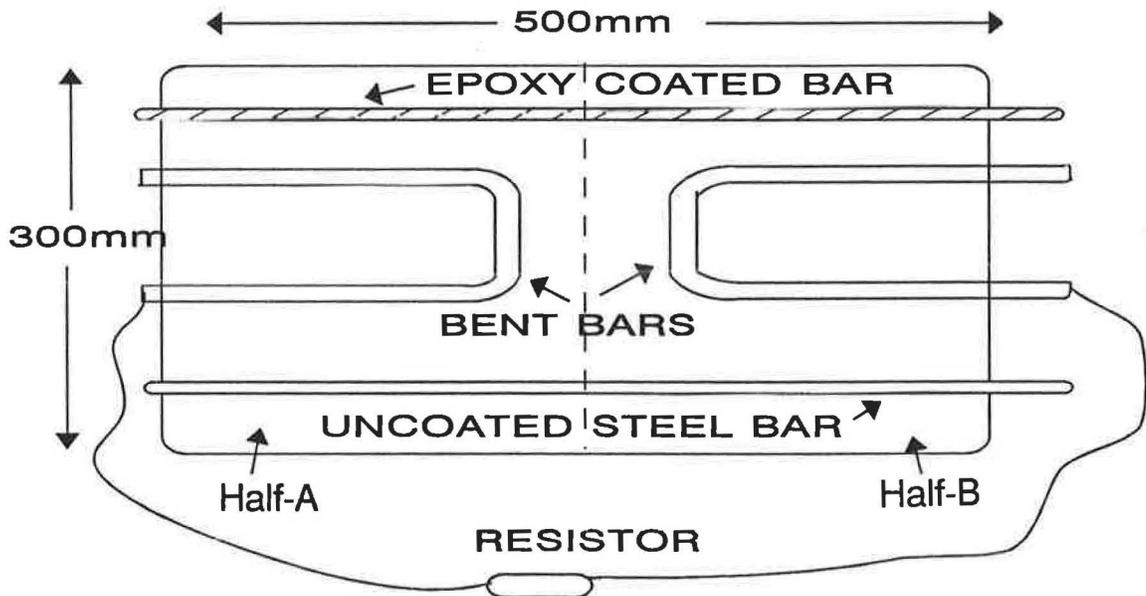
CROSS SECTION OF BEAM

PLAN VIEW OF SLAB

Figure 1 Prism and slab test specimens.

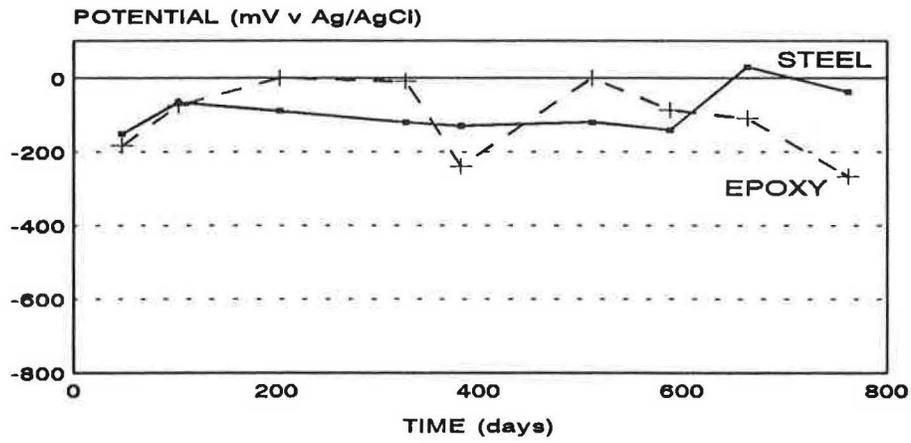
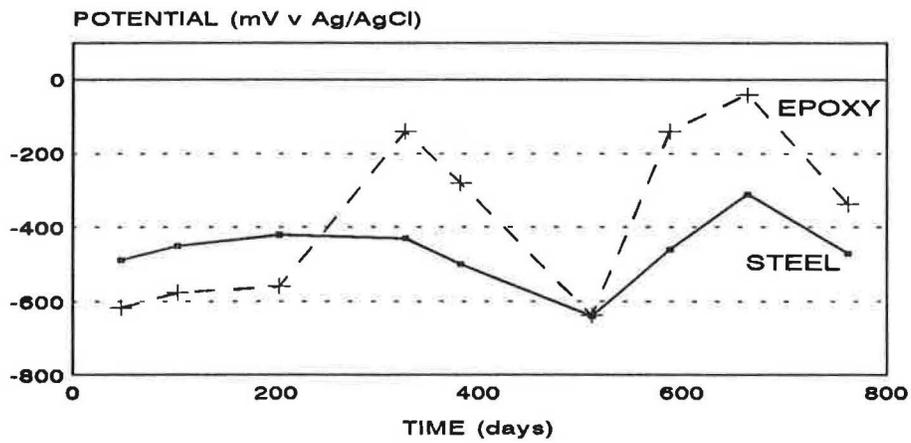
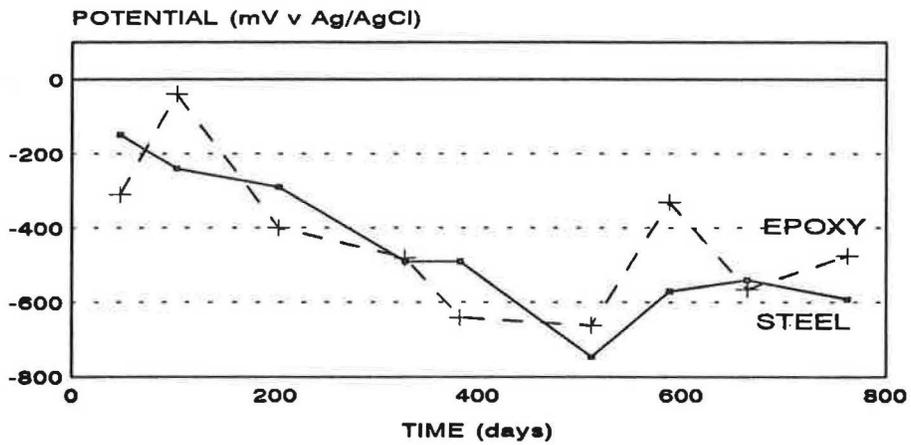
Figure 2 Typical half cell potential measurements on single slab specimens.

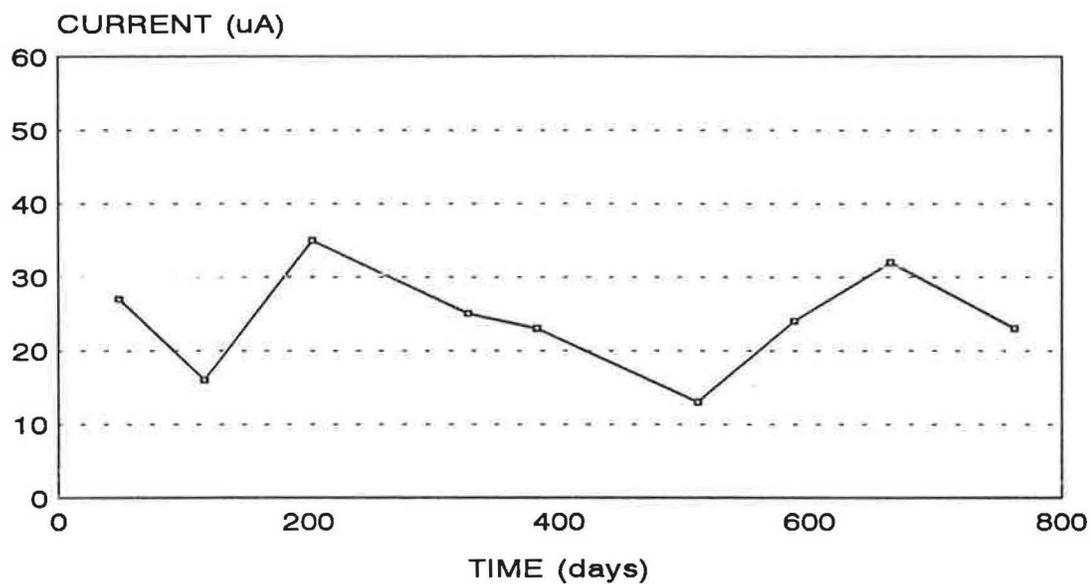
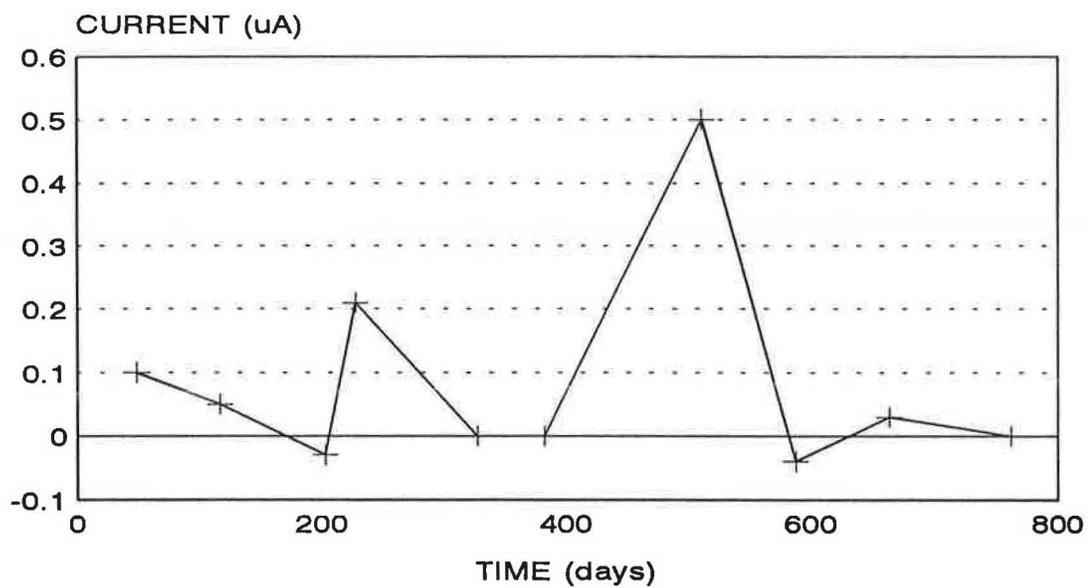
Figure 3 Average corrosion current measured between bent bars in slab specimens containing cast-in chloride in one side only. [First named bar is in the chloride side].

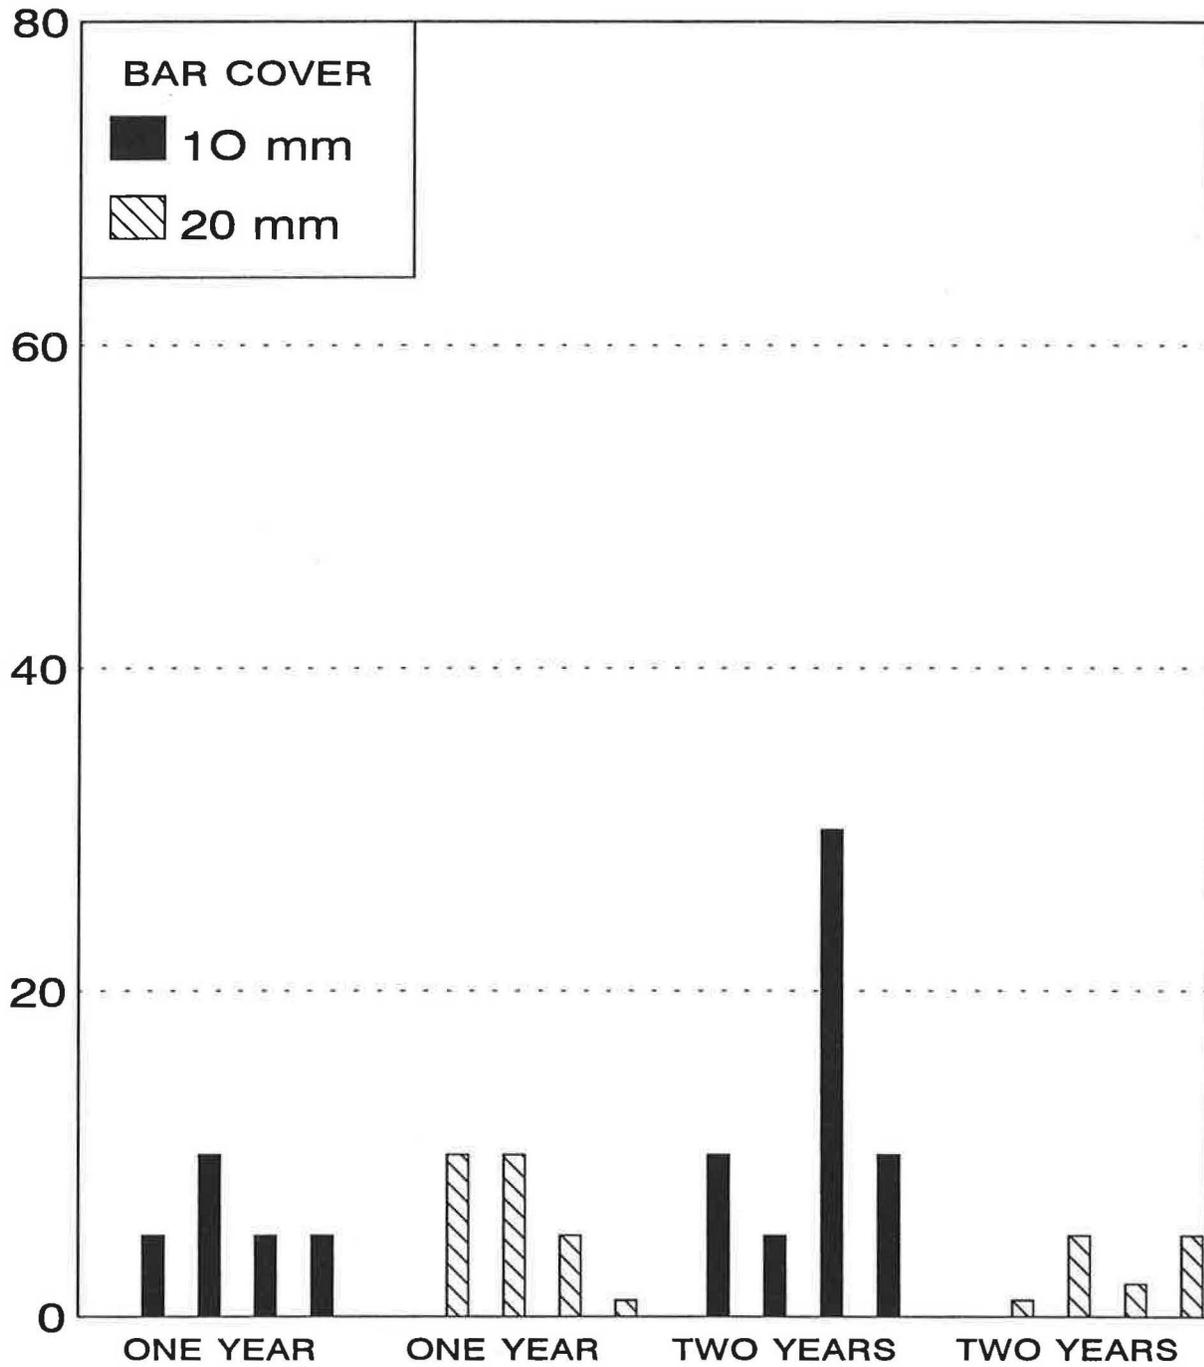
Figure 4 Percentage of surface corroded for uncoated bars removed from chloride contaminated beam specimens after one and two years exposure.

Beam specimens. After removing the bars from the concrete, the extent of visible corrosion was assessed. Only the bars from the chloride contaminated beams showed signs of significant corrosion. At one year, up to 10% of the bar surface was corroded for uncoated bars with both 10 mm (0.39 in) and 20 mm (0.79 in) cover. At two years, the area of corrosion had increased for the 10 mm (0.39 in) cover bars, see Figure 4.

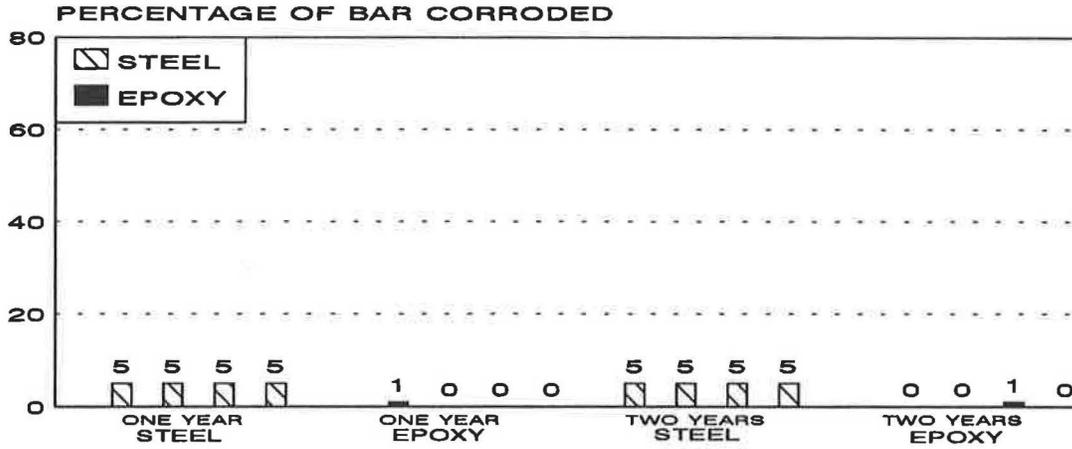
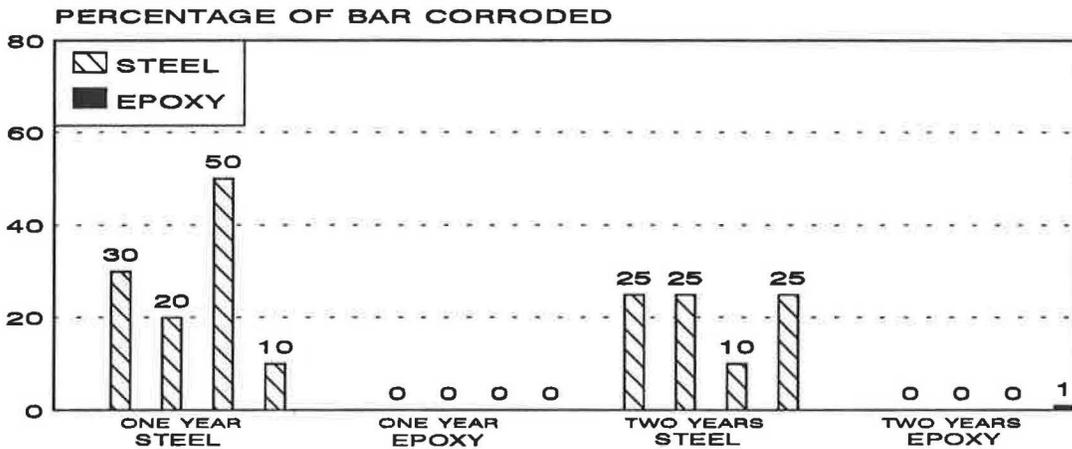
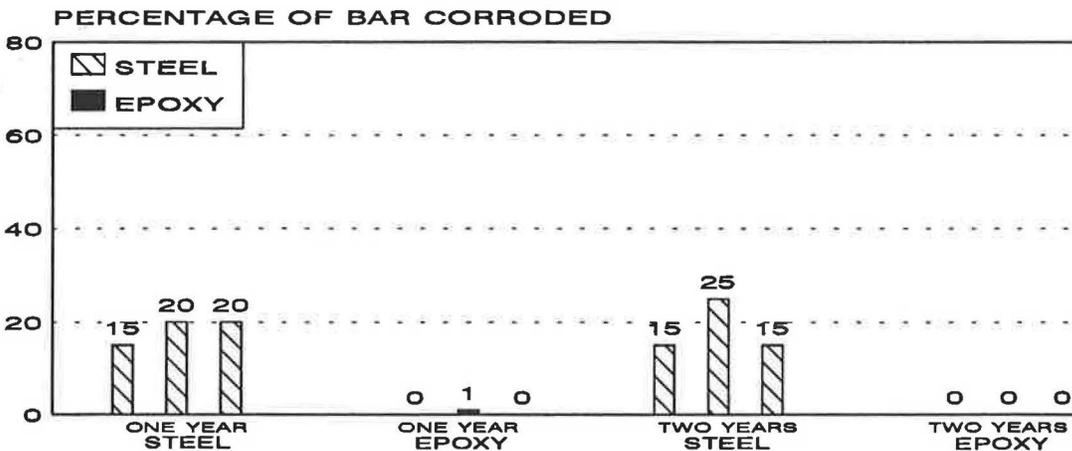
Figure 5 Percentage of surface corroded for straight bars removed from slab specimens after one and two years. [Numbers within each figure show the actual value].

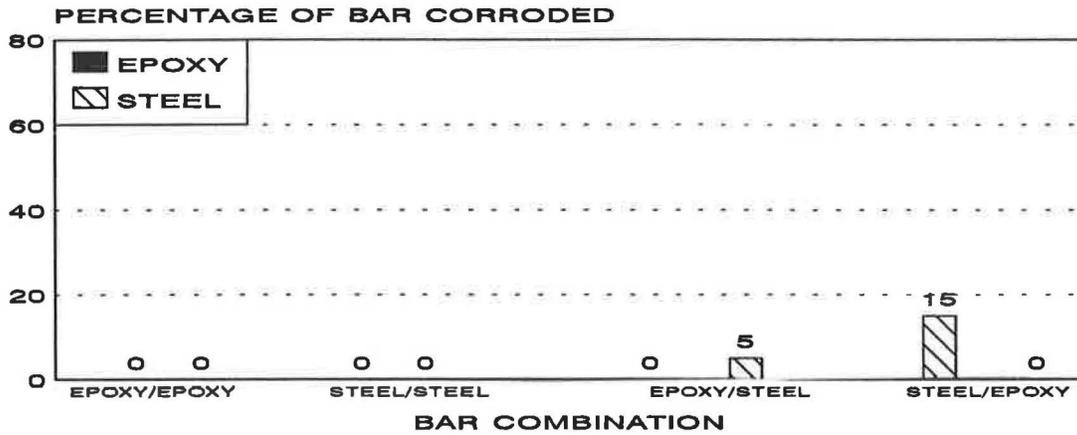
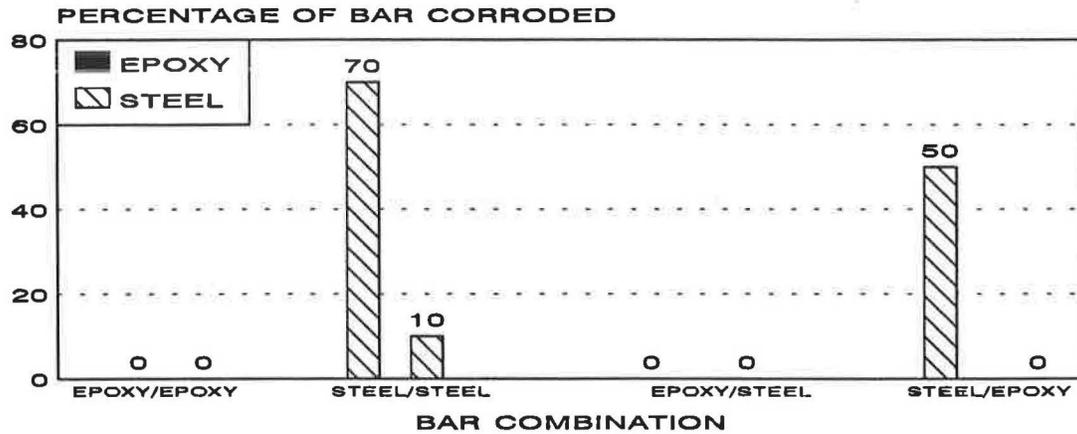
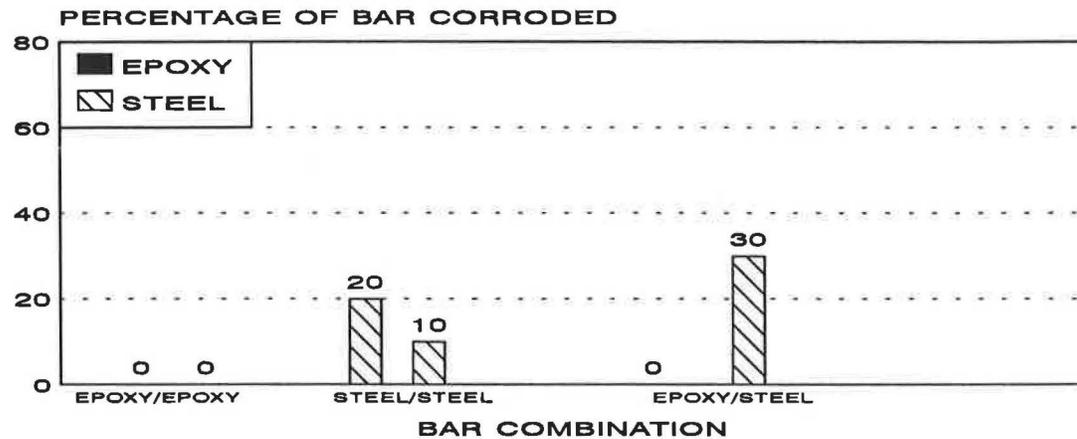
Figure 6 Percentage of surface corroded on bent bars removed from slab specimens after one year. [Where appropriate, the first named bar of the combination was in the chloride side].

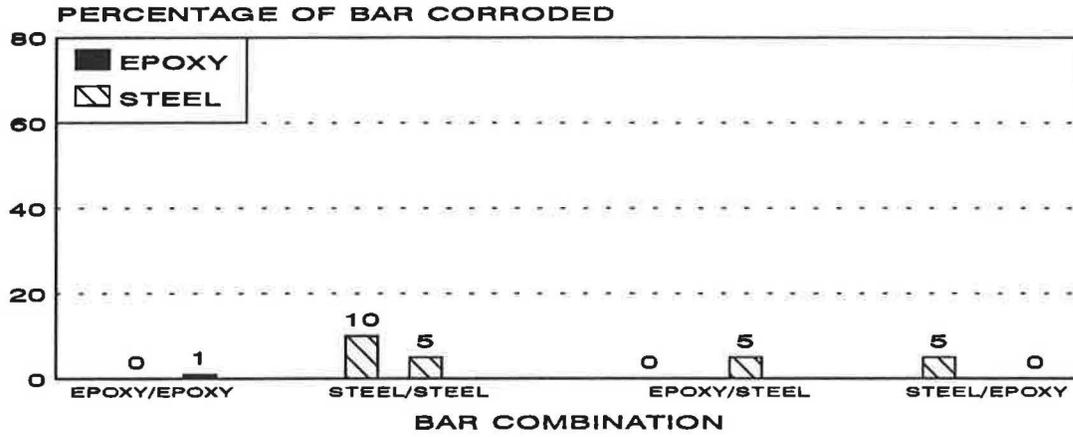
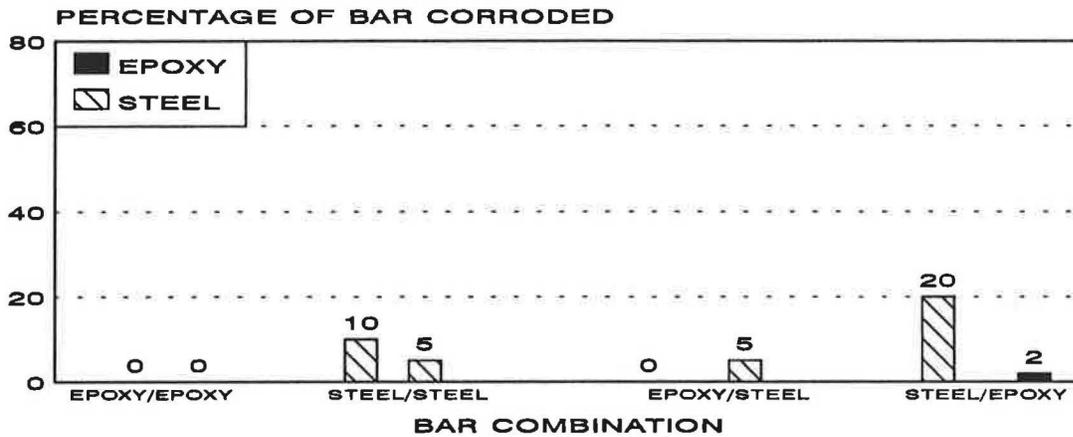
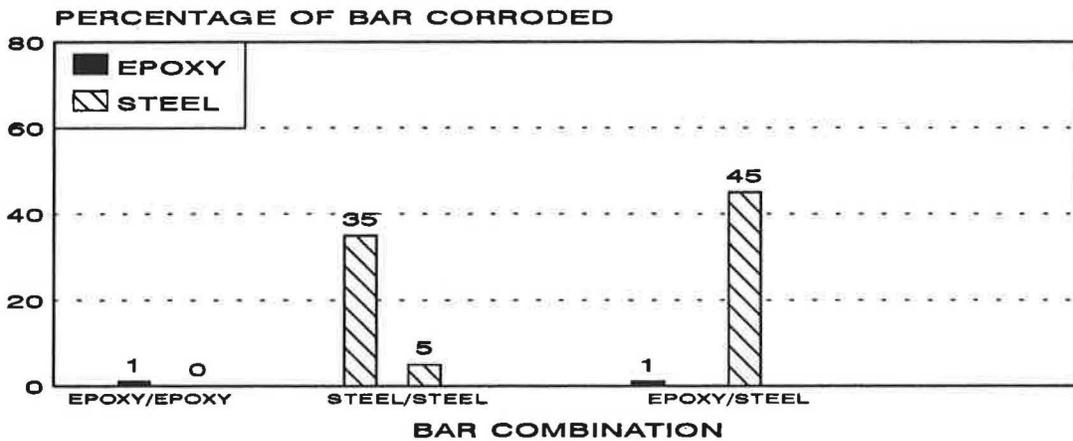
Figure 7 Percentage of surface corroded on bent bars removed from slab specimens after two years. [Where appropriate, the first named bar of the combination was in the chloride side].

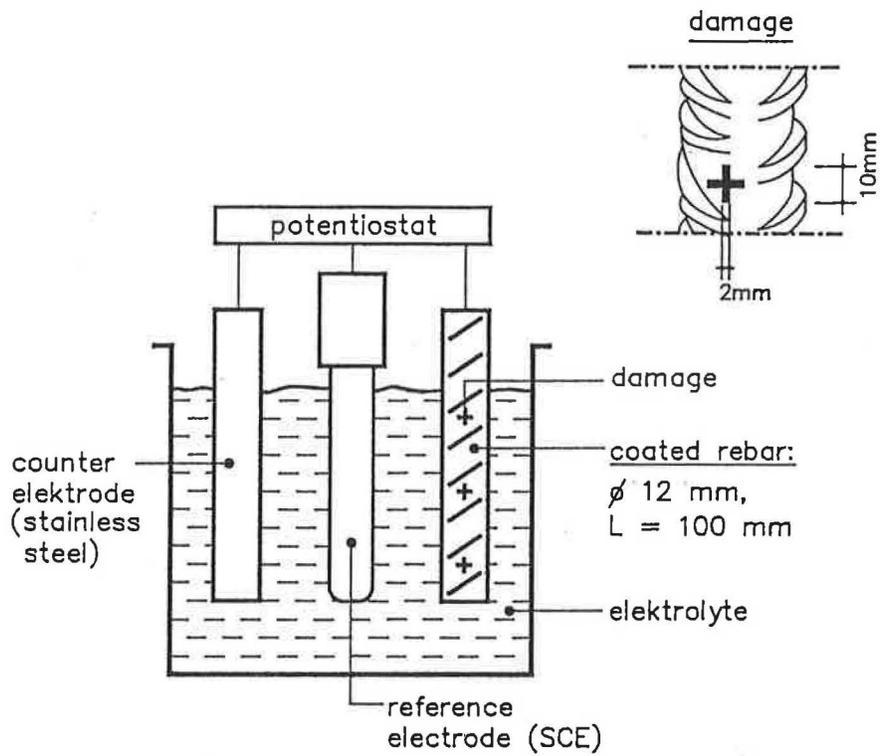
Series	Polarisation	Potential (mV) (SCE)	Electrolyte
1	anodic open circuit cathodic	+ 100 - ~600 - 1000	3,5%NaCl
2	anodic open circuit cathodic cathodic	+ 100 - ~100 - 1000 - 1800	0,3nKOH+0,05nNaOH
3	anodic open circuit cathodic	+ 100 - ~500 - 1000	0,3nKOH+0,05nNaOH+3,5%NaCl

Figure 1 Test set-up (schematic) and test parameters.

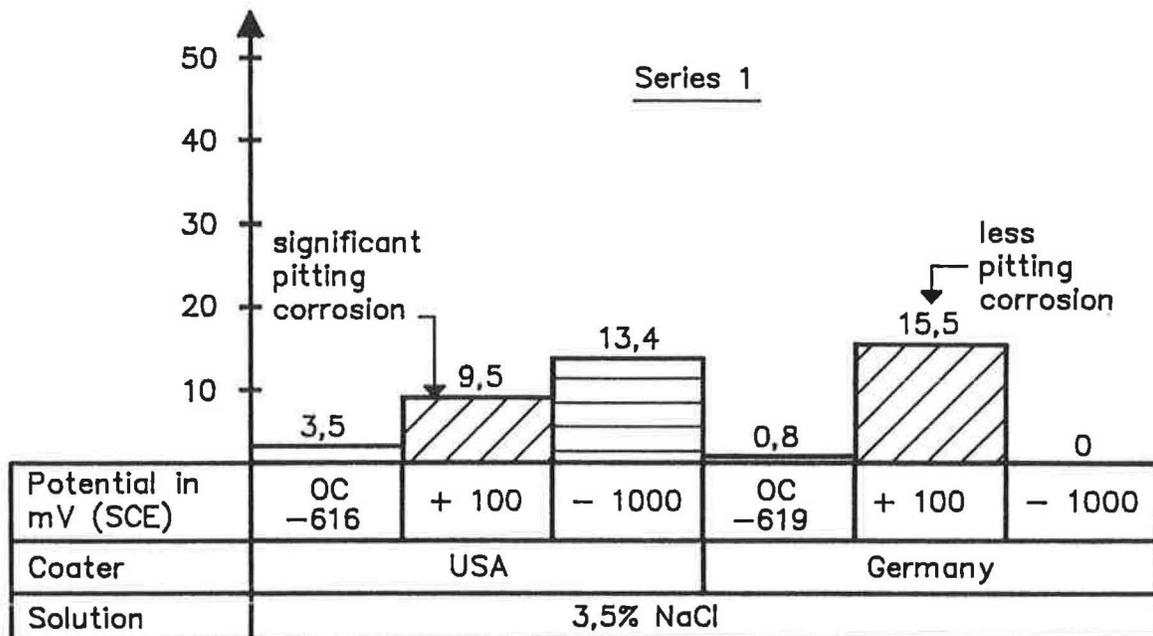
Figure 2 Disbondment (%) of coating after 30 days exposure in NaCl solution at different potentials.

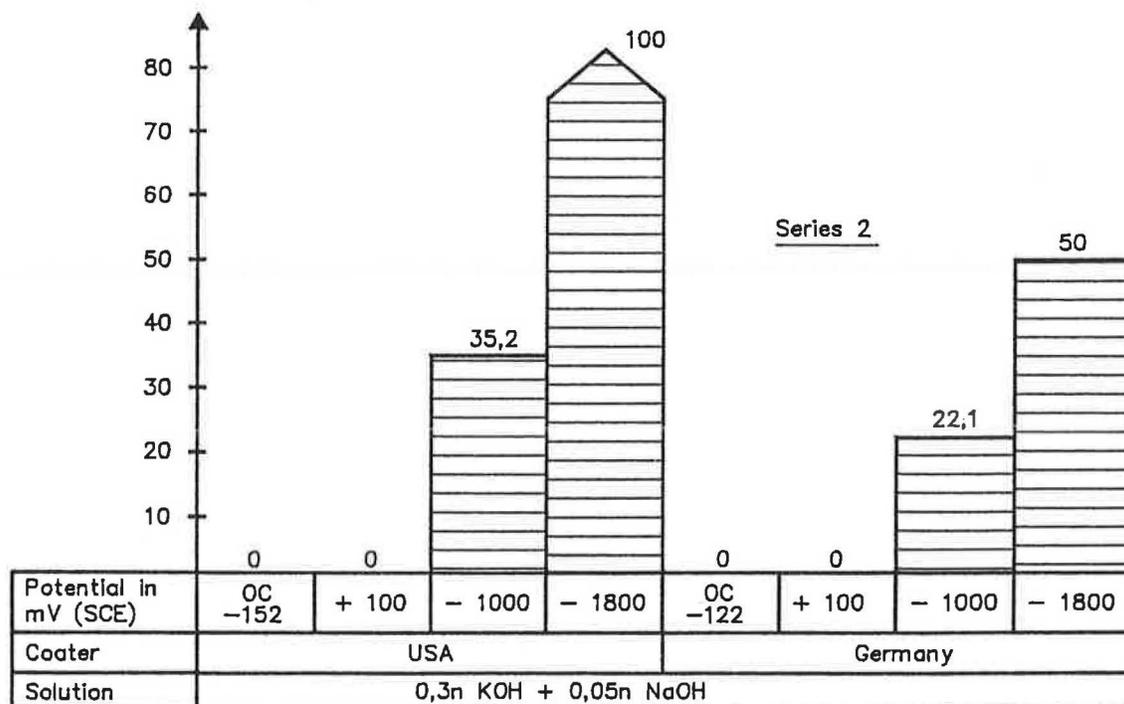
Figure 3 Disbondment (%) of coating after 30 days exposure in KOH + NaOH solution at different potentials.

Epoxy-coated bars exposed to an alkaline solution of KOH + NaOH (pH=13.5) suffered considerable disbondment under cathodic polarization, see Figure 3. At -1800 mV the coating of the bar from Coater A could be removed completely, while the bar from Coater B showed a disbondment of 50%. Neither bars showed signs of corrosion under anodic polarization and OC potential.

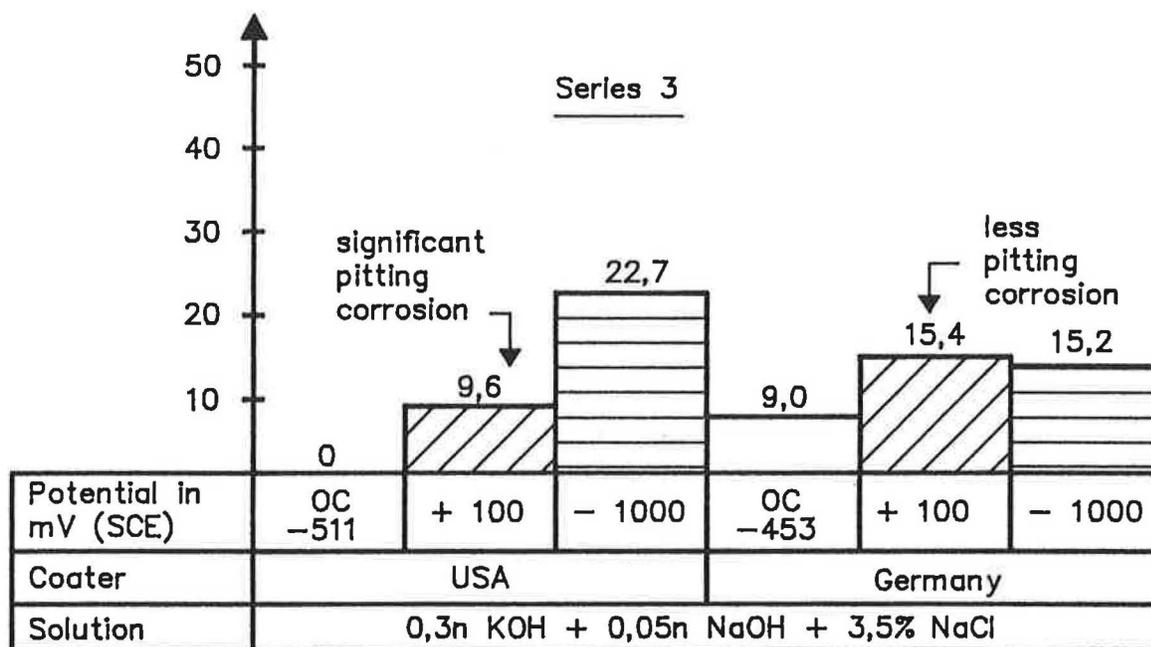
Figure 4 Disbondment (%) of coating after 30 days exposure in KOH + NaOH + NaCl solution at different potentials.

Exposure to the mixed solution of KOH + NaOH and NaCl caused disbondment under cathodic and corrosion under anodic polarization in both bars. There was more disbondment and pitting corrosion on the bars from Coater A than on the other bars, see Figure 4.

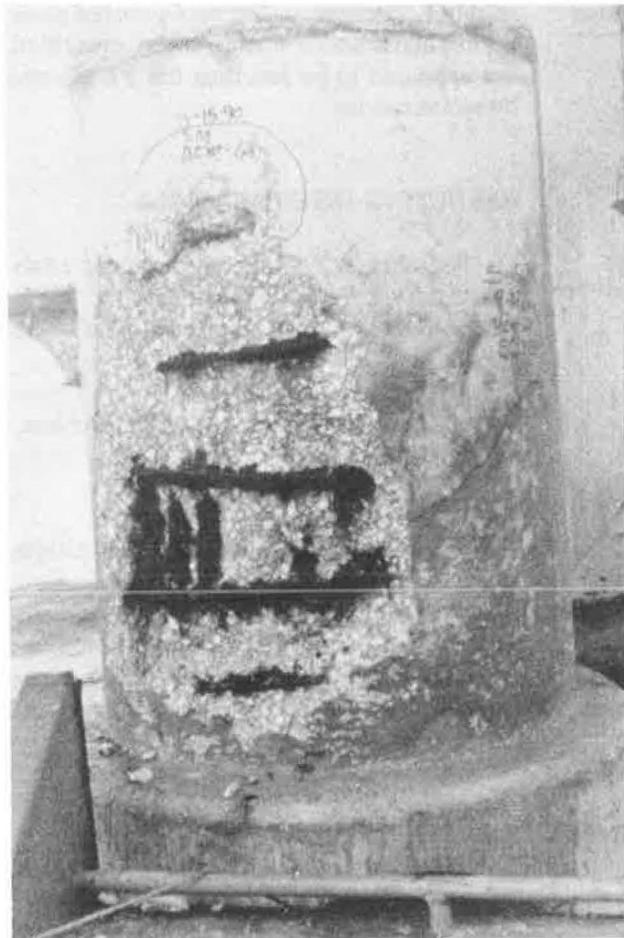
Figure 1 Typical corrosion deterioration common to Seven Mile Bridge observed in 1987.

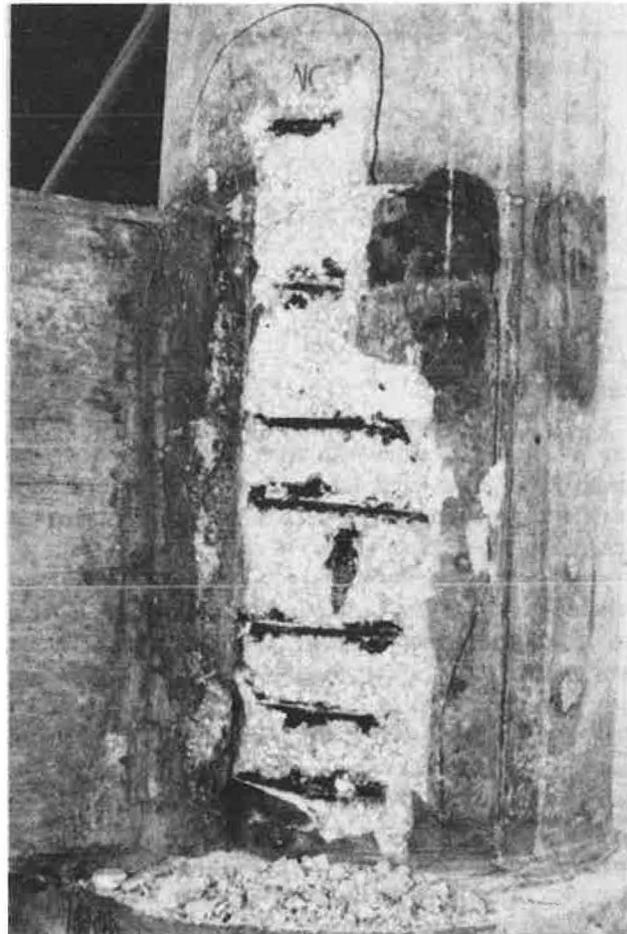
Figure 2 Typical corrosion deterioration common to Niles Channel Bridge observed in 1987.
