CIRCULAR

Epoxy-Coated Reinforcement in Highway Structures

Committee on Corrosion

TRANSPORTATION RESEARCH BOARD
NATIONAL RESEARCH COUNCIL

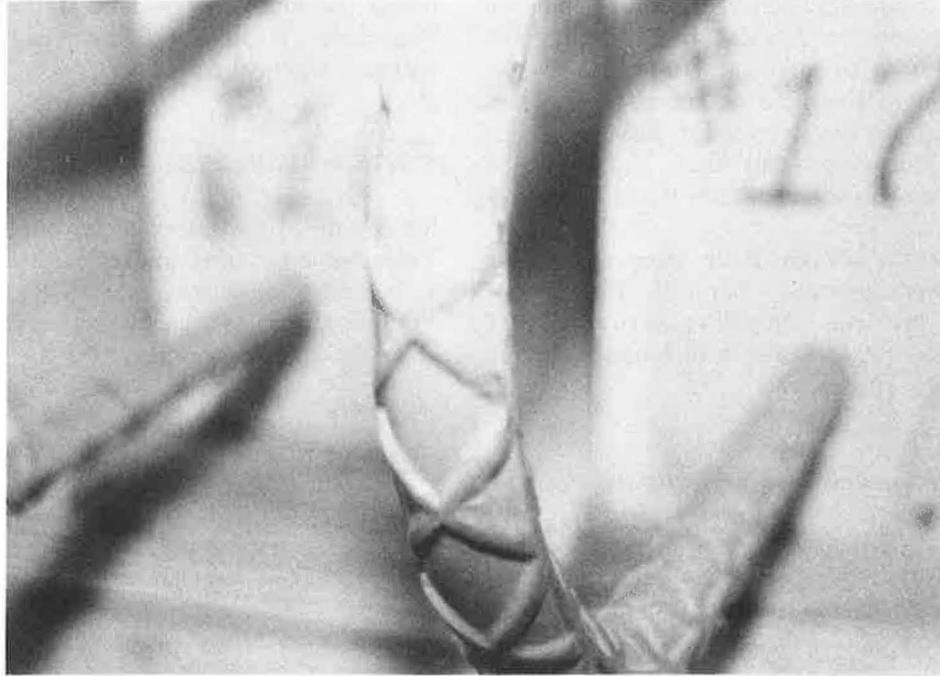
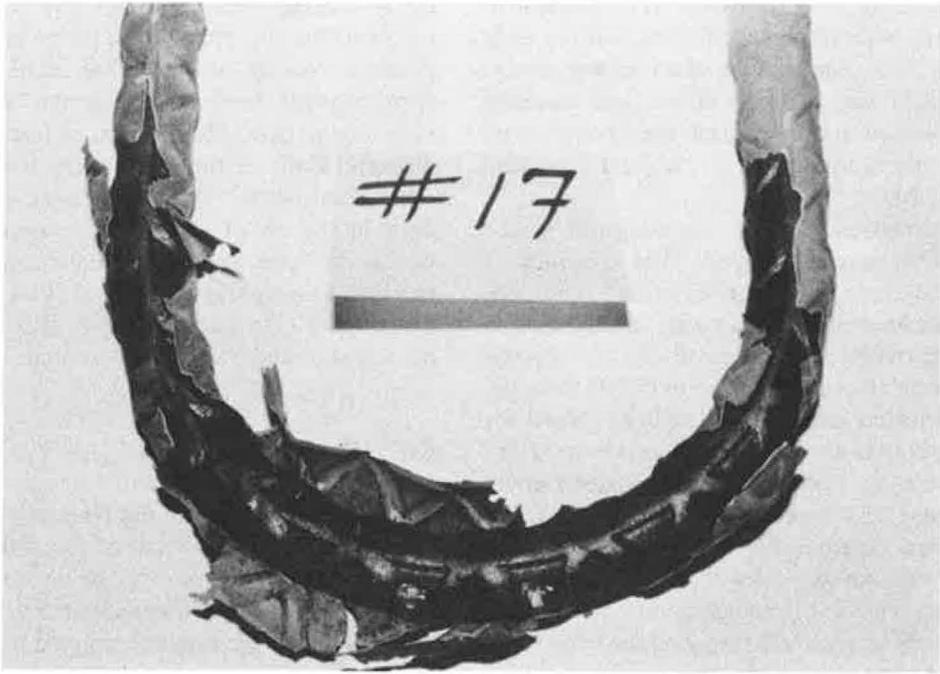
Figure 3 Sample #17 with small defects present before test (top) and extreme disbonding, localized and general corrosion after test (bottom).

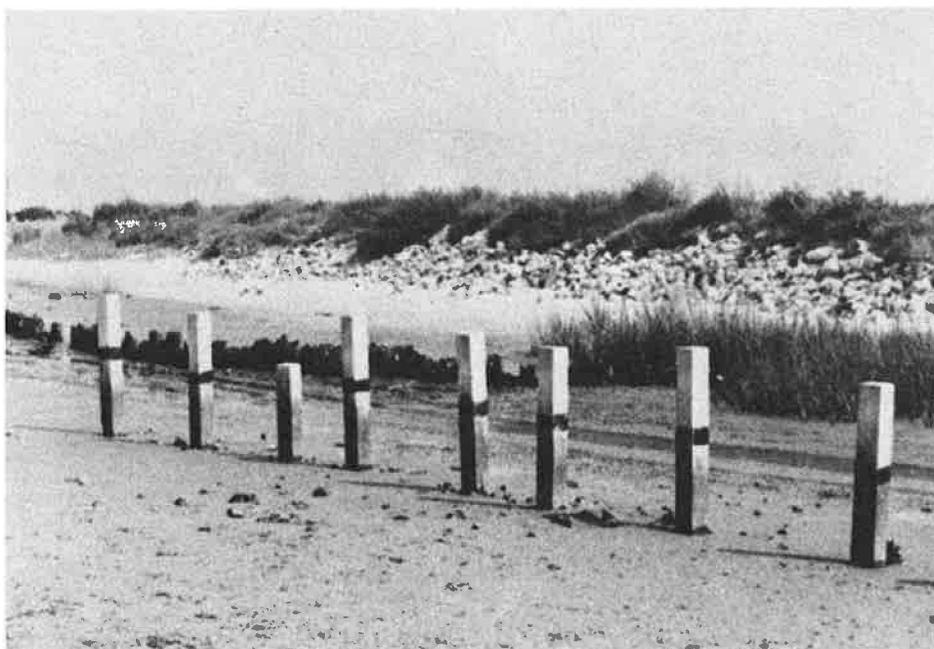
Figure 4 Matanzas Inlet test site after placement of test pilings in 1979 with application of coal-tar epoxy bands around areas containing the rebar support chairs.

A test site established at Matanzas Inlet (Intracoastal Waterway) on the east coast of Florida was used to evaluate epoxy-coated and bare rebar test piles (9). The test piles were installed in 1979 in the corrosive marine environment, Figure 3. After approximately nine years of exposure, three test piles were removed for examination, one with epoxy-coated steel rebars, one with bare rebars and one with galvanized steel. The epoxy-coated rebar pile outperformed the bare rebar piling. However, the epoxy-coated rebars used in this study were not typical of those supplied to construction projects. The

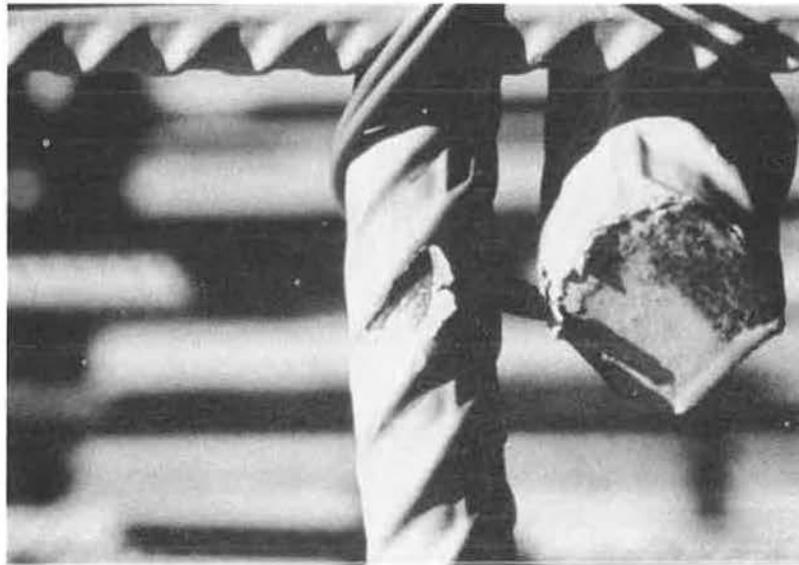
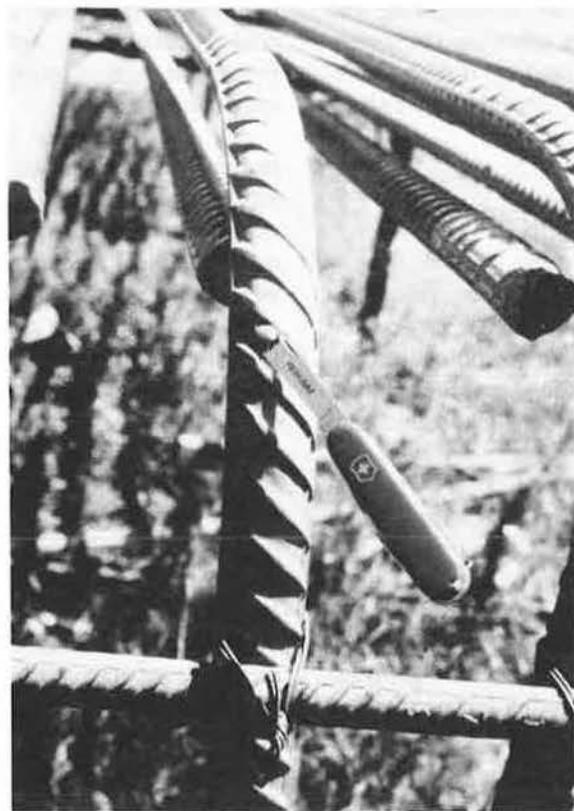
Figure 5 Epoxy coating easily removed with pocket knife along fabricated (bent) areas.

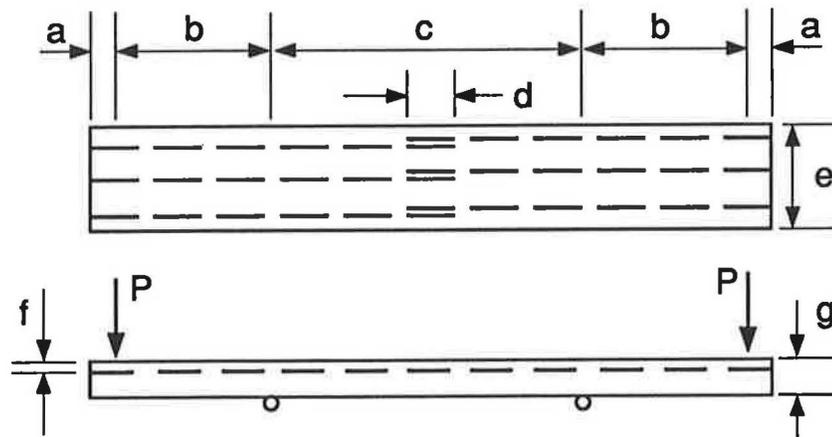
bar size (mm)	a (mm)	b (mm)	c (mm)	d (mm)	e (mm)	f* (mm)	g (mm)	stirrups
22	152	1219	1219	305	610	64	203	10 mm @152 mm
35	152	1219	1219	711	711	64	305	10 mm @152 mm

*f=clear cover above the reinforcement

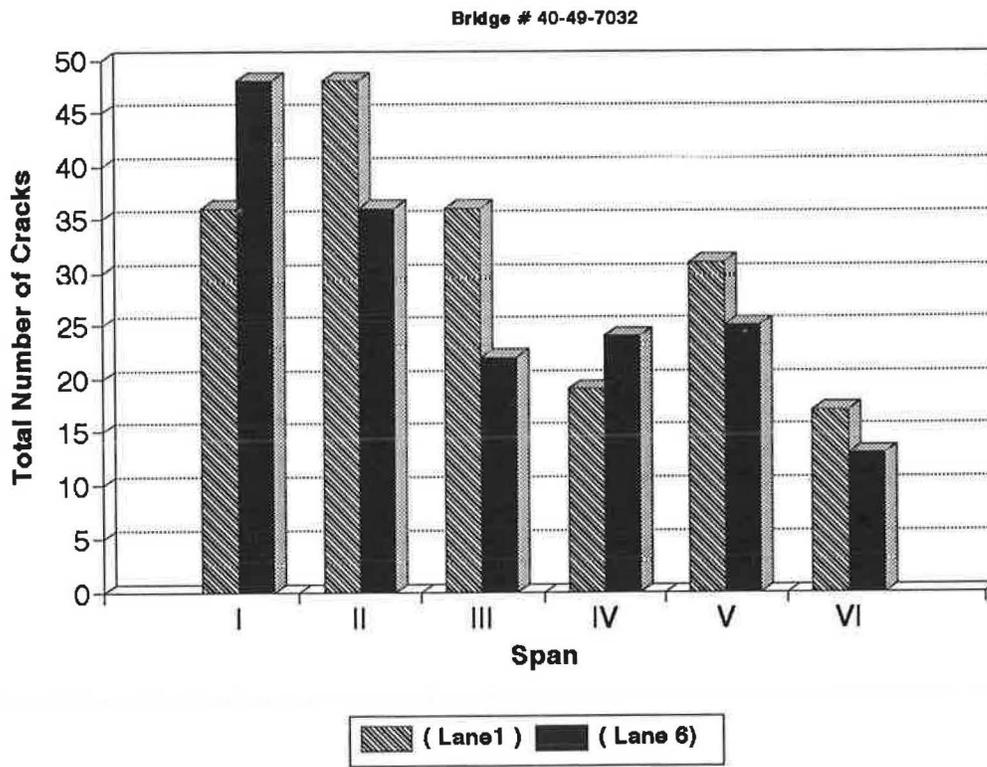
Figure 5 Total number of cracks.

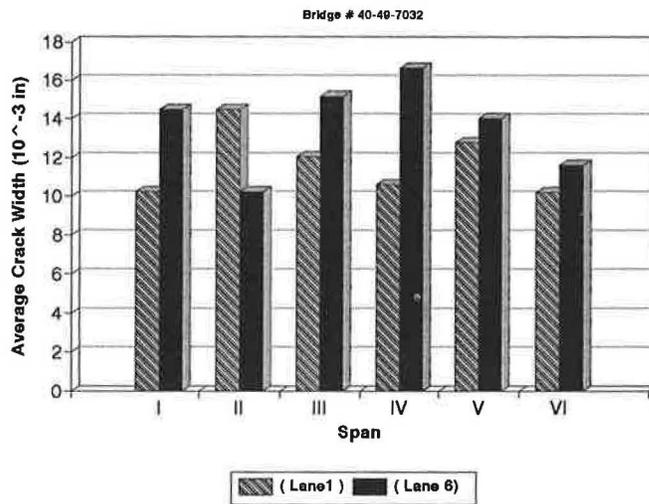
Figure 6 Average crack width.

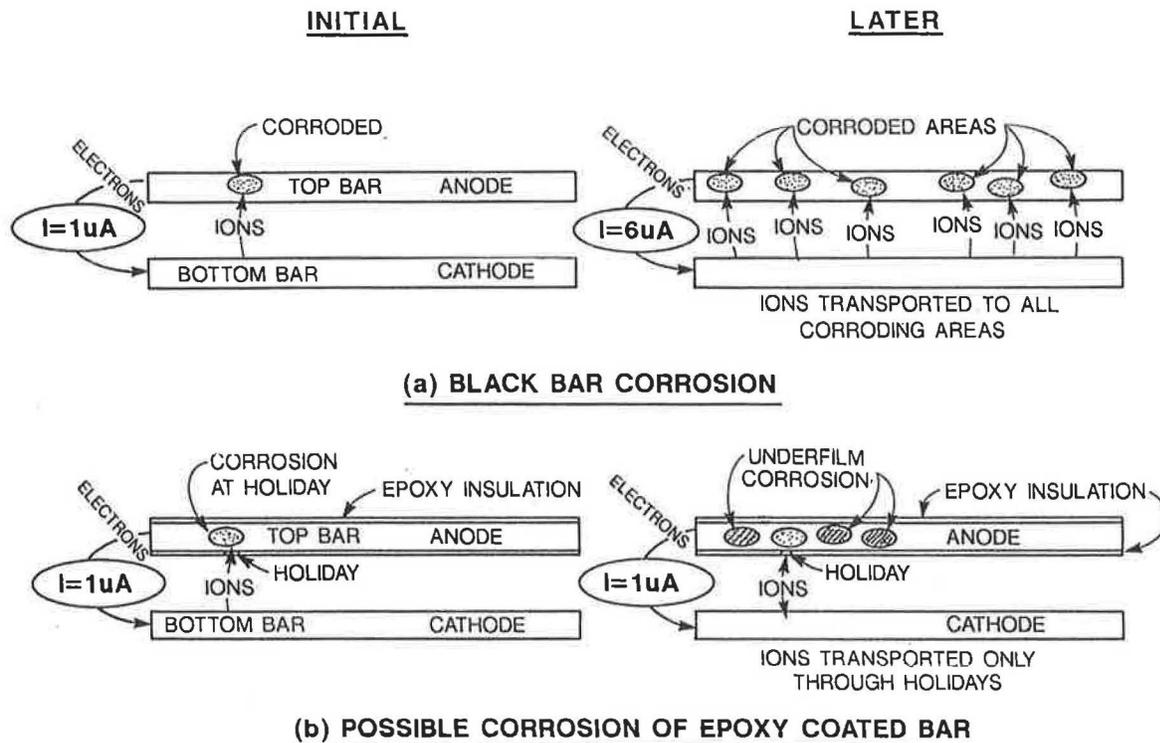
Figure 1 Macrocell current "I" may indicate greater corrosion for black bar than for epoxy coated bar.

In summary, corrosion measurement by electrical testing of slabs containing corroding epoxy-coated bars is not nearly as straightforward as is the testing of slabs with corroding uncoated black bars. Of the three procedures discussed above, the WJE authors believe that the resistance measurements give better information concerning the bar corrosion condition than do I/O potential or corrosion currents. This is because initial resistance measurements give a good indication of the areas of holidays at the start of the test. Changes in resistance are then due either to changes in concrete resistivity or holiday and bare area effects. Since concrete resistivity changes in black-bar companion slabs should be similar to those in slabs with epoxy-coated
