HIGHWAY RESEARCH CIRCULAR

An Investigation of Asphalt Cement Subsealing and Lime-Cement Jacking

by Ignatius F. Rizzuto, Associate Civil Engineer and

New York State Department of Public Works

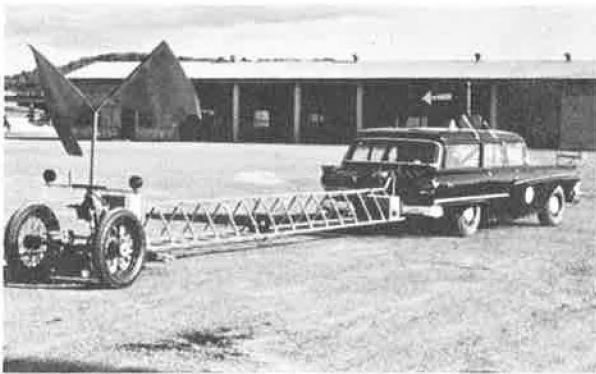
FIGURE 2 - CHLOE Profilometer

Present Serviceability - The condition of the subsealed pavements before and after treatment was determined by the Present Serviceability Index formula. This required a visual inspection in which all cracks and patches were measured and recorded (Figure 1). The lengths of cracks greater than 1/8 inch and the area of all patches were used in the PSI formula. Surface roughness also was measured, first with the Thruway's CHLOE profilometer (Figure 2), and later with a BPR type roughometer acquired by the Department (Figure 3). The correlation of the two devices is given in Appendix C.

As previously noted, PSI determinations were made for all of the subsealed test pavements using the Thruway's CHLOE profilometer before treatment and a BPR-type roughometer after treatment. Equivalent evaluations of the Thruway jacking sites were not performed. However, the results of similar determinations made by the Thruway Authority on a previously jacked portion of pavement are included in the discussion. The equation used in this study is shown on the next page.

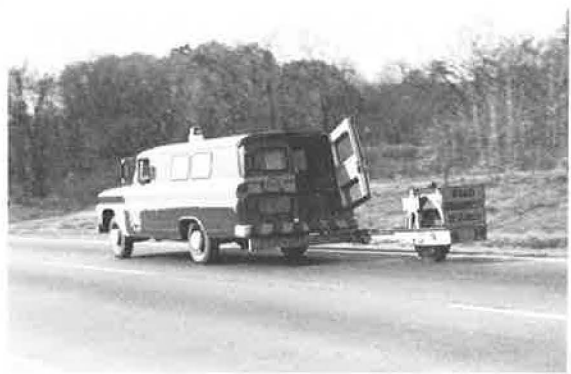
FIGURE 3 - BPR-Type Roughometer

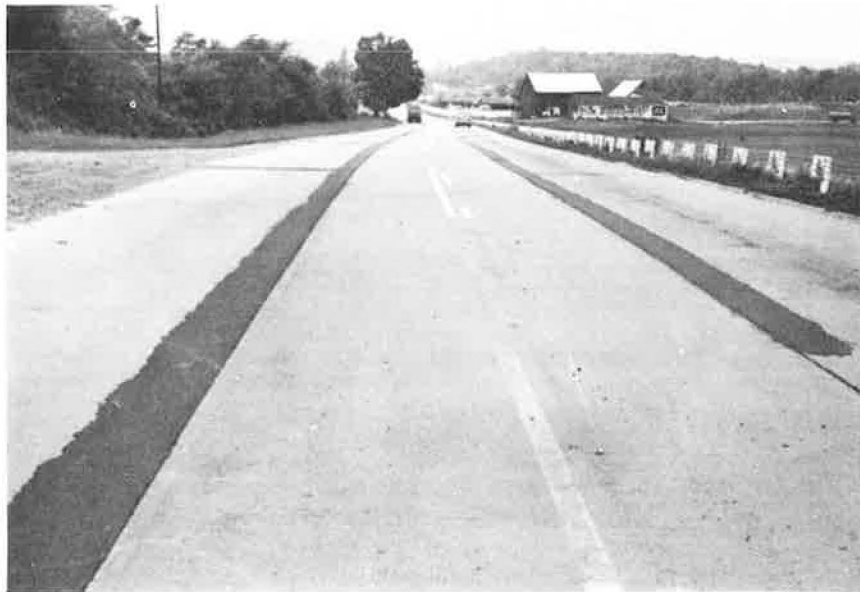
FIGURE 6 - Patching Required After Subsealing
Route 20, New Lebanon, June 1963

One result of the subsealing operations was a marked increase in longitudinal joint faulting which averaged about 1/4 inch before treatment. A comparison of pavement cross-sections, determined by plotting precise elevations before and after treatment, and augmented by periodic direct measurements, established that longitudinal faulting increased initially on all pavements, except at Site 8-32 WB, where there was a slight decrease. Increases of 17 to 54 percent in longitudinal faulting were recorded immediately after subsealing where spotted coverage was used, and 88 to 106 percent on the two sites which received blanket coverage. Moreover, these increases were still evident at the end of the 13-month recording period. This suggests that subsealing can create a hazardous condition, unless precautionary measures are taken to patch longitudinal joints which become excessively faulted (Fig. 6). No evidence of additional longitudinal faulting was noted on the lime-jacked pavements.

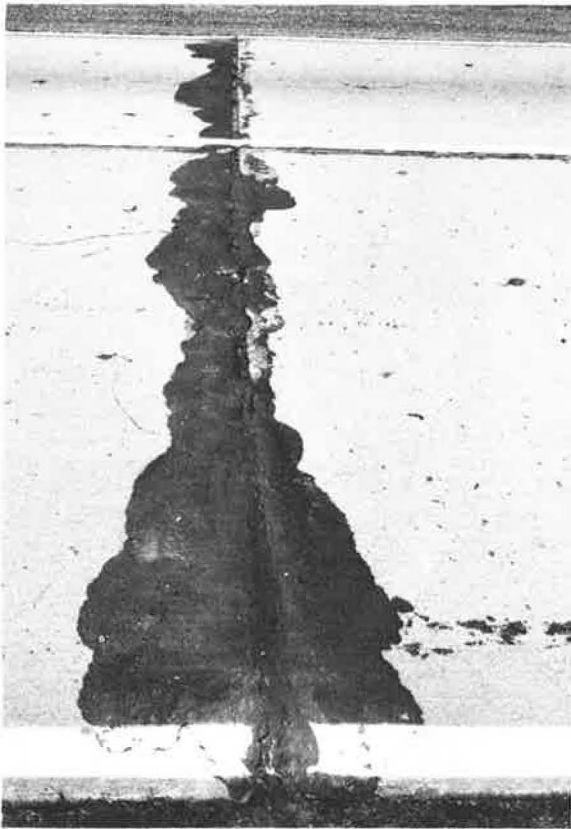
FIGURE 7 - Extruded Subsealing Asphalt. Site 6-20, Route 17, Elmira (June 1964)

Asphalt extrusion contributes to the temporary nature of the fault reduction achieved by subsealing. Within a few days after treatment, asphalt began extruding from many of the transverse joints on Sites 8-10 and 8-20. By the following summer, the extrusion reached the proportions illustrated in Figure 7, and showed no sign of diminishing. Approximately 25 gallons of asphalt per hole were used on these pavements, except the southbound lane of Site 8-20 which required only 16 gallons per hole (Table 3). Similar extrusion occurred at Sites 6-10 and 6-20 where the quantity of asphalt was about 30 gallons per hole.

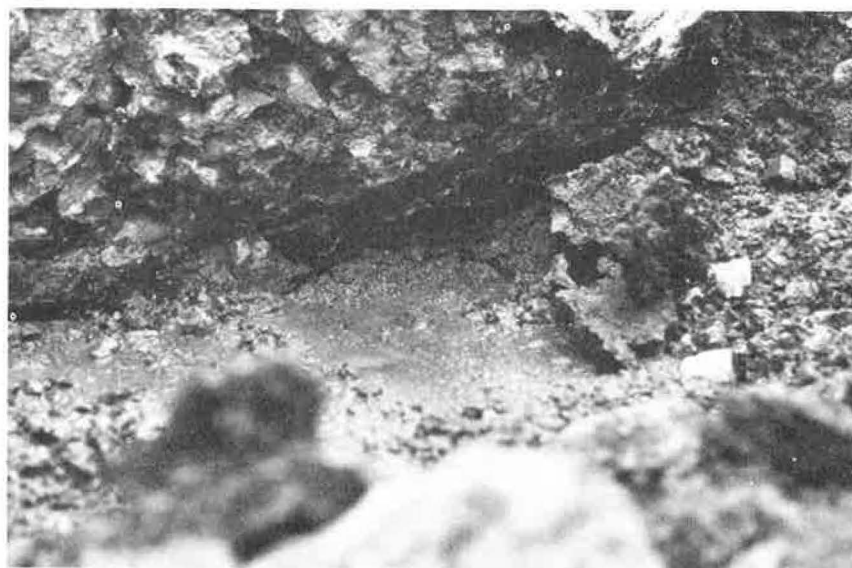
FIGURE 9 - Water Seeping Through
a Subsealed Void. Route 9W,
West Point (June 1964)

The State specifications require that mud or water encountered beneath the pavement be removed prior to subsealing. The specified procedure consists of digging trenches in the shoulders adjacent to joints and cracks, and expelling the mud or water through the trenches with compressed air forced into the drilled holes. In practice, this operation is generally performed only when an extremely wet condition is encountered, since attempts under drier conditions have been ineffective. Accordingly, this step was not included in the treatment of the test sites.

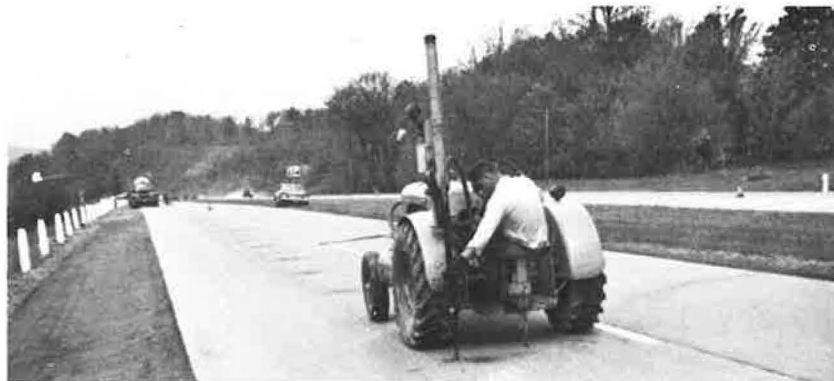
FIGURE A-1 - Typical Subsealing
Drill used on Site 6-20.

The drilling was accomplished with a pneumatic drill mounted on a self-propelled air compressor of the type shown in Figure A-1. The average time to set up, drill, and move to the next hole location was three minutes. Average output per day was 200 holes for spotted coverage and slightly higher for blanket coverage. In District 6 the contractor drilled and subsealed one lane at a time, whereas in District 8 both lanes were drilled prior to subsealing. The only discernible difference was that the holes in the adjoining lane made it easier to estimate the area covered by the asphalt.

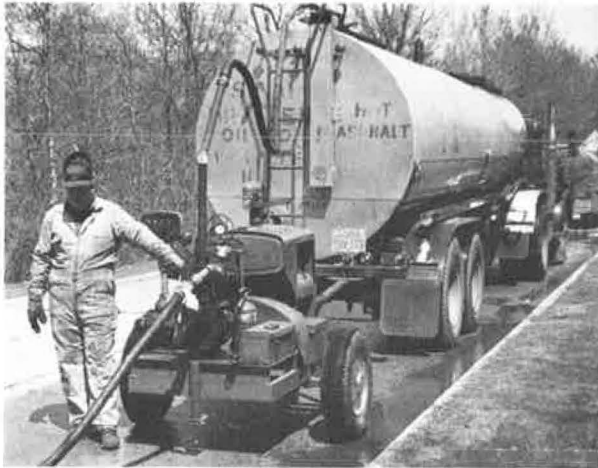
FIGURE A-2 - Asphalt Tanker & Trailer-mounted subsealing pump used in District 8.

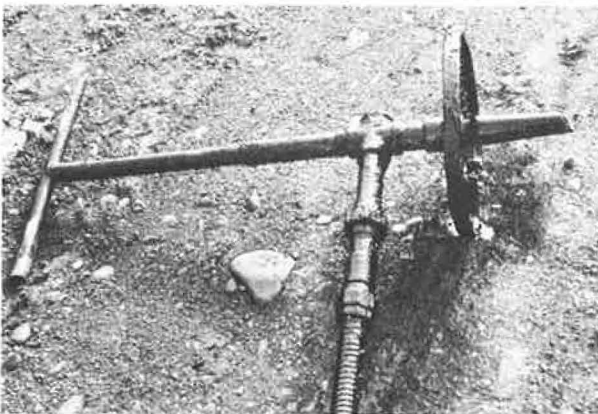
FIGURE A-3 - Subsealing nozzle used on Sites 6-10 and 6-20.

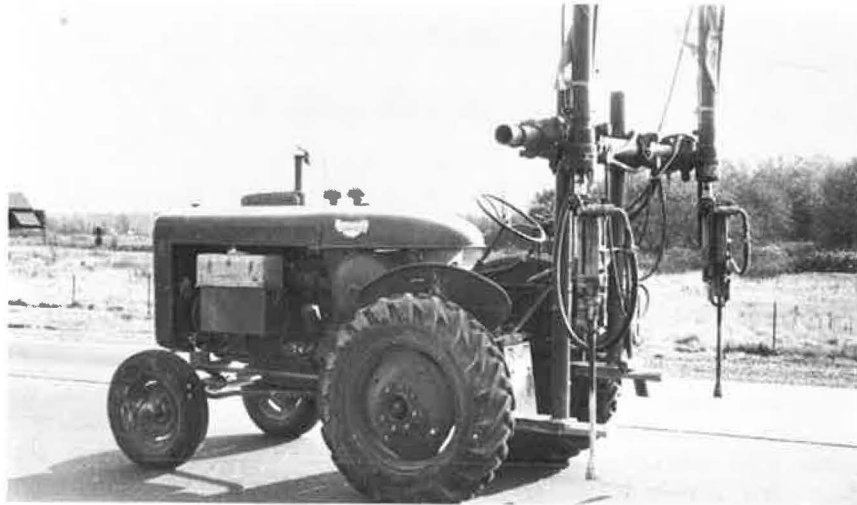
FIGURE B-1 - Standard NYS Thruway Jacking Drill

Drilling: Drilling was done with carbide-tipped bits on 18 inch drill steel. The average cycle time for the simultaneous drilling of two 2 5/8 inch diameter holes was reported by LaFleur (11) to be six minutes and we verified this. The hammers are 45 pound air-controlled Schramm sinkers mounted on a Schramm 125 cfm self-propelled air compressor as in Figure B-1. The Thruway drill pattern was two holes spaced six feet apart transversely and spotted in the longitudinal direction according to the condition of the pavement. Drilling was usually done just prior to jacking so that both crews could be protected by the same traffic control devices. These operations were also restricted to one lane at a time for the same reason.

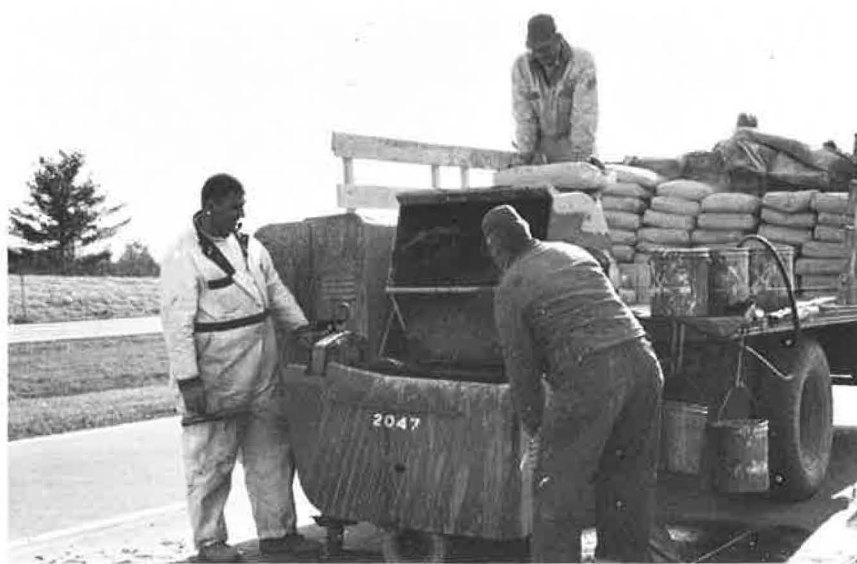
FIGURE B-2 - Eight cubic foot mixer being dumped into a Koehring Model 10 mud-jack.

Jacking: The size of mixer used depending on the pavement condition and the length of time it could be closed to traffic. When a large volume of slurry was required, a towed Model 13-S type paving mixer was used. When the anticipated quantity was small, or slower production could be tolerated, the 8 cubic foot mortar mixer shown mounted on the rear of the supply truck in Figure B-2 was used. The required mixing time varied widely so mixing was continued until a uniform consistency was reached. The mix was then dumped into the hopper of a Koehring Model 10 mud-jack (Figure B-3).

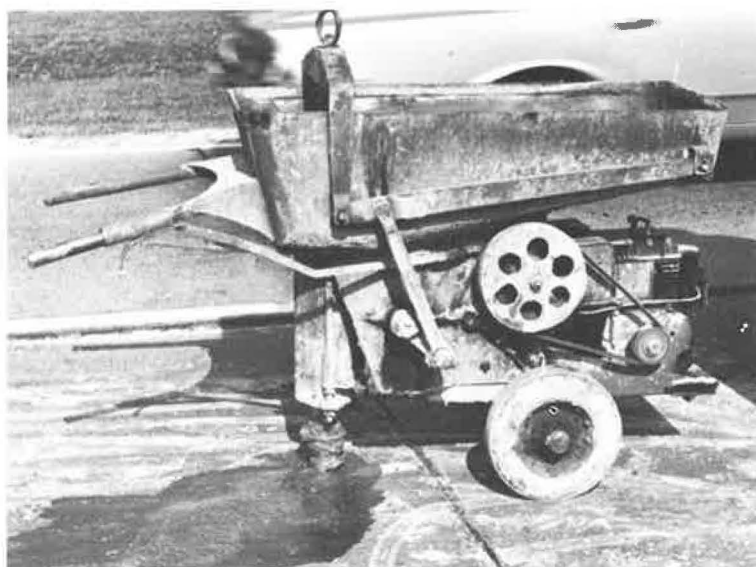
FIGURE B-3 - Model 10 Mud-jack with engine and pump exposed.

The mud-jack consists of a mix hopper and a slow speed, single cylinder, piston pump driven by a single cylinder 2 hp gasoline engine. The pump was designed to handle a maximum of 47 cfh (5.9 gpm) at a maximum pressure of 100 psi. These pump characteristics appear to be about the optimum for making limited lifts because they provide exact control over pavement displacements. However, when large pavement displacements must be made or large voids filled, Thruway personnel report that a pump having higher capacity would greatly increase production.

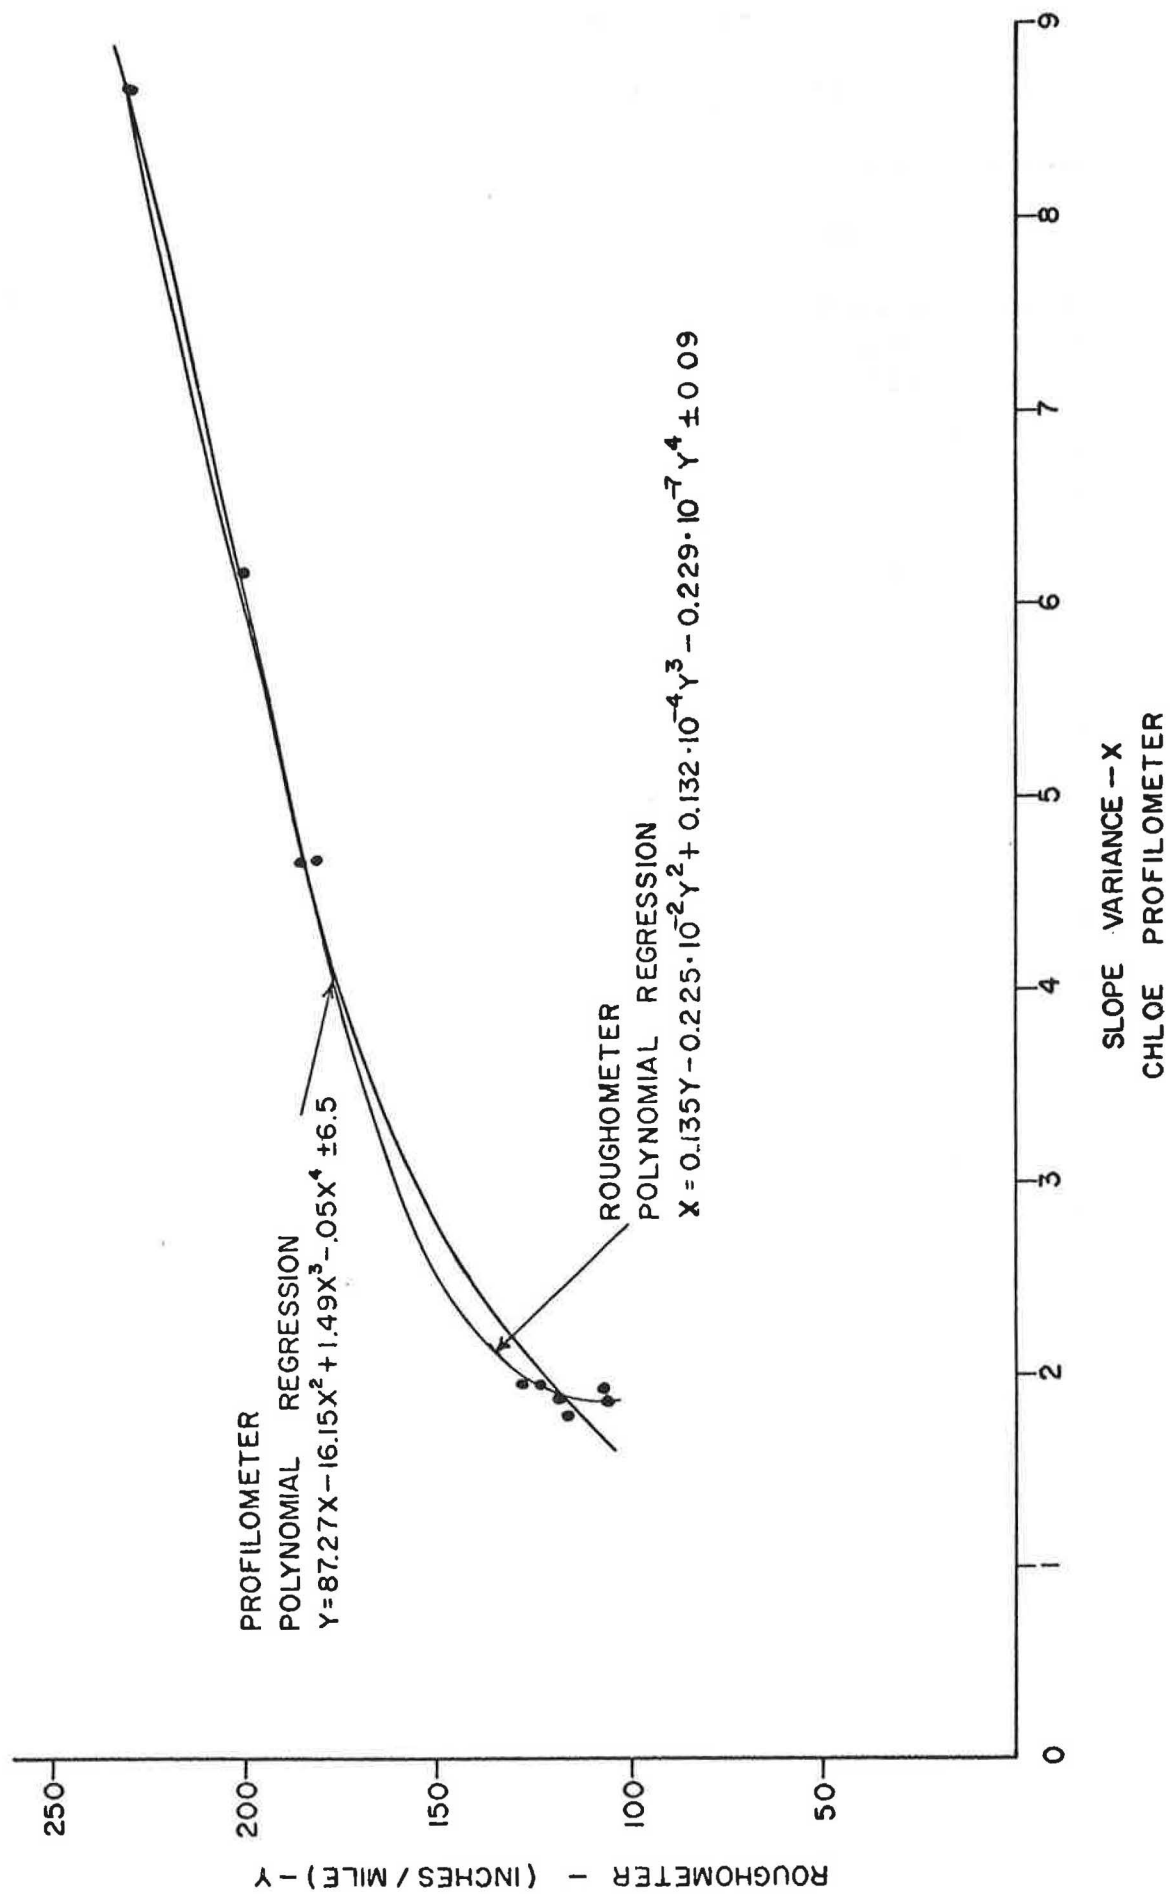
FIGURE NO-C-1 CORRELATION STUDY OF N.Y.S. ROUGHOMETER & N.Y.S. THRUWAY PROFILOMETER

A similar polynomial regression analysis using the roughometer as the independent variable showed that a fourth order equation having a standard error of estimate of plus or minus 0.09 was the best regression line obtainable (Figure C-1). It should be noted that these equations are only applicable for the range of values used in this study and must not be extrapolated. The correlation coefficient, a function of the angle of intersection of the two regression lines is not given because it has no significance for a curvilinear relationship and, in fact, cannot be computed.
