# EFFECTS OF EL NIÑO STORMS CALIFORNIA'S PACIFIC COAST HIGHWAY

JOHN D. DUFFY

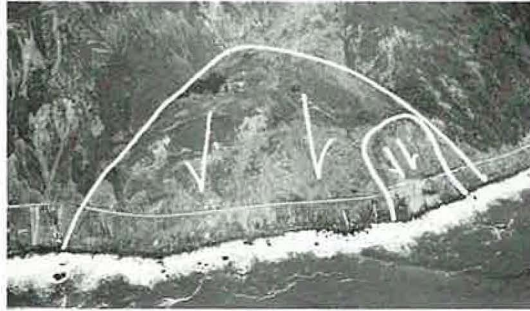
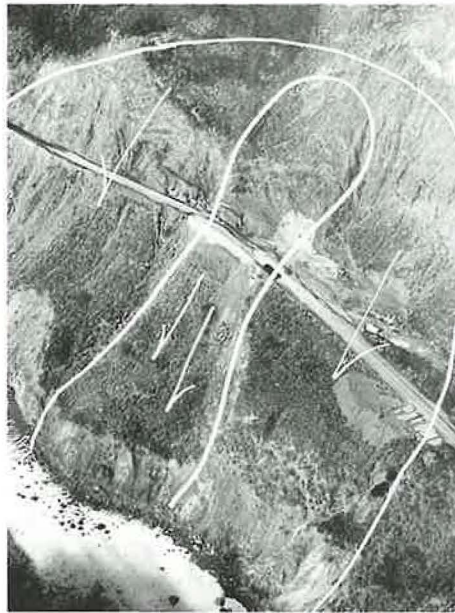
Three major  
landslides in  
Monterey, California  
(from top): Duck  
Ponds, Big Slide,  
Grandpa's Elbow.

The Duck Ponds landslide complex, which removed approximately 120 meters of roadway, is approximately 900 meters in length and 900 meters wide, encompassing about 275 acres of mountain-side. The toe of the slide exits into the Pacific Ocean. The portion of the slide that affected the roadway was approximately 120 meters wide and 300 meters long, occurring within the larger landslide complex. This smaller slide moved along a portion of the ancient slide plane, connecting to the toe of the slide at sea level. The depth to the slide plane was estimated at 60 meters. Approximately 9 acres of earth moved—equivalent to 1.5 million cubic meters or 4 million tons of earth.

Big Slide landslide is approximately 600 meters long, toeing out into the Pacific Ocean. Its average width is estimated to be 200 meters and its thickness 60 meters. Approximately 32 acres of earth moved—equivalent to 7.5 million cubic meters or 17 million tons of earth. About 90 meters of roadway translated downslope approximately 5 meters. Subsequent cracking and distortion made the roadway impassable.

Grandpa's Elbow landslide transported 360 meters of roadway approximately 10 meters downslope. This slide is estimated to be 900 meters in length and 360 meters wide. The depth to the slide plane is about 60 meters. Approximately 82 acres of earth moved—equivalent to 20 million cubic meters or 45 million tons of earth.
