Modular Energy Dissipators

A.L. Simon and S. Sarikelle

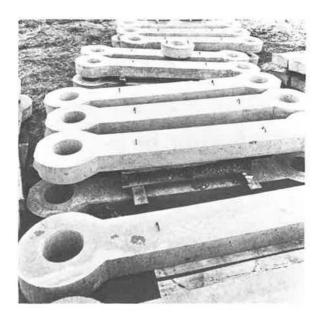
Figure 3. Modular structural elements.

The modular structural elements of the MED system are shown in Figure 3. These five basic modular elements are arranged to fit local conditions. The horizontally placed elements are held by concrete-filled steel or aluminum posts. The posts are driven into the ground after the first layer of standard modular pieces is located on a prepared site. Stacking of the 6-in-thick components to the desired height can be completed quickly. The arrangement of the structural components at the Canal Fulton site is shown in Figure 3.

The standard module sizes were structurally designed in lengths of 4, 6, 8, 10, and 12 ft. Corresponding filler members, columns, and optional structural pads make up the complete system. The advantages of the MED system,

assuming that the components are made under factory conditions, are (a) lower cost per component, (b) better quality control, (c) higher concrete strength, and (d) less labor per component. The additional advantages related to the on-site construction are use of unskilled local labor and shorter construction time as construction involves mainly earthwork and assembly of precast components.
