Centuries Later, Bridge Research Continues to Pay Off

Robert J. Reilly, Projects Engineer, Cooperative Research Programs

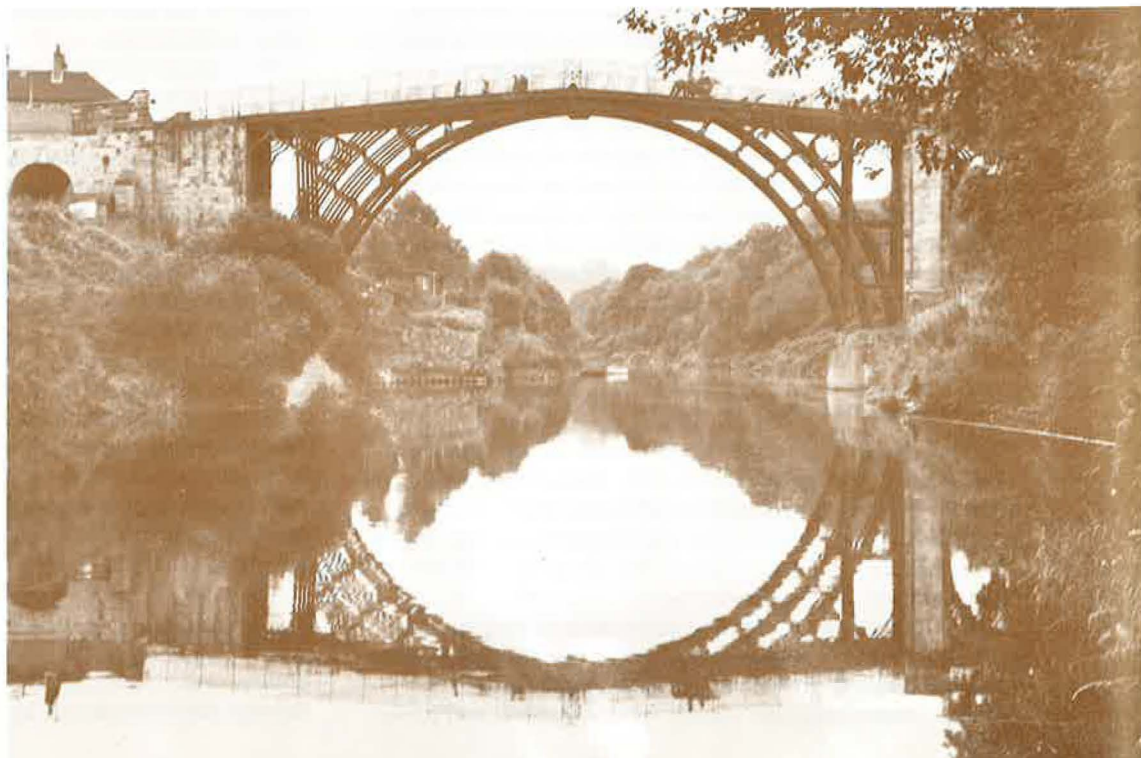
2. The world's first iron bridge was built over the Severn River in England, 1779. Cast iron, used in this bridge and in others built in the early 19th century, has adequate compressive strength but is brittle and weak in tension. This bridge, modeled after masonry arches built during that period, is still standing. However, many other cast iron structures failed soon after construction.

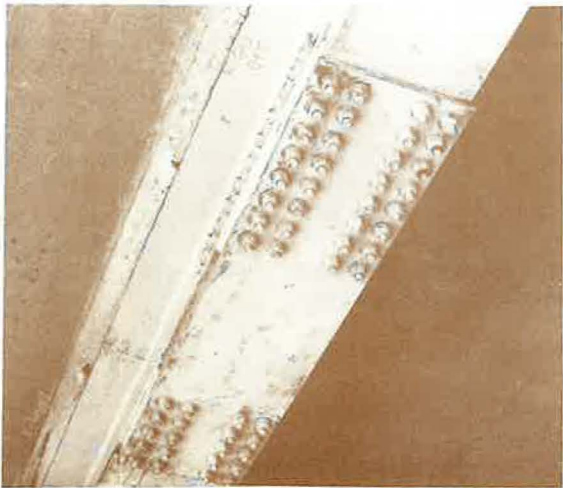
8. Bolted splice used to repair beams with severe fatigue cracking. This method was used to repair several cracked beams at a cost of approximately \$2000 each, in the Yellow Mill Pond Bridge.

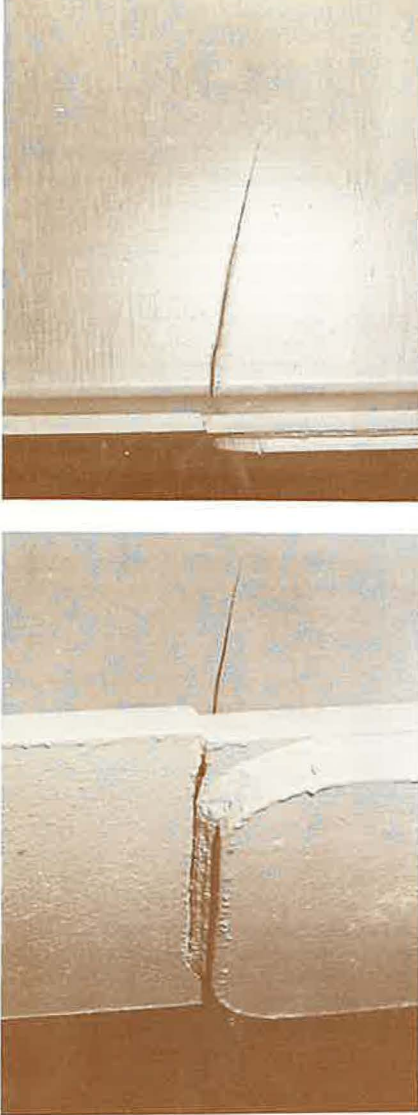
5. Side view (top) of a cover-plated steel girder shows a fatigue crack starting in the flange at the toe of a fillet weld at the end of the cover plate and extending through part of the web. The same girder (bottom) is viewed from below showing fatigue crack extending through the flange (foreground) and into the web (top of picture).

6. The crack shown in Figure 5 was found in the Yellow Mill Pond Bridge on the Connecticut Turnpike (Interstate 95), near Bridgeport, after about 13 years of exposure to a high volume of truck traffic. This bridge has 28 simple spans, each supported by 6 or more girders with all but a few of these girders having 4 cover plate ends, resulting in about 700 fatigue-prone locations.

The technique of peening the toe of a fillet weld at the end of a cover plate has been applied to several bridges, most notably the Yellow Mill Pond Bridge in Connecticut. In this single example, approximately \$1.4 million in repair costs were avoided by using peening to extend the service life at

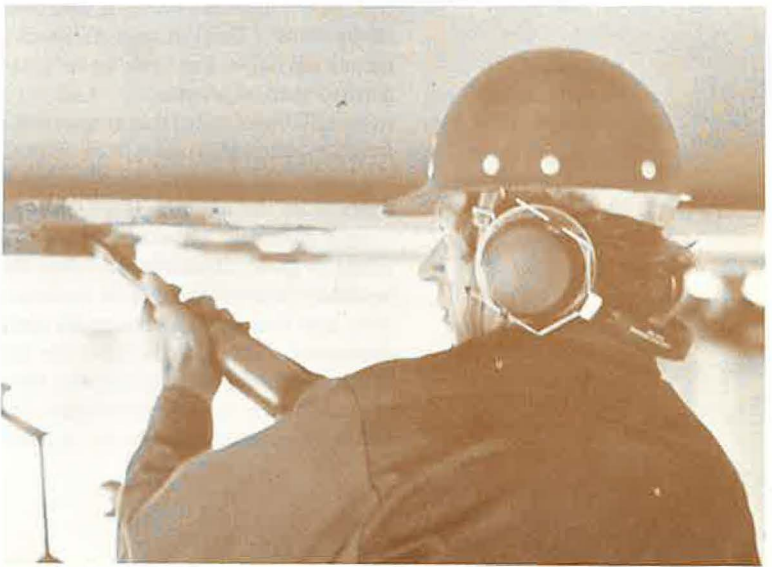
9. Research at Lehigh University has shown that air-hammer peening along the weld toe at the end of a cover plate can extend significantly the fatigue life of a bridge beam. At a cost of about \$50/joint, peening was used to retrofit some 700 cover plate ends in the Yellow Mill Pond Bridge, thus avoiding almost certain fatigue cracking problems and the need for costly bolted splices in this heavily traveled structure.

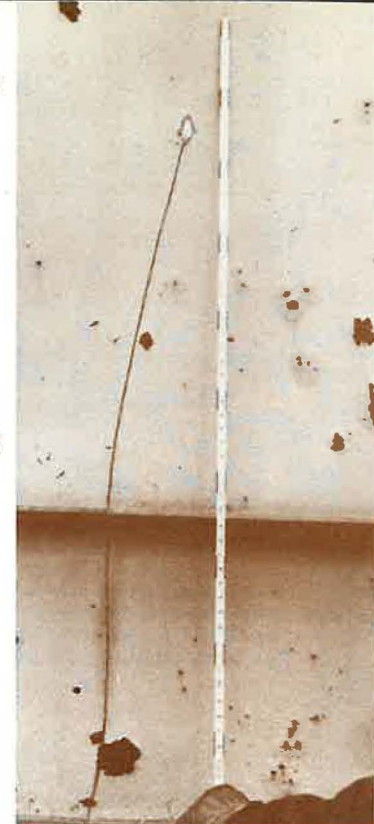
11. Fatigue crack starts at a defective groove weld in the stiffener and extends into the web (top of picture). Research at Lehigh University has demonstrated the effectiveness of a retrofit technique that entails drilling small holes in the web to arrest the crack growth. This technique has already been used on many bridges in several states and is being applied to more than 200 bridges in Virginia. These holes, which are sometimes drilled at a cost of less than \$50 each by highway agency personnel during periodic bridge inspections, prevent the crack from growing into the web and eliminate the need for major repairs at a cost of at least \$5000 each.

A second technique, also developed during Fisher's research, entails drilling holes in the girder web to remove or arrest the fatigue crack originating at a defect in a structural detail such as the butt-welded splice in a longitudinal stiffener. The technique has been used to retrofit fatigue-prone bridge details in Illinois, Iowa, Minnesota, and Wisconsin, and, starting this year, it will be applied to more than 200 bridges in Virginia.

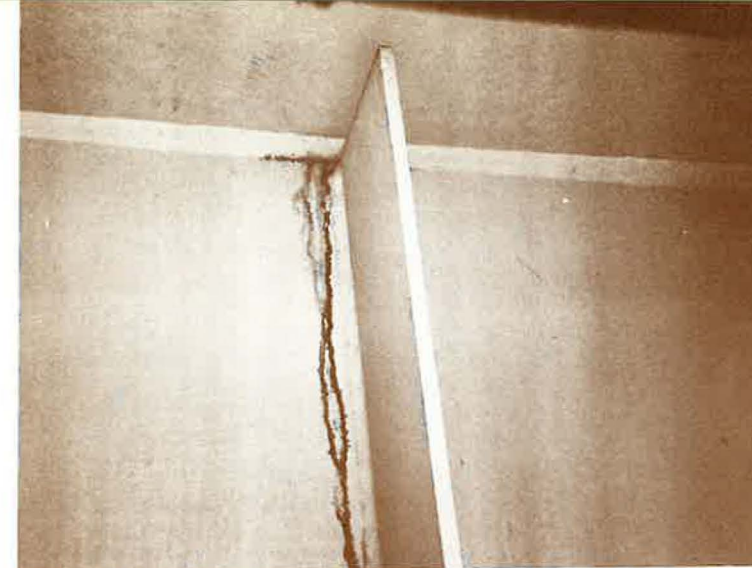
13. Cracking can be seen in this photograph along the flange-web weld near the top of the transverse stiffener, with rust stains running down the web. A retrofit technique developed by John Fisher of Lehigh University has been used to arrest the growth of fatigue cracks and to reduce the severity of out-of-plane deformations in many bridges. This technique involves drilling holes at the ends of the crack and increasing the gap between the flange and the end of the transverse attachment. The total cost of applying this retrofit technique to fatigue-prone members in 36 bridges in Iowa was estimated to be less than the cost of the removal and replacement that would have been required if fatigue cracking were allowed to destroy the girders in just one of these structures.

Another solution developed in this study applies to the problem of fatigue cracking caused by out-of-plane distortion of the girder web at the end of a transverse attachment. The technique of drilling holes at the ends of the crack and increasing the length of the gap between the end of the attachment and the tension flange has been used to retrofit many bridges including the Poplar Street Bridge in St. Louis and 36 bridges in Iowa.
