# Woodrow Wilson Memorial Bridge, Washington, D.C.: Concrete Deck Reconstruction

*The innovative techniques developed to replace and widen the concrete deck of the Woodrow Wilson Bridge may well be applicable to other bridge rehabilitation projects throughout the country*

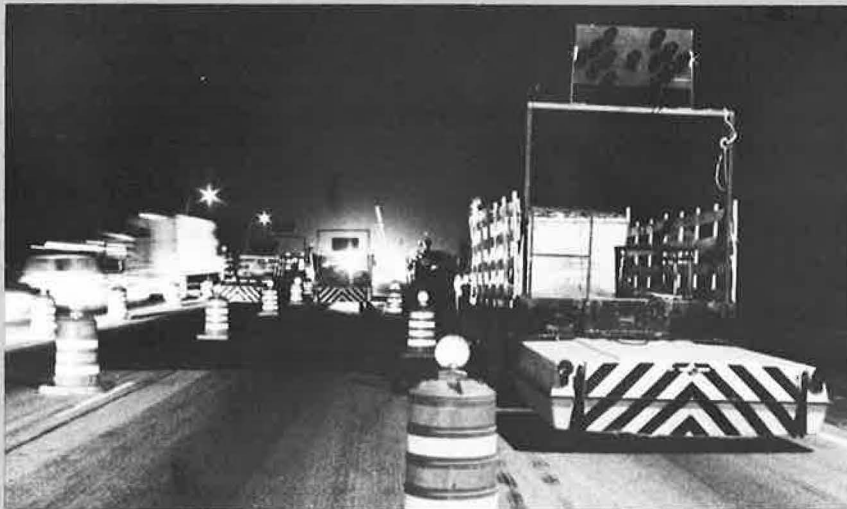
Absorption Systems, Inc. The Hex-Foam TMAs are portable crash cushions that are attached to the rear end of maintenance trucks to provide an impact-absorbing barrier between errant vehicles and work crews. Hex-Foam is designed to crush on impact, dissipating collision energy while bringing the impacting vehicle to a safe stop. The TMAs have been shown to protect stationary maintenance vehicles from an impacting vehicle traveling up to 45 mph.

By using three TMAs as a protective barrier between equipment and motorists, the time required for the equipment-moving procedure was reduced to 45 minutes. Once the equipment was in place, all traffic was rerouted onto two lanes of the six-lane bridge while decking and painting work continued. During daytime pothole-patching operations, two TMAs were set up to form a shield protecting workers at the end of the work zone.

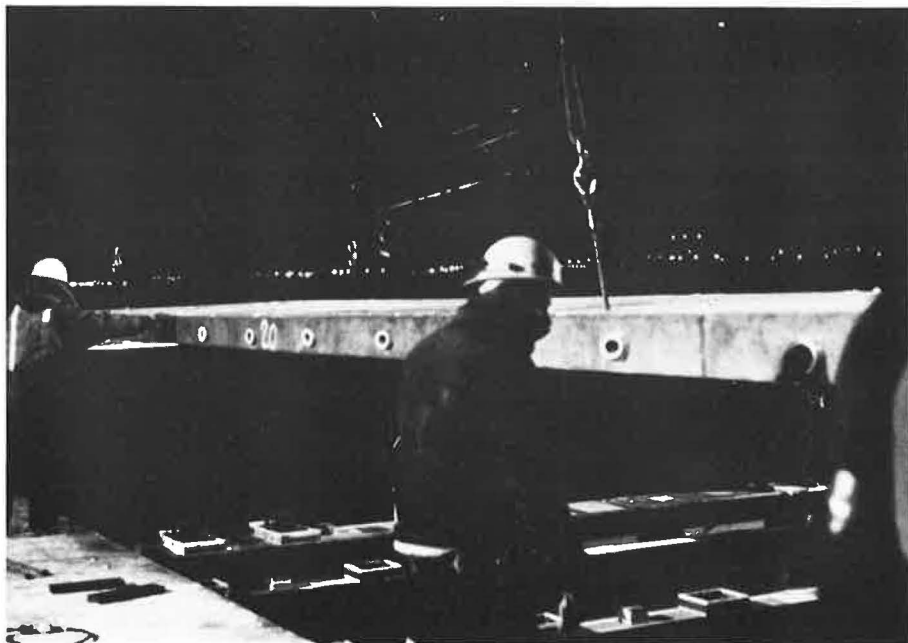
Precast deck panel is lowered into place during nighttime construction work. Ovals are ducts for longitudinal post-tensioning.

tensioning is a primary component of the structural design of the panels, whereas the principal function of the longitudinal post-tensioning is the elimination of transverse joints, thereby sealing out water and eliminating reflective cracking in the wearing surface. The longitudinal post-tensioning was performed in place through an average of 17 panels. The transverse joints between the panels were filled with methyl methacrylate polymer concrete immediately before longitudinal post-tensioning.
