Bridge Failures —

Aftermath and Investigation

JOHN M. HANSON

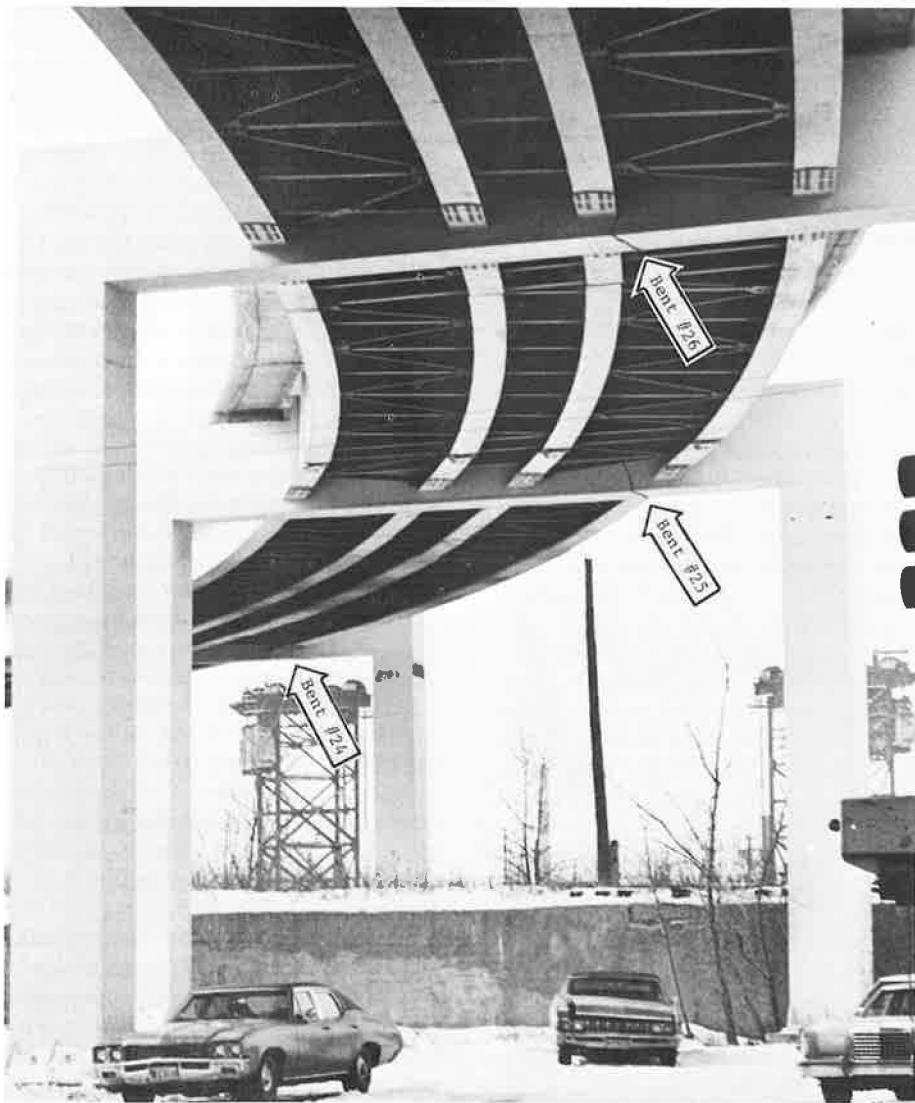
Figure 1. Cracked bents in Dan Ryan Rapid Transit, Chicago (arrows point to location of fractures). (photograph courtesy of Chicago Department of Public Works)

While riding on a train passing under the 8-year-old Dan Ryan Rapid Transit in Chicago on January 4, 1978, Herman Solarte observed a crack extending almost completely through a steel bent that was supporting the overhead superstructure. Solarte, a structural engineer, recognized the danger and notified the Chicago Transit Authority as soon as the train arrived in downtown Chicago. The Authority responded immediately; an on-site investigation revealed the major crack reported by Solarte and also major cracks in two adjacent bents. (Views of the cracked steel bents are shown in Figures 1 and 2.) For the next 11 days the city suffered a crisis of significant proportion while the major commuting line was closed to permit an investigation of the extent of the damage. Shoring was installed under the fractured bents and others before the system was reopened.

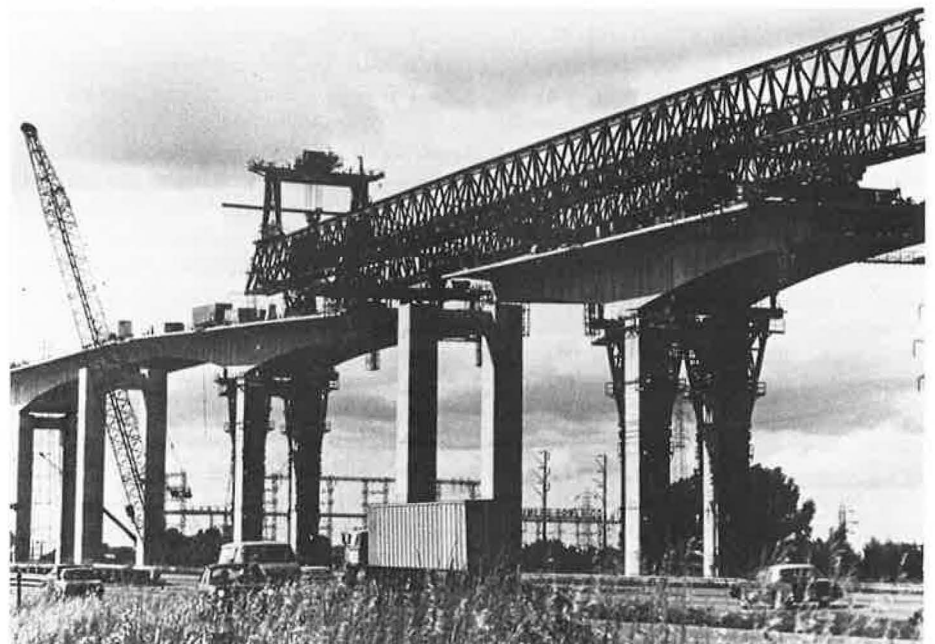
Figure 3. Deflected cantilever in Zilwaukee Bridge, Saginaw, Michigan. (photograph courtesy of Michigan Department of Transportation)

On August 28, 1982, there was a failure in a "blocked" expansion joint in the segmental post-tensioned Zilwaukee Bridge at Saginaw, Michigan. The end of the cantilever (shown in Figure 3) twisted and deflected about 5 ft, and the joint in the adjacent span rose about 3 ft. Concrete on the compression side of the blocked joint was crushed, as shown in Figure 4. Construction of the bridge was delayed for several months as investigators sought the cause of failure and developed repair procedures for the extensive damage.

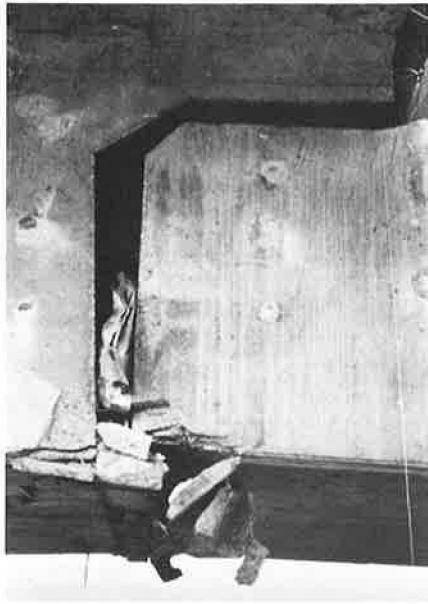
Figure 4. Spalled compressive region of "blocked" joint in Zilwaukee Bridge. (photograph courtesy of Michigan Department of Transportation)
