Concrete—A Faithful Servant

CARL F. CRUMPTON

Crumpton is Engineer of Research, Kansas Department of Transportation.

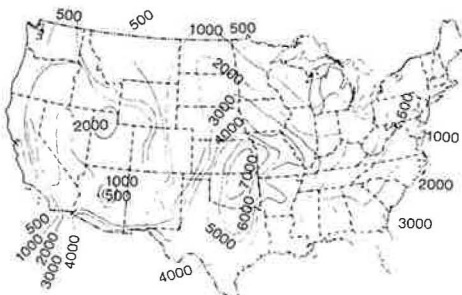
FIGURE 1 Summer degree-hours above 85°F.

est number of summer degree-hours above 85°F of any spot in the nation (Figure 1). Hot (summer temperatures can get as high as 110° to 120°F) and windy weather leads to high evaporation rates.

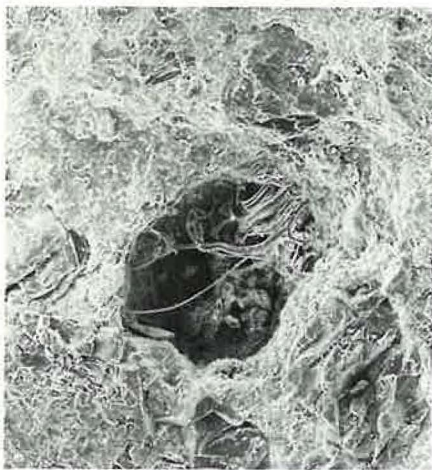
FIGURE 4 Air void in concrete with fibrous halite crystals.

Looking at salted concrete with the scanning electron microscope has revealed the same types of salt crystal growths in concrete as reported for halite from caves in limestone and tubes in lava. In those places, helectites, stalactites, stalagmites, columns, crusts, and euhedral crystals of common salt have been observed. Inside the air voids in the concrete, fibers, spirals, ribbons, columns, and bundles of fibers have been seen. These studies have shown the importance of that 8 percent air in providing tiny voids for the salt crystals to grow into without disrupting the concrete (Figure 4). My driveway was not air entrained, and thus it succumbed to the pressures of salt crystal growth and freeze-thaw cycling.

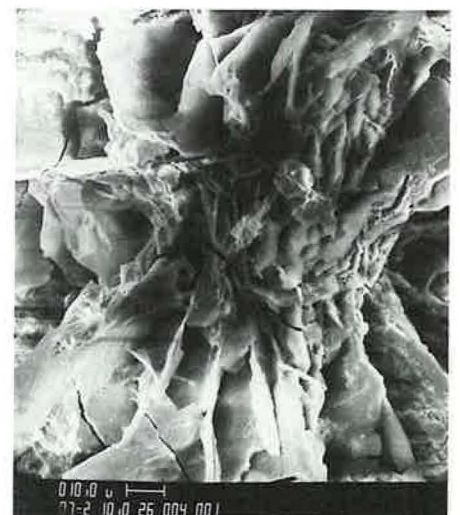
FIGURE 6 Boxwork rust crystals growing within portland cement concrete.

With the electron microscope, the Kansas DOT has scanned concrete taken from as near a corroding rebar as possible. Swordlike laths of rust were seen thrusting into the concrete near the steel (Figure 5A,B). Other forms of rust seen were boxworks and fretworks of thin-walled, apparently triangular crystals with one of the points of the triangles growing away from the reinforcing steel (Figure 6). Eventually the

X-ray diffraction studies of the layered rust showed the minerals goethite and magnetite. The lathlike and fretwork crystal forms are common for

goethite. The bulk of the massive or globular rust appears to be amorphous limonite, which does not show in the diffraction patterns.

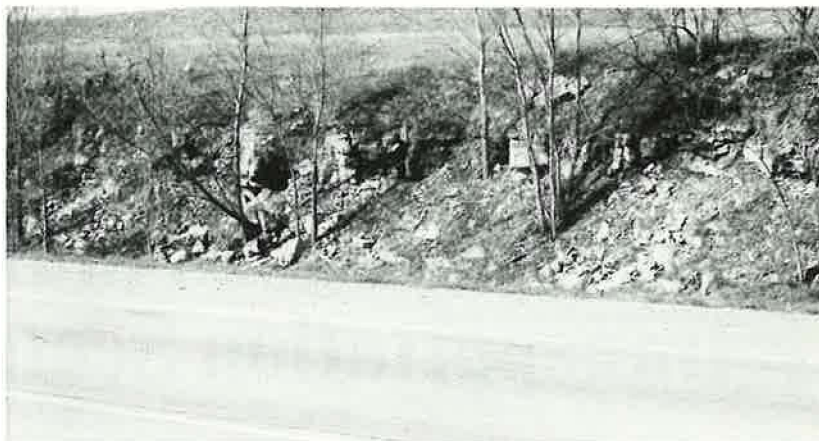
FIGURE 8 Exposed rock often weathers more quickly than exposed concrete.

Even so this man-made rock called concrete often performs better than some of nature's own rocks. Many concrete pavements are in better condition after 20 years of exposure to weather, salt, and traffic than are the 300-million-year-old rocks first exposed to the weather in cutslopes during road construction. Those rocks did not receive the direct pounding of millions of cars and trucks nor the direct application of deicing salts that the pavements received to render them snow- and ice-free for travelers, yet they have weathered even more rapidly (Figure 8).
