Seismic Retrofit: The California Experience

FRIEDER SEIBLE,
M. J. NIGEL PRIESTLEY, AND
JAMES E. ROBERTS

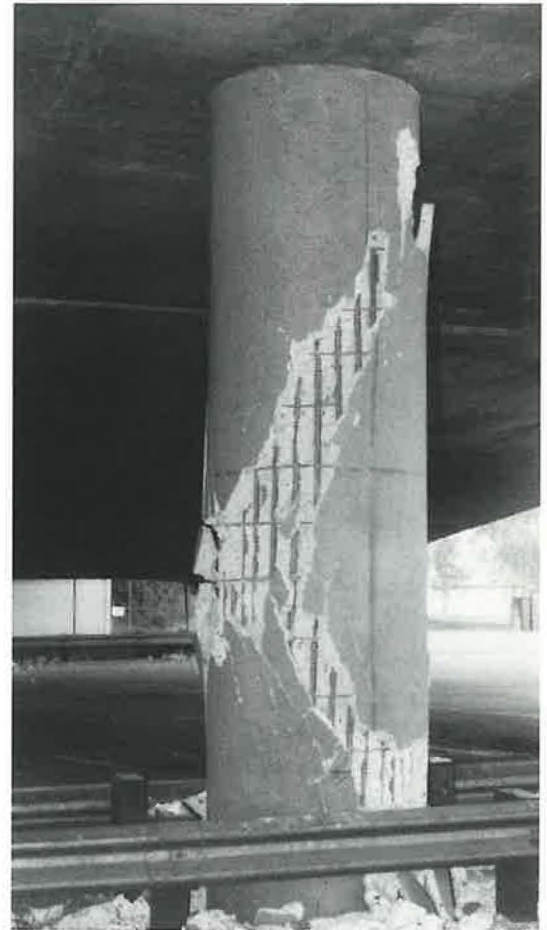
Column shear failure was one of several problems experienced by bridges as a result of the Northridge, California, earthquake of 1994.

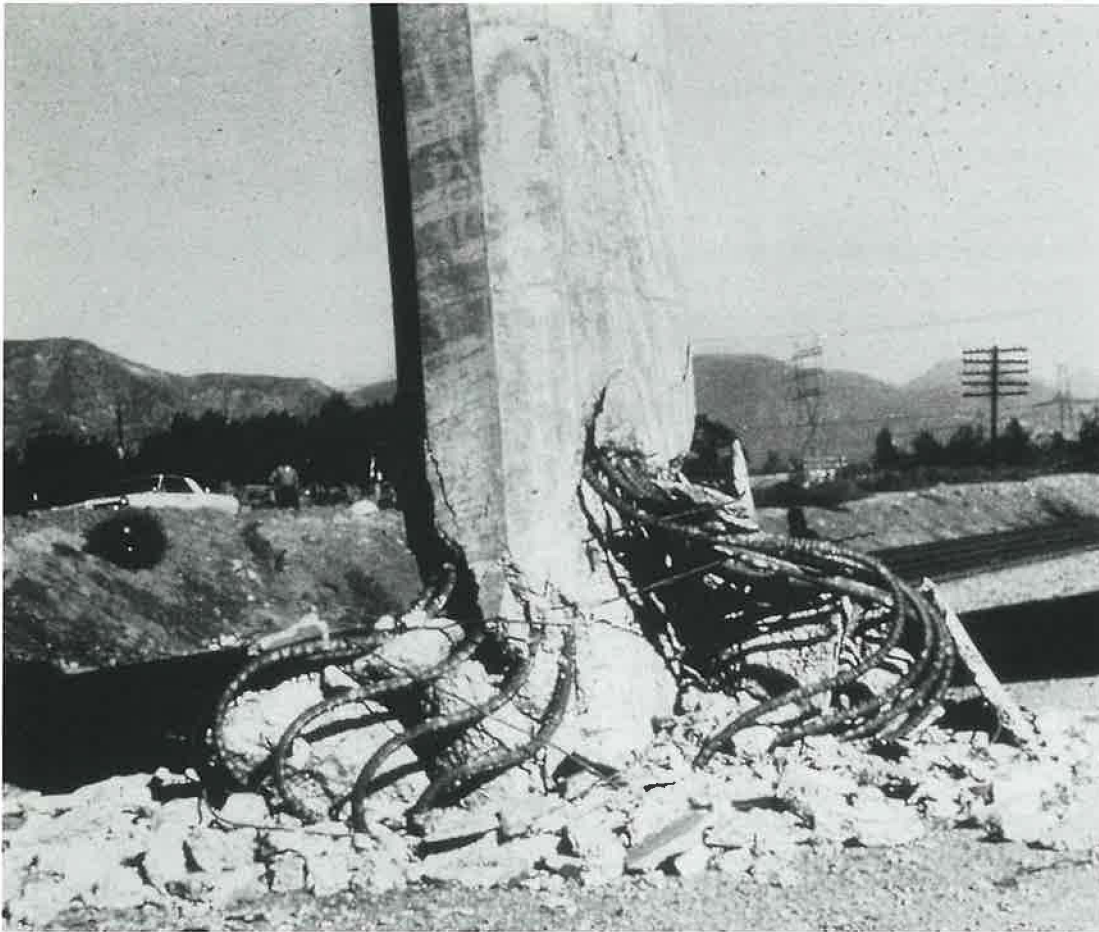
Plastic hinge confinement failures (*above*) and column shear failures (*right*) were among the damage suffered by bridges in the 1971 earthquake in San Fernando, California.

However, the 1971 San Fernando earthquake clearly revealed other bridge deficiencies, such as confinement failures of flexural hinges; reinforcement debonding failures at column ends; and shear failures in shorter, typically multicolumn bents. Between 1971 and 1986, research results and recommendations developed under the Federal Highway Administration-sponsored Applied Technology Council (ATC)-6 program led to significant changes in design practice for new bridges based on the use of acceleration response spectra to determine significantly increased design force levels and detailing requirements for confinement of the column core. The deficiencies in existing bridge columns prompted a Caltrans research program at

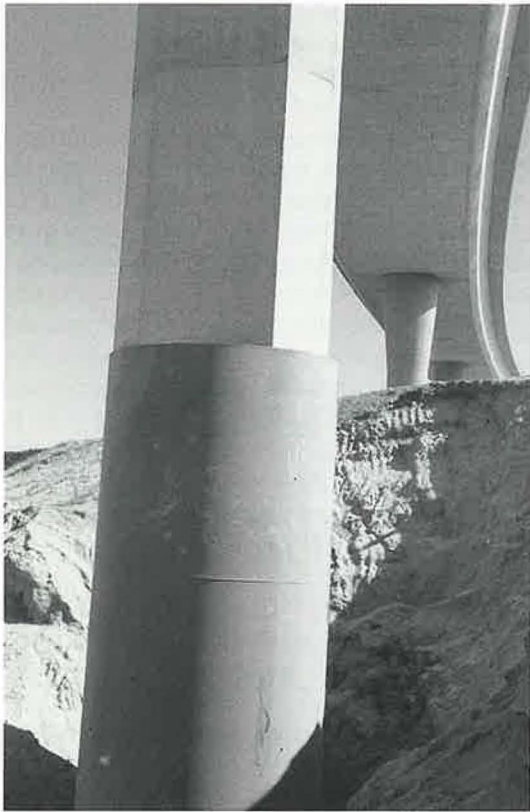
The Caltrans bridge seismic retrofit program includes partial-height steel jacketing of single-column bents (top) and a recently developed automated advanced composite jacketing system (below).

The retrofit technology development and implementation program continued at a rapid pace after the Loma Prieta and Northridge earthquakes. New column jacket technologies utilizing advanced composite (glass and carbon) jacketing systems were developed at UCSD. Numerous tests were con-
