Durability and Maintenance of Lime-Stabilized Bases

Conrad M. Kelley

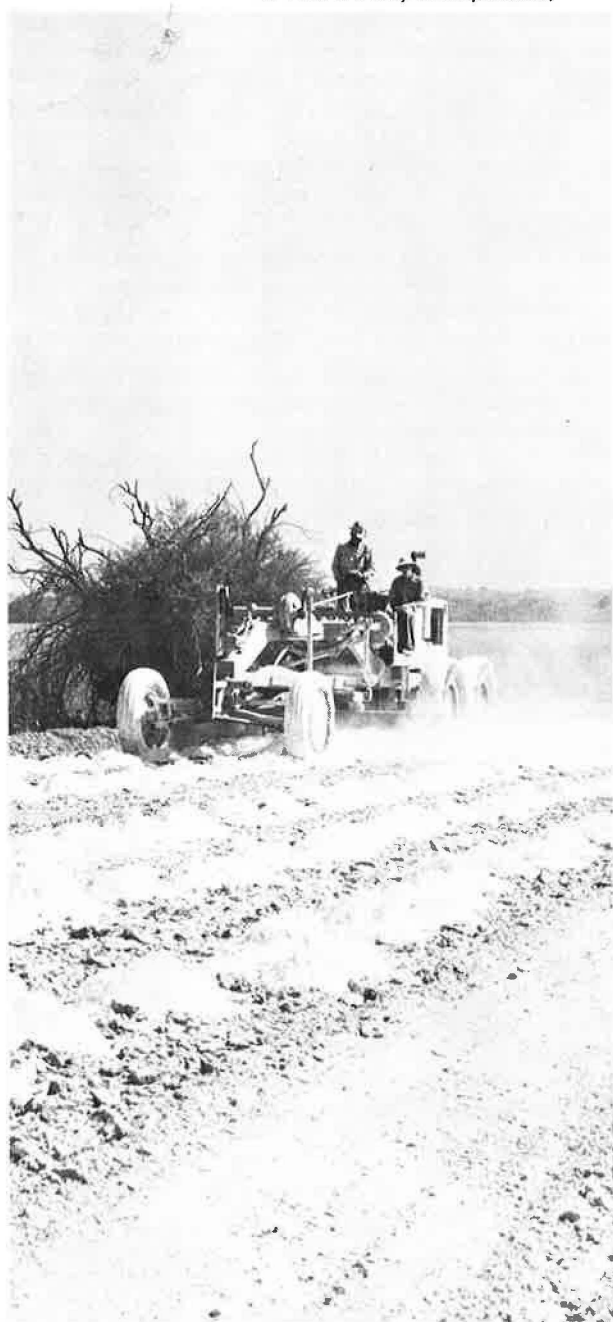
A motor grader mixes lime with the dry base material in the construction of an access road at Fort Sam Houston, Texas, in 1951. (Photo courtesy of Fourth Army Headquarters.)

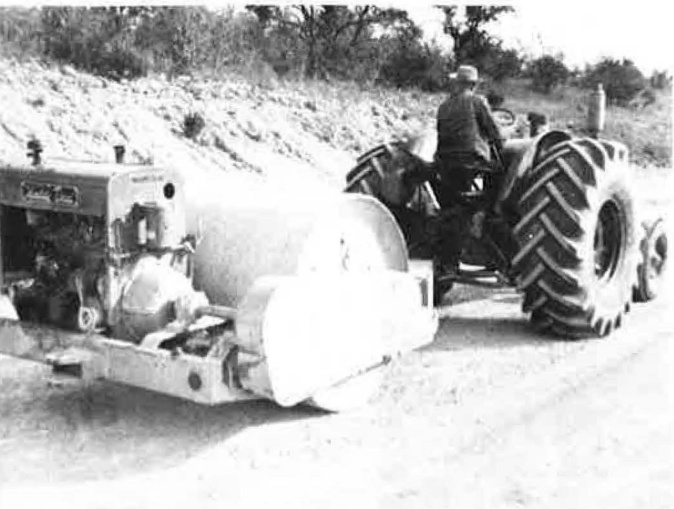
1 A vibratory roller compacts a lime-treated base at Fort Hood, Texas. This road was built 20 years ago and is still giving good service.

The first lime project at Fort Hood was built in 1953. In 1958, 80 km (50 miles) of range roads were built on which a 10 to 15-cm (4 to 6-in) lime-treated, shell-aggregate base material was placed on existing open surface gravel or stone roads; the surfacing was a double asphalt treatment. One project, Old Copperas Road, was sealed in 1963, overlaid with 4 cm (1.5 in) of hot-mixed asphalt in 1965, resealed in 1973, and overlaid again in 1976. The road carries heavy traffic and is in excellent condition.

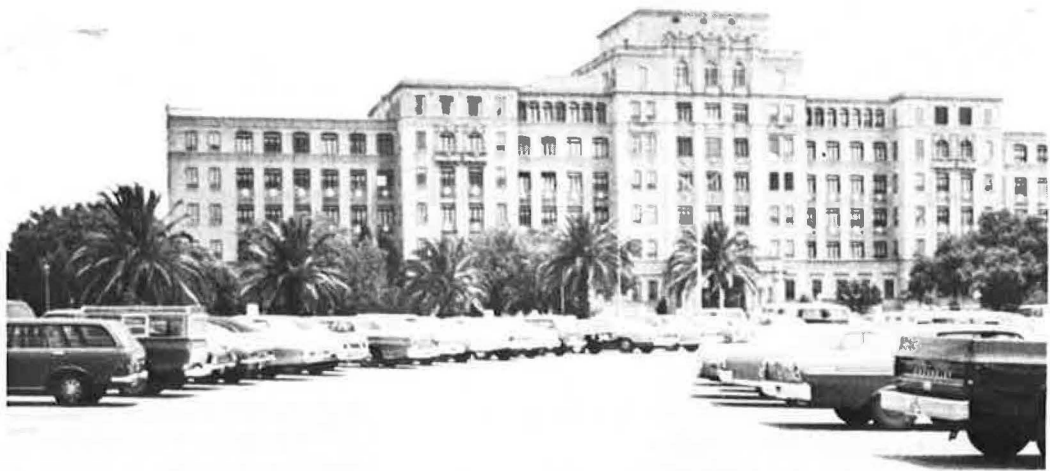
2 Fort Sam Houston, Texas, home of the Army Materials Laboratory where design recommendations for army roads and streets were prepared.

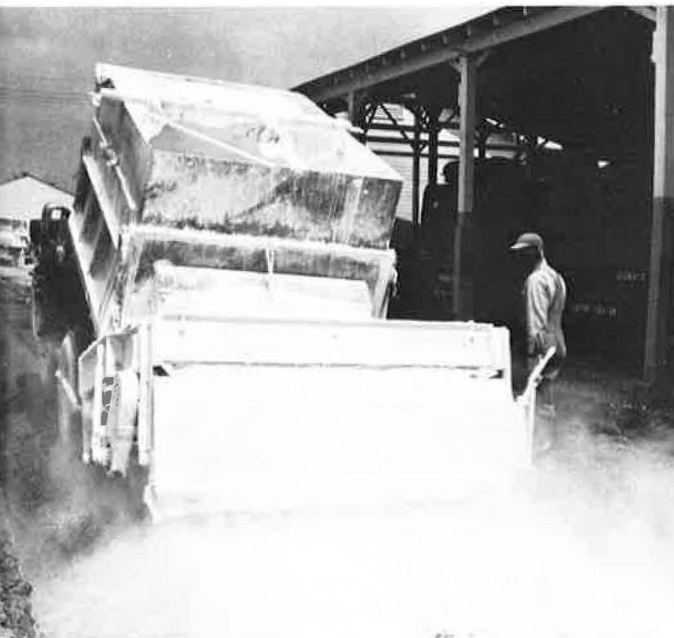
3 Spreading lime on a street at Fort Polk, Louisiana, in 1951, before mixing it into the base.
