Durability of Steel-Formed and Sealed Bridge Decks

P. D. Cady, Department of Civil Engineering, Pennsylvania State University
J. B. Renton, New York State Department of Transportation

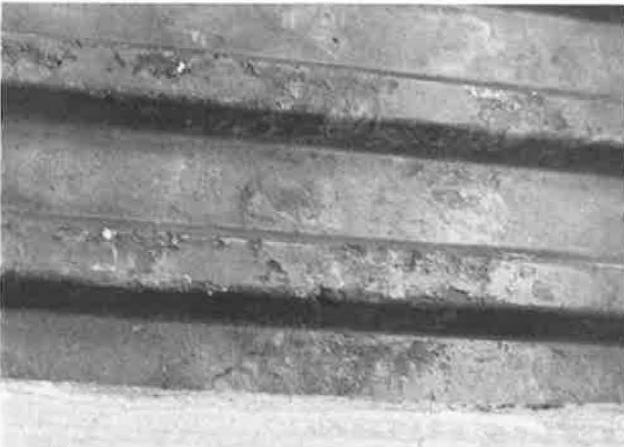
Figure 5. Condition of concrete in form removal area.

The concrete exposed by form removal was found to be in sound and excellent shape, as shown in Figure 5. Only

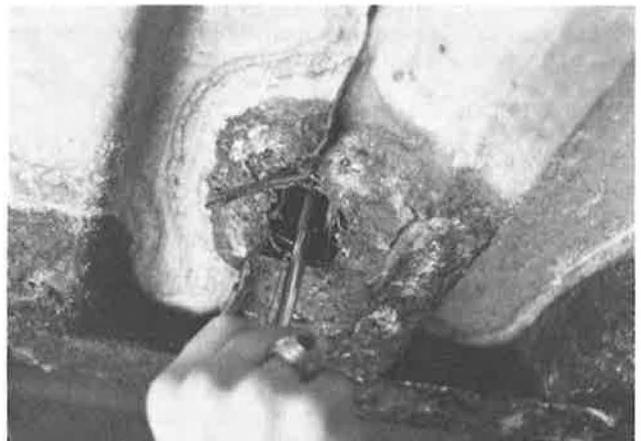
Figure 7. Corroded form and deteriorated concrete at location of foreign material in deck.

Corrosion on the inside of removed sound-form panels was virtually nonexistent. Two of the form panels that were removed displayed a few spots of light rusting, and a third showed evidence of slight corrosion on an area in which sawdust and wood chips had been inadvertently left when the concrete was placed.

one instance of incomplete consolidation of the concrete in the valley portion of the form was observed. In two cases, foreign materials left on the forms at the time of concrete placement were found embedded in the concrete, as shown in Figure 6. An unusual instance of form corrosion and concrete deterioration due to a block of wood left on the form is shown in Figure 7.
