**TRANSPORTATION RESEARCH RECORD 664**

# **Bridge Engineering**

## **Volume 1**

**Proceedings of a conference conducted by the Transportation  
Research Board, September 25-27, 1978**

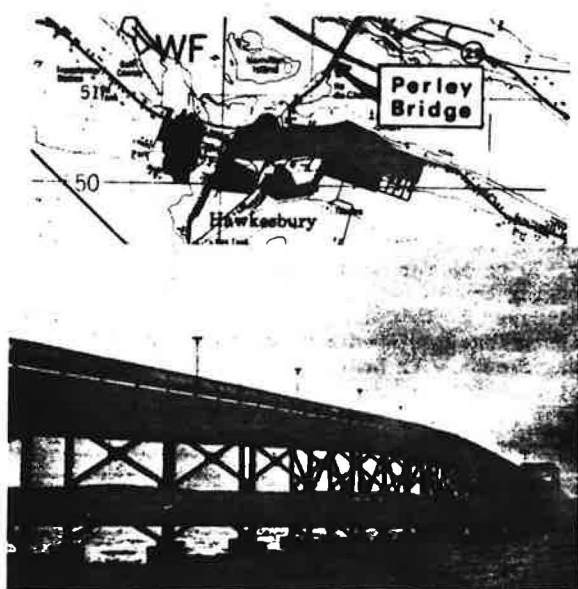
Figure 1a. Perley Bridge.

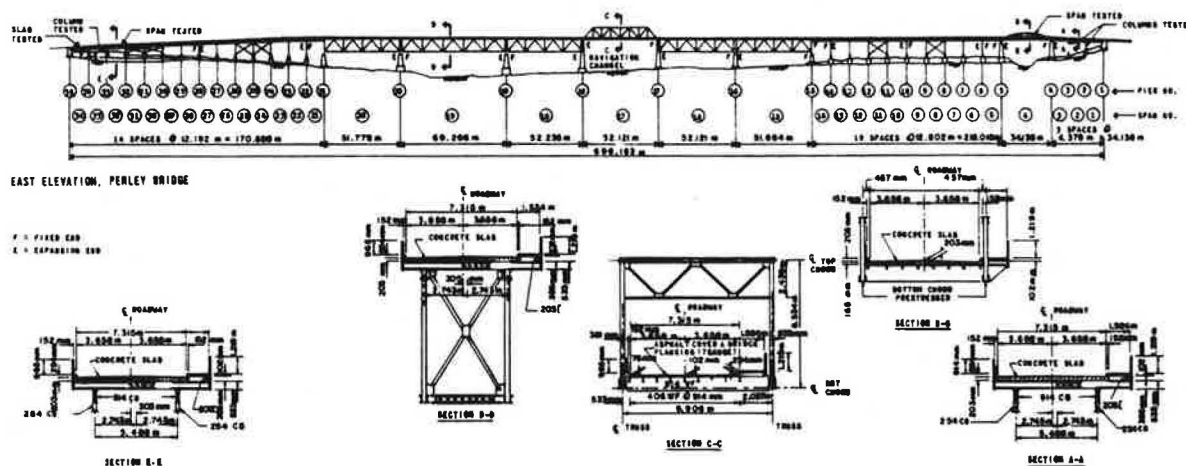
Figure 1b. General arrangement (existing).

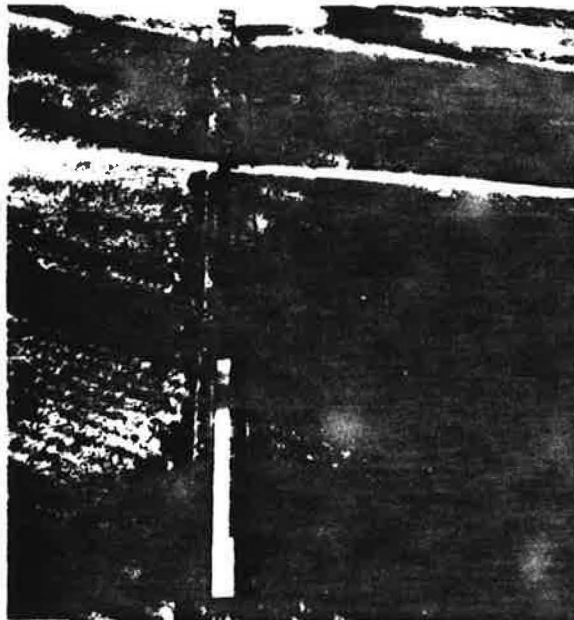
Figure 4e. Spall areas (underside of the deck)
