# Crash Testing of Nuclear Fuel Shipping Containers

Robert M. Jefferson and H. Richard Yoshimura, Sandia Laboratories, Albuquerque

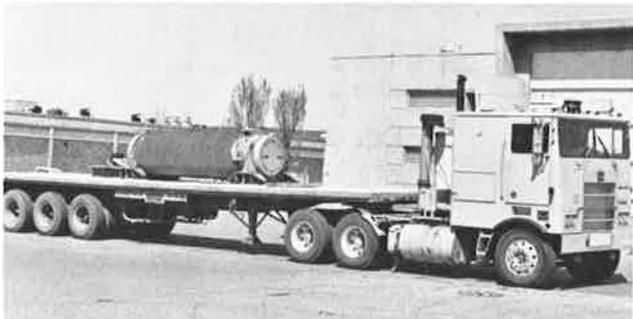
Figure 4. 15 x 140 cask used in grade-crossing test.

For the grade-crossing test, a 23-Mg cask, complete with trailer and tiedown structure, was obtained. The cask, similar in construction to the cask used in head-on barrier tests, was mounted on the trailer by a band tiedown system, as shown in Figure 4. A tandem-axle, gasoline-powered tractor supported the cask and trailer during the test.

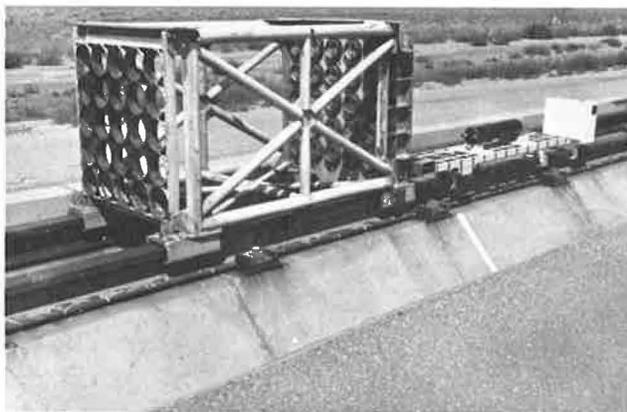
Figure 7. Cask transport model.

A  $\frac{1}{8}$ -scale model of the cask transport system shown in Figure 7 was tested at our rocket sled track facility. To assess damage to the cask structure, an adequate model (excluding fins) of the cask and impact limiter was constructed. The tractor-trailer model was designed with emphasis on the major masses and structural elements. Only those elements expected to contribute

significantly to the cask dynamics were included. The model, therefore, simulated the major dynamics and resultant damage expected in the full-scale test.

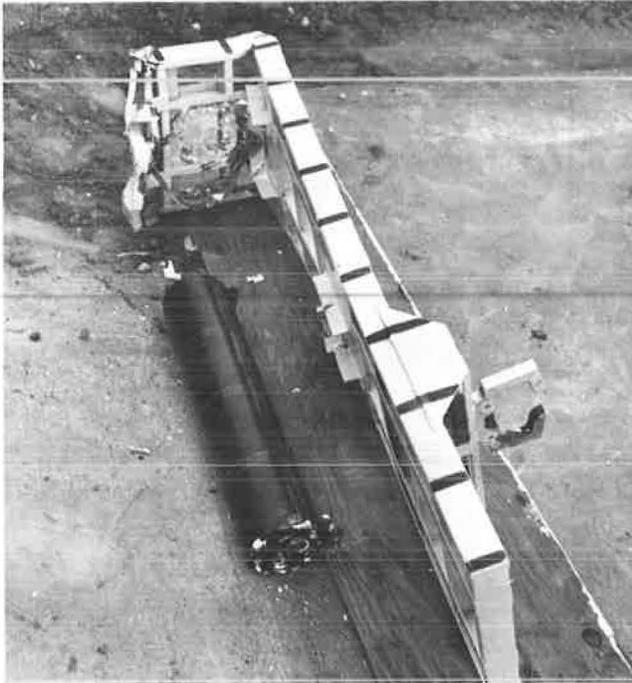
Figure 8. Posttest damage—scale-model test.

Using a rocket, the model transport system was propelled into a scaled concrete wall at 97 km/h. A posttest view of the damage is shown in Figure 8. Scale-model results agreed closely with analytical predictions. High-speed data films showed that the transport and cask system response closely followed that predicted in the case where the tiedown did not fail. The impact limiter was partially crushed, and the cask was undamaged, except for minor deformations around the tiedown attachment points.

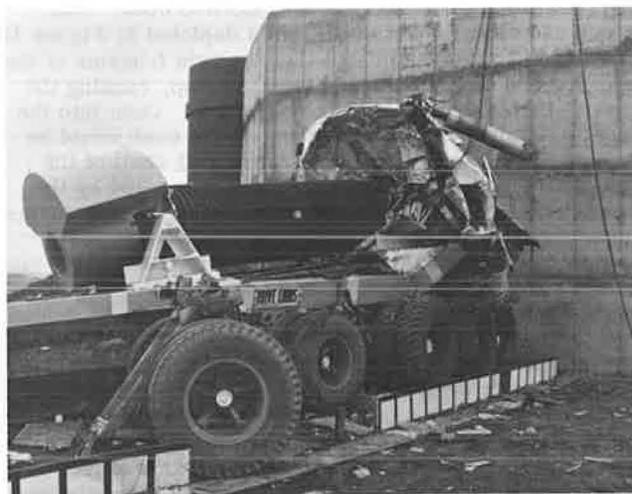
Figure 13. Posttest view—130-km/h truck test.

Figure 13 shows the condition of the cask and transport system after the second test. After removal of the cask from the trailer, seepage at a rate of about 2 drops/min was detected from the cask head. The seepage later stopped after release of about 100 cc of fluid. Inspection of the cask revealed that the head was peened onto the cask and that the front of the cask had bulged. Several dents found on the surface of the cask head (Figure 14) were caused by the impact of the trailer fifth-wheel pin, which was forced in front of the cask by buckling of the trailer. Slight bending of the front portion of the cask occurred due to nonsymmetric impact conditions. As predicted, the front portion of

the cask was permanently deformed (bulged). Rigid body accelerations measured on the cask were about 70 g's (11). The cask head was removed with great difficulty. Inspection of the fuel assembly revealed deformation of the impact end. Some fuel-pin buckling occurred; however, no clad failure was detected.

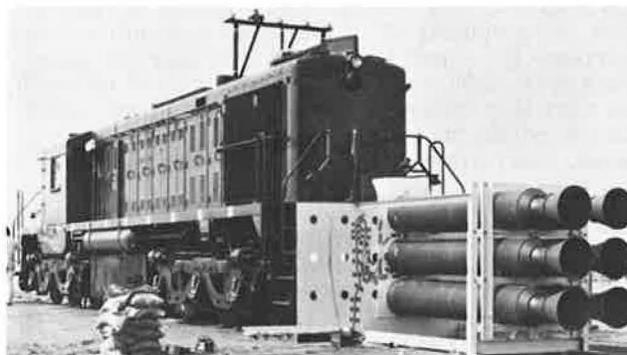
Figure 19. Rocket-powered locomotive—full-scale grade-crossing test.

the 109-Mg locomotive to test speed (Figure 19), after which it coasted to an impact at 131 km/h. As predicted by pretest analysis and scale-model test results, the frame of the locomotive was crippled and formed a ramp, which allowed the cask to rise into the superstructure (Figure 20). As shown in Figure 21, failure of the locomotive frame closely resembled that in the model test. After superstructure crush up, the cask rolled to the right side of the locomotive, tumbled in the dirt, and came to rest between the rails. Posttest inspection of the cask indicated that the deformation behavior of the cask was very similar to that of the scale model. Two 26-mm depressions, which were caused by the impact with the I-beam members of the frame, were left on the surface of the cask. Leak testing of the cask after impact indicated a small leak in the head seal when the cask was pressurized. This leakage, had the cask contained water, would have caused essentially no risk to the public. The cask head was removed without difficulty and the fuel assembly was found to be intact. There was some bowing of the fuel pins; however, no clad failure was detected.
