# Evaluation of Patching in Continuously Reinforced Concrete Pavements

Darrell J. Maxey and Michael I. Darter, Department of Civil Engineering, University of Illinois at Urbana-Champaign  
Scott A. Smiley, Brown and Root, Inc., Houston, Texas

An evaluation of concrete patching in continuously reinforced concrete pavements (CRCP) located in Illinois was made. Problems in designing and constructing permanent concrete patches were identified; the costs of patching were estimated; and the performance of typical patches was evaluated. Illinois has constructed over 4827 two-lane km (3000 miles) of CRCP, major portions of which are displaying increasing occurrence of distress that requires patching. Patches placed in recent years are performing inadequately. A survey of over 800 CRCP patches showed one-fourth requiring replacement and one-fifth requiring an adjoining patch. Constructing a typical 3x3.7-m (10x12-ft) patch is labor intensive, time consuming, and expensive. Between six and eight people can only place a patch a day at a cost of \$1000-1600. The poor performance of many patches can be attributed to inadequate design specifications and poor construction techniques. The inform

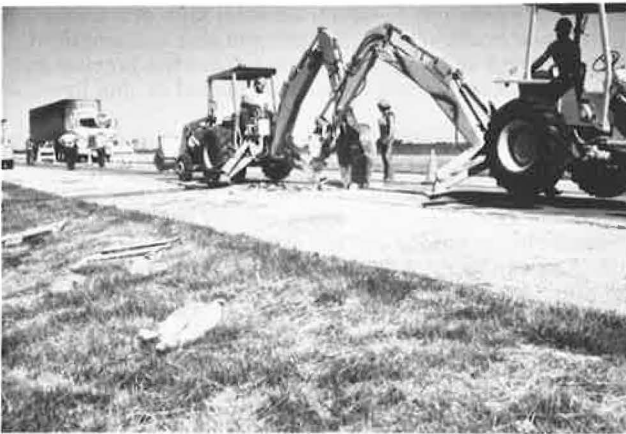
Figure 8. Hydrahammer breakout and mechanized pavement removal operation.

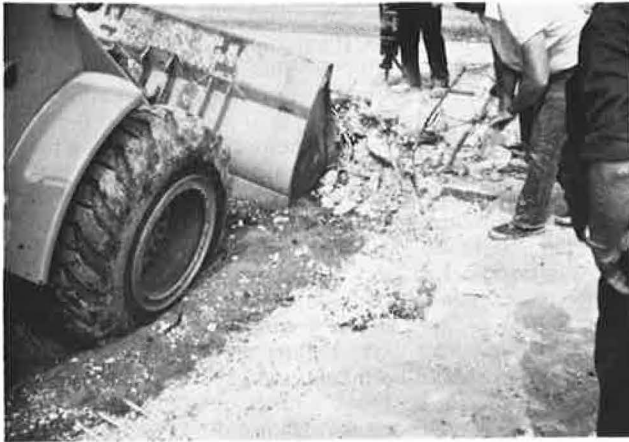
Figure 12. Equipment damage to subbase and subgrade.

After the distressed concrete has been removed, the maintenance crew can examine the subbase and determine its condition. In many instances, the subbase will be saturated and badly disintegrated (Figure 12). The generally poor condition of the subbase can be expected whenever a patch is planned for an edge punch-out or wide crack or when lane settlement suggested by faulting along the centerline between lanes exists. This is because the initiating factor in these two distresses and several others may be a localized loss of support. This loss of support can be caused by (a) a weak subgrade underneath the subbase, (b) accumulation of water in the subbase and subgrade, and (c) disintegration of the stabilized subbase and localized pumping of the stabilized granular subbase. Much foundation support is lost by allowing the distressed area to deteriorate and spread to a large area.
