Heavy-Vehicle Tests of Tubular Thrie-Beam Retrofit Bridge Railing

C.E. KIMBALL, JR., M.E. BRONSTAD, AND J.D. MICHIE

A retrofit modification has been developed for a current concrete parapet design that has a narrow walkway configuration to improve its safety performance with impacting vehicles. The retrofit was originally developed for and tested with subcompact and standard-sized automobiles; the successful results indicated that the design might also perform with heavier vehicles that weigh up to 40 000 lb (18 144 kg). An earlier paper covered the automobile tests performed with the original retrofit system. Reported here are findings from six vehicle crash tests performed with the retrofit system—four tests with the original design and two tests with a modified design necessitated when vehicle rollovers occurred during the test series. The modified retrofit system successfully redirected a 40 000-lb intercity bus that impacted at 56.3 mph (90.6 km/h) and a 14.5° angle. In addition, it redirected a minicompact automobile that impacted at 58.1 mph (93.5 km/h) and an 18.8° angle; the vehicle exhibited no tendency to wedge under the higher rail design. Tests were documented by usi

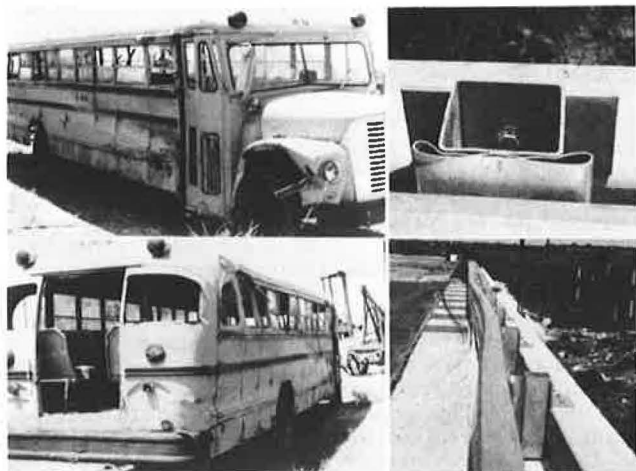
Figure 6. Vehicle and barrier damage, test RF-26.

This was a test at a steeper angle (15°) than that of the original design by using the vehicle from RF-24. Impact conditions were 57.1 mph (91.9 km/h) and a 14.7° angle. As shown in Figure 3 (third row) the school bus initially rolled toward the barrier as the front end was being redirected and continued that roll as the rear section impacted. The result was that the bus rolled on top of the barrier and slid on it until the downstream end was reached. At that point the bus dropped to grade and continued sliding an additional 95 ft (29 m). Figure 6 shows the extensive body damage sustained by the bus in the rollover. It also shows the barrier damage, which included deformation to six collapsing-tube elements, two tubular Thrie-beam rail sections, and one post.

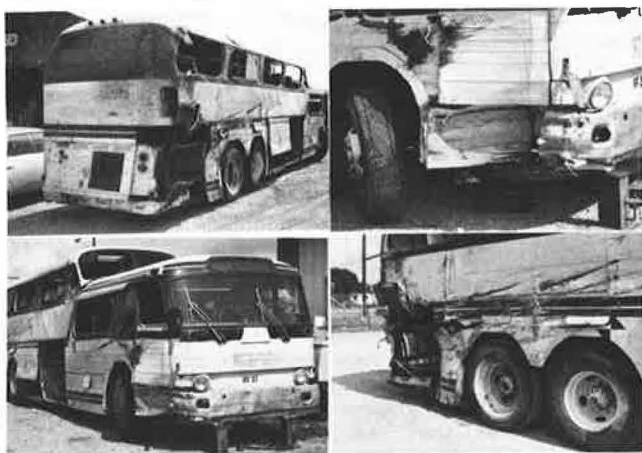
Figure 7. Vehicle damage, test RF-27.

The intercity bus used for RF-25 was reused for this test. Impact conditions were 59.7 mph (96.1 km/h) and a 17.6° angle. As shown in the sequential photographs of Figure 3 (fourth row), results were similar to those of test RF-26; i.e., the vehicle rolled on top of the barrier, slid along it to the end, dropped to grade, and continued sliding an additional 102 ft (33 m). Figures 7 and 8 show the extensive vehicle and barrier damage sustained during the test.

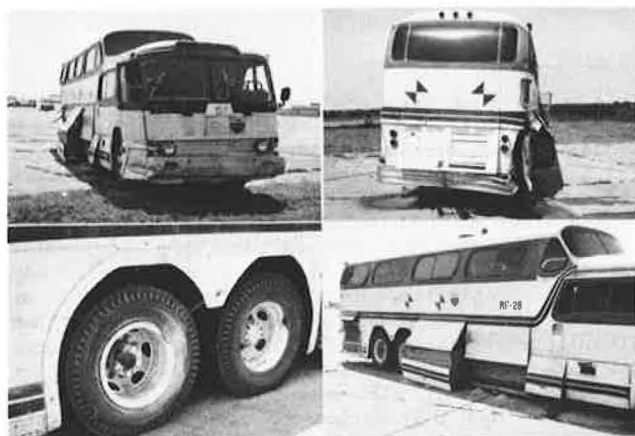
Figure 9. Vehicle damage, test RF-28.

This was the first test of the modified retrofit design. Test conditions were similar to those of RF-27 in which the rollover occurred. As shown in Figure 3 (fifth row) the bus impacted at 56.3 mph (90.6 km/h) and a 14.5° angle and was smoothly redirected after reaching a maximum roll angle of 14° . The bus was only moderately damaged, as shown in Figure 9, and was driven from the test site. Figure 10 shows the damage sustained by the retrofit system and by the concrete parapet.

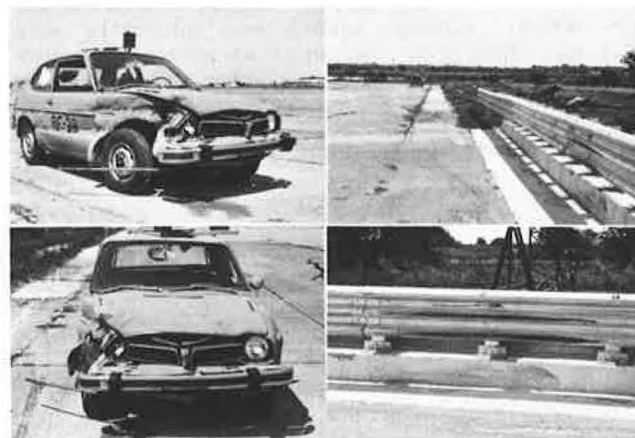
Figure 11. Vehicle and barrier damage, test RF-29.

Since the rail height had been increased to 38 in (965 mm), this test was necessary to ensure that smaller automobiles would not become wedged under the front rail of the system. Impact conditions for the 1840-lb (835-kg) minicompact automobile were 58.1 mph (93.5 km/h) and an 18.8° angle. As shown in Figure 3 (bottom row), the vehicle was smoothly redirected and there was no apparent snagging. Figure 11 shows the sheet-metal damage of the vehicle (confined mostly to the right front fender) and the

rail and curb scuffing sustained by the barrier. The vehicle suspension and drive train were undamaged, and the vehicle was driven from the test site.
