## Field-Performance Comparison of Two Earthwork Reinforcement Systems

JOSEPH B. HANNON, RAYMOND A. FORSYTH, AND JERRY C. CHANG

A field-performance comparison of two different earthwork reinforcement systems constructed on Interstate 5 near Dunsmuir, California, is presented. Two mechanically stabilized embankment (MSE) walls and one reinforced-earth (RE) wall, all of comparable height, were constructed with the same type of backfill material. The MSE state system uses welded steel bar mats for reinforcement as compared with the flat steel strips of the proprietary RE system. All three walls were extensively instrumented. The steel stresses in the MSE bar mats were uniformly low; the maximum was 4 ksi as compared with the variable stress measured along the RE strips (9.3 ksi maximum). Erection times were comparable for both systems. The stress patterns developed in the MSE reinforcement tend to confirm the premise that MSE can be used with low-quality backfill, which would offer a significant economic advantage.

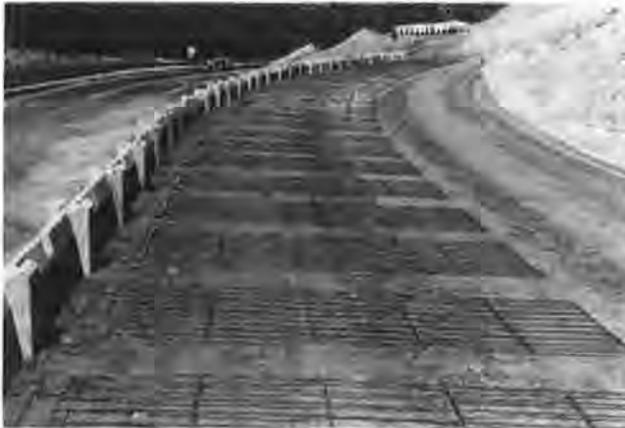
Figure 6. Steel bar mats for MSE in position on fill.

Mats were then placed on the fill (Figure 6), and their threaded rods were inserted through the lower holes in the panels. Two washers and a nut were fastened to the end of each threaded rod, and a waterproofing sealant was pumped through the holes in panels between the washer and the outside wall face. The mats were then pulled back from the wall until the nut on the end forced the washers to rest tightly against the countersunk holes on the outside wall face. Backfill material was placed over the mats and compacted. When the backfill thickness was approximately 12 in over the mats, the nuts on the end of the threaded rods were tightened. The countersunk holes on the outside wall face were filled flush by using a cement grout mixture.

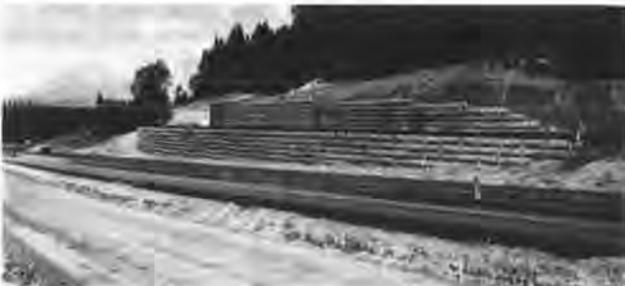
Figure 7. Completed MSE walls.

in 12 days. The completed installation is shown in Figure 7.

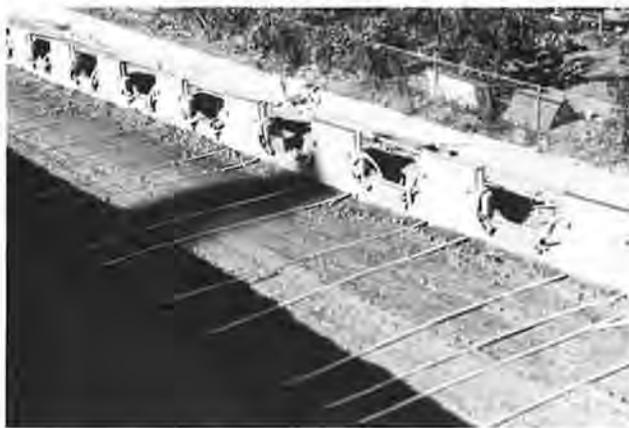
Figure 9. RE face panels held in position by wooden clamps with reinforcing strips attached.

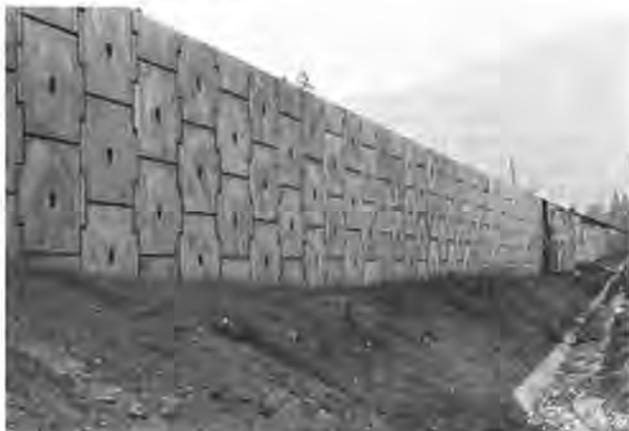
Figure 10. Completed RE wall.

Backfill and permeable materials were transported to the wall site in bottom dumps and compacted with a 12-ton vibratory steel drum roller. Continuous grading and leveling by using a motor grader complemented the compaction operation. A water truck provided additional moisture. Laborers shoveled material larger than 2 in away from the wall face, and compaction along the edge of the wall was achieved by a small hand-operated vibratory steel roller. The completed wall is shown in Figure 10.
