# Slope Stability in the Washington, D.C., Area: Cretaceous Clays

J. SCHNABEL AND F. GREFSHEIM

## Design of Cut Slopes in Overconsolidated Clays

VERNE C. MCGUFFEY

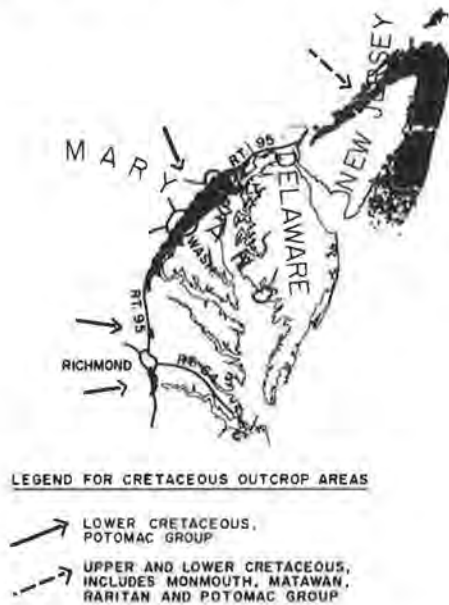
Figure 1. General geology: Cretaceous sediments of Middle Atlantic coastal plain region.

The overconsolidated clays studied here are Cretaceous-age Potomac Group outwash sediments. This is part of the general Middle Atlantic coastal plain deposits extending from the fall line to the edge of the continental shelf. Figure 1 shows this area and the approximate region of the Potomac Group outcrops extending from central Virginia north through New Jersey. These soils have been a noted problem related to slope stability, primarily along the relatively widespread belt of outcrops extending from Baltimore to northern Virginia and particularly in the areas of hilly topography in southeast Washington, D.C., and the easterly part of northern Virginia immediately to the south. The case studies of existing landslides reported here are in the latter areas of hilly topography. According to a recent report by Force and Moncure (4), the Potomac clay of these areas is relatively pure montmorillonite and montmorillonite-illite mixed layer material with a notable proportion of silt. At the

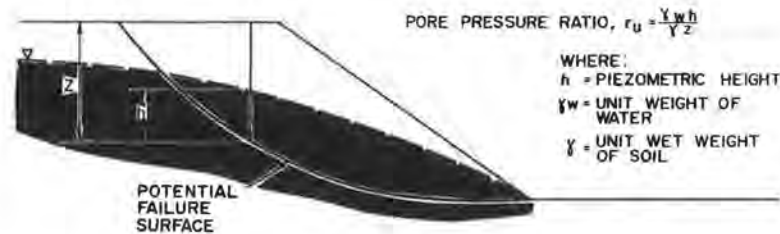
Figure 3. Definition of pore pressure ratio ( $r_u$ ).

For the intermediate groundwater condition, defined as  $r_u = 0.3$ , the term  $r_u$  is the pore pressure ratio. This term is defined in Figure 3. Field observations indicate perched water at least
