Experimental Tire-Anchored Timber Wall

KENNETH A. JACKURA, JOSEPH B. HANNON, AND RAYMOND A. FORSYTH

The design, construction, and first-year performance of an experimental tire-anchored timber retaining wall constructed with salvaged materials are described. The tire-anchored timber wall is an extension of previous research by the California Department of Transportation in which tire sidewalls were used to reinforce embankments. Two walls were constructed in August 1981 on CA-203 at Mammoth Lakes, California. They consisted of used railroad ties for facing supported by embedded tire sidewall and steel tie-back anchor assemblies. Wall heights varied from 3 to 12 ft with a 1.5:1 sloping backfill. One wall was instrumented to monitor stresses in the anchor bars and horizontal and vertical movements of the face. The walls are performing satisfactorily after one winter season that included an earthquake that measured 5.8 Richter local magnitude. No visual damage or increases in anchor bar stress were sustained or recorded even though ground accelerations at the site were estimated to be between 0.2 and 0.3 *g*. The tire anchor walls were constructed at a bid price of \$22/ft² compared

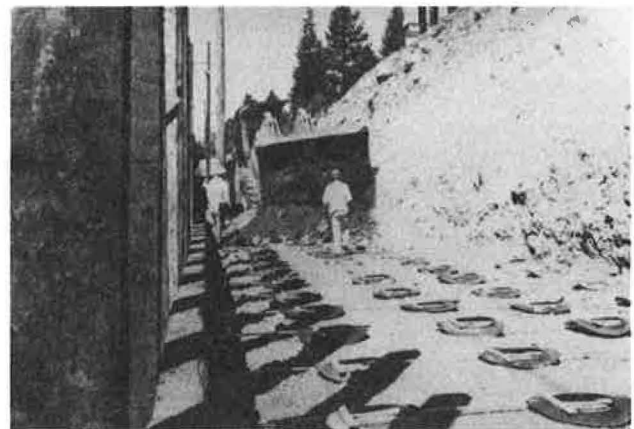
Figure 7. Placement of tire-anchored assemblies.

on 2-ft vertical centers to accommodate the anchor bars. The anchor assemblies were placed on the backfill as it reached each reinforcement level. The threaded ends were inserted through the facing, and a 4x4x0.25-in galvanized steel plate washer and nut was attached. The tire sidewalls were hooked over the cross-arms and pulled tight against it (see Figure 7). Backfill was placed over the anchor assemblies as shown in Figure 8. The rods were then tightened to a specified torque after placement and compaction of 2 ft of soil over each reinforcing level.

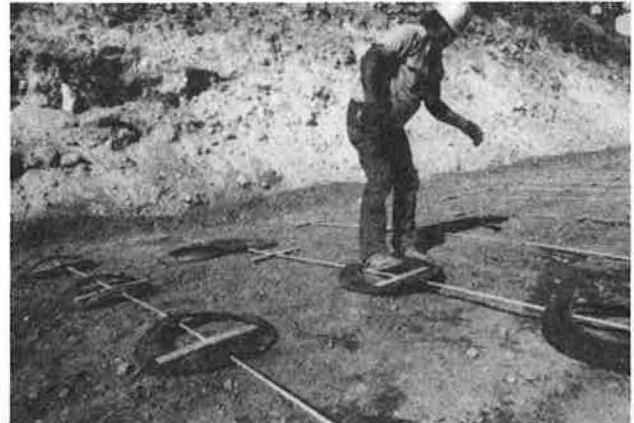
Figure 8. Backfill operation.

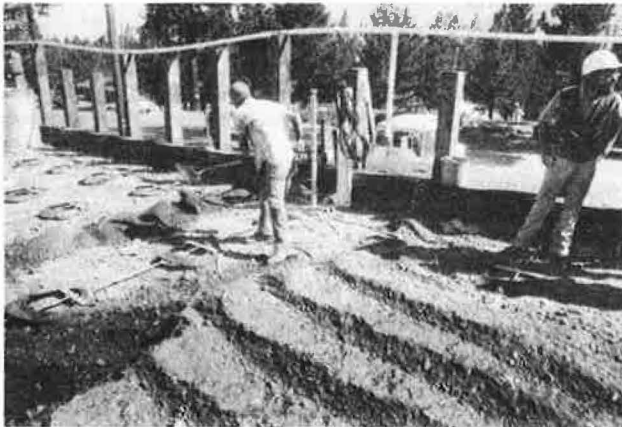
Figure 9. Placement and hand compaction of fill over instrumented tire anchor bar assemblies.

The instrumented anchor assemblies were covered with hand-compacted fill (see Figure 9) before equipment was allowed to pass over the instrumentation area. Figure 10 shows a close-up view of the completed wall. A distant view is shown in Figure 11. Brush layering and straw were placed on the slope above the wall to prevent erosion.

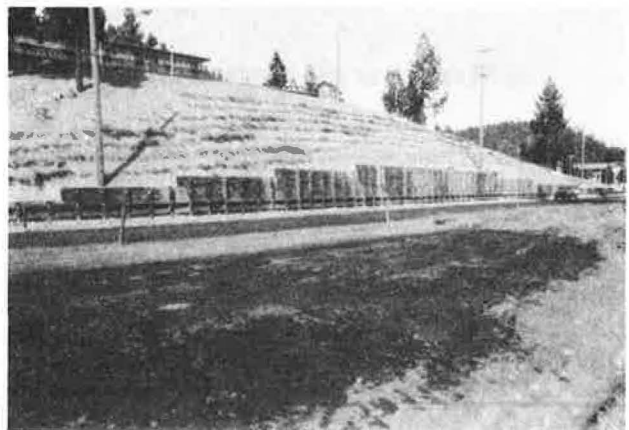
Figure 11. View of completed tire-anchored timber wall and erosion protection on slope.
