## The Obstacle Course: Pedestrians in Highway Work Zones

HIMMAT S. CHADDA AND GEORGE H. BRISBIN, JR.

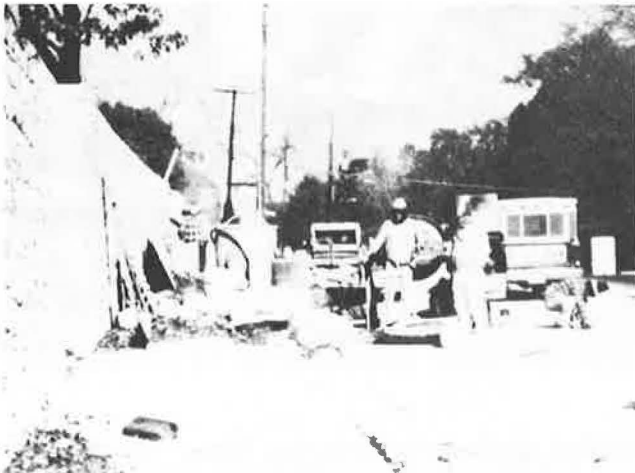
Figure 1. Sidewalk completely blocked by construction material; no pedestrian information or accommodations provided.

Figures 1 through 8 provide evidence of some typical hazards and pedestrian safety problems that result from the lack of (or inadequate) accommodation for pedestrians in work zones. Blocking or closing of existing sidewalk pathways without providing alternate pathways and adequate information endangers the safety of pedestrians in and around work zones. The lack of pedestrian accommodations and guidance forces pedestrians to choose their own paths, walk in traffic lanes, and place themselves in hazardous conditions. Improperly placed traffic-control devices, signs, barriers, and separators create their own hazards and add to the confusion of pedestrians and motorists alike.

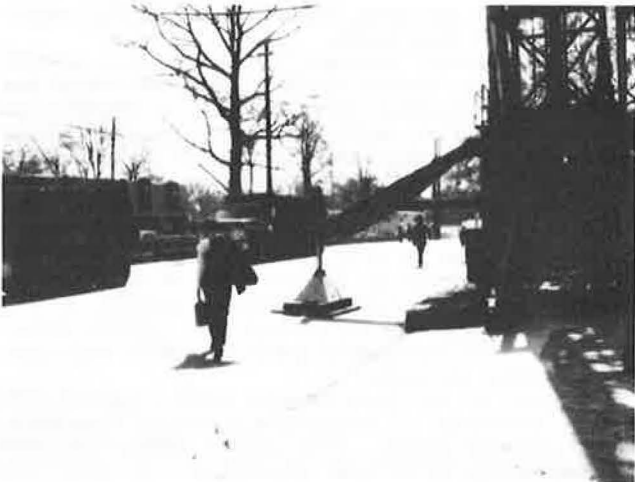
Figure 2. Sidewalk completely blocked by construction equipment; pedestrians forced into traffic lanes.

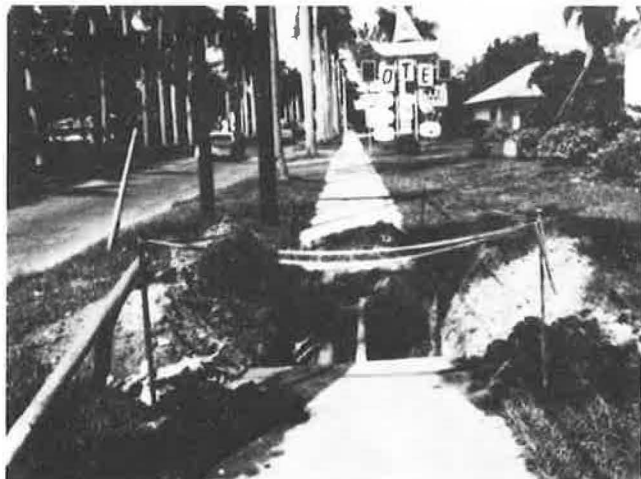
Figure 3. Inadequate protection around utility excavation creates pedestrian safety problem.

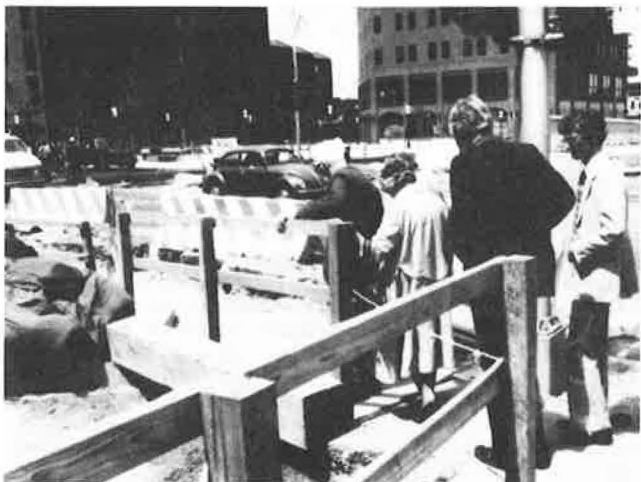
Figure 4. Temporary ramps with steep slopes create unsafe conditions for pedestrians with mobility problems.

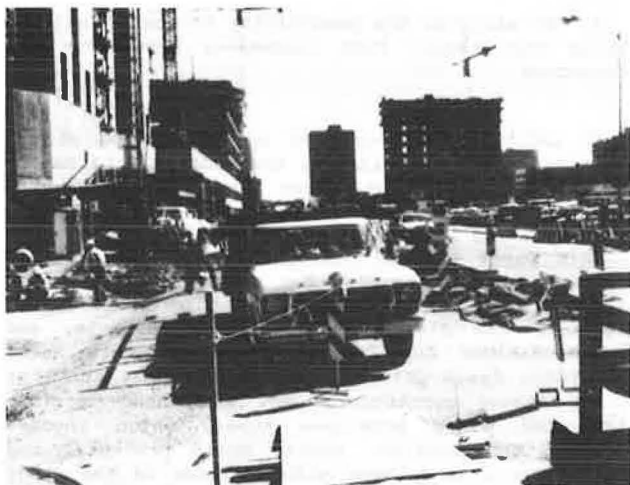
Figure 5. Inadequate delineation of pedestrian pathway and protection results in confusion and discourages use.

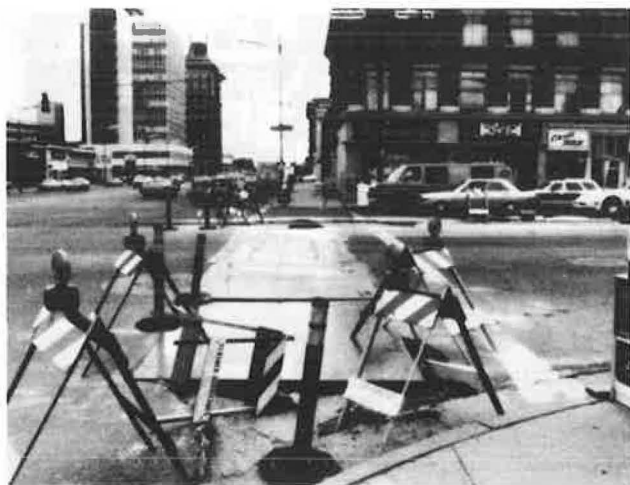
Figure 6. Crosswalk blocked by several devices; no pedestrian information provided.

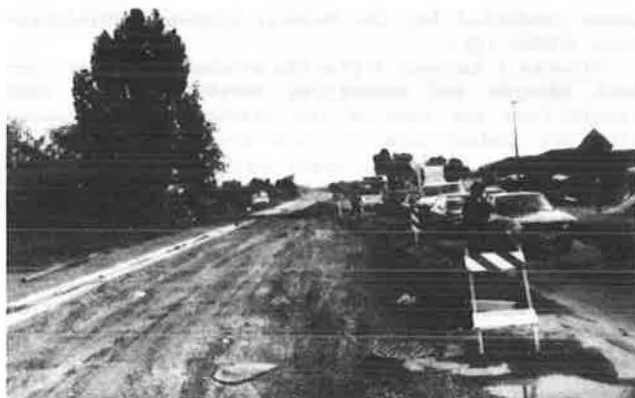
Figure 7. Absence of pedestrian access to abutting properties on highway widening project results in hazardous conditions.

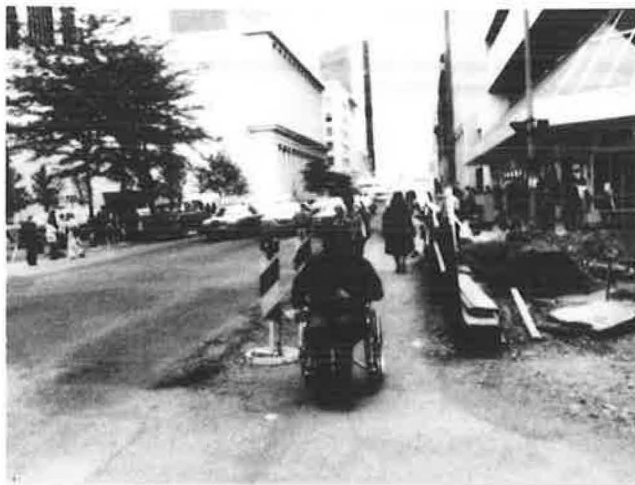
Figure 8. Inadequate separation and protection from vehicles endanger pedestrians' safety.

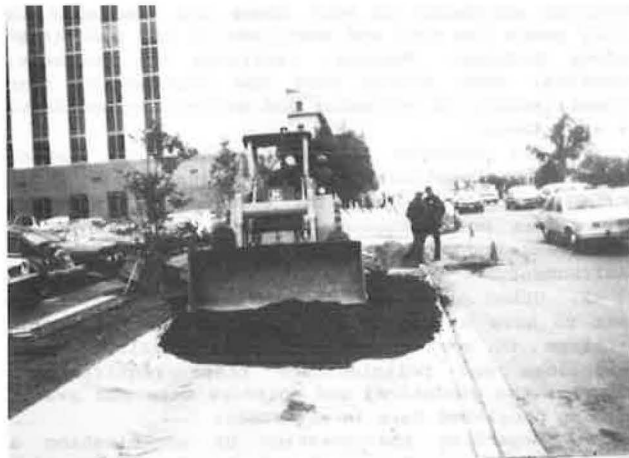
Figure 10. Example of bad pedestrian accommodation; pedestrian needs totally ignored on this side.

vestigations and critiques of as many different types of pedestrian work zones as possible. Field investigations also provided a basis for identification of good and bad practices related to provisions for pedestrian control and safety in work zones. An example of good and bad pedestrian accommodation at the same work zone site is shown in Figures 10 and 11. Adequate guidance, channelization, and bypass away from the work site were provided for pedestrian traffic on one approach (Figure 11), while pedestrian needs were totally ignored on the other approach of the same site (Figure 10).

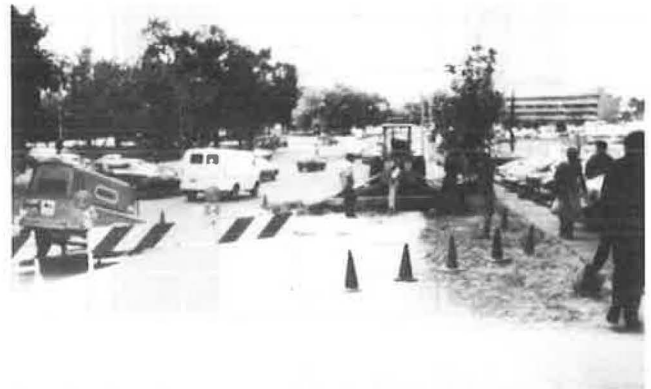
Figure 11. Example of good pedestrian accommodation; adequate pedestrian bypass provided on this side.
