TRANSPORTATION RESEARCH RECORD 916

Engineering Fabrics in Transportation Construction

Treatments for Reduction of Reflective Cracking of Asphalt Overlays On Jointed-Concrete Pavements in Georgia

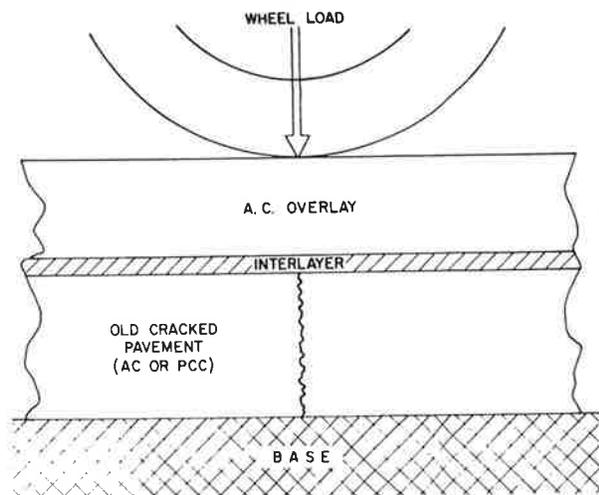
Figure 1. Pavement overlay components.

Reflection cracking develops from movement of the pavement under the overlay (Figure 1). It can be caused by several mechanisms, such as

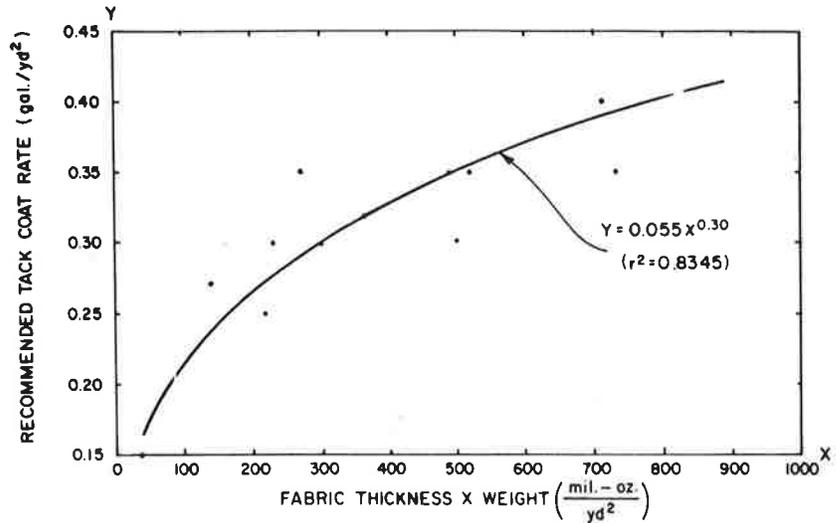
Figure 2. Recommended tack-coat rate versus fabric weight x thickness.

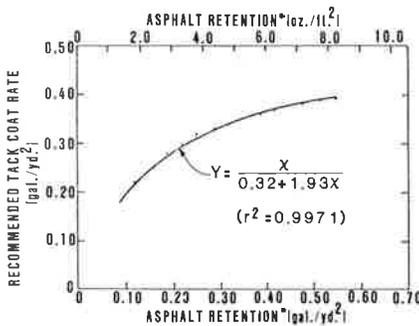
Figure 3. Recommended tack rate versus asphalt retention.

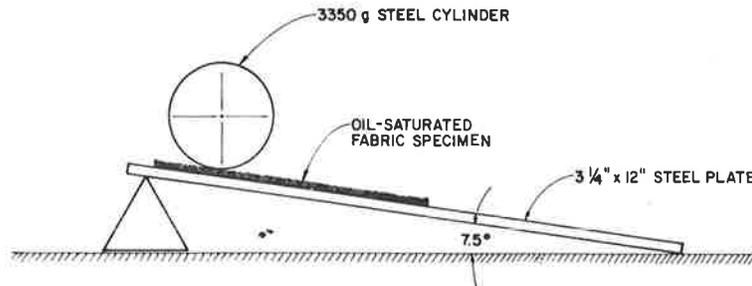
Figure 4. Motor oil retention test setup.

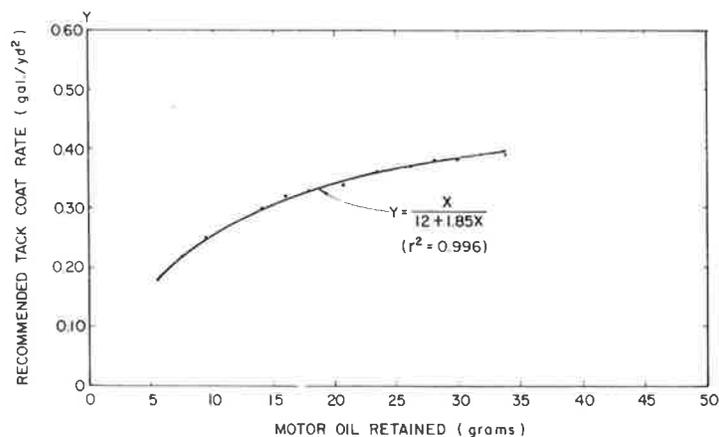
Figure 5. Recommended tack-coat rate versus motor oil retention.

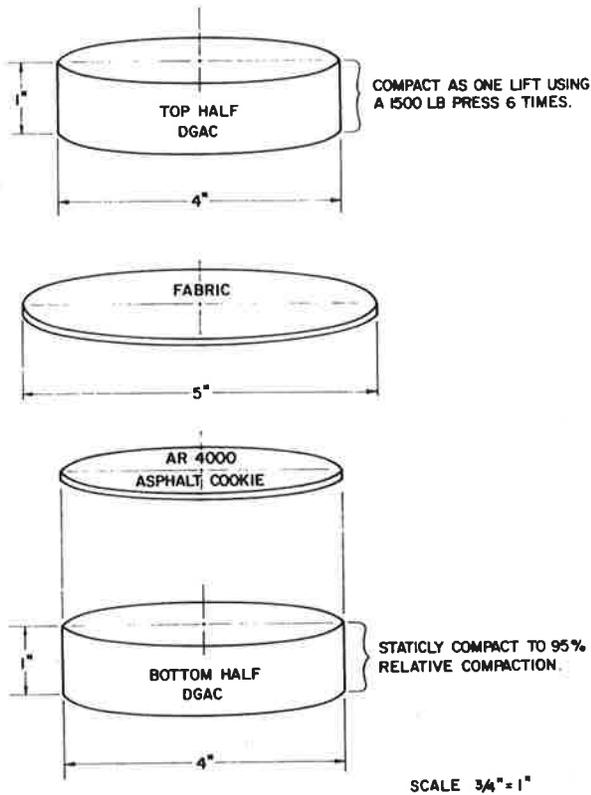
Figure 6. Permeability test specimen.

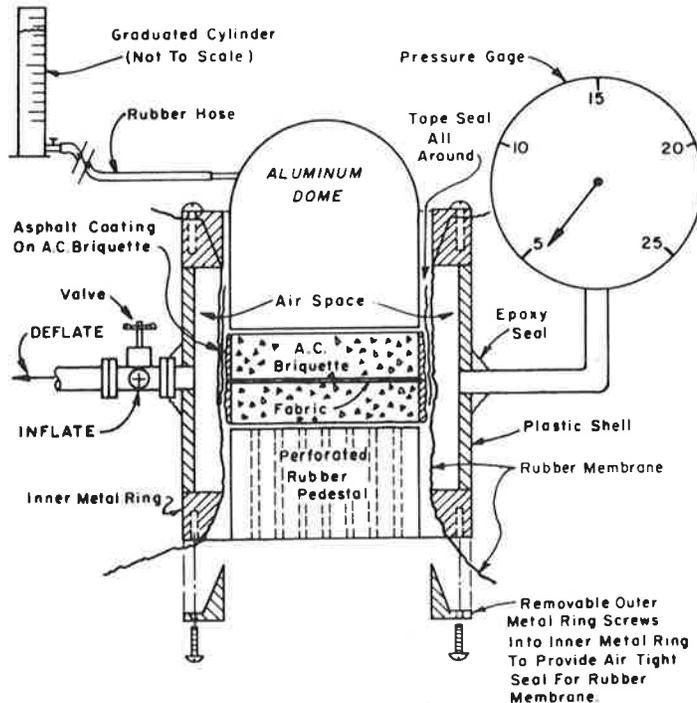
Figure 7. Water permeability apparatus.

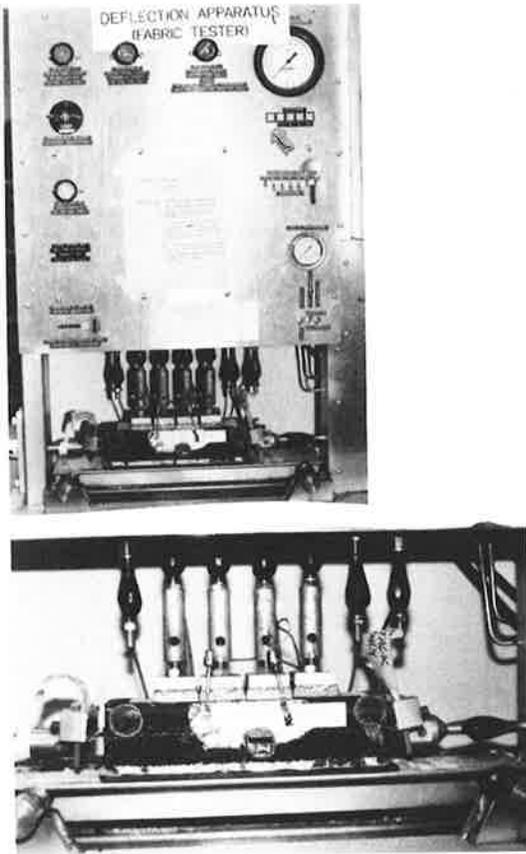
Figure 8. Flexural fatigue machine.

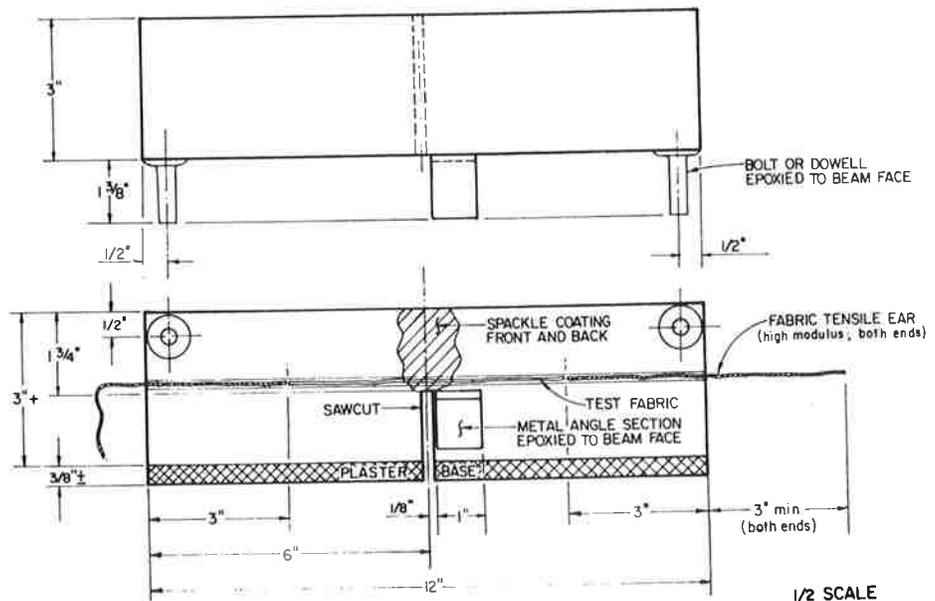
Figure 9. Flexural fatigue beam specimen.

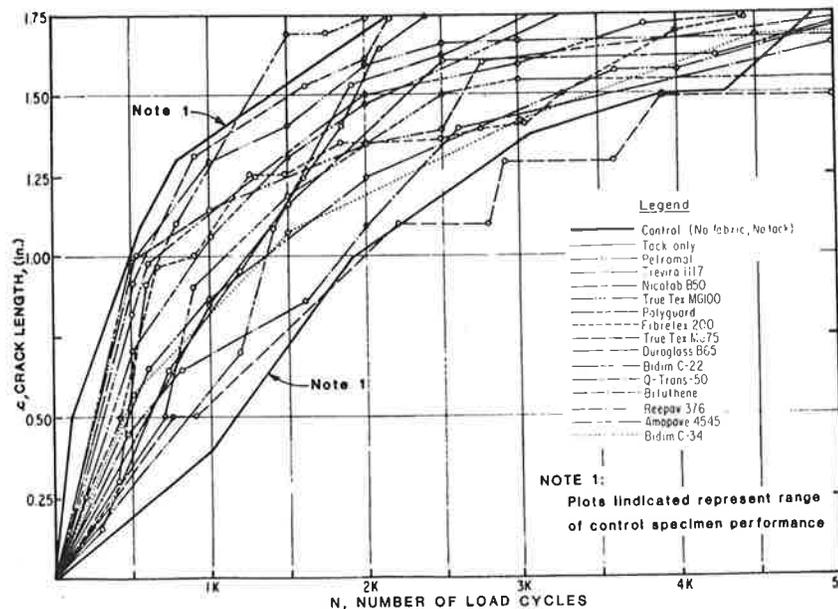
Figure 13. Averaged c versus N curves for each interlayer type.

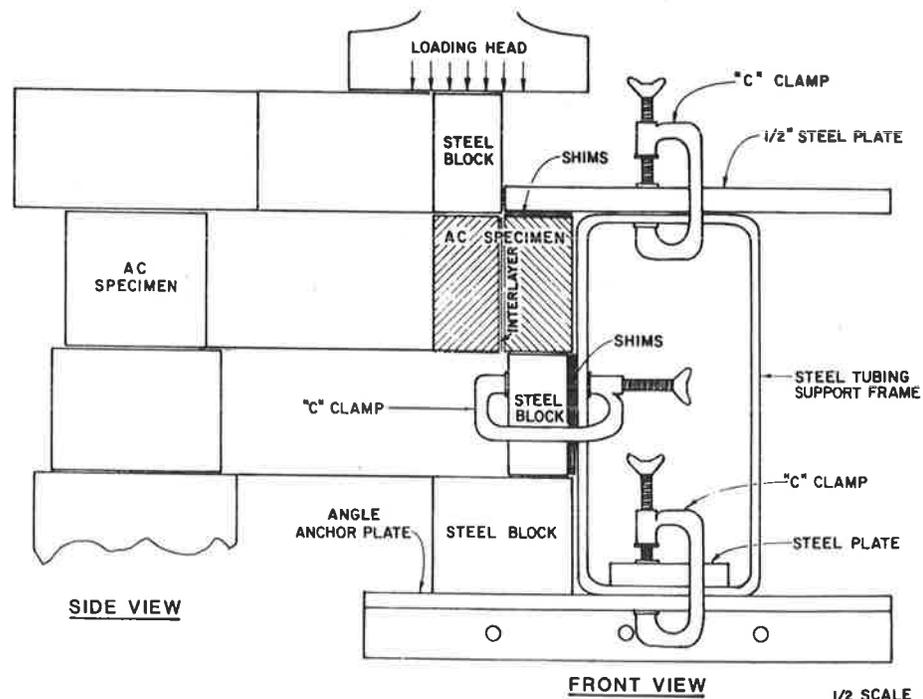
Figure 14. Interlayer shear test setup.

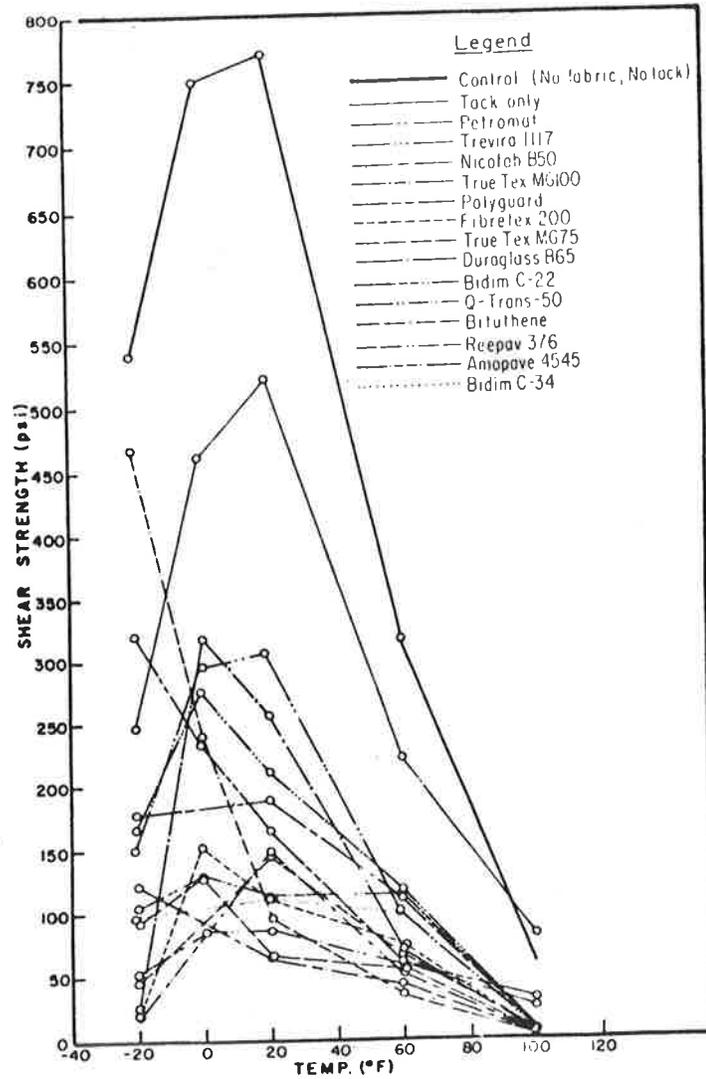
Figure 15. Average interlayer shear strength versus temperature.

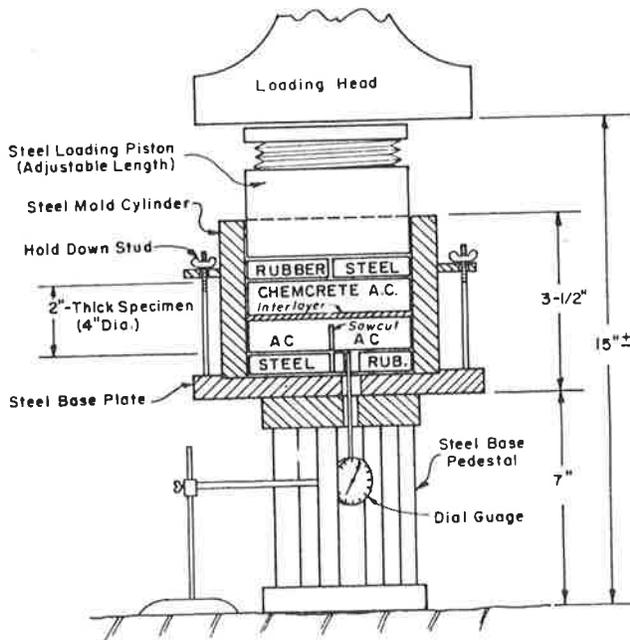
Figure 16. Shear fatigue test setup.

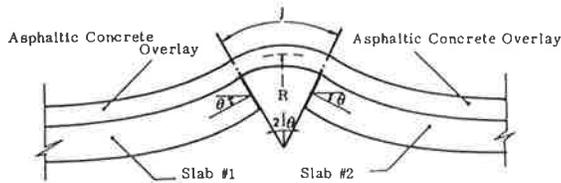
Figure 1. Bending of overlay by joint vertical movement.

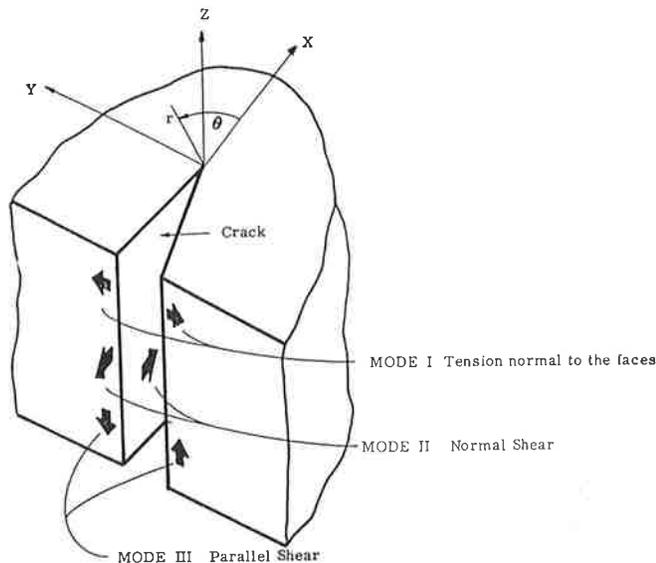
Figure 2. Modes of crack deformation.

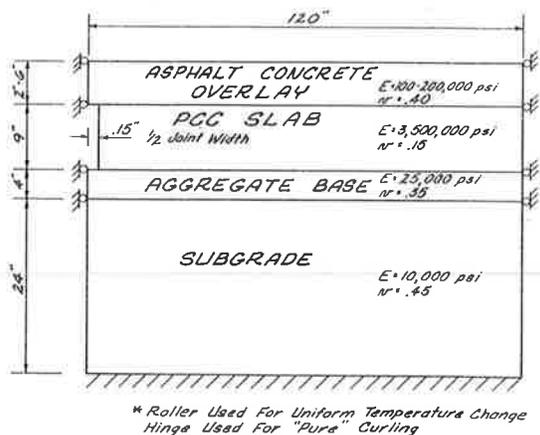
Figure 5. Schematic of two-dimensional finite-element model.

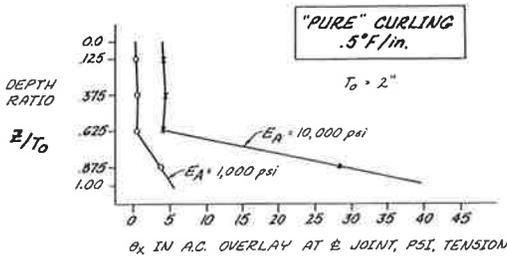
Figure 6. Overlay stress for curling load.

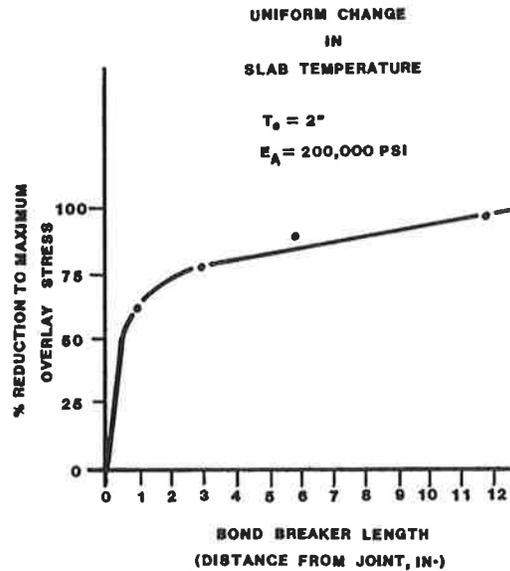
Figure 10. Overlay stress versus bond-breaker length.

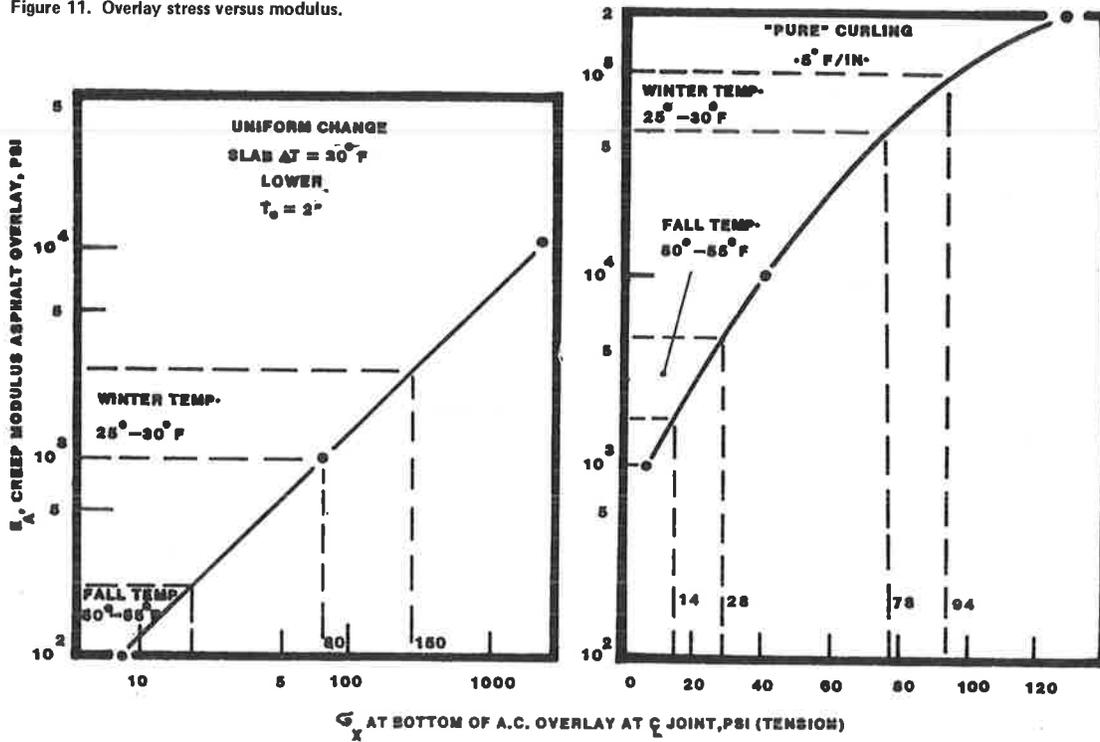
Figure 11. Overlay stress versus modulus.

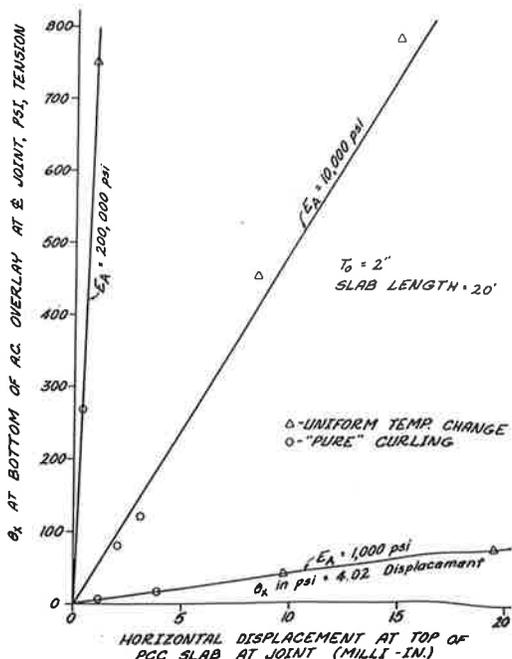
Figure 14. Overlay stress versus joint opening.

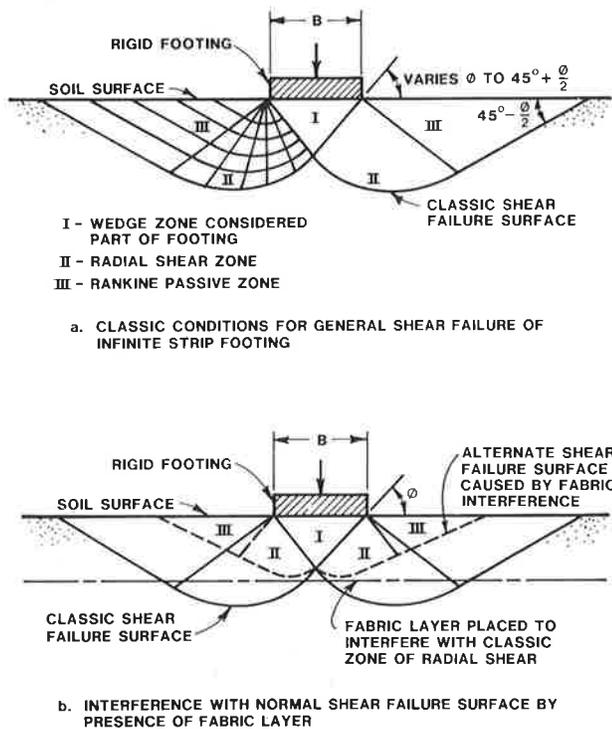
Figure 1. Use of engineering fabric to cause interference with normal soil shear deformation patterns.

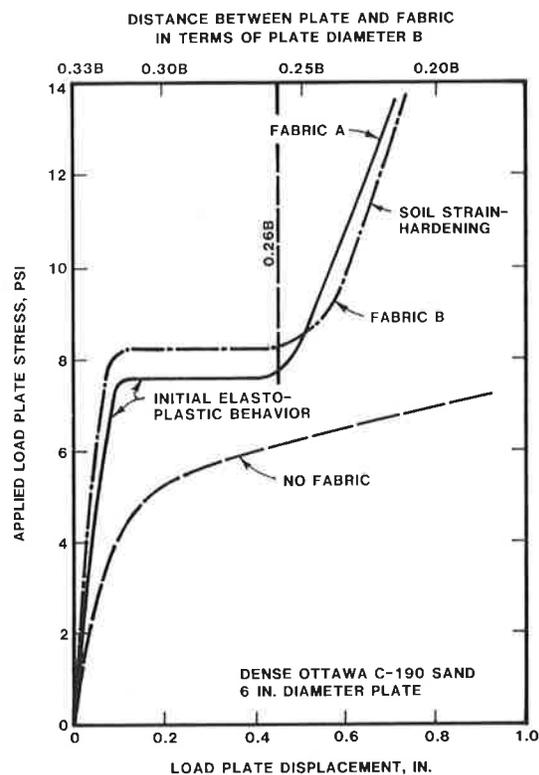
Figure 2. Effect of optimum-depth fabric placement on soil mass load-deformation behavior.

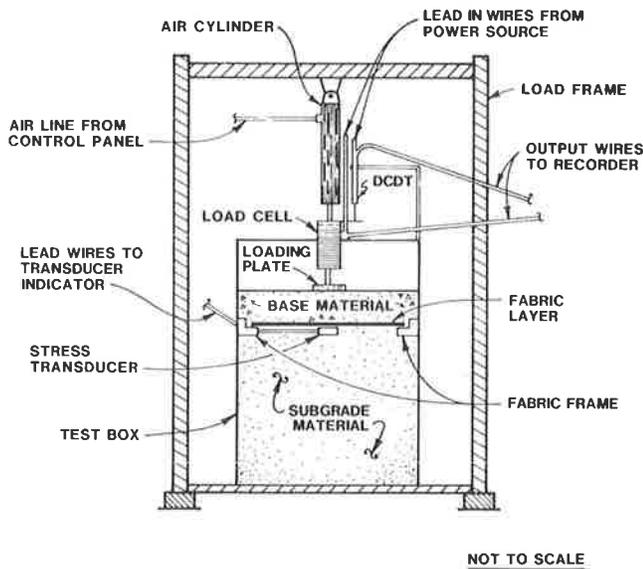
Figure 3. Apparatus used in model subgrade, fabric, and base load testing program.

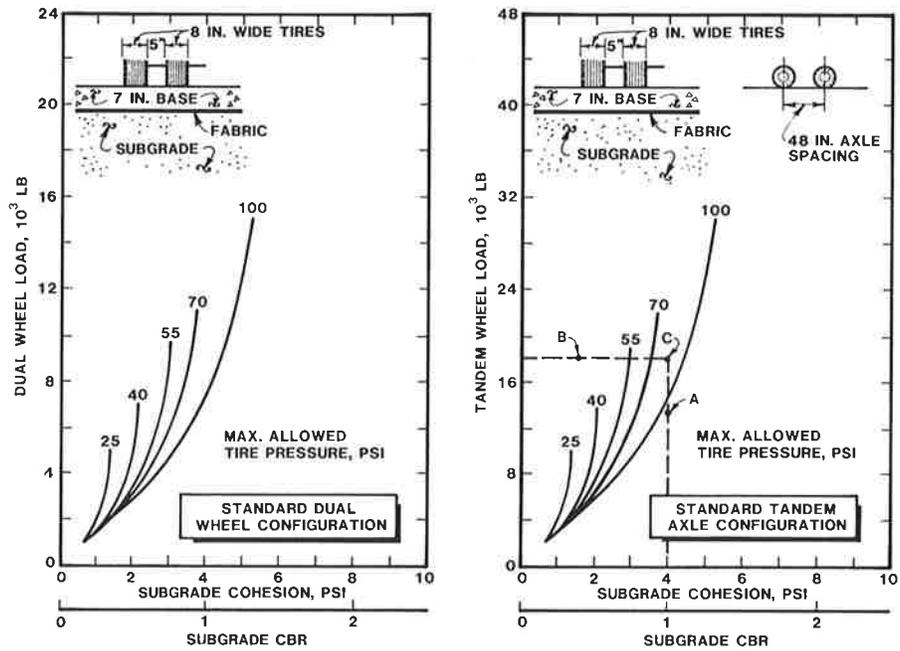
Figure 7. Typical unsurfaced road design curves using optimum-depth concept.

isfactory performance. The required thickness of aggregate cover on the fabric (7 in. of densely compacted cohesionless material) is shown in the upper portions of the figure. Similar curves for other actual or equivalent tire sizes are available elsewhere (4,8), as are data and procedures for fabric cover material selection, road construction procedures, and fabric selection criteria based on site-specific fabric survivability and field workability considerations.

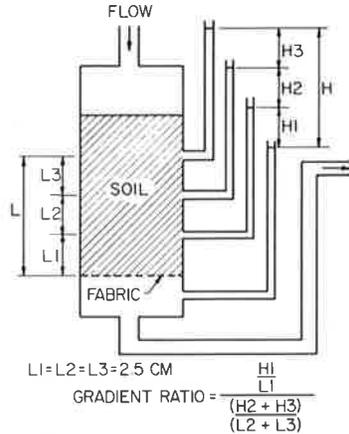
Figure 1. Method of determining Corps of Engineers' gradient ratio with Calhoun-type constant-head apparatus.

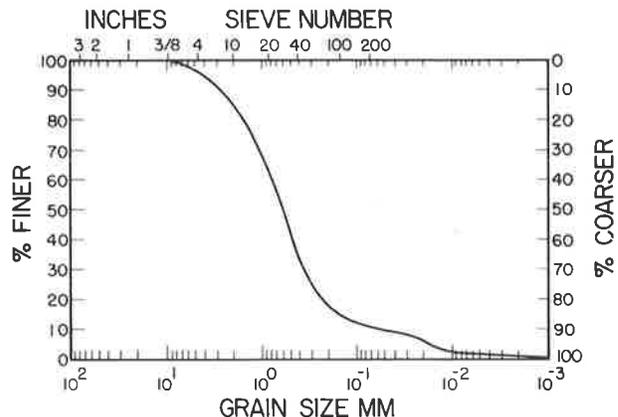
Figure 7. Test soil gradation.

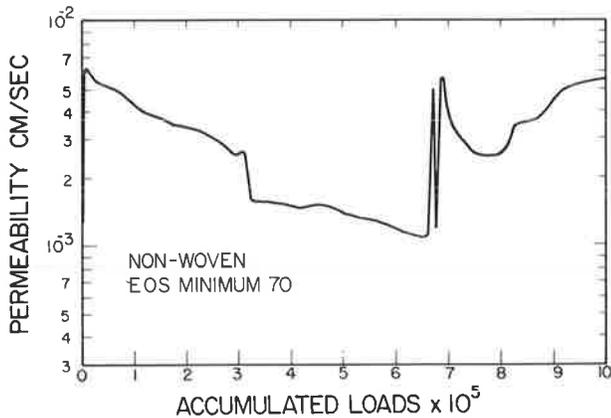
Figure 8. Sample permeability versus accumulated loads.

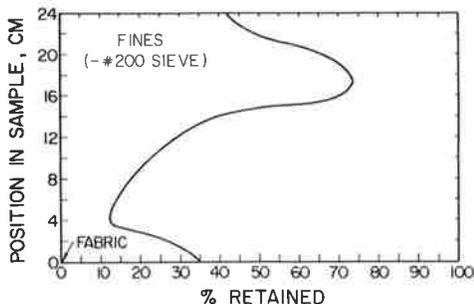
Figure 10. Percentage of fines (smaller than No. 200 sieve) remaining in sample versus position in sample.

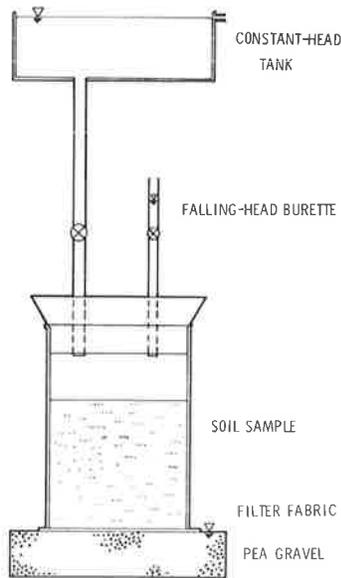
Figure 1. Permeameter used for hydraulic testing.

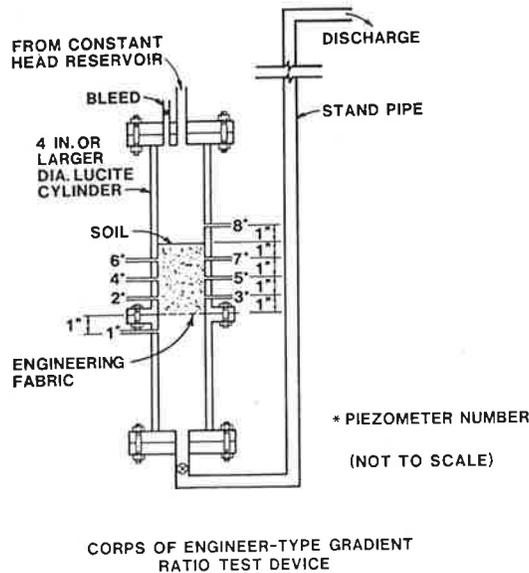
Figure 1. COG constant-head permeameter.

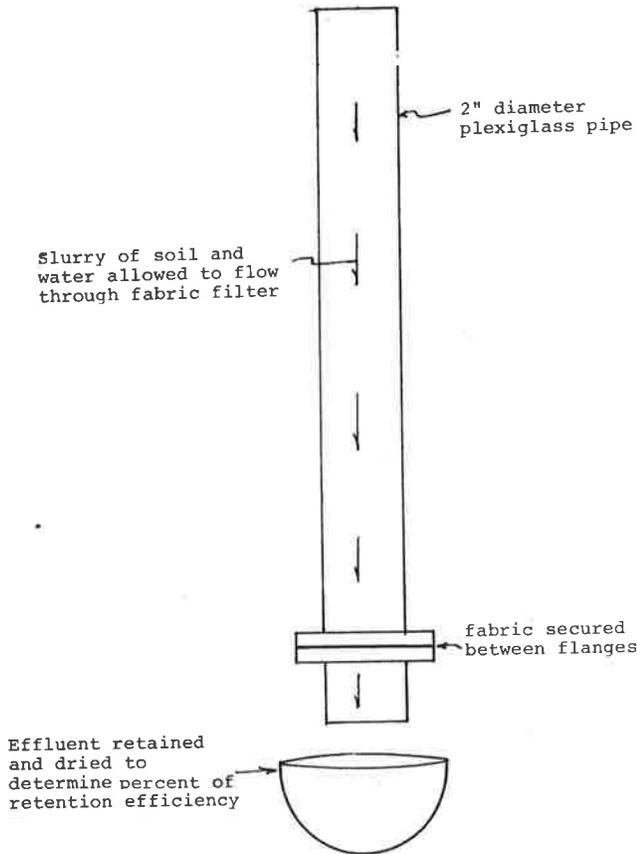
Figure 6. Slurry filtration test apparatus.

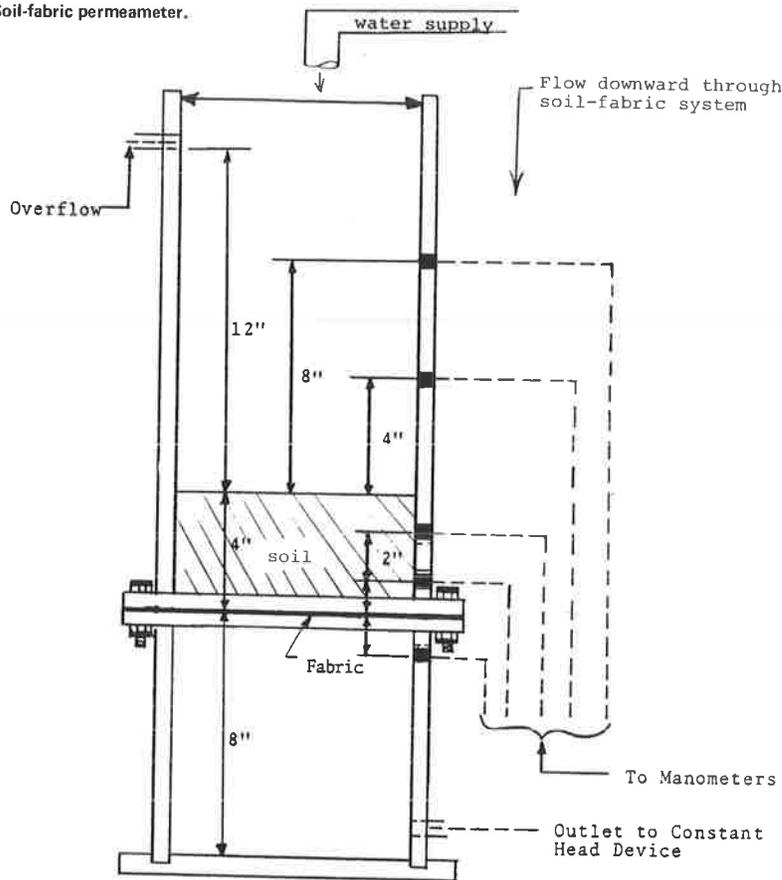
Figure 8. Soil-fabric permeameter.

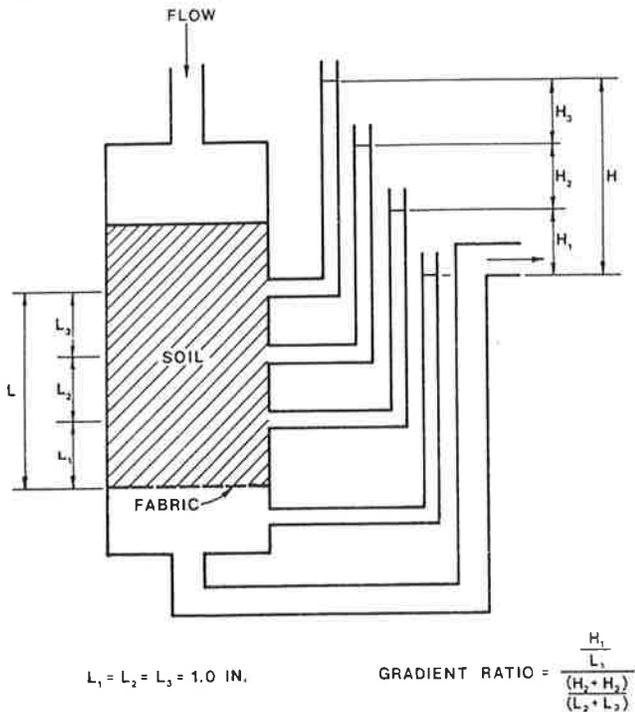
Figure 9. GR permeameter.

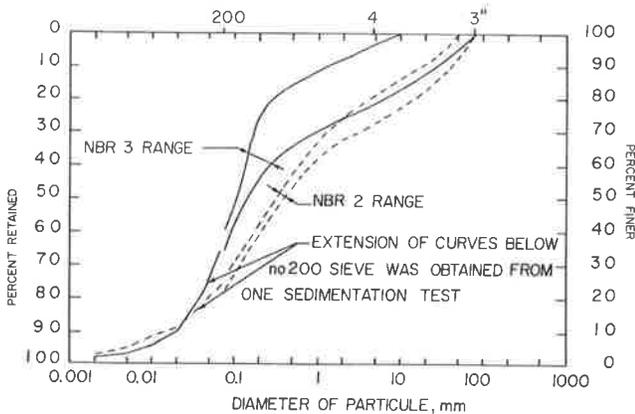
Figure 6. Granulometric ranges of NBR-2 and NBR-3 tills.

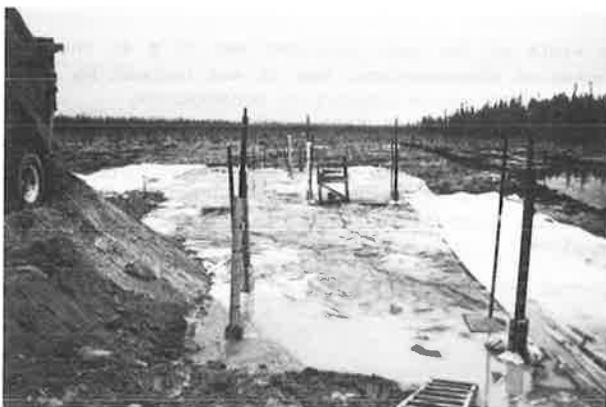
Figure 7. NBR-3 test fill A: type A geotextile as foundation reinforcement and type B geotextile for retaining fill material on slope.

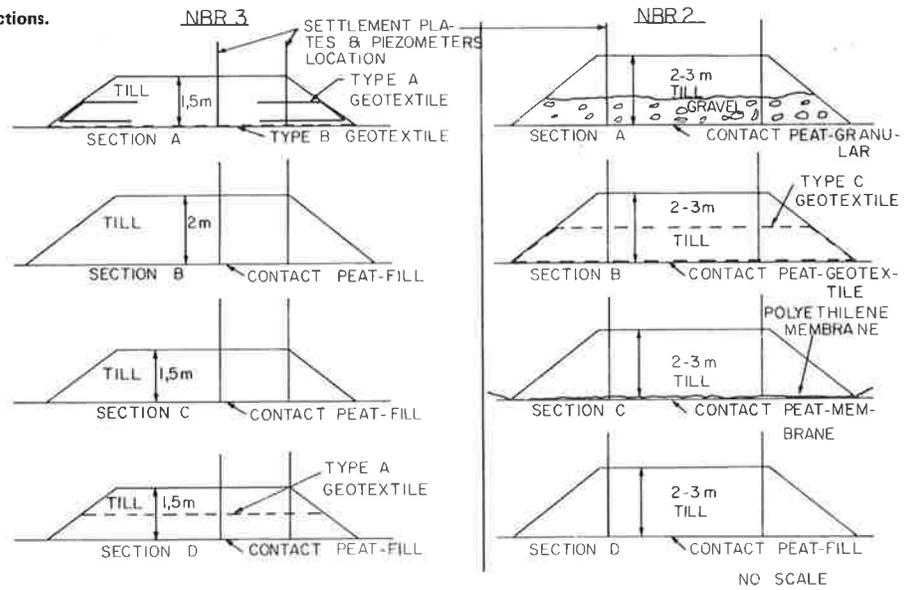
Figure 9. NBR-3 and NBR-2 test fill sections.

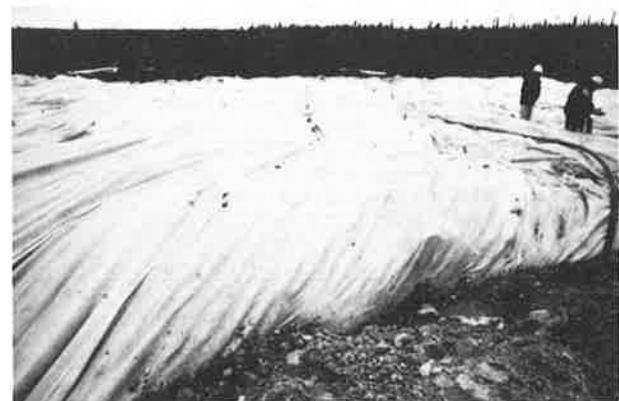
Figure 13. NBR-2, section B: lateral displacement and heave of peat.

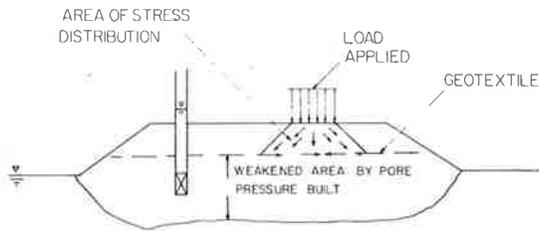
Figure 14. Use of geotextile over a locally weakened fill.

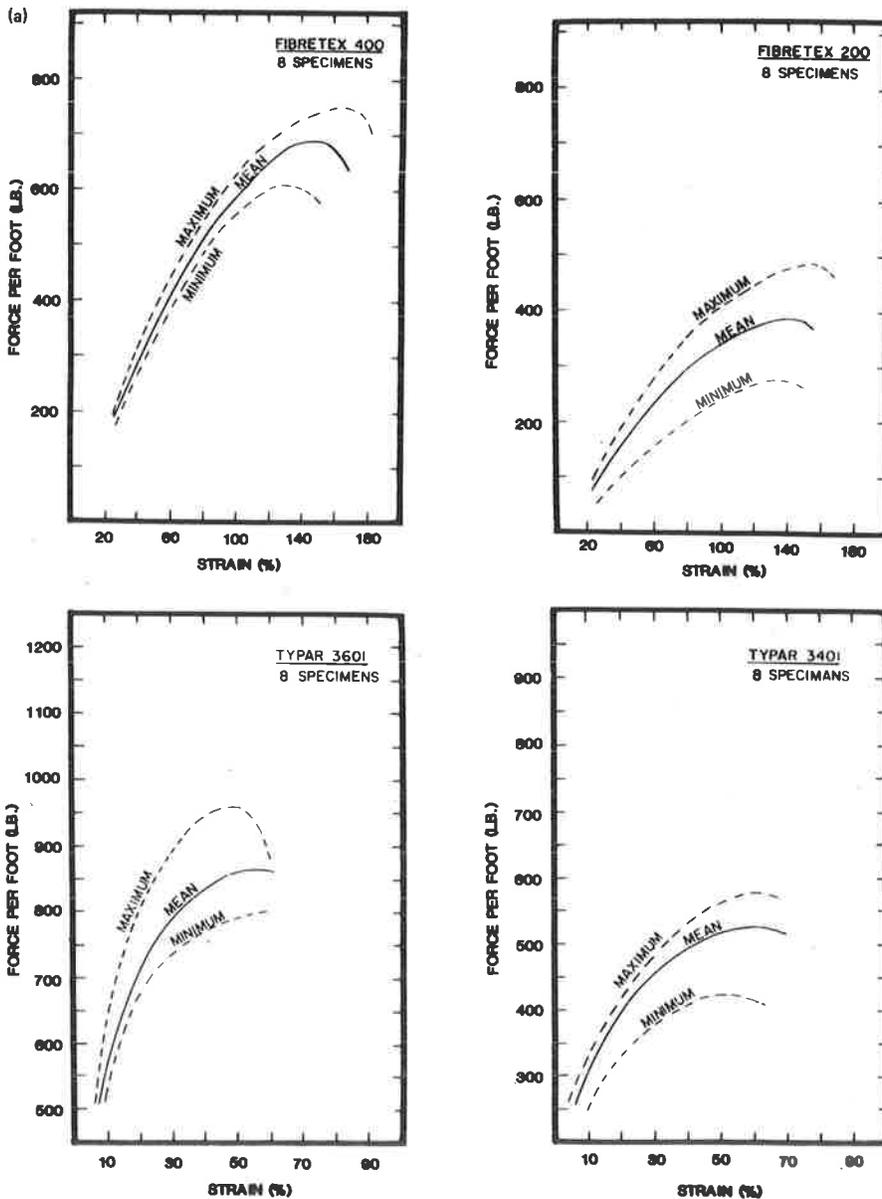
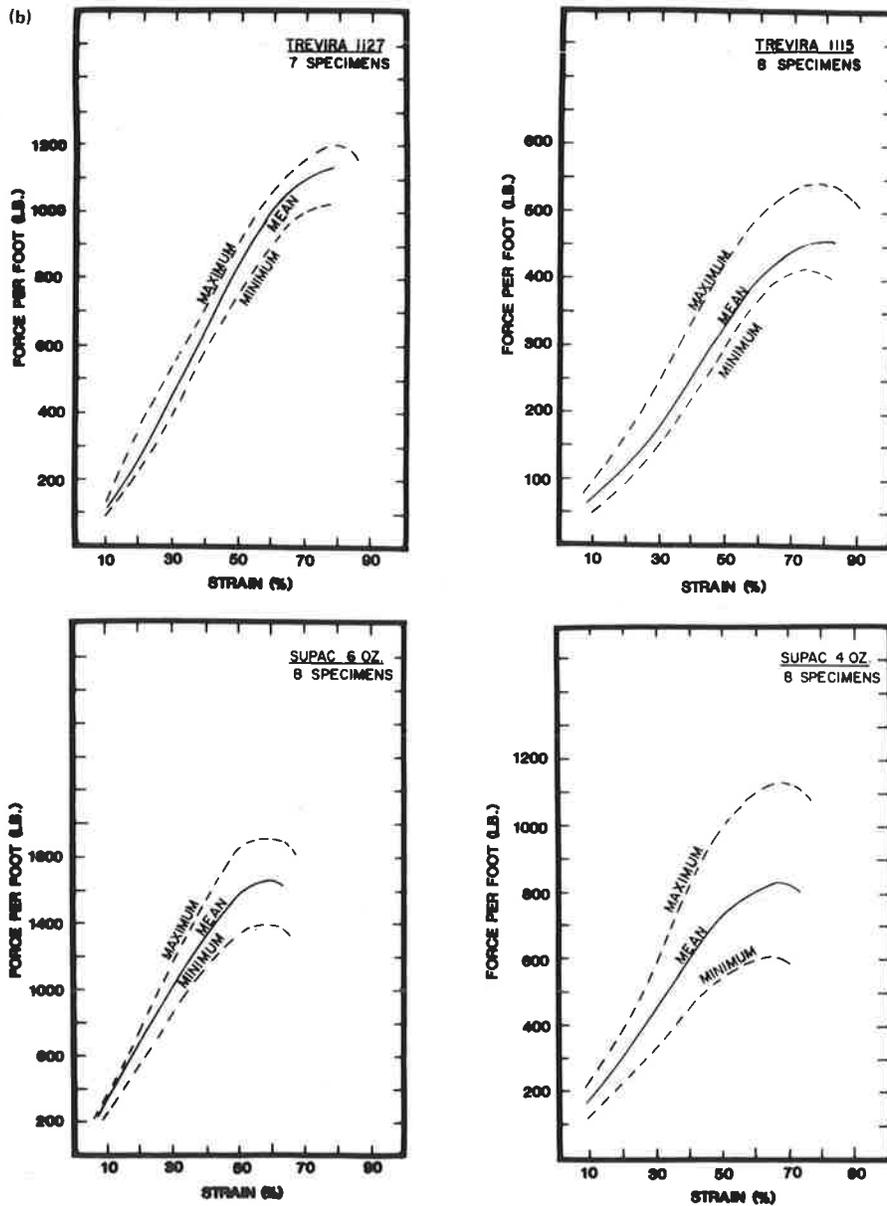
Figure 2. Geotextile load-strain curves.

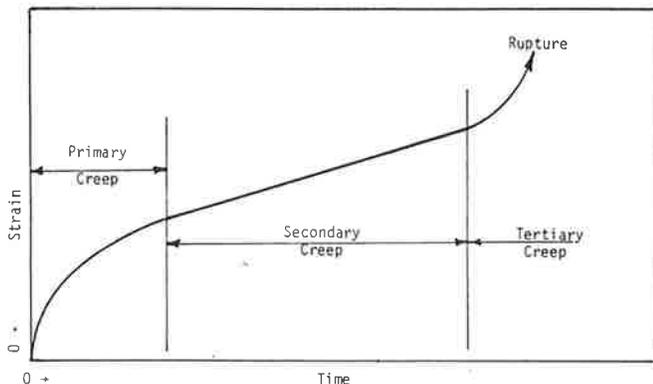
Figure 3. Phases of creep for typical geotextile tested in isolation at constant load and temperature.

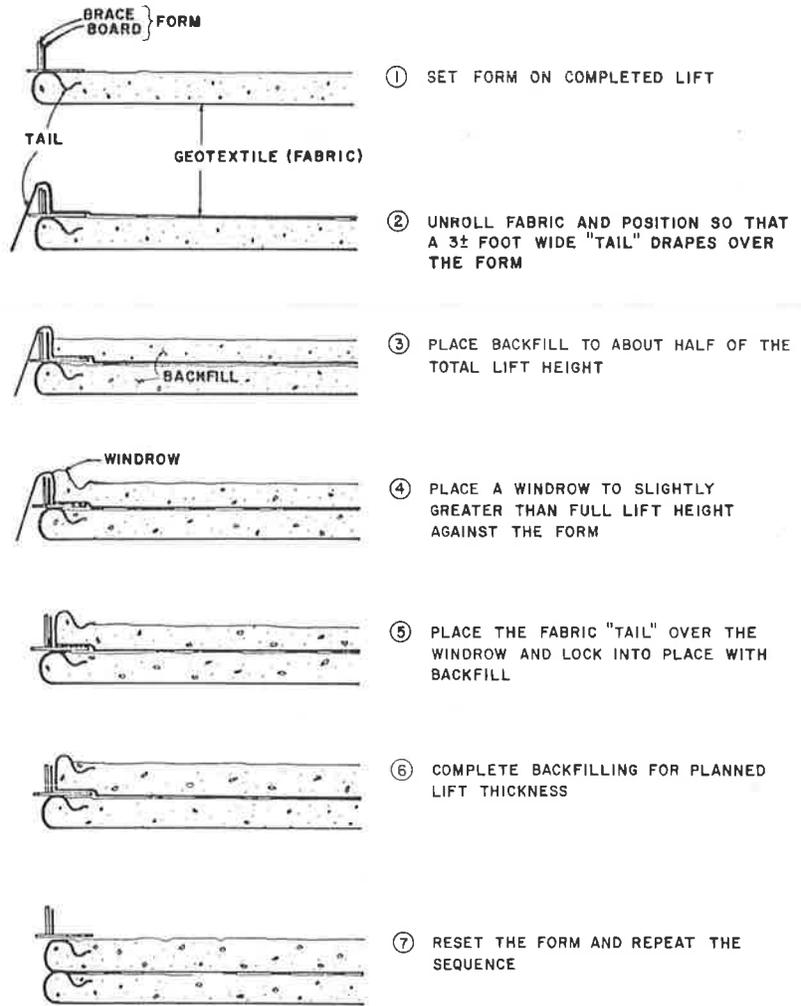
Figure 4. General geotextile wall construction procedure.

The face-forming system used on this project performed satisfactorily. Nevertheless, the experience suggests it is only reasonable for lifts up to about 15 in. Thicker lifts would require a different or modified forming system.

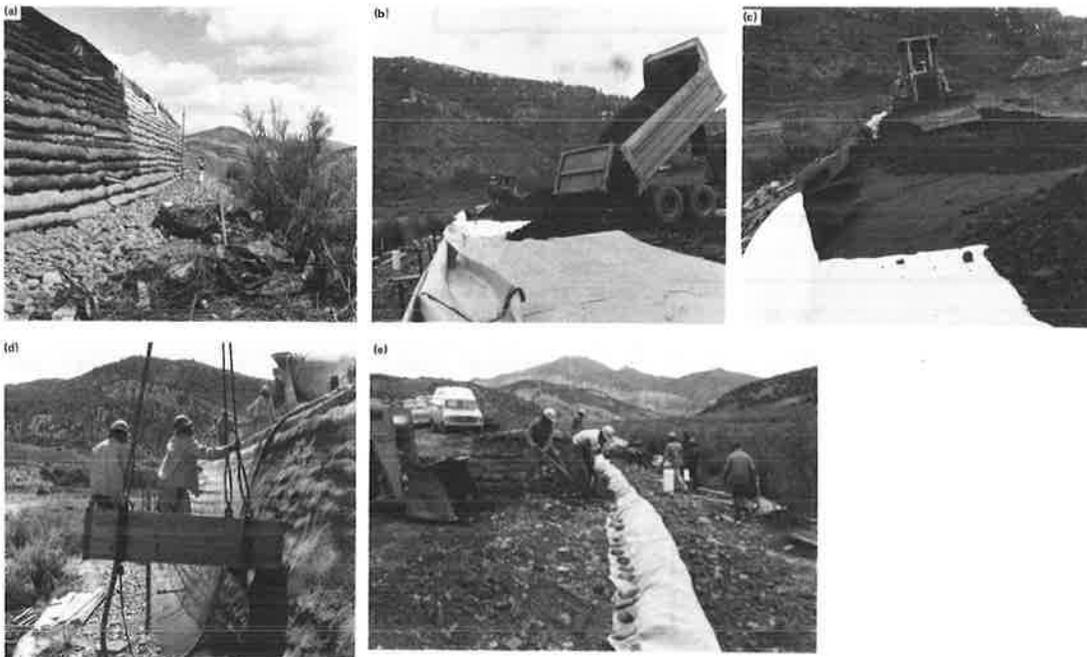
Figure 5. Wall construction.

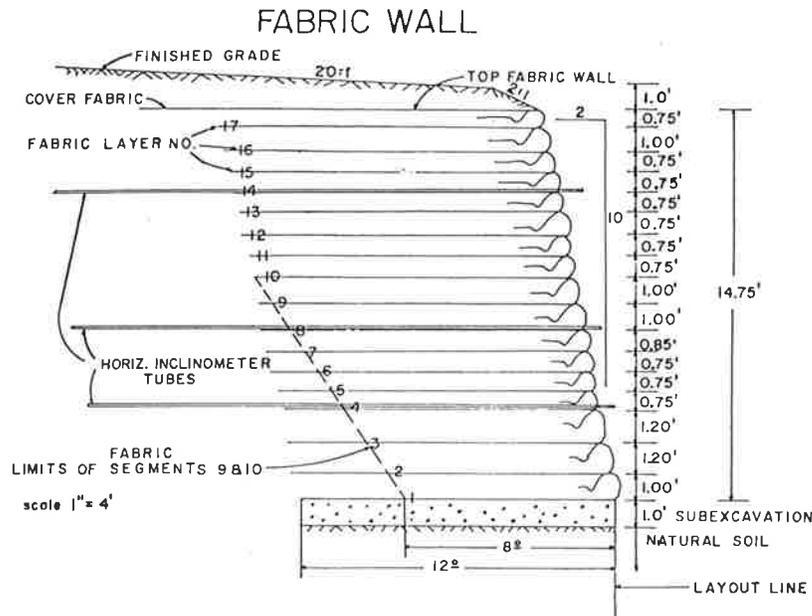
Figure 6. Geotextile wall section.

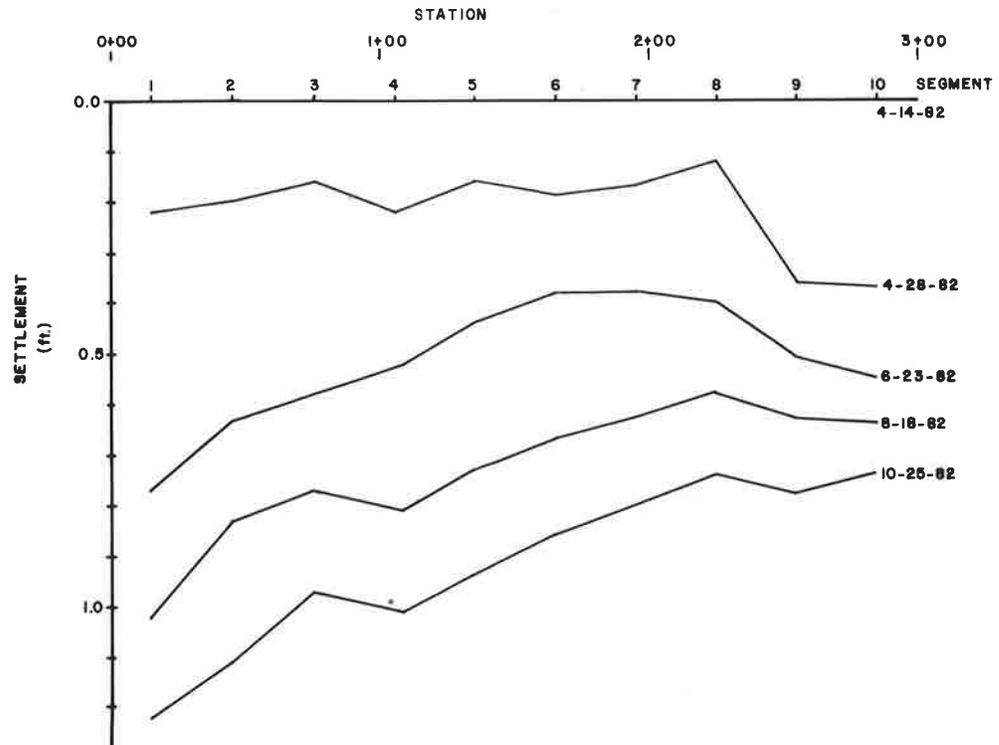
Figure 8. Average total settlement of fabric wall.

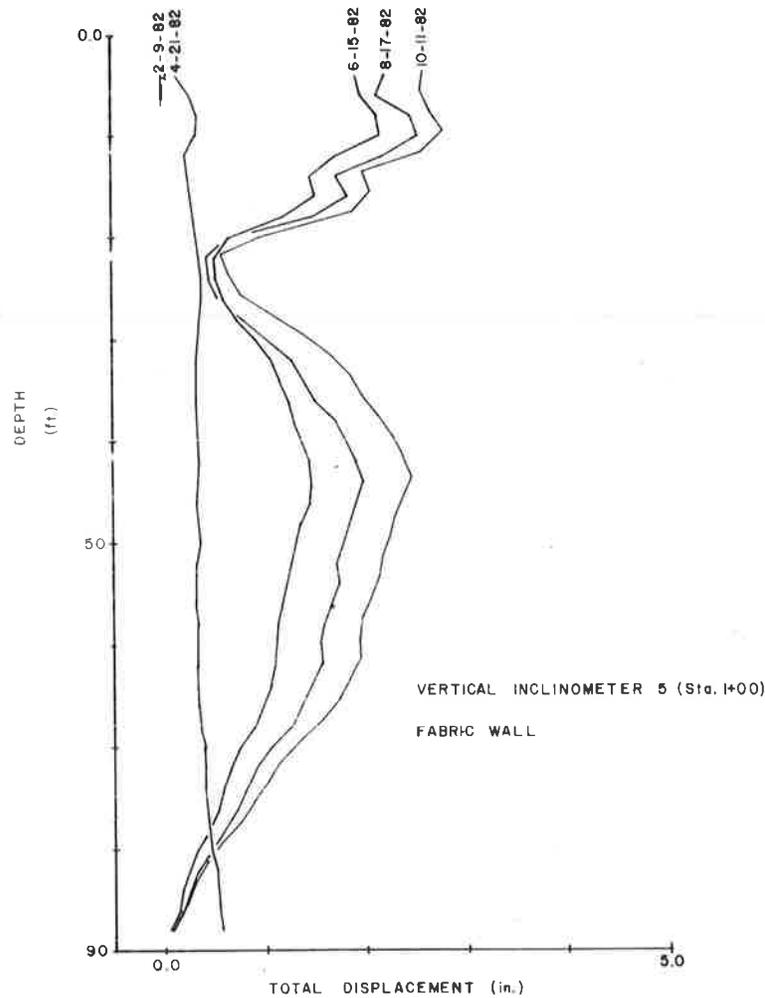
Figure 9. Horizontal deflections of fabric wall.

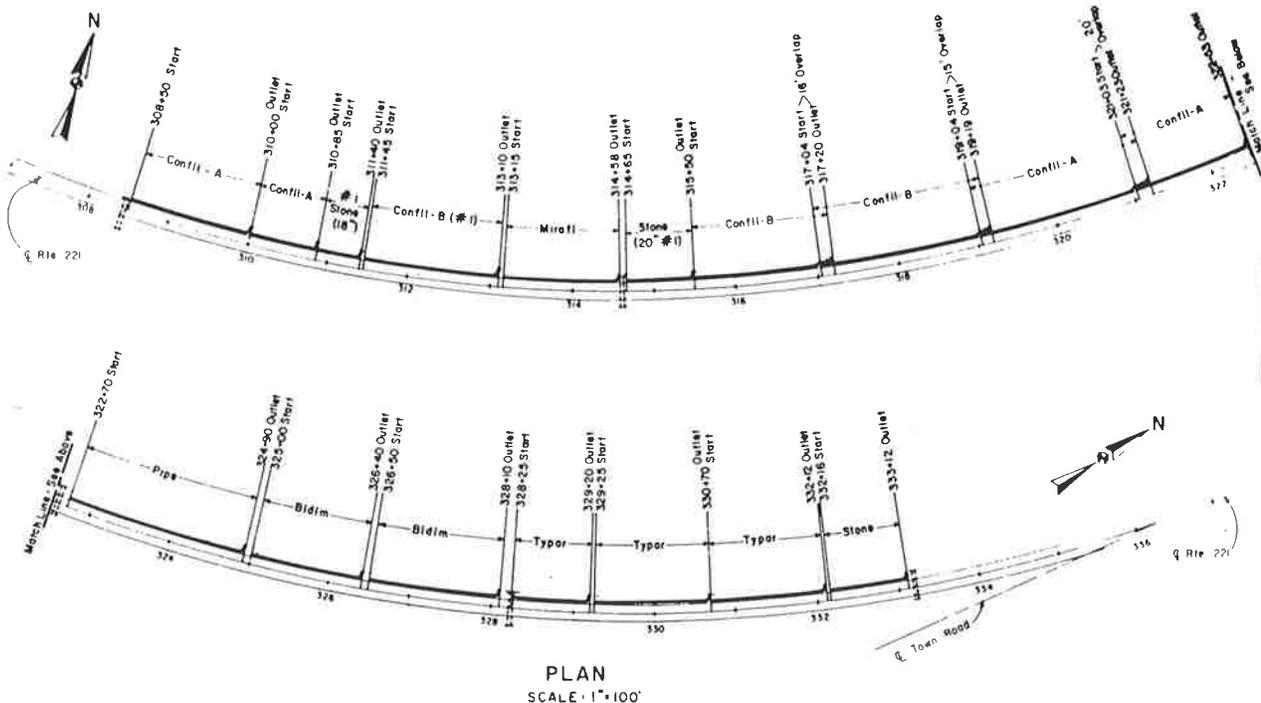
Figure 2. Plan view of underdrain system.

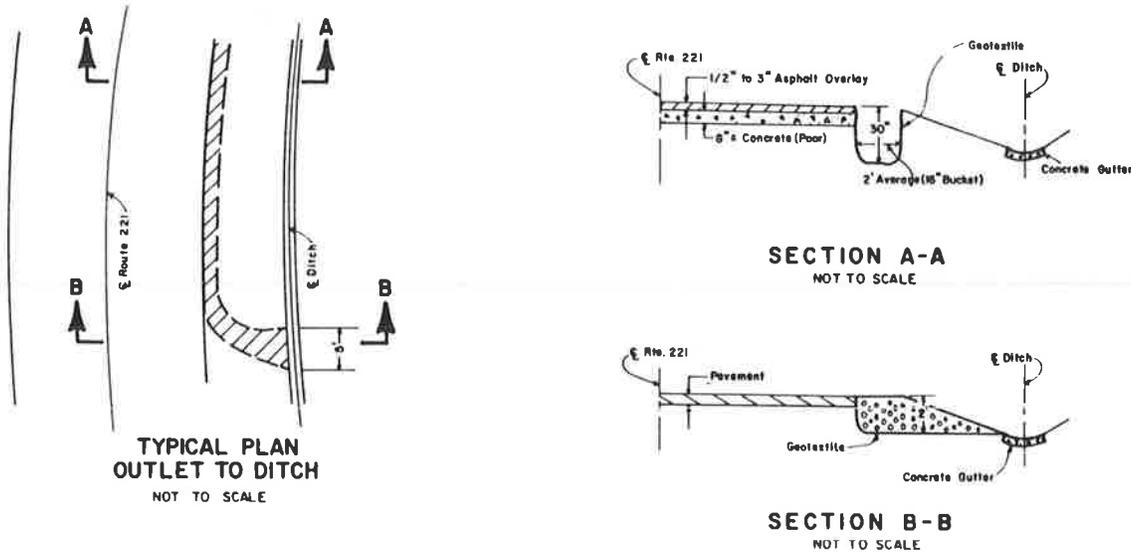
Figure 3. Typical installation details.

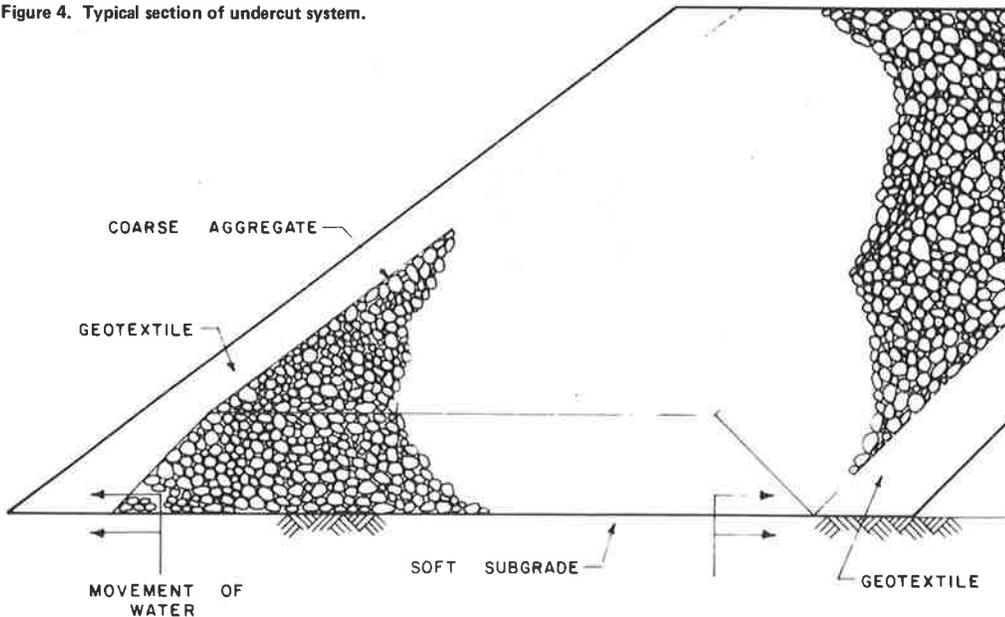
Figure 4. Typical section of undercut system.
