TRANSPORTATION RESEARCH RECORD 916

Engineering Fabrics in Transportation Construction

Treatments for Reduction of Reflective Cracking of Asphalt Overlays On Jointed-Concrete Pavements in Georgia

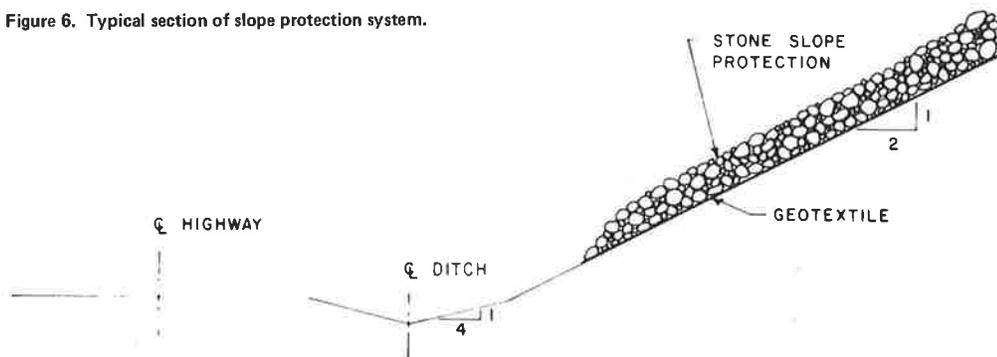
Figure 6. Typical section of slope protection system.

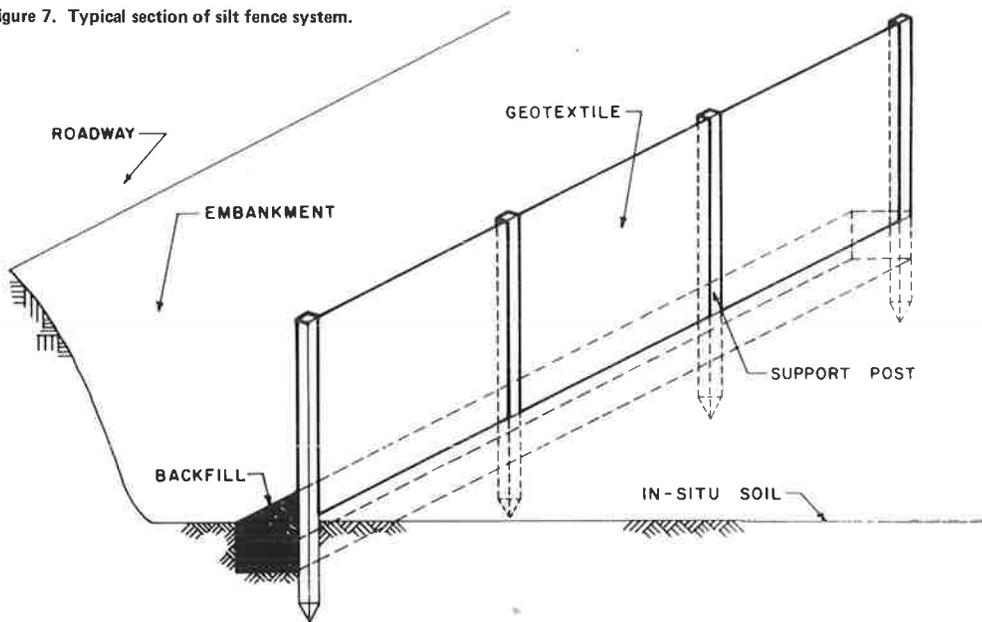
Figure 7. Typical section of silt fence system.

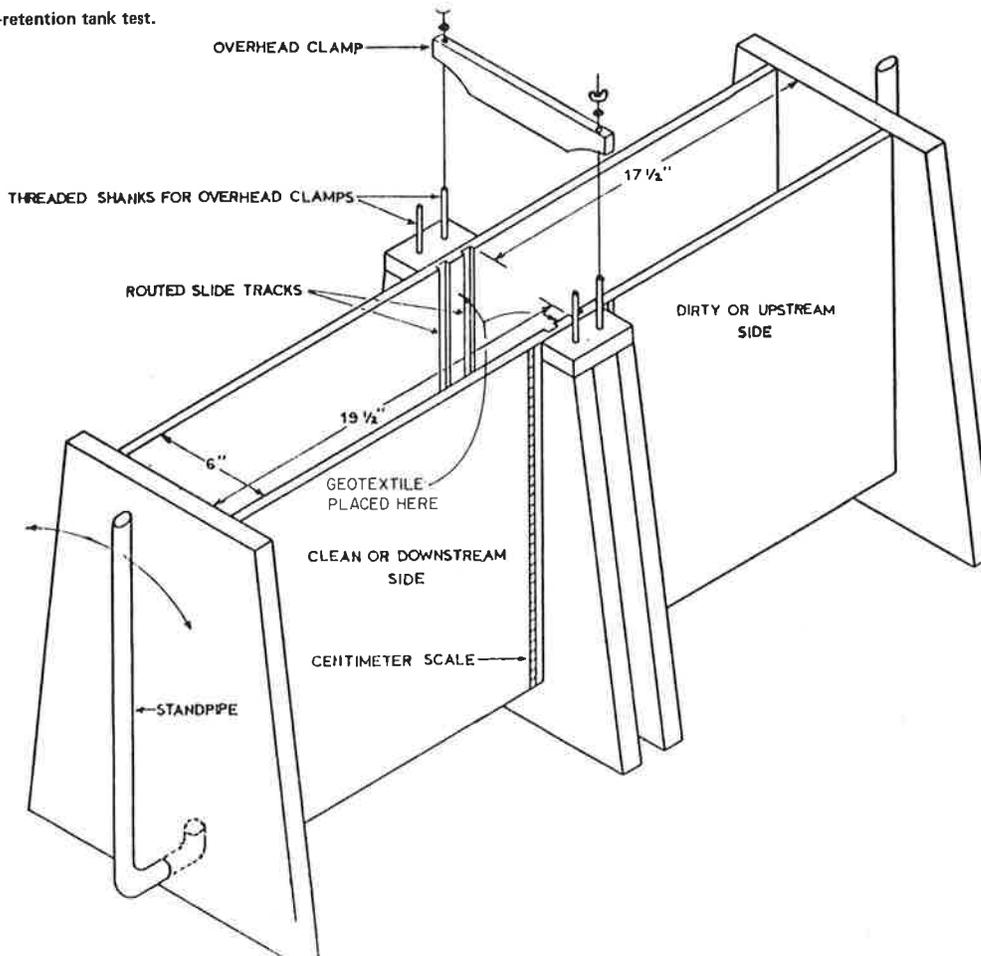
Figure 8. Soil-retention tank test.

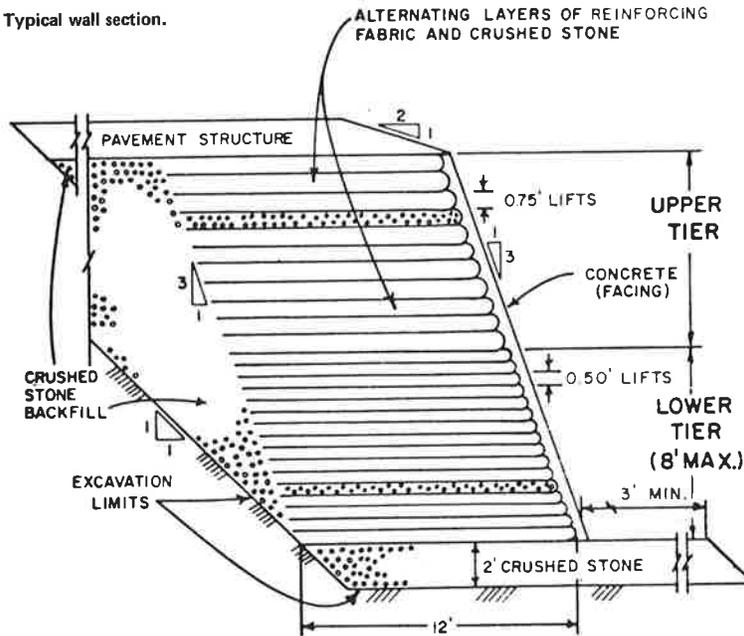
Figure 9. Typical wall section.

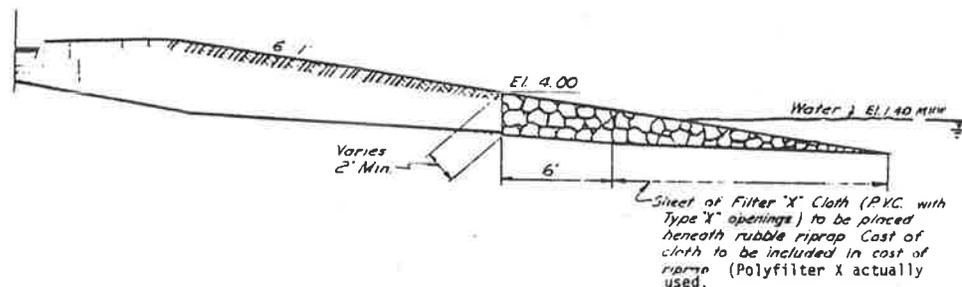
Figure 2. Proposed design of seawall.

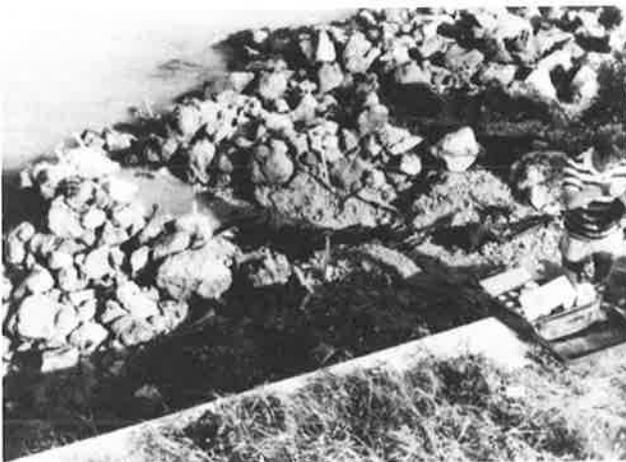
Figure 4. Excavated section at bridge abutment corner at site 1.

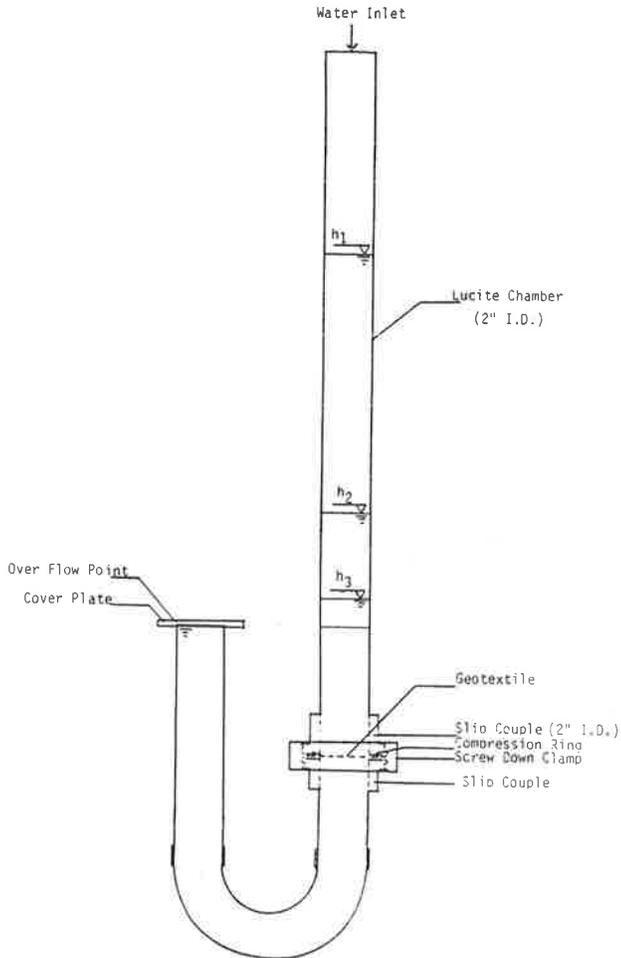
Figure 5. STS geotextile permeameter.

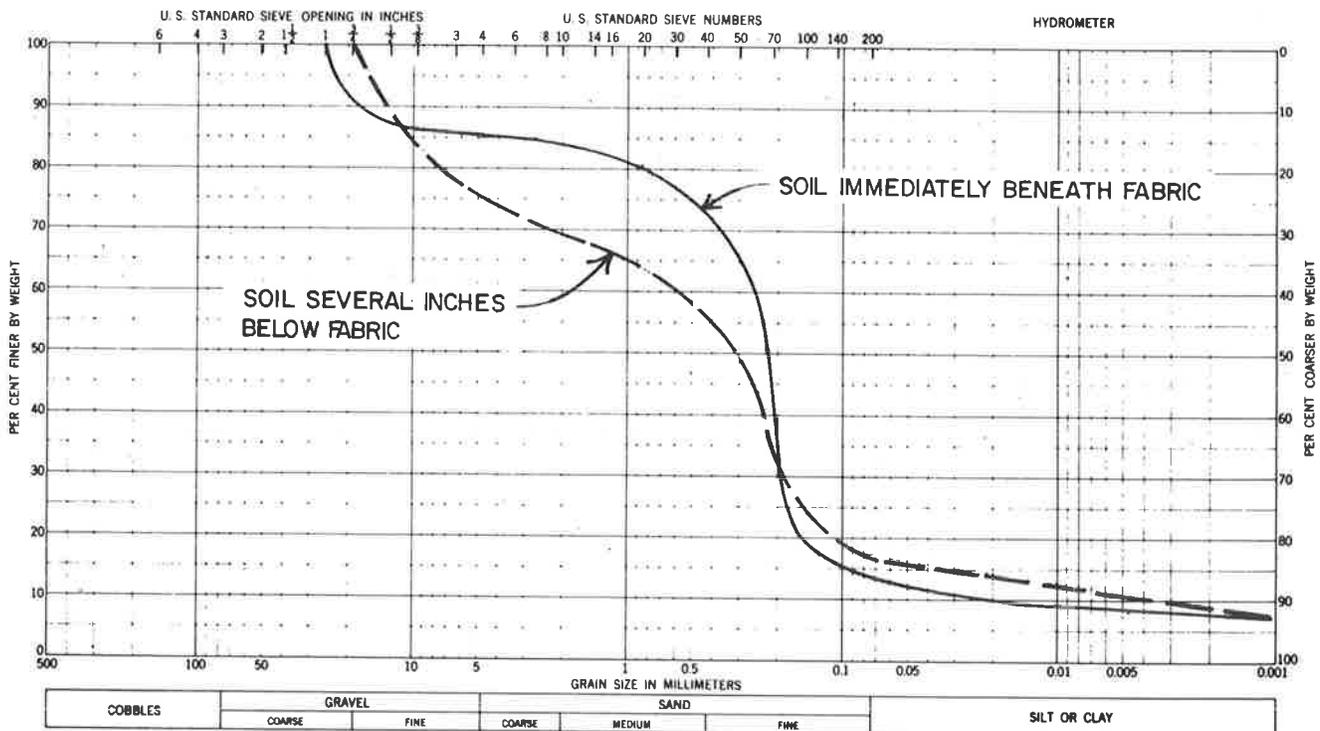
Figure 8. Grain-size distributions for soil immediately beneath and several inches below bridge abutment protection fabric from site 1.

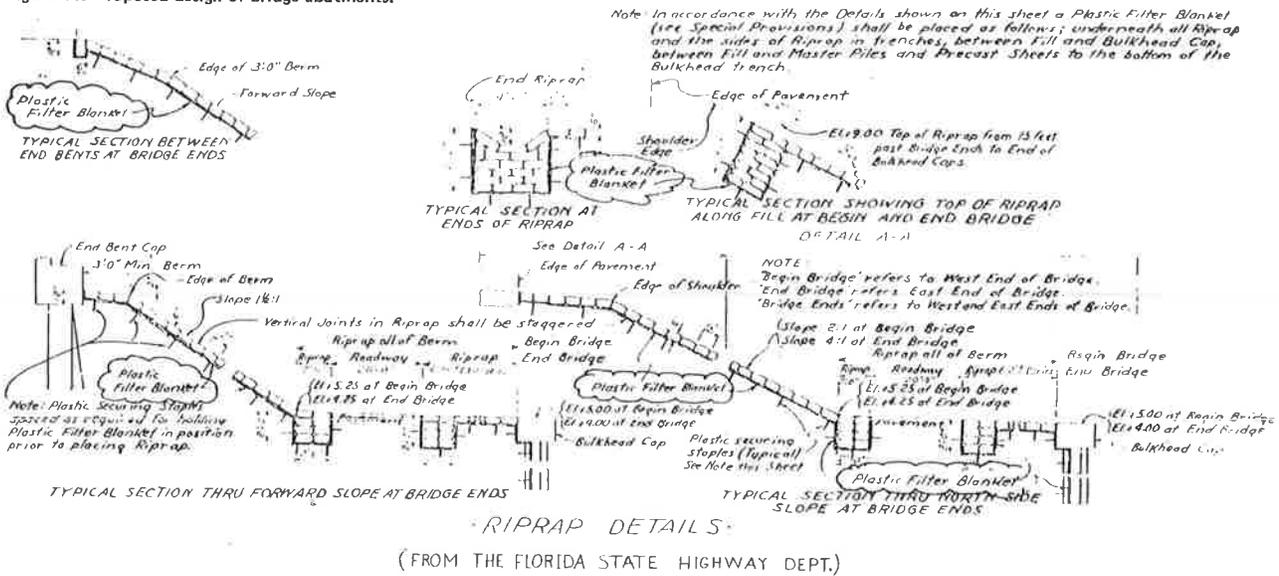
Figure 11. Proposed design of bridge abutments.

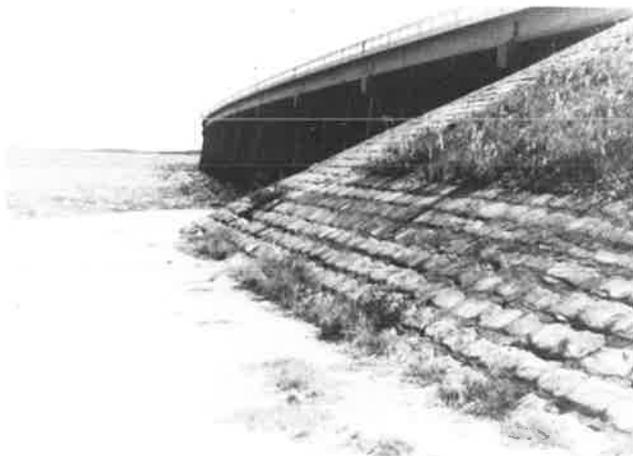
Figure 13. Armoring system: bridge side slopes and top of seawall, Bahia Honda Bridge.

stability of the sand-cement constructed facilities, as shown in Figures 12 and 13. No erosion problems were apparent at any of the drains, slopes, and seawalls protected by the sand-cement armoring system, which indicated that the installation was functioning as designed. The armoring, in most cases, has held up completely. Some surface wear was noticeable; however, no washouts of the rip-rap were observed.
