# Solar Radiation Effects on Frost Action in Soils

CHESTER W. JONES

Engineers should be aware of the effects of solar radiation on frost action in soil foundations and the subsequent effect on the performance of surface structures. Damage to concrete canal drop structures and linings from frost heave on shaded sides in contrast to sun-exposed sides is described. To demonstrate passive solar effects on frost penetration, winter temperatures were measured on the concrete surfaces and in the soil subgrade beneath black-painted and unpainted concrete linings on both the shaded and sun-exposed sides of a small canal. Periodically data on air temperatures, snow cover, and cloud conditions were collected and incident radiation and radiation reflected from the different concrete surfaces were measured. Frost penetrated 37 percent less on the painted, sun-exposed side than on the unpainted, sun-exposed side. Because of long-wave, nighttime radiation, frost penetrated 28 percent more on the painted shaded side than on the unpainted shaded side. For the unpainted concrete, frost penetrated 9 to 13 percent less on sun-exposed than on shaded sides.

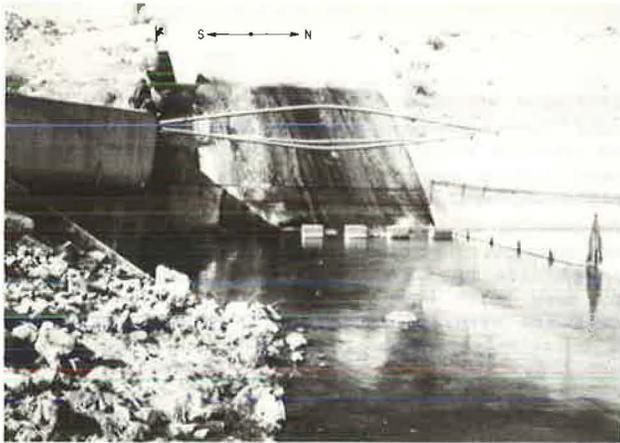
Figure 1. Damage caused by frost action in the soil on the shaded south wall and on the south side of the inclined channel.

Figure 1 shows a rectangular inclined canal drop of

reinforced concrete affected by frost action. This canal runs east-west and the inward deflection of the concrete walls has been mostly on the south side where shading occurs in winter; the lateral force of soil frost action in the backfill is apparent from the bending of the 75-mm-diameter steel pipes added for support. Some of the wall backfill on the shaded side has been removed to relieve pressure, and weep holes have been drilled in the walls to lower the water table. The sun-exposed north wall is relatively undamaged although the drainage from weep holes shows the presence of ground water. The reinforced concrete inclined channel has also been damaged from differential frost heave; greater heave occurred in the south half than in the north half.

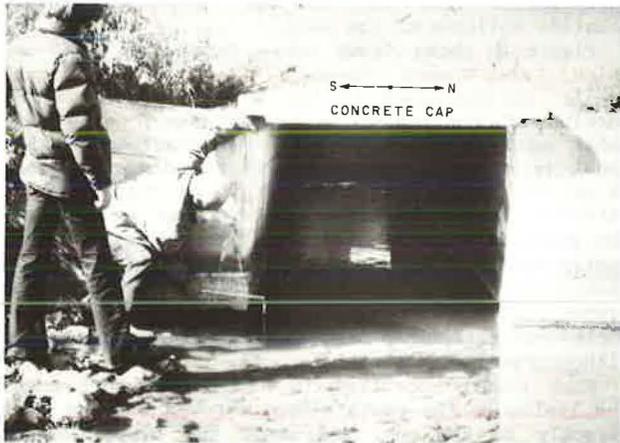
Figure 2. Inward deflection of south wall at the outlet of a chute is restrained by a concrete cap and additional soil.

Frost damage on the outlet of a rectangular inclined drop of reinforced concrete is shown in Figure 2. Here the top of the south wall of the east-west oriented structure has tipped inward about 200 mm. As a maintenance procedure, a concrete cap superimposed with soil has been added to prevent possible collapse of the wall.

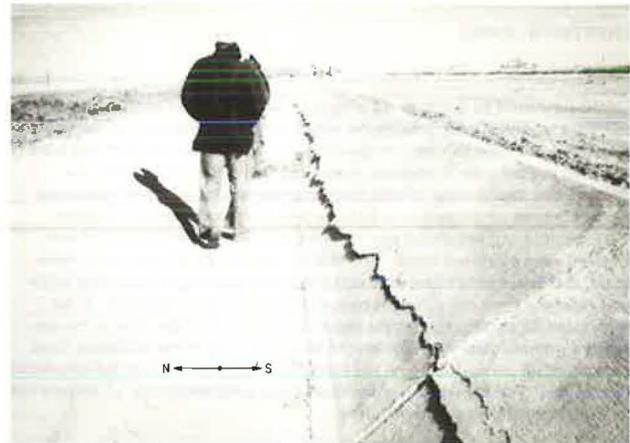
Figure 3. South side of concrete canal lining broken during spring thawing period.

Figure 3 shows frost heave damage to a 65-mm-thick, slip-formed concrete lining in a small canal. At the crack in the side slope, the upper portion of the lining is offset upward an amount about equal to the 65 mm lining thickness. This canal is oriented east-west and the damaging crack is on the south side slope which is completely or partially shaded at times when the sun is low over the southern horizon in winter. The crack appeared mostly during a 2-week period in March, following a particularly cold winter. Apparently during the winter, frost action in the soil subgrade heaved the whole concrete-lined section relatively uniformly without causing noticeable cracks.

When thawing occurred in March, the soil under the lining on the north slope, exposed more or less directly to the sun, and under the bottom lining thawed faster than that on the partially shaded south side; and the concrete was broken by the differential settlement. Although other factors such as the insulating effects of snow may have been involved, a study of the angle of the sun on the lining in winter (see Figure 7) offers a possible basis for explaining the slow uniform heave and the faster differential settlement; in March the angle is greater than at any other time since significant freezing temperatures started at the onset of winter. Exploration at the end of March showed ice lenses still under the south slope. After complete thawing of the soil, the offset was reduced to about 25 mm. For north-south oriented canals, insolation is more even on both sides of the canal and damage from frost heave is usually much less.

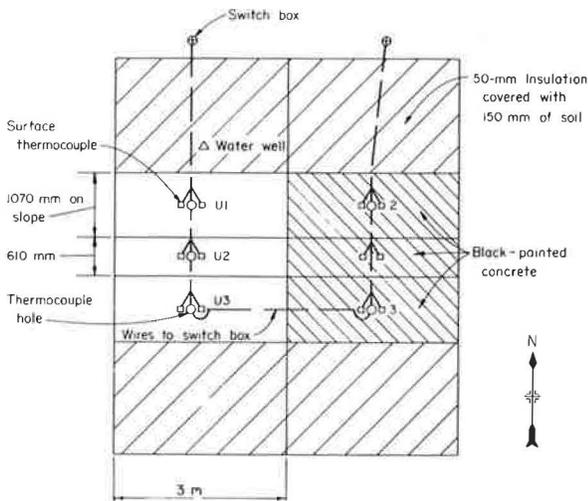
Figure 4. Frost test section showing black and unpainted concrete sections, insulated sides of the test area, and the thermocouple system.

The test sections consisted of two adjacent sections of concrete lining each about 3 m in length (see Figure 4). Polystyrene insulation 50 mm in thickness with a 150-mm soil cover was placed on the ground at the edge of each side of the canal lining to prevent frost penetration from outside the lining (see Figure 7). After a thorough cleaning of the concrete surface, both the shaded and unshaded sides, one section of lining was covered with one coat of primer and two coats of black vinyl acetate paint (see Figure 5). Surface thermocouples were installed in pairs on the sides and bottoms of the painted and unpainted test sections (see Figures 4 and 6). The thermocouple tips were attached to the concrete with screws and black or clear silicone sealant.

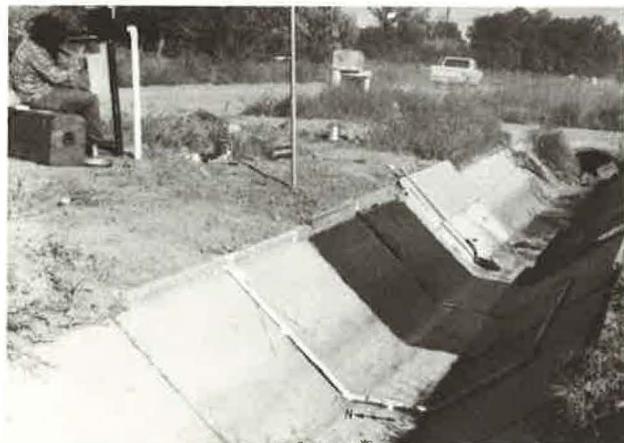
Figure 5. Black-painted concrete lining with unpainted control section in the foreground.

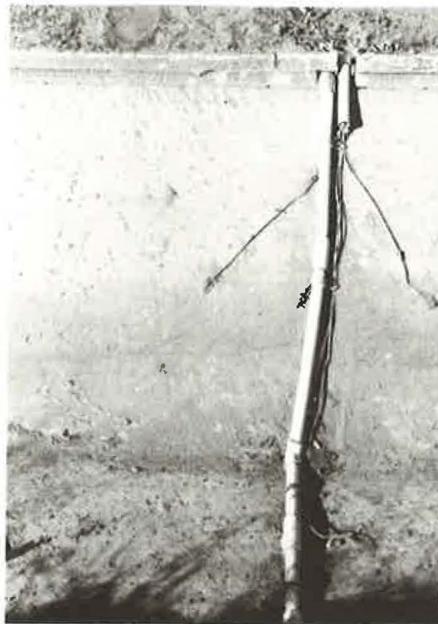
Figure 6. Thermocouples for measuring surface temperatures. Wires in PVC conduit lead to subsurface thermocouples.

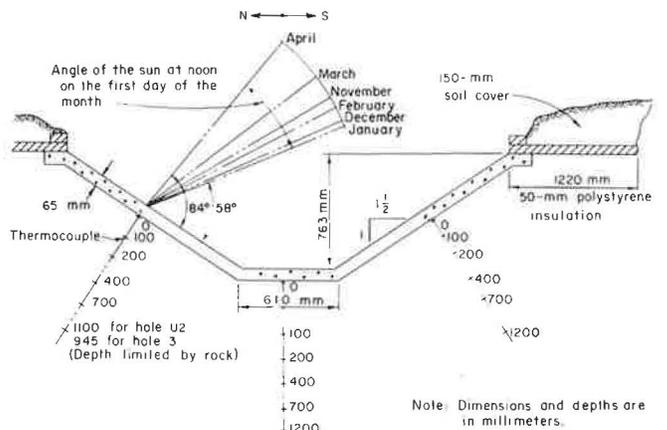
Figure 7. Cross section of concrete lining showing the locations of subsurface thermocouples and angles of the sun on the sun-exposed slope.

Figure 7 shows a cross section of the lining with the location of thermocouples beneath the concrete. Thermocouples were installed by (a) coring a 100-mm hole through the concrete, (b) augering a hole in the soil below perpendicular to the concrete surface, (c) placing the thermocouples which were loosely attached at the desired spacing to a lath in the hole, (d) refilling the hole around the thermocouples with a soil-water slurry, and (e) filling the concrete hole with fresh concrete. The thermocouple wires were of the polyvinyl-coated, copper-constantan type. They were connected to multiple-position switches mounted on steel posts. A thermocouple for recording air temperature was located about 1 m from the ground surface in a specially constructed wooden box attached to one of the switchbox posts.

The intensity of insolation on a plane surface depends on the angle of the sun's rays with the surface; the highest intensity is at 90°. A plot of sun angles on the sun-exposed north side of the canal lining for the middle of each month during the test period is shown on Figure 7. These were computed from the angle of the side slope, the latitude, and the declination of the sun.

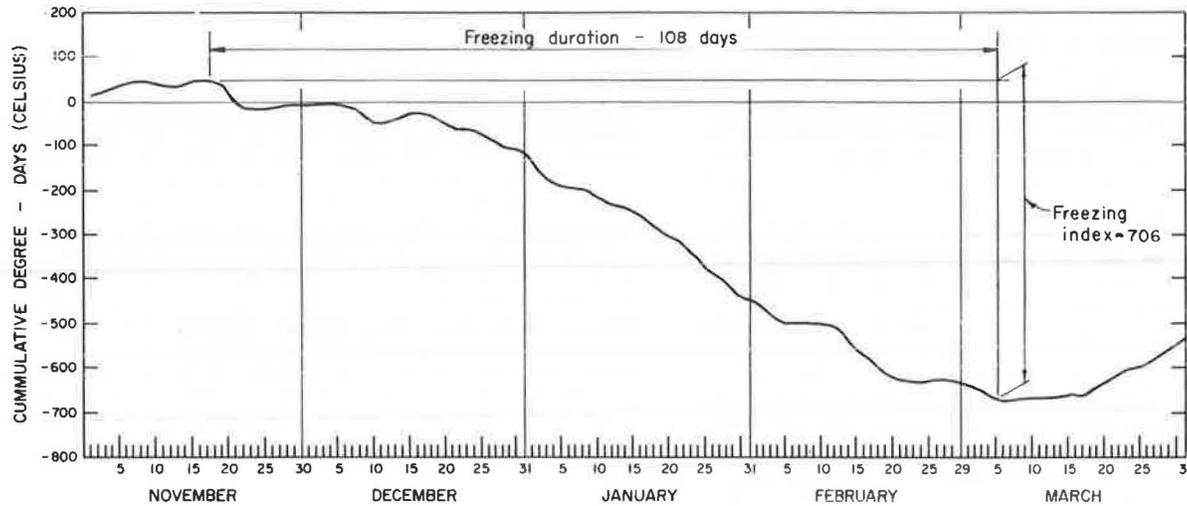
Figure 8. Cumulative degree-days for Pavillion, Wyoming—winter of 1977-78.

The town of Pavillion is located at 43°50' north latitude and 108°41' west longitude at an elevation of 1660 m. A cumulative degree-days curve for the winter of 1977-1978, based on air temperatures recorded at Pavillion, is given in Figure 8; this type of curve is useful for comparing temperatures in different locations (6). This shows that the freezing index was 706 degree-days Celsius; each day's contribution in degree-days is the algebraic difference between the average of maximum and minimum daily temperatures and 0°C. The freezing duration for the winter was 108 days.

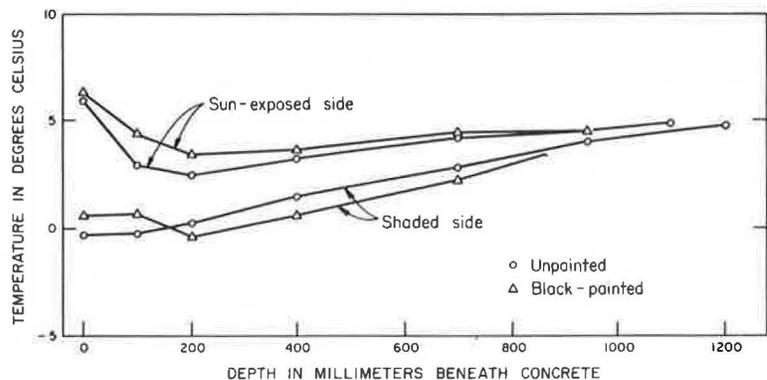
Figure 9. Average of temperatures measured below the slopes of concrete canal lining during winter of 1977-78.

Averages of all temperatures measured during the winter recording period at each thermocouple location beneath the concrete are plotted in Figure 9. The temperatures of both black-painted and unpainted concrete were higher on the sun-exposed side than on the shaded side by about 6°C at zero depth (bottom of the concrete) and less than 1°C at 1000 mm. It can also be seen that compared to the unpainted concrete, the average temperatures beneath black-painted concrete on the sun-exposed side are higher and temperatures beneath black-painted concrete on the shaded side are lower.

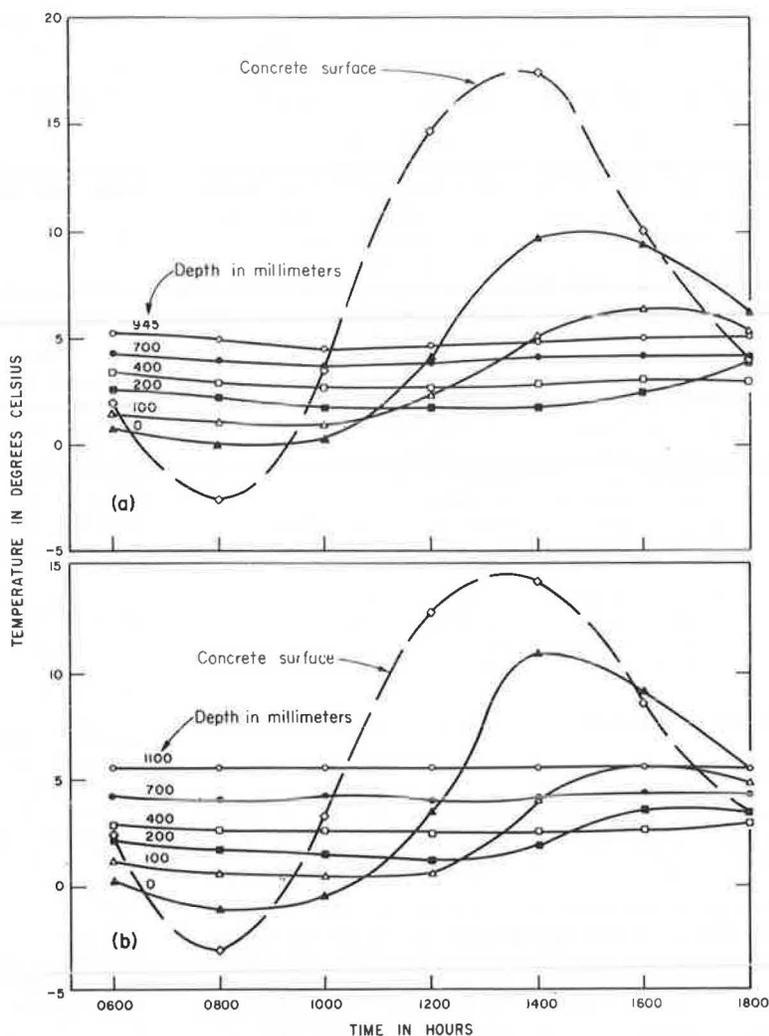
Figure 10. December 13, 1977: surface and subsurface temperatures for (a) painted and (b) unpainted concrete canal lining on sun-exposed side (thin clouds of medium height).

An example of a 1-day record of concrete surface and soil subsurface temperatures is shown in Figures 10 and 11; on that day there were thin clouds of medium height. On clear days or when clouds were not heavy, the plots of temperatures during the day show a wide variation between temperatures at the surface and those beneath the concrete on the sun-exposed side. As would be expected, the variation was much less on the shaded side.

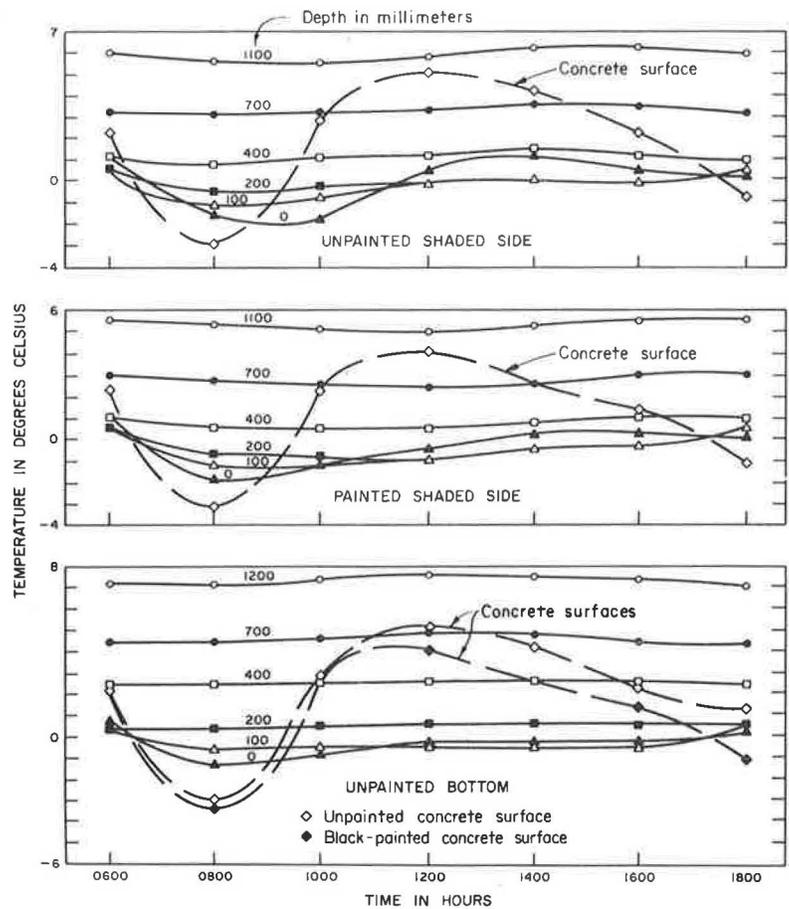
Figure 11. December 13, 1977: surface and subsurface temperatures for painted and unpainted shaded side and on unpainted bottom.

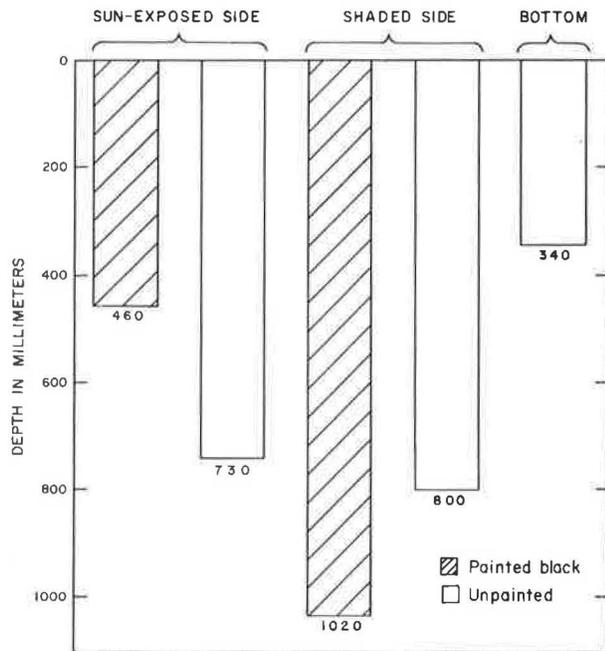
Figure 12. Maximum frost penetration beneath concrete canal lining.

A plot of maximum frost penetration is shown in Figure 12. Although the black surface generally absorbed more radiation than the unpainted concrete during the day, this was offset by the longer wave radiation from the black surface at night. Therefore, although the black surface reduced frost penetration 37 percent on the sun-exposed side, it caused an increase in penetration of 28 percent on the shaded side. For the unpainted section, frost penetration was 9 percent less on the sun-exposed side of the canal compared with the shaded side. During the preceding winter, temperatures on the same section indicated that frost penetration was about 700 mm on the sun-exposed side compared with 800 mm on the shaded side for a difference of 13 percent.
