Bridge Rail to Restrain and Redirect 80,000-lb Trucks

T.J. HIRSCH AND ALTHEA ARNOLD

A standard Texas traffic rail type C202 was modified to increase its height and strength to restrain and redirect an 80,000-lb (36,300-kg) van-type tractor-trailer under 50 mph (80.5 km/h), 15-degree angle impacts. The concrete parapet was increased to 36-in. (91-cm) high, and an elliptical steel rail was mounted on steel posts to increase the rail height to 54 in. (137 cm). One crash test was conducted on the bridge rail. The truck was restrained and redirected smoothly. This test has shown that a simple and economical rail can redirect heavy van-type trucks at speeds up to 50 mph (80.5 km/h) and 15-degree angle impacts. The cost of this rail is estimated at about \$80 to \$90/ft. Typical passenger car bridge rails in Texas now cost about \$25 to \$35/ft.

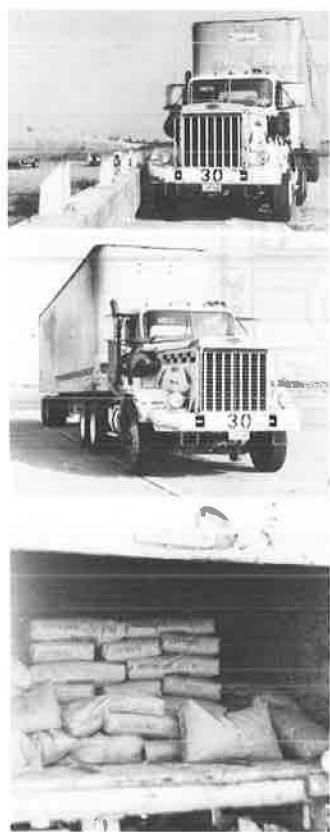
Figure 7. 80,000-lb truck before test.

This bridge rail system was designed to contain and redirect an 80,000-lb (36 287 kg) van-type tractor-trailer. A simulated bridge deck with this rail system was built at the Texas Transportation Institute Proving Grounds and tested with a 1978 auto car tractor-trailer ballasted with sand bags to 79,770 lb (36 184 kg). Drawings showing the dimensions of this vehicle along with loaded and unloaded weights on each axle or pair of axles are shown in Figures 5 and 6. Before and after test photographs of the truck are presented in Figures 7 and 8.

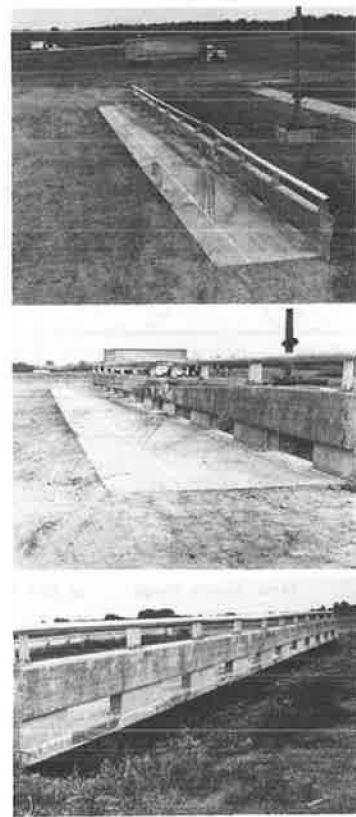
Figure 9. Bridge rail and truck after test.

The truck impacted the rail at 49.1 mph (79.0 km/h) and 15-degree angle. Impact occurred between posts 3 and 4, and the truck was redirected smoothly. Figure 9 shows the bridge rail and test site immediately after test 6. The truck entry and exit path can be seen clearly. The truck sustained damage to the right front and right tandem wheels. The trailer body bulged out slightly on the right side from the shift in load (sand bags). The trailer body was in contact with the upper railing over a length of approximately 40 ft (12 m) (Figure 8). This point of contact was centered about 4 in. (10 cm) above the trailer floor, which is at 54 in. (137 cm) as shown in Figure 5. A summary of the crash test data is given in the list below.
