Portable Traffic Barrier for Work Zones

DEAN L. SICKING, HAYES E. ROSS, JR., D.L. IVEY, and T.J. HIRSCH

A portable, positive construction zone barrier is described. The barrier is suitable for use at sites where work will take as little as several hours. It is constructed from used cars and thrie-beam guardrail. Two full-scale vehicular crash tests of the portable barrier are described that demonstrate its adequacy in terms of impact performance. The barrier can be used in construction zones where conventional positive barriers have been impractical.

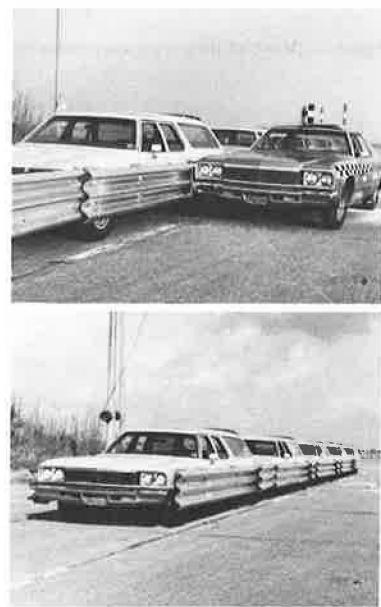
Figure 1. Used car barrier.

The used car barrier is shown in Figure 1 and described in Figures 2 and 3. The vehicles used in

the barrier were 1973 and 1974 Plymouth Suburban station wagons. These vehicles have torsion bar front suspension, which allows the height of the front bumper to be adjusted easily for towing. Standard thrie-beam guardrail is attached to each of the vehicles, as shown in Figure 3. The thrie beam

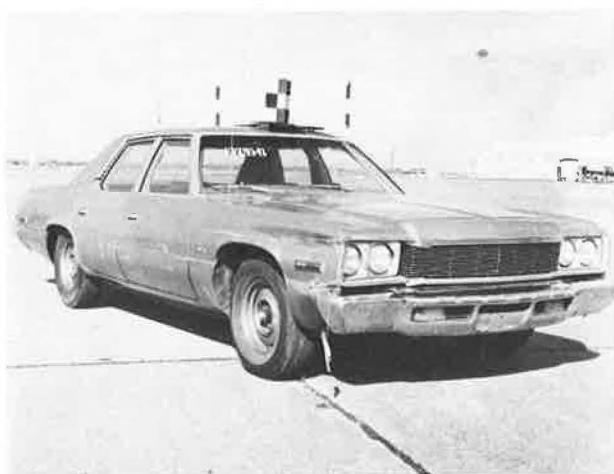
Figure 8. Test vehicle and barrier after test 1.

Figure 8 shows the test vehicle and barrier after test 1. As shown in this figure, damage to the test vehicle was limited to sheet metal deformations. The barrier sustained no visible damage and was driven from the test site. Barrier displacement was limited to 2 in. Test 1 was considered successful because damage to the test vehicle was light and damage to the barrier was negligible.

In the first test a 4,500-lb (2043-kg) vehicle impacted at 51.7 mph (83.2 km/h) and 7 degrees. The test vehicle was redirected smoothly and exhibited no tendency to become snagged on the barrier. As the data given in Table 2 indicate, all occupant

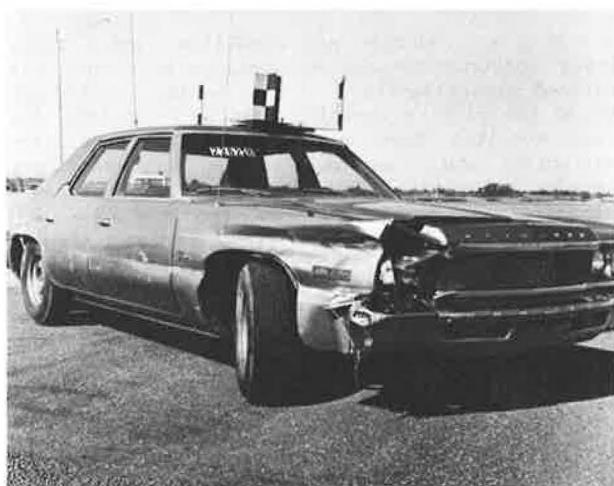
Figure 10. Used car barrier after test 2.

The test vehicle (see Figure 9) was damaged only lightly. Barrier damage (see Figure 10) was limited to minor deformations in the three-beam rail and the

barrier vehicle sheet metal. The barrier was driven from the test site, and no barrier repair was required. This test was also considered successful.
