Use of Sinkholes for Drainage

DAVID L. ROYSTER

ABSTRACT

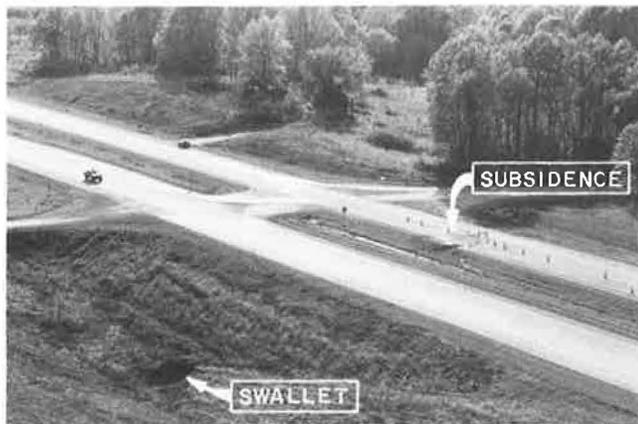
FIGURE 1 Subsidence caused by piping from water introduced into a sinkhole along TN-76.

In August 1975 the paving of a 2.98-mile, four-lane section of TN-76, for which the grading and drainage had just been completed, was let to contract. The paving was completed in May 1976. By the following spring (1977), a 20-ft section of the southbound lane at Vaughn's Road began to subside (Figure 1). An investigation revealed that an approximate 200-ft section of both lanes had been constructed over a sinkhole that contained at least two swallets. The elevation of the lowest portion of the sink before filling was approximately 498 ft. The elevation of the finished pavement at this point was 518 ft, which meant that the maximum filling of the sink was 20± ft. The easternmost swallet had been left uncovered to accommodate drainage in this area. All drainage from an area of approximately 400,000 ft² was directed to this one swallet.

The subsidence was repaired with a bituminous mix and the lane reopened to traffic. In the spring of 1978, however, the subsidence recurred, which resulted in the closing of the left southbound lane and shoulder area. Soon thereafter a subsurface investigation was initiated. Fifteen borings were made in and around the area of the subsidence and around the perimeter of the sink to determine the type and condition of the fill material, overburden, and in-place rock. Standpipe piezometers were placed in a number of these borings to determine the depth, slope, and fluctuation of the water table.

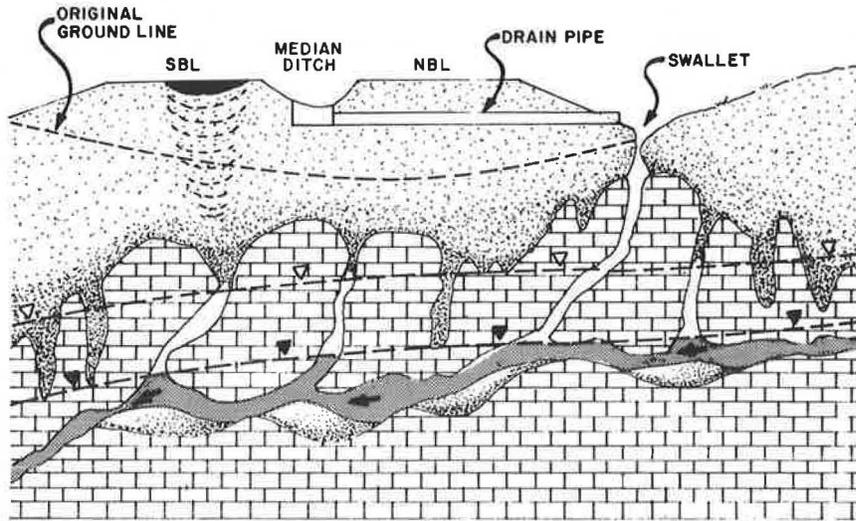
FIGURE 2 Schematic cross-sectional diagram of the TN-76 subsidence problem.

Because of the necessity of getting the project under contract by August, only 3 weeks of readings of water depths were possible. The water table--except for 1 day in which the elevation stood at 428 ft in response to 2.5 in. of rain over a 3-day period--remained steady at elevation 426 ft. The easternmost piezometer generally read 0.2± in. higher than the one installed some 200 ft to the west. This was taken as an indication, supported by the surface contour configuration, that the water table sloped in a northwesterly direction. From this a determination was made that the subsidence was caused by piping from a localized high-water condition that occurred during periods of high and intense precipitation. Most of the water was introduced through the one remaining swallet in the sink area (Figure 2).

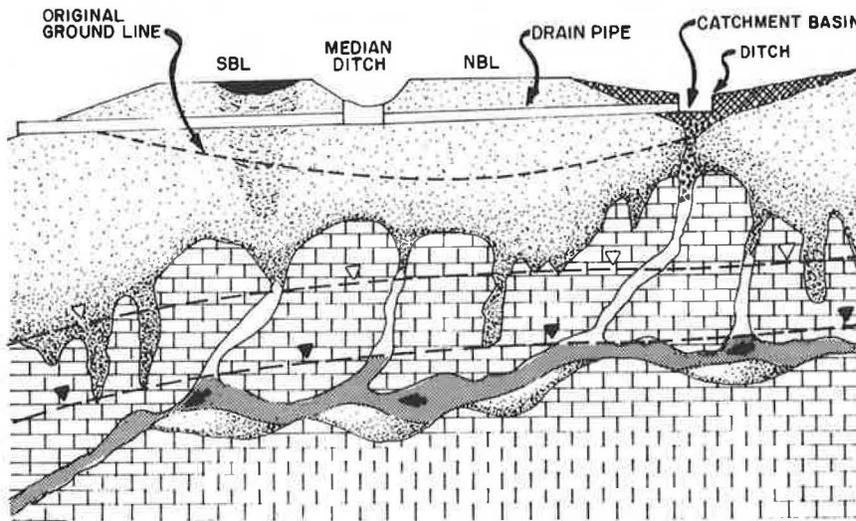
FIGURE 3 Schematic cross-sectional diagram of the TN-76 subsidence correction.

The corrective measure involved sealing the swallet and rerouting the surface drainage toward the Red River drainage area northwest of the project (Figure 3). It was theorized that, because any of the rerouted water entering the subsurface would do so on the downslope of the normal water table relative to the roadway and because there were at least 80 ft of "freeboard" between the surface and the normal water table, the localized high-water condition would be eliminated. This, in turn, was expected to eliminate the piping problem. In the 5 years since the completion of the project (constructed at a cost of \$91,316) no further problems have developed (Figure 4).

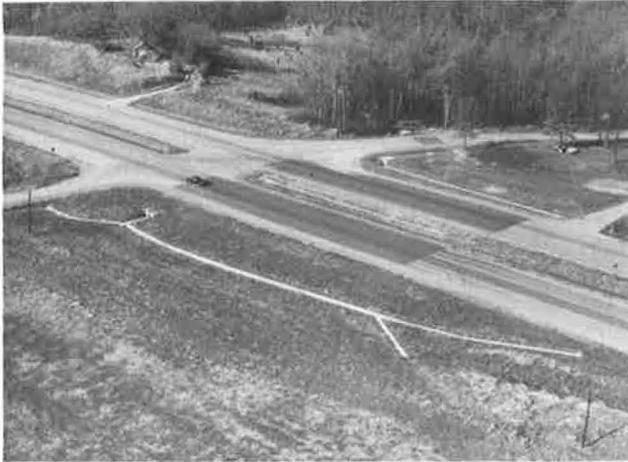
FIGURE 4 The corrective measure involved sealing and filling the sinkhole and re-directing the surface water toward the Red River drainage area.

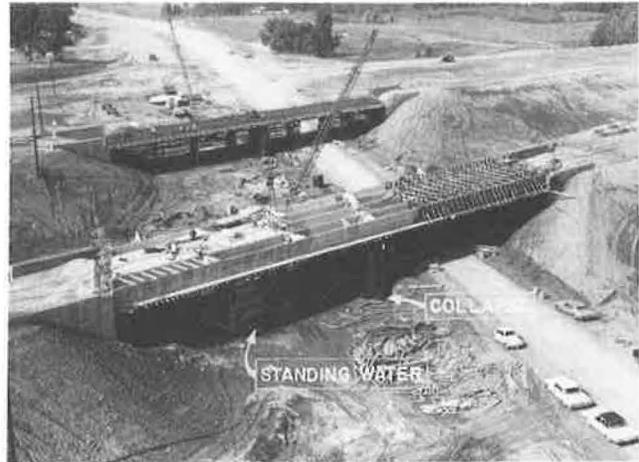
FIGURE 6 Collapse of soil around a pile cap along westbound I-24 over TN-76 bridge in Montgomery County.

Several other subsidence and collapse problems have occurred in and around the I-24 and TN-76 interchange since construction began in 1975. A large portion of the entire interchange lies within the sink area. One of the more serious problems involved one of the piers on the I-24 bridge that carries the westbound lane across TN-76 (Figures 6 and 7). During construction, water collecting around the pile cap following a heavy rainstorm resulted in collapse of the soil around the cap. The collapse was caused by a piping action along the H-piles that penetrated to bedrock. The situation posed no great problem for the pier; problems did, however, involve the falsework that supported the beams and other structural components that were being placed. Had the collapse enlarged, some of the falsework would definitely have been affected. The problem was solved by filling and sealing the collapse and by diverting the

surface water away from the area. This treatment seems to work well where there is a thick soil overburden (50± ft. in this case), where the normal water table is well below the soil-rock interface (25± ft in this example), where the water table does not fluctuate excessively (piezometers installed in the problem area indicated variations of no more than 5 ft over a 3-month period), where there are significant voids in the in-place rock caused by the solution of joints and bedding planes (several corings at the bridge site proved this to be the case), and where there are no major swallets in the immediate area on the up-slope side of the water table relative to the problem area.

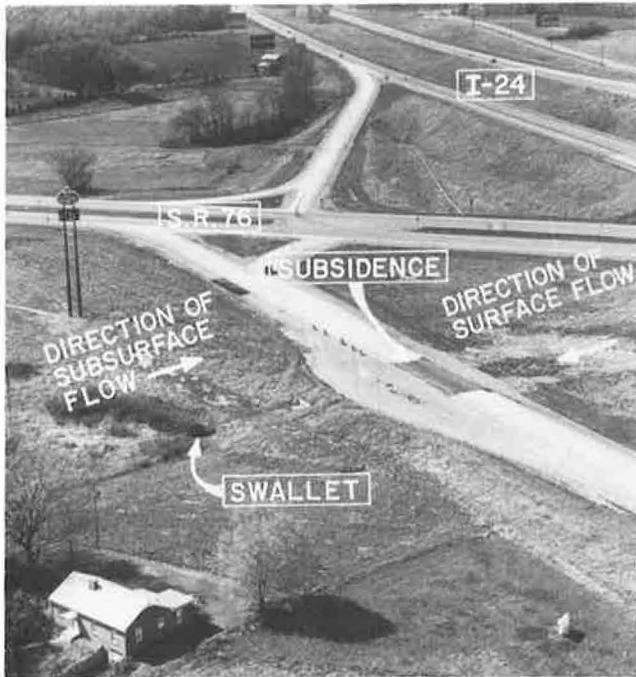
FIGURE 5 Subsidence of the I-24 eastbound on-ramp as viewed in April 1980.

Another example of subsidence resulting from directing surface water into a swallet on the upslope side of the water table occurred approximately 1 mile from the TN-76 and Vaughn Road project. This problem, which has not been corrected, affects the eastbound on-ramp of Interstate 24 at TN-76 (Figure 5). All of the surface water in the southeast quadrant of the interchange is directed into a sinkhole approximately 100 ft south of the on-ramp. Although a subsurface investigation has not been conducted, indications are that the surface water entering the swallet is flowing back under the ramp in a northeastern direction and producing a piping action that is causing the subsidence. The problem will be corrected as soon as funds become available.

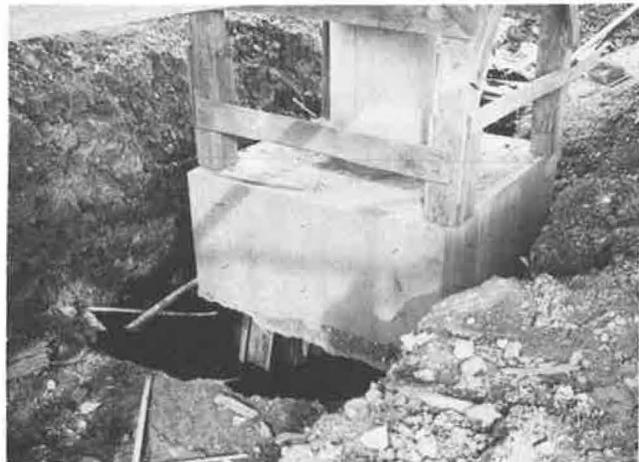
FIGURE 7 Close-up view of the collapsed condition shown in Figure 6.

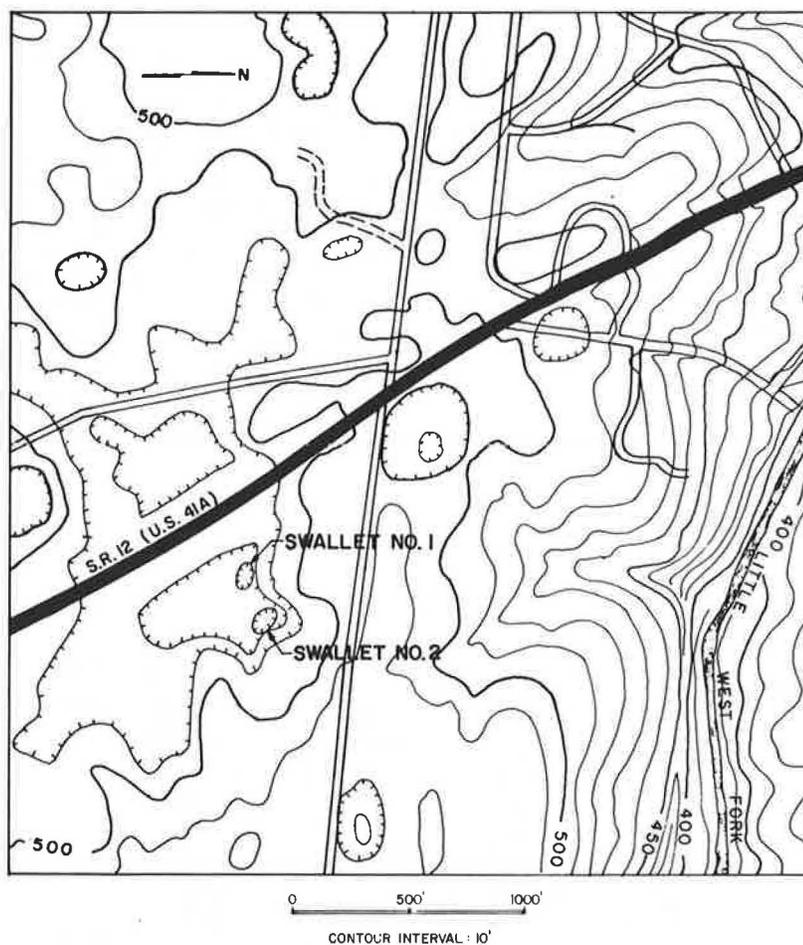
FIGURE 9 Location of swallets within Ringgold Sink.

As is the case with most sinkholes in the area, the swallets, or tubes, that lead to the subsurface in the Ringgold Sink have developed along pinnacles of limestone near the surface. The surface of the in-place rock drops off rather dramatically in all directions from the pinnacles. For example, at swallet 1, the pinnacles occur within 7 to 10 ft of the surface in an approximate 30 ft radius, with the rockline dropping off 40 to 50 ft outside this zone in a distance of only 30 to 40 ft. Most of the surface water appears to flow along the soil-rock interface before percolating deeper into the subsurface through solution-enlarged joints and bedding planes, and ultimately into possibly larger channels and conduits that feed the two or three springs that empty into Little West Fork some 2,000 ft to the north. The elevation of the flow line of the

springs where they exit is 385± ft. The elevation of the water table beneath the depression, as measured in the five piezometers, varied between 419.5 and 421.5 ft. As might be expected, the greatest number of cavities (and these appeared mostly to be soil-filled) occurred in the pinnacle areas. Core recovery outside these areas where the regolith was 40 to 50 ft thick usually ran 90 to 100 percent. The overburden consisted largely of a cherty clay, with clay contents generally ranging between 45 and 60 percent and plasticity indices between 25 and 30. Approximately 3 or 4 ft of silt and organic material overlay the residuum in swallet 1 (Figure 9).

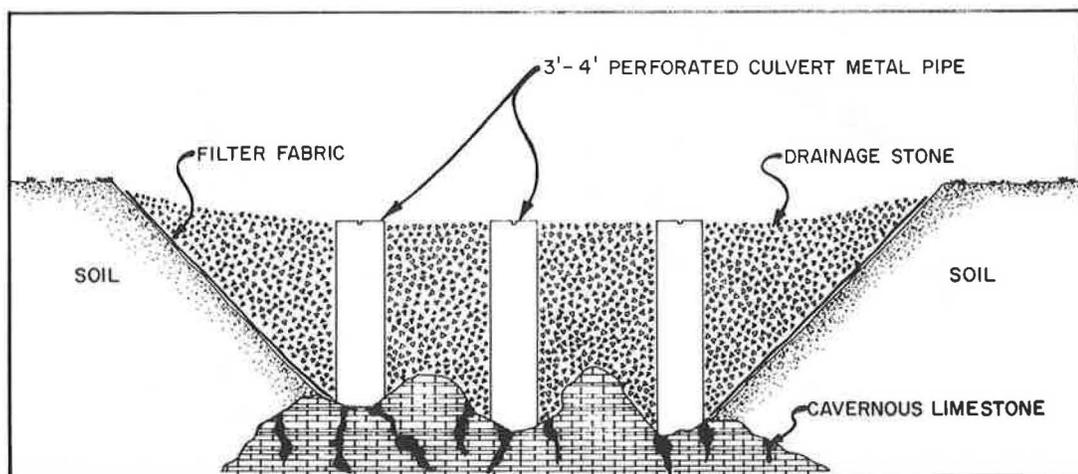
FIGURE 10 Schematic cross section of sump design for the Ringgold Sink.

The final repair alternative considered involved improving the drainage of the existing swallets. This improvement would consist of excavating the swallet areas to in-place rock, installing perforated standpipes (3 to 4 ft in diameter) and backfilling with drainage stone (Figure 10). Also included were grouted riprap ditches, which would direct the water into the sumps, and several siltation fences.

Excavation, as well as drainage stone placement, will be accomplished with a clamshell to avoid compaction and consolidation in and around the swallets. The construction of sump 1 will be completed before beginning work on sump 2 to minimize siltation and the possibility of blockage in case of flooding while work is under way. All excavated material will be disposed of outside the drainage basin. The backfill material (drainage stone) will be required to meet the following gradation: 60 to 40 percent between 2 and 1 ft along its maximum dimension, 40 to 20 percent between 1 ft and 6 in., 20 to 10 percent between 6 and 2 in., and 5 to 0 percent less than 2 in. In addition, filter fabric will be placed on the excavated slopes to minimize erosion and siltation at the drainage stone-soil interface (Figure 10).
