## Analysis of Accidents Involving Breakaway-Cable-Terminal End Treatments

JERRY G. PIGMAN, KENNETH R. AGENT and TOM CREASEY

This paper includes an analysis of 50 accidents involving breakaway-cable-terminal (BCT) end treatments and 19 accidents involving median-breakaway-cable-terminal (MBCT) end treatments as used in Kentucky. The primary data base consisted of Kentucky accident records for the years 1980-1982; selected accidents were included that occurred before 1980 and after 1982. An attempt was made to document each accident with a police report, photographs, and a maintenance repair form. Results showed that the BCT end treatment performed properly in 60 percent of the accidents; that is, the end treatment performed as it was designed, with the wooden posts breaking away or the guardrail redirecting the vehicle. Only five impacts were known to involve small cars and the BCT performed improperly in four of those accidents. It should be noted that the BCT used in Kentucky is similar to the design tested and evaluated as part of the NCHRP studies and included in the AASHTO barrier guide. The primary difference was that before 1982, most BCTs in Kentucky were installed so tha

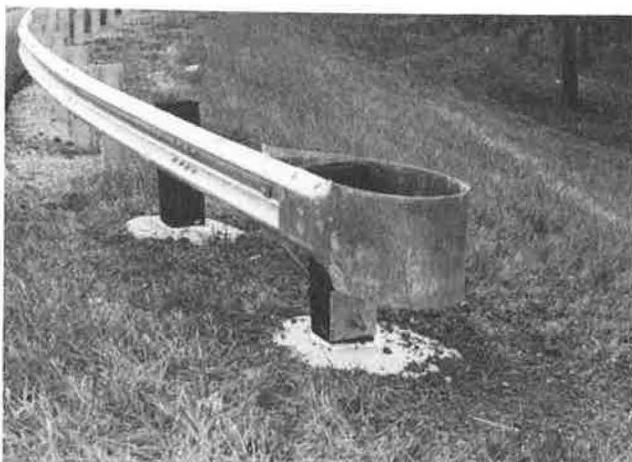
FIGURE 1 BCT end treatment (Kentucky's Type 4).

Kentucky was one of the first states to install BCTs; the first installations were made in 1974. Through 1983 the total number of installations made and included in the Kentucky Department of Highway's summary of unit bid prices was 3,633. The average cost for each was \$515. A summary of BCT installations and costs for 1974-1983 is presented in Table 1. The BCT is the current recommended standard in Kentucky for all fills and solid rock cut sections that have an adequate recovery zone behind the guardrail. It should be noted that several BCTs without the parabolic flare have been installed in Kentucky. Before 1982 most BCTs were installed with the last 125 ft of rail placed on a simple curve (4.5 degrees) and an offset of 6 ft. In 1982 Kentucky's standard drawing for BCT installations was revised to reflect a parabolic flare over the last 37.5 ft with a 4-ft offset at the end. A recent installation of a BCT in Kentucky with a 4-ft offset and parabolic flare is shown in Figure 1. Shown in Figure 2 is a BCT installed by using the 4.5-degree simple curve with an offset of about 6 ft. Significant problems can occur if the end is not flared. Only a few accidents were found that involved a BCT without the designed offset. When the BCT end treatment is installed with the designed flare and offset, impacts with the end may result in very accept-

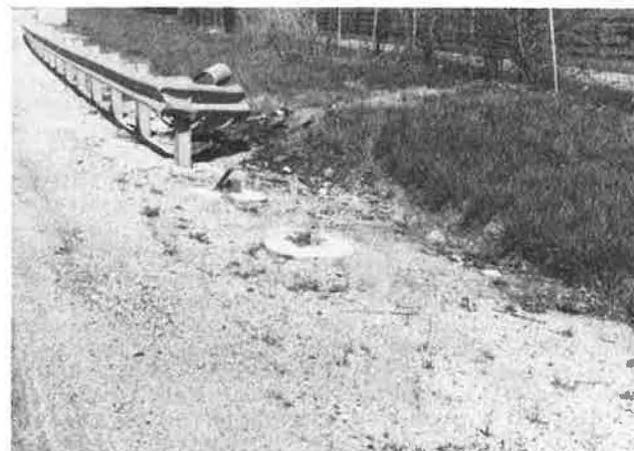
able performance, as shown in Figure 3. This BCT was constructed by using the 4.5-degree simple curve as the method to achieve the desired offset.

FIGURE 3 Proper performance of BCT end treatment.

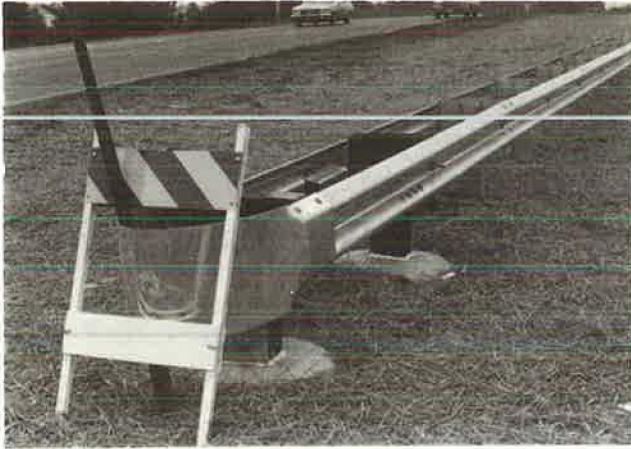
FIGURE 4 MBCT end treatment (Kentucky's Type 6).

The MBCT has not been installed in Kentucky as extensively as the BCT. For the period 1974 through 1983, a total of 573 was installed as a part of new construction or reconstruction projects and the average cost was \$627 per installation (Table 1). Kentucky's design utilizes two BCTs joined together at the end section as shown in Figure 4. It was noted earlier that head-on impacts into unflared BCTs could result in spearing of the vehicle. Similar problems are associated with head-on impacts into Kentucky's MBCT design (Figure 5). There appears to be little uniformity nationwide in the types of designs used for MBCT end treatments. Only a few states adopted the MBCT for use as it was designed and tested by SWRI. A typical installation using that design is shown in Figure 6. It should be noted that the BCT and MBCT evaluated in this study are the types used in Kentucky. Although the BCT now used in Kentucky is very similar to the design tested, evaluated, and recommended as part of the NCHRP studies (5), the MBCT varies considerably from the MBCT design recommended as part of the NCHRP studies (7,8).
