Timber Pole Safety by Design

DON L. IVEY and JAMES R. MORGAN

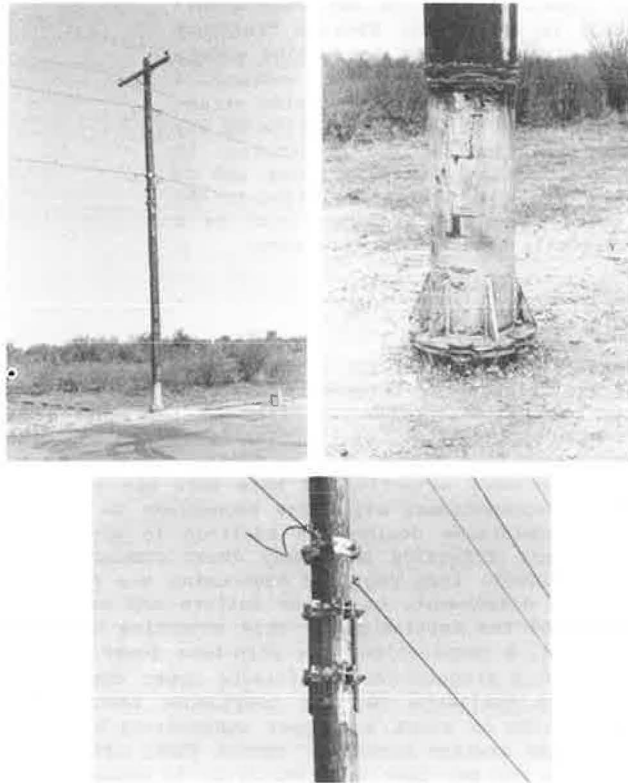
FIGURE 1 Modified utility pole installation.

The HBS design consists of a slip base similar to those developed by TTI 17 to 20 years ago for use on sign and luminaire supports (4): an upper hinge mechanism and structural support cables (overhead guys) (Figure 1). The slip base connection is unique in that it is a six-bolt connection to reduce weight.

These mechanisms are activated on impact and are intended to reduce the inertial effects of the pole on the errant vehicle while minimizing the impact on utility service. Typical performance of the HBS is shown in Figure 2. The slip base is designed to withstand the overturning moments imposed by in-service wind loads and, at the same time, slip when subjected to the forces of a collision.

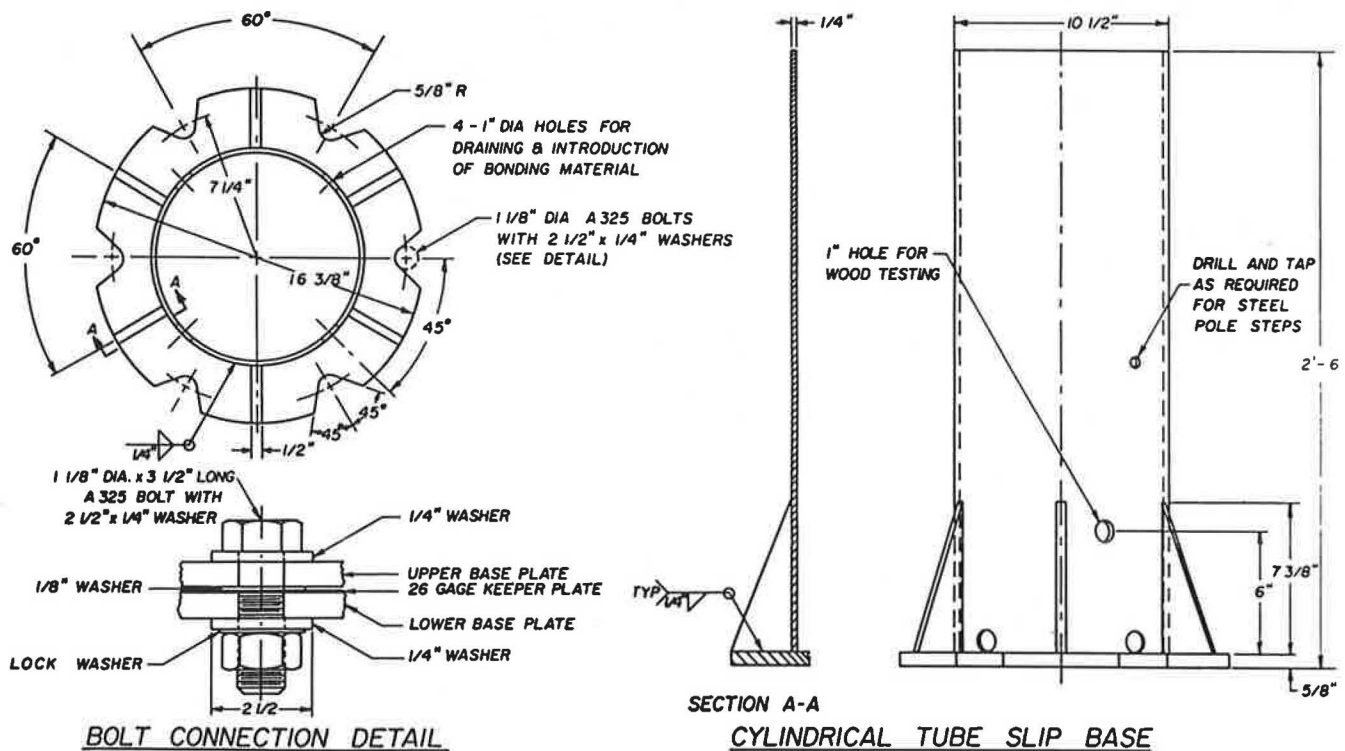
FIGURE 3 Lower connection—slip base.

A lower shear plane is created through installation of a slip base at an elevation of 3 in. above grade. The elevation of the slip base is intended to avoid snagging on the underside of an errant vehicle. This shear plane consists of two 5/8-in.-thick plates separated by a 26-gauge keeper plate (intended to maintain a bolt circle diameter of 15 1/2 in.) and by washers 2 1/2 in. in diameter by 1/8 in. The base plates are connected to each other by six 1-in.-diameter high-strength bolts with washers 2 1/2 in. by 1/4 in. These bolts are torqued to 200 ft-lb. Connection of the wooden utility pole to the slip base is through a steel pipe or tubing (Figure 3). These tubes are nominally 12 in. in diameter and 30 in. long and are welded to the base plates. In addition, the base plates are braced by 5/8-in.-thick stiffeners that are welded to both the base plate and the steel tube.

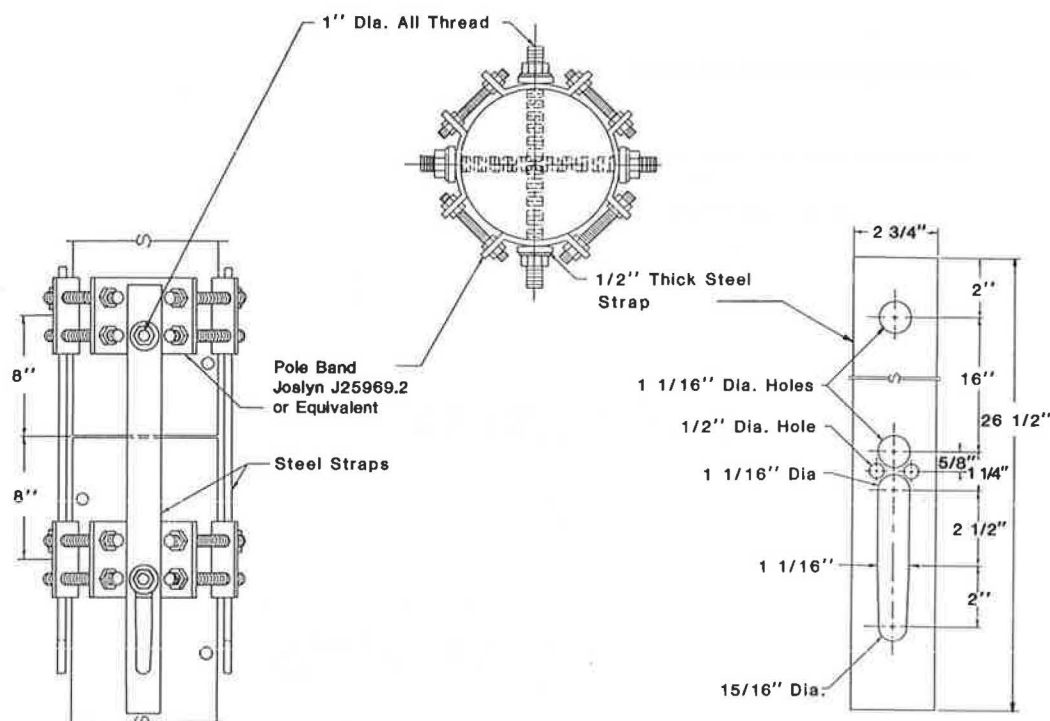
FIGURE 4 Upper connection—pole band with modified slotted straps.

The upper hinge mechanism is sized to adequately

transmit service loads while hinging during a collision to allow the bottom segment of the pole to rotate out of the way. This connection consists of two four-part pole bands installed above and below a saw cut through the pole and four straps connecting the two pole bands. The pole bands and straps are further secured to the pole by means of 1-in.-diameter through bolts as shown in Figure 4. At the bottom pole band, the bolts pass through the ends of the straps. At the lower end, the bolt holes are separated from four 1/2-in.-long slots by a 3/16-in. section of steel. Initial bending resistance is provided by the strength of this 3/16-in. margin. When the margin is punched out, resistance is offered by friction between the straps and bolts and by bending of the straps. When significant rotation has occurred, the bolts bear on the end of the slot, thereby providing the required ultimate bending strength. This upper connection reduces the effective inertia of the pole and minimizes the effect of any variation in hardware attached to the upper portion of the pole during a collision. The entire HBS system is designed to achieve the industry standard safety factor of four before ultimate failure. This design has been verified by static tests.

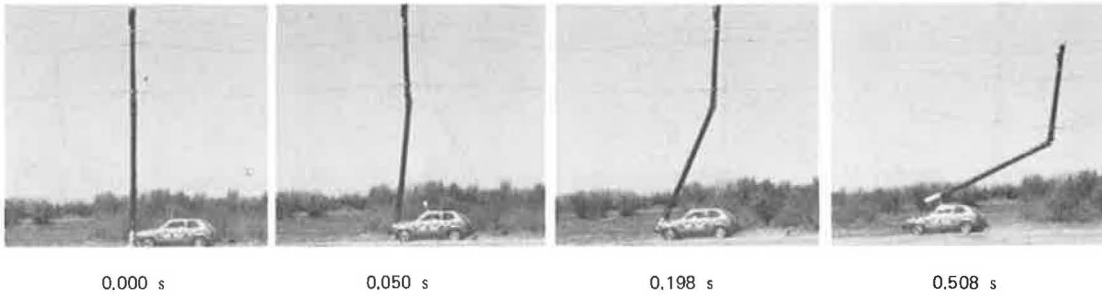
FIGURE 5 Summary of results for Test 4859-16 (Compliance Test 1).

Test No.	4859-16	Impact Speed	39.9 mi/h (64.2 km/h)
Date	4/03/85	Change in Velocity	11.5 mi/h (18.5 km/h)
Test Article	Breakaway Wooden Utility Pole	Change in Momentum	957 lb-s
Lower Connection	Slip Base	Vehicle Accelerations	
Upper Connection	Pole Band No. 3	(Max. 0.050 s Avg)	
Vehicle	1979 Honda Civic	Longitudinal	-8.0 g
Vehicle Weight		Lateral	0.8 g
Test Inertia	1826 lb (829 kg)	Occupant Impact Velocity	
Gross Static	2160 lb (981 kg)	Longitudinal	12.0 fps (3.7 m/s)
Vehicle Damage Classification		Lateral	4.2 fps (1.3 m/s)
TAD.	12FC2	Occupant Ridedown Accelerations	
CDC.	12FCEN2	Longitudinal	-1.0 g
Maximum Vehicle Crush		Lateral	0.5 g
Bumper Height.	10.0 in (25.4 cm)

The tests selected are given in Table 1. The primary purpose of each test is shown in the final column. The actual test conditions achieved are shown in parentheses. For example, in Test 1 the actual vehicle weight was 1,826 lb and the speed determined at impact was 39.9 mph.

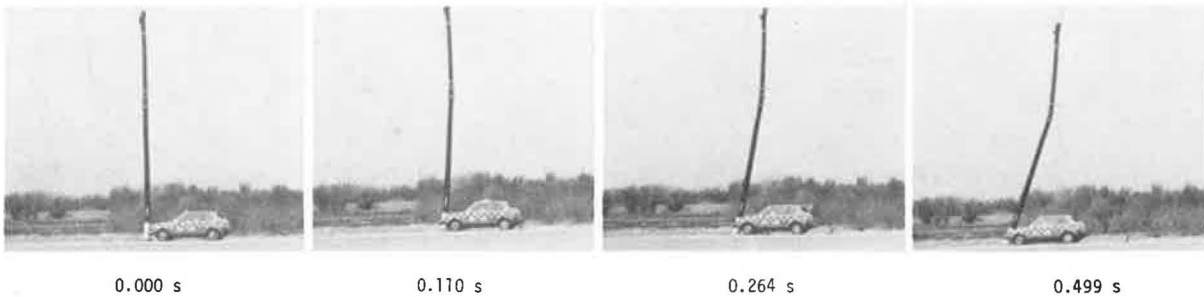
FIGURE 6 Summary of results for Test 4859-12 (Compliance Test 2).

Test No.	4859-12	Impact Speed.	19.5 mi/h (31.4 km/h)*
Date	2/20/85	Change in Velocity*	11.3 mi/h (18.2 km/h)
Test Article	Breakaway Wooden Utility Pole	Change in Momentum*	915 lb-s
Lower Connection	Slip Base	Vehicle Accelerations	
Upper Connection	Pole Band No. 2	(Max. 0.050 s Avg)	
Vehicle	1979 Honda Civic	Longitudinal	-6.7 g
Vehicle Weight		Lateral	0.7 g
Test Inertia	1775 lb (806 kg)	Occupant Impact Velocity	
Gross Static	2115 lb (960 kg)	Longitudinal	10.1 fps (3.1 m/s)
Vehicle Damage Classification		Lateral	3.5 fps (1.1 m/s)
TAD.	12FC3	Occupant Ridedown Accelerations	
CDC.	12FCEN1	Longitudinal	-2.1 g
Maximum Vehicle Crush		Lateral	1.9 g
Bumper Height.	8.0 in (20.3 cm)

*Impulse period computed from 0 to 0.500 sec.

Finally, Figure 12 was constructed using all available test data and a computer simulation. This figure shows the various zones of interaction between vehicles and HBS-modified poles. It also shows the calculated failure boundary for unmodified Class 4 timber utility poles. The activation boundary for the HBS occurs at about 10 mph for small vehicles and will decrease slightly as vehicle weight increases. As speed increases, the next zone is where the lower connection is activated and the pole is pushed in front of the impacting vehicle. The vehicle then stops and the pole leans on or descends on the vehicle. The velocity of the falling pole is so low that significant passenger compartment intrusion will not occur. This was illustrated by Compliance Test 2.

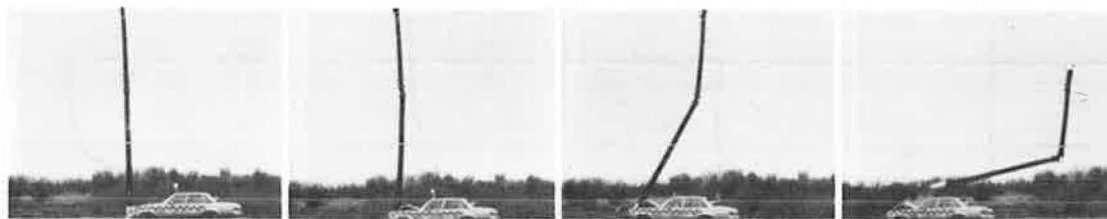
FIGURE 7 Summary of results for Test 4859-13 (Compliance Test 3).

Test No. 4859-13
 Date 2/27/85
 Test Article Breakaway Wooden
 Utility Pole
 Lower Connection Slip Base
 Upper Connection Pole Band No. 2
 Vehicle 1980 Chevrolet
 Malibu
 Vehicle Weight
 Test Inertia 3365 lb (1528 kg)
 Gross Static 3700 lb (1655 kg)
 Vehicle Damage Classification
 TAD 12FC5
 CDC 12FCEN2
 Maximum Vehicle Crush
 Bumper Height 18.7 in (47.5 cm)

Impact Speed 40.7 mi/h (65.5 km/h)
 Change in Velocity 10.8 mi/h (17.4 km/h)
 Change in Momentum 1655 lb-s
 Vehicle Accelerations
 (Max. 0.050 s Avg)
 Longitudinal -6.7 g
 Lateral 1.4 g
 Occupant Impact Velocity
 Longitudinal 11.9 fps (3.6 m/s)
 Lateral 6.3 fps (1.9 m/s)
 Occupant Ridedown Accelerations
 Longitudinal -1.4 g
 Lateral 1.1 g

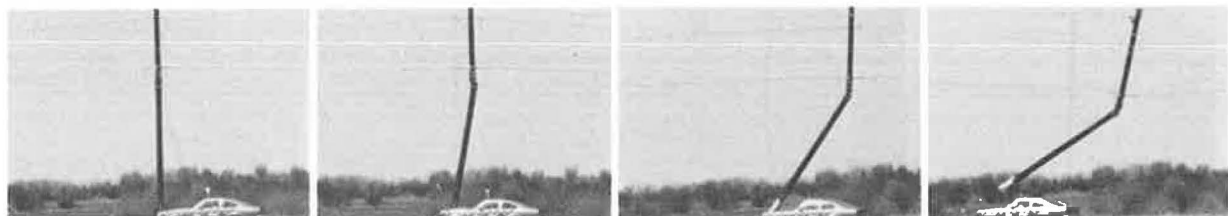
FIGURE 8 Summary of results for Test 4859-14 (Compliance Test 4).

Test No. 4859-14
 Date 3/22/85
 Test Article Breakaway Wooden
 Utility Pole
 Lower Connection Slip Base
 Upper Connection Pole Band No. 3
 Vehicle 1975 Chevrolet
 Vega
 Vehicle Weight
 Test Inertia 2500 lb (1135 kg)
 Gross Static 2830 lb (1285 kg)
 Vehicle Damage Classification
 TAD 12FR3
 CDC 12FREN2
 Maximum Vehicle Crush
 Bumper Height 15.0 in (38.1 cm)

Impact Speed 60.0 mi/h (96.5 km/h)
 Change in Velocity 11.0 mi/h (17.7 km/h)
 Change in Momentum 1253 lb-s
 Vehicle Accelerations
 (Max. 0.050 s Avg)
 Longitudinal -10.2 g
 Lateral -1.3 g
 Occupant Impact Velocity
 Longitudinal 15.6 fps (4.8 m/s)
 Lateral No Contact
 Occupant Ridedown Accelerations
 Longitudinal -1.8 g
 Lateral NA

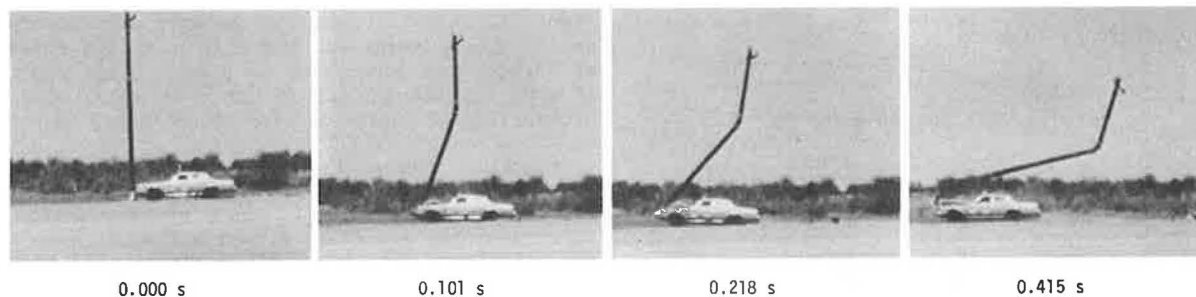
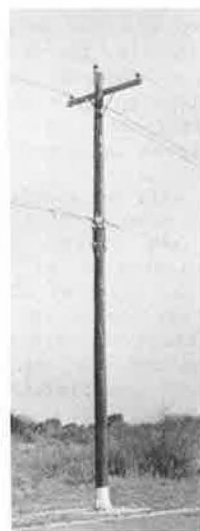
FIGURE 9 Summary of results for Test 4859-5 (Compliance Test 5).

Test No.	4859-5	Impact Speed.	56.8 mi/h (91.4 km/h)
Date	6/29/84	Change in Velocity.	7.0 mi/h (11.3 km/h)
Test Article	Breakaway Wooden Utility Pole	Change in Momentum.	1487 lb-s
Lower Connection	Slip Base	Vehicle Accelerations	
Upper Connection	Pole Band No. 2	(Max. 0.050 s Avg)	
Vehicle.	1979 Chrysler Newport	Longitudinal.	-4.9 g
Vehicle Weight		Lateral	0.6 g
Test Inertia	4331 lb (1966 kg)	Occupant Impact Velocity	
Gross Static	4665 lb (2118 kg)	Longitudinal.	10.7 fps (3.3 m/s)
Vehicle Damage Classification		Lateral	None
TAD.	12FC4	Occupant Ridedown Accelerations	
CDC.	12FCEN3	Longitudinal.	-0.8 g
Maximum Vehicle Crush		Lateral	No Contact
Bumper Height.	28.0 in (71.1 cm)		
Hood Height.	22.0 in (55.9 cm)

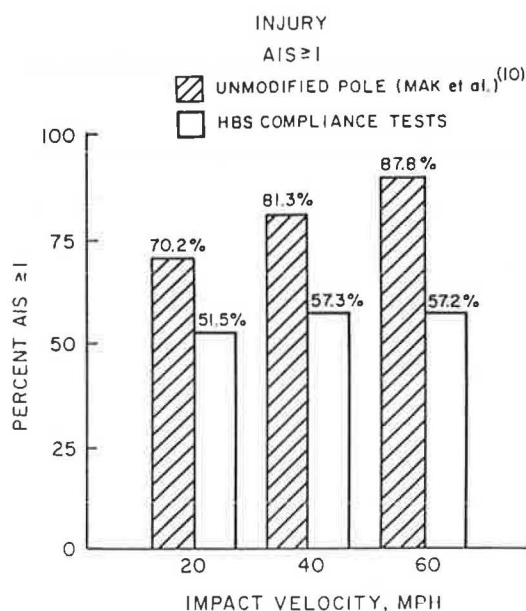
FIGURE 10 Comparison of injury levels from HBS compliance tests with unmodified pole injury levels (% AIS 1).

rate levels for any test can be seen by examining Table 2, it is somewhat easier to compare those levels using Figures 10 and 11. These bar graphs were developed for each test speed using Method 1 and present the average injury level for all tests at that speed. In Figure 10 it is seen that a significant improvement results. The greater improvement, however, is shown by Figure 11. A major decrease in the AIS ≥ 3 injury rate is demonstrated. This decrease, for the five compliance tests conducted, averages 91 percent. It is apparent from

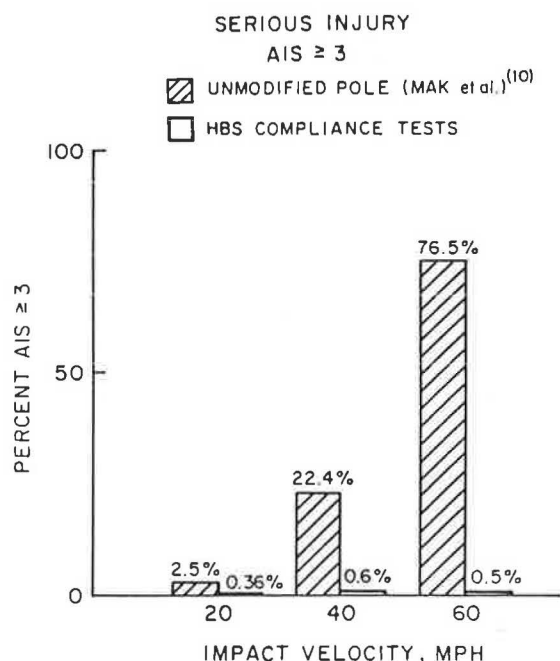
FIGURE 11 Comparison of injury levels from HBS compliance tests with unmodified pole injury levels (% AIS 3).

Figure 11 that the reduction becomes more pronounced as the speed increases. There is a slight advantage at 20 mph that progresses to a major improvement at 60 mph. For the 40- and 60-mph test conditions, the probability of injury greater than AIS = 3 is reduced by 97 percent.

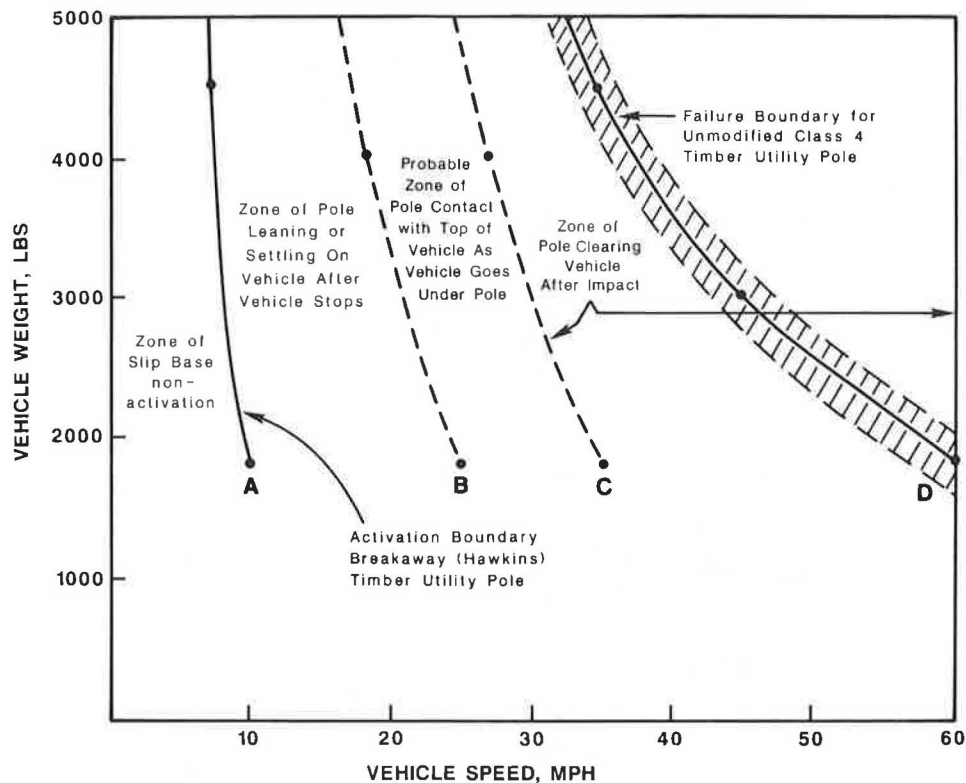
FIGURE 12 Zones of vehicle-pole interaction.

In the next zone the vehicle will go completely under the pole, but the pole will make contact with the roof or truck structure as the vehicle moves through. Passenger compartment intrusion will be minimal in this zone because of the rotation of the lower pole segment to a position where it will glance off or be pulled across the roof structure. The zone is not precisely defined but will vary as vehicle structural stiffness and coefficient of restitution vary. Finally, the zone where the pole clears the vehicle after impact is everywhere to the right of Curve C. This is the zone illustrated by compliance Tests 1 and 3-5.
