Report and Review of a Major Slabjacking Case History

A review is presented of a major case history of lifting and leveling portland cement concrete highway slabs by injection of a fluid cement/pozzolan material between the subgrade and the slab. The paper includes history and background data as well as current practices, advantages, disadvantages, and specific procedures. Grout materials, mixtures, equipment, and lifting controls are discussed.

In June of 1981 the Wyoming State Highway Department solicited bids for Statewide Slabjacking Project SMP-7892. It was to involve the lifting and re-leveling of concrete bridge approach slabs, highway dips caused by improper compaction over underground structures, and filling of voided areas behind sloped concrete paving around bridge abutments. There were more than 167 separate locations listed, from Green River to Gillette, Wyoming, on state and Interstate highways 373, 80, 25, and 90.

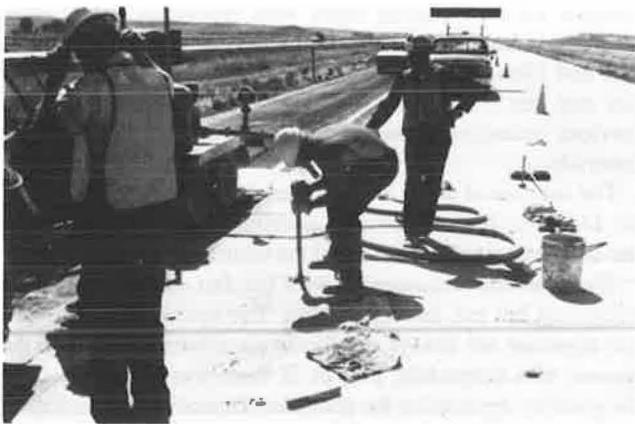
FIGURE 2 Typical grouting operations.

Typical grouting operations are shown in Figure 2.

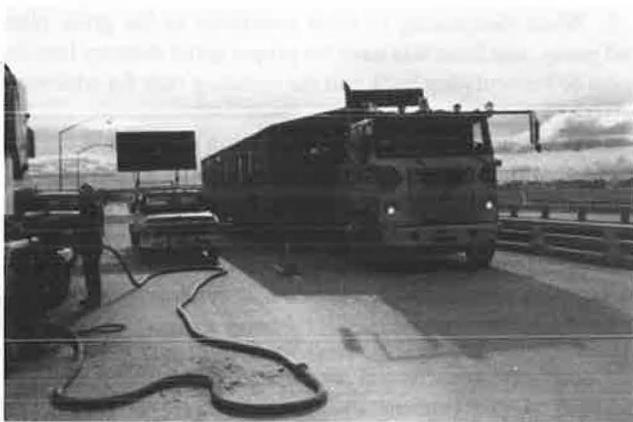
FIGURE 3 Wide loads and high-speed trucks are a constant safety hazard.

The most dangerous aspect of this project was that the grouting technicians were working close to high-speed traffic (Figure 3). Despite repeated attempts by the traffic controllers to slow traffic to the posted 40 mph (64 km/hr) the speed of a passing vehicle in the adjacent lane averaged 57 mph (92 km/hr). This meant that the grouting technicians and engineers had to be alert at all times, especially when working a row of holes along the center dividing line. Semitrailer trucks passing at high speeds would cause a rush of air followed by a suction effect that threatened to pull workers under the truck unless they were

Due to the many varied locations of this project, it was not feasible to consider installing median barriers for protection; therefore, requesting a patrol car to work with the traffic controllers became the most effective way of holding speeds to a minimum.
