Mitigating Artesian Water Flow by Pressure Grouting on U.S. 101 in San Jose, California

KEN JACKURA AND ED GRAF

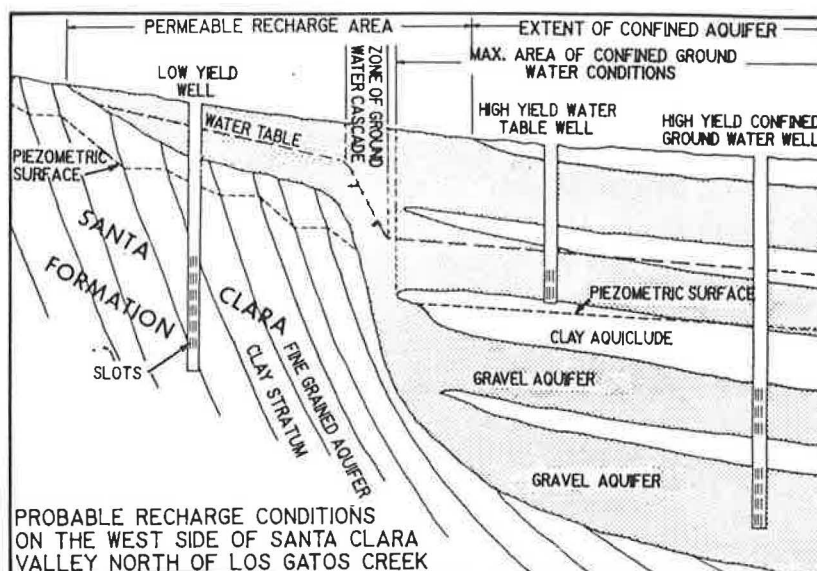
FIGURE 2 Generalized soil cross section of northwestern San Jose area showing aquifers and predominant method of natural recharge through the Santa Clara formation.

Underlying this upper aquifer are three others at depths of about 150, 350, and 550 ft. All are significant water-bearing strata. The aquifers are separated by impervious boundaries of clays, mixtures of clay, silts, sands, and cobbles. A generalized cross section of the subsurface conditions is shown in Figure 2. The illustration has no scale, but provides a general idea of the underground conditions showing water transport and recharge behavior. Recharge of the aquifer systems is primarily through the Santa Clara formation lying west of the site. Some recharge is also developed through infiltration and is most predominant in the uppermost aquifer.

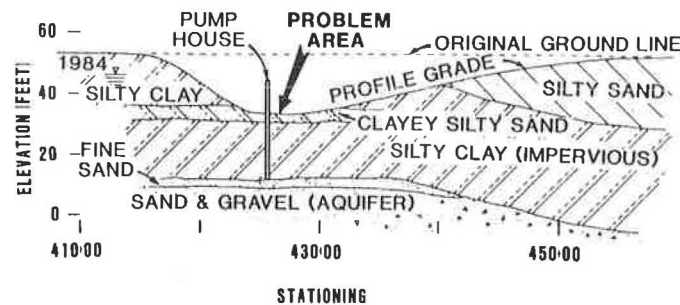
FIGURE 3 U.S. 101 profile of grade and soil types between Stations 410 and 460.

Borings conducted in the early 1950s revealed silts and clays to a depth of 40 ft within the major portion of the depressed section, as illustrated on the profile map (Figure 3).

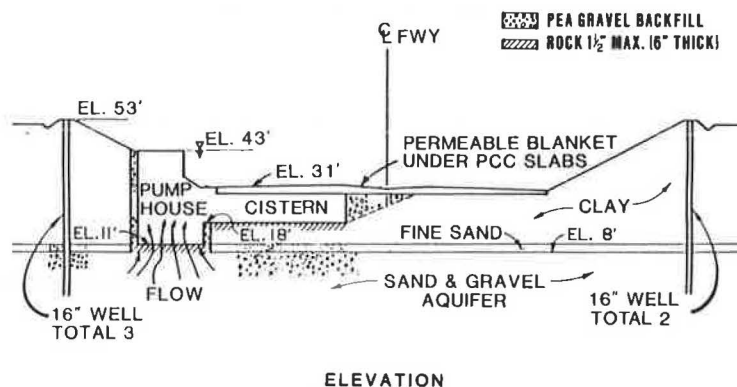
FIGURE 4 San Jose 10th Street Pump House, U.S. 101 (looking north).

Collected groundwater and storm water runoff was to be handled by a pump house and a 50-ft × 50-ft × 8-ft-high cistern as shown in Figure 4. Uplift pressures on the pump house and cistern were developed on the assumption that the phreatic line would be no higher than 2 ft below the finished profile grade elevation of 31 ft. Hence, buoyancy of these features was predicated on that assumption.

After reaching some critical pressure head, possibly 5 to 8 ft above freeway grade, piping of the fine sand layer overlying the sand and gravel aquifer into the clean gravel backfill developed opening channels for large water flows to the surface (see Figure 4). Inducing quick release of the pressure head at the surface aggravated the scouring action of the sand blanket just beneath the pavement and resulted in the further undermining of the pump house and cistern.

Phase I grouting was to seal the perimeter of the pump house. This was accomplished from the sloping surface around the pump house using grout injection points driven to Elevation 10 (Figure 4) and staged up.

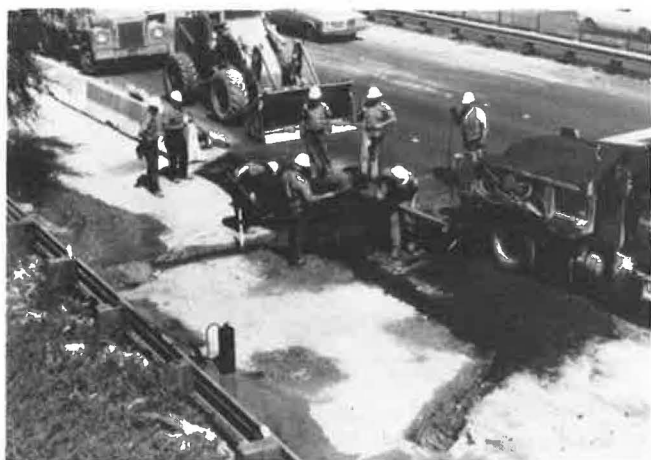
other Caltrans crews started relieving the hydrostatic pressure by trenching along the southbound lane shoulder. Trenching produced immediate relief of the slab uplift pressure by releasing large water flows estimated in excess of 1,000 gpm (Figure 5). Simultaneously, several workers descended into the cistern for inspection. Water flows into the cistern from the original drainage system were negligible and the crews decided to core into the 18-in. thick concrete walls to help relieve the large surface flows. Sixteen 2-in.-diameter core holes were drilled during the next several days; each hole produced large streams of water estimated at between 50 to 100 gpm.

FIGURE 5 Temporary repair of shoulder where a relief trench was cut to allow the water to flow from the highway subgrade.

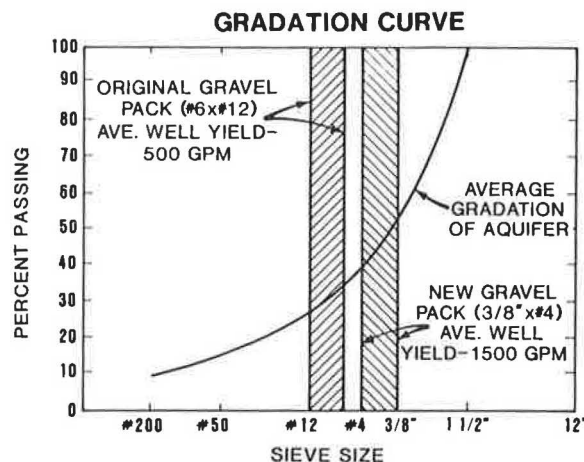
Soil borings made by Caltrans before the well drilling indicated the aquifer was made up of the least 60 percent gravel with less than 10 percent minus No. 200 sieve sizes. Sampling techniques limited the maximum material size to 2 in.; hence, larger sampling diameters would have undoubtedly yielded a higher gravel percentage. Figure 6 shows the gradation of the aquifer and the No. 6 \times No. 12 Monterey sand used as gravel pack.

FIGURE 6 Gradation averages of aquifer and gravel packs. Original gravel pack incorporated 0.045-in. slotted screen; new gravel pack incorporated 0.100-in. slotted screen.

As a result, a decision was made to install three additional wells, two on the south side of the freeway and one on the north side. This time Caltrans engineers decided to install a 100-slot screen (0.100-in. opening) and increase the gravel pack to $\frac{3}{8}$ in. \times No. 4 (see Figure 6) to increase well yield and risk migration of fines from the aquifer.

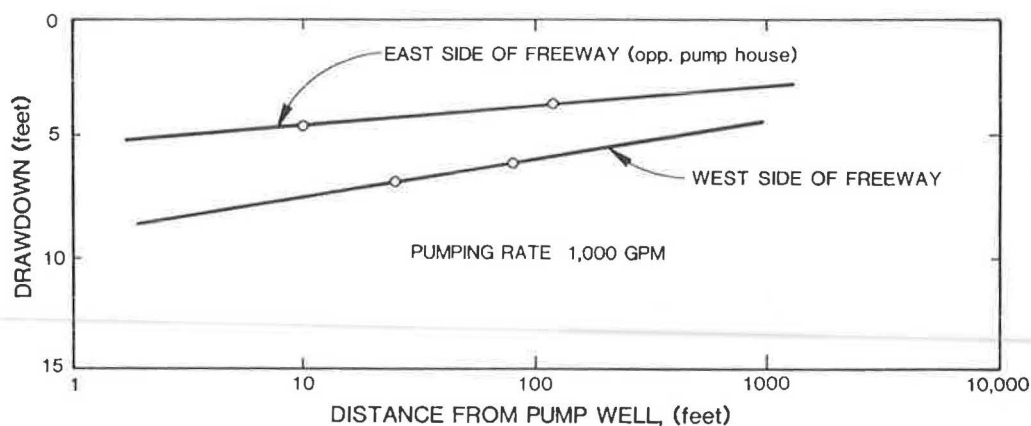
several weeks and indicated an approximate 5-ft drawdown at 100 ft under a combined pumping rate of 1,000 gpm (Figure 7). Because the wells were located approximately 110 ft from freeway centerline, a combined long-term pumping rate of at least 3,000 gpm was estimated to develop a theoretical 15-ft drawdown at centerline. A 15-ft drawdown was considered about the minimum required for an economic grouting program.

FIGURE 7 Drawdown characteristics of aquifer on east and west side of freeway. East side curve typified area drawdown when full dewatering was implemented.

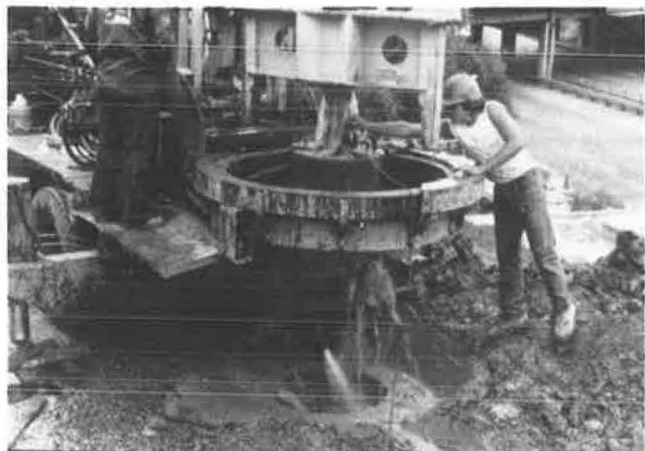
Once these new wells were in and flushed, pumping began with significant increases in flow. The new north-side well had a long-term capacity in excess of 2,500 gpm, whereas the two south-side wells had long-term capacities of about 1,500 gpm. The belief that a significant increase in the migration of fines would occur was unfounded as pumped water indicated turbidity almost the same as that in the first two wells. With all pumps turned on, more than 5,000 gpm could now be pumped resulting in a drawdown of about 19 ft (Elevation 24) in the vicinity of the cistern. Figures 8 and 9 show the wells after installation and water discharge during pumping.

FIGURE 8 Bucket rig used in drilling wells. Upper 40 ft lined with 30-in. corrugated metal pipe and concrete backfilled. Water jet spray used for cleaning.

Subsequently, plans were made to install wells on both sides of the freeway at dike (original ground) level. Initially only two wells were planned, one on each side of the freeway. Holes were augered with a 36-in.-diameter bucket to a depth of 40 ft and cased with a 30-in. corrugated metal pipe with the annular space backfilled with concrete. Following this, a 16-in.-diameter 45-slot (0.045-in. openings) stainless-steel well screen was placed. Well-screen length was 30 ft and the screen was positioned within the limits of the aquifer. Gravel packing around the screen consisted of No. 6 \times No. 12 Monterey sand (Figure 6). Gravel pack and well-screen size used were the responsibility of the experienced well-drilling contractor.

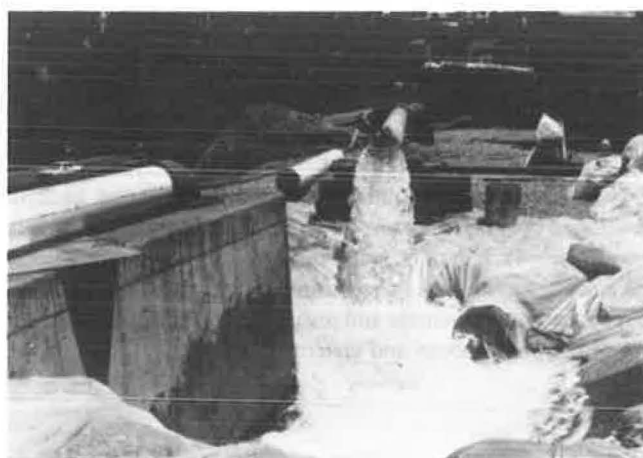
FIGURE 9 Discharge from one of the wells during well development.

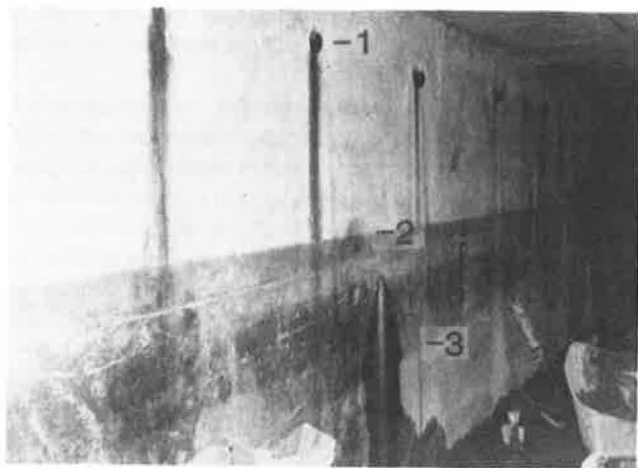
cistern (previously drilled to relieve water pressure from the highway pavement) scoured fines from the subgrade, the underlying silt and clay layer, and presumably from the aquifer itself, and ended up in the cistern, which acted as a settlement pond. During the pump-house grouting (Phases I and II) almost 150 yd³ of silt was removed from the cistern using a propane-powered Bobcat loader and hoisting it to the surface for transportation to a disposal site. Figure 10 shows the drilled relief holes and silt line within the cistern.

FIGURE 10 Inside 8-ft tall cistern. Note (a) drilled water pressure relief holes, (b) high water line, and (c) silt line.

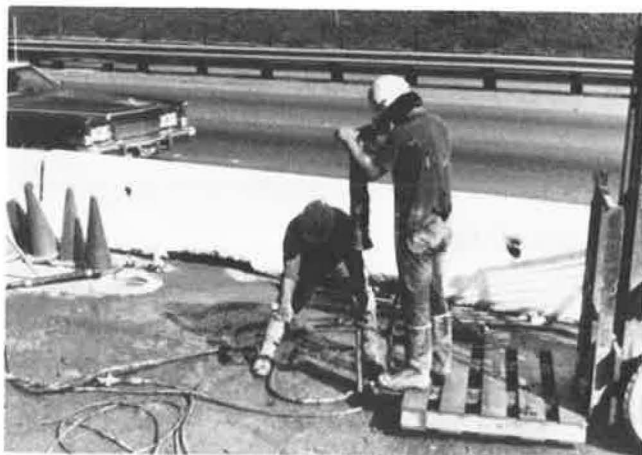
To determine pile tip elevation and anchor pullout resistance, soil anchors were driven into the ground at freeway surface and load tested. Soil anchors consisted of perforated 2-in.-diameter Schedule 80 steel pipe in 5-ft lengths, coupled with steel pipe sleeves (40-kip rupture). The anchors were driven by a pneumatic 90-lb pavement breaker (Figure 11) to depths of 30, 40, and 50 ft into the sand and gravel and then grouted in place. A minimum holding capacity of 30 kips was necessary, which was developed with the 50-ft penetration depth. Figure 12 shows the loading and reaction-frame apparatus used for the pullout resistance tests.

FIGURE 11 Air hammer used in driving soil anchors to depth. Location where test soil anchor is driven.

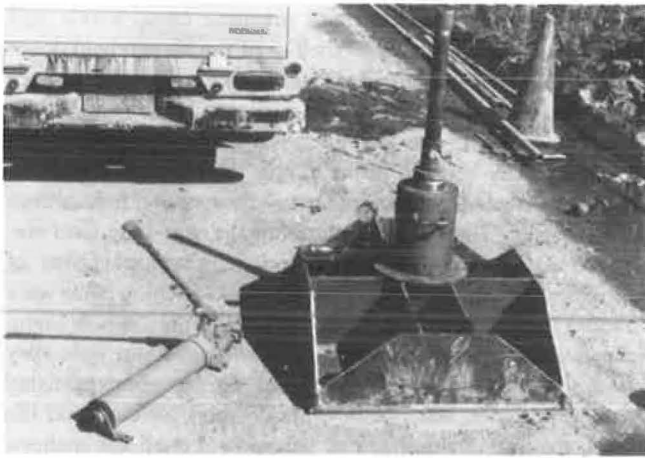
FIGURE 12 Hydraulic jack and reaction frame used for testing pile anchor capacity.

Design working load of each anchor was 20 kips with the ultimate estimated load between 30 and 35 kips. During the grouting process, anchors were periodically load tested for pullout capacity. Approximately 10 percent were tested with the first few indicating low pullout capacities of between 25 and 27 kips. Sandblasting the pipe and a change in the grouting procedure before placement resulted in the pullout resistance exceeding the 30-kip capacity requirement.

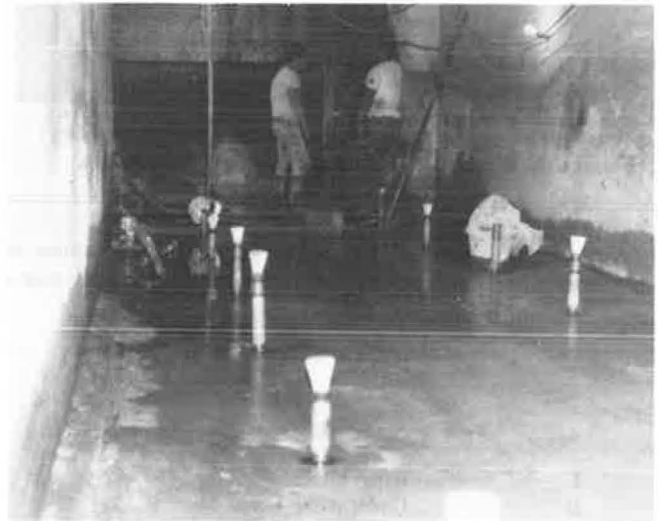
Figure 13 shows the soil anchors installed within the cistern before grouting and cutoff. Because the dewatering reduced the head, there was only a small inflow from the aquifer through these anchors. Casings were set from the top of slab to above the water table owing to the high head in the pump house, and all work progressed through the casings until the anchors were grouted.

FIGURE 13 Soil anchors installed in cistern before grouting and cutoff.

Once the technique was developed for anchor placement and grouting, the contractor began placement of the anchors within the cistern on September 7, 1985. A total of 105 soil anchors were placed within the cistern and 33 were placed within the pump house. The job was completed on November 1, 1983, 43 working days after driving the first anchor.
