TRANSPORTATION RESEARCH RECORD **1104**

# Geotechnical Grouting

TRANSPORTATION RESEARCH BOARD  
NATIONAL RESEARCH COUNCIL

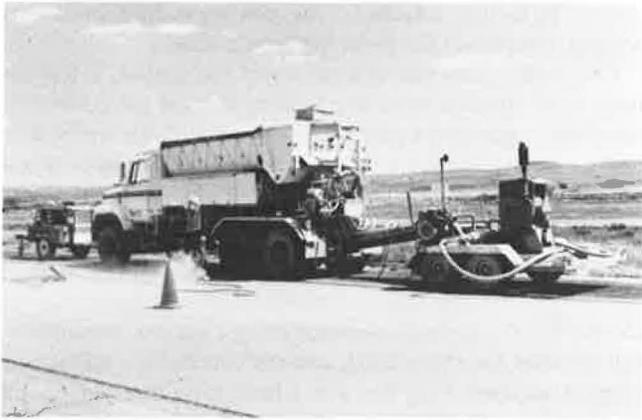
FIGURE 1 Grout plant set up for bulk handling of materials.

1. A modified Daffin concrete mobile used as a volumetrically calibrated batch plant. It had a loaded capacity of 324  $ft^3$  (9.17  $m^3$ ) of bulk materials with a 300-gal (1136-L) water tank, all mounted on a tandem truck.
2. A custom-built pumping trailer consisting of a 7  $ft^3$  (0.20  $m^3$ ) agitating tank, a high-speed colloidal mixing unit, and a 6-in. (152-mm) cavity advancing Moyno pump.
3. Two auger feed bulk tankers, used to tender the concrete mobile with pozzolan and cement materials.

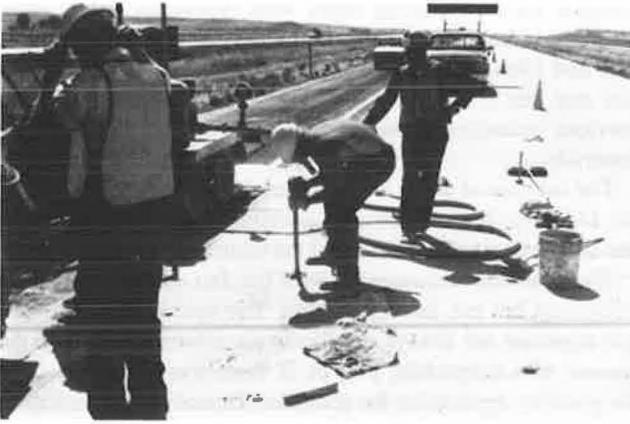
FIGURE 2 Typical grouting operations.

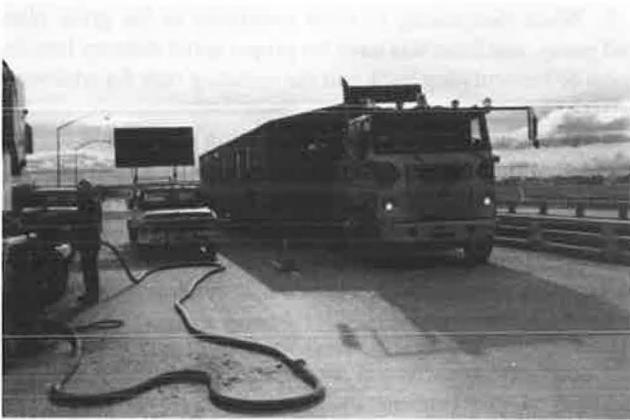
FIGURE 3 Wide loads and high-speed trucks are a constant safety hazard.

The most dangerous aspect of this project was that the grouting technicians were working close to high-speed traffic (Figure 3). Despite repeated attempts by the traffic controllers to slow traffic to the posted 40 mph (64 km/hr) the speed of a passing vehicle in the adjacent lane averaged 57 mph (92 km/hr). This meant that the grouting technicians and engineers had to be alert at all times, especially when working a row of holes along the center dividing line. Semitrailer trucks passing at high speeds would cause a rush of air followed by a suction effect that threatened to pull workers under the truck unless they were

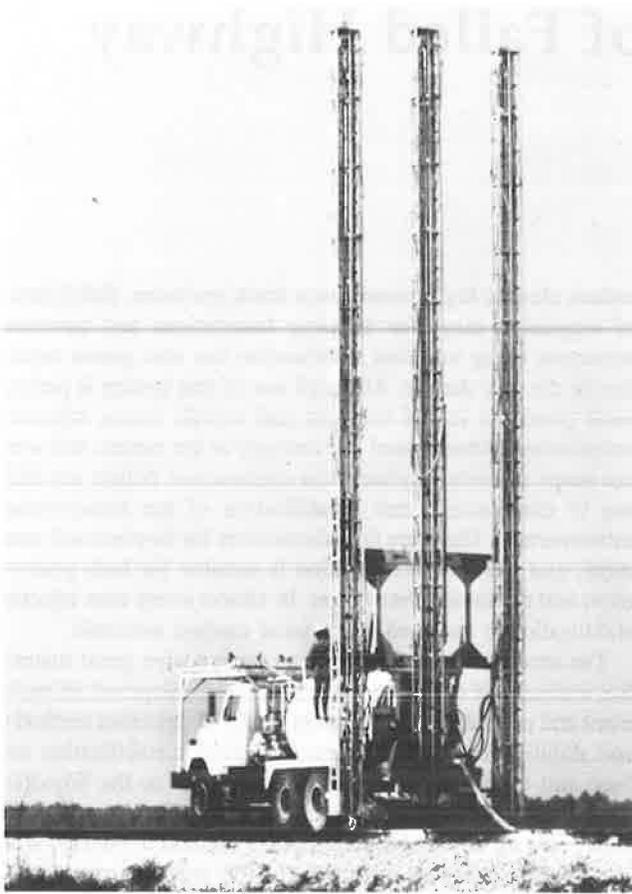
FIGURE 1 Injection truck, 40 ft.

50 to 200 psi. It will operate on railroad tracks, paved roads, or compacted surfaces. Other injection vehicles are mounted on rubber-tired or crawler tractor machines (see Figures 2 and 3) for off-road capability such as embankments or construction sites. The bulk slurry mixing tanks are usually 10 ft in diameter by 30 to 40 ft long and are used for mixing either lime or L/FA slurry. These tanks are portable and are easily transported from one site to another with a tractor truck. Some tanks (Figure 4) are equipped with high-pressure pumps so that slurry can be

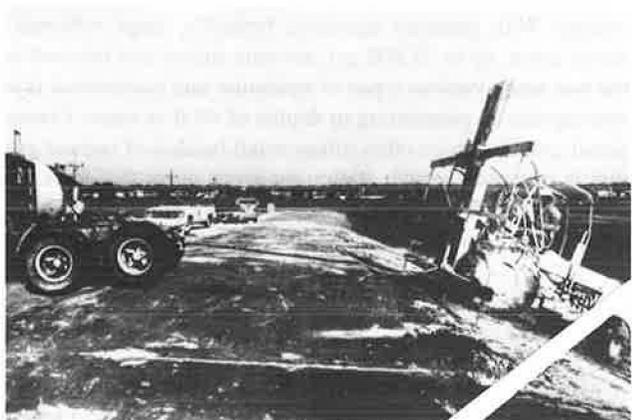
FIGURE 2 Rubber-tired off-road injection machine operating on an embankment.

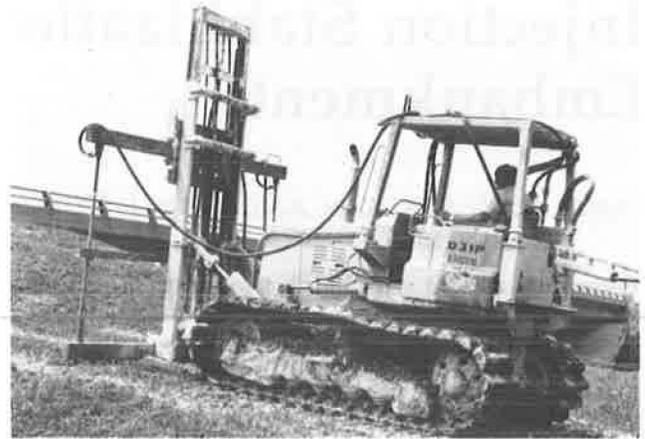
FIGURE 3 Trac-powered injection equipment on highway embankment.

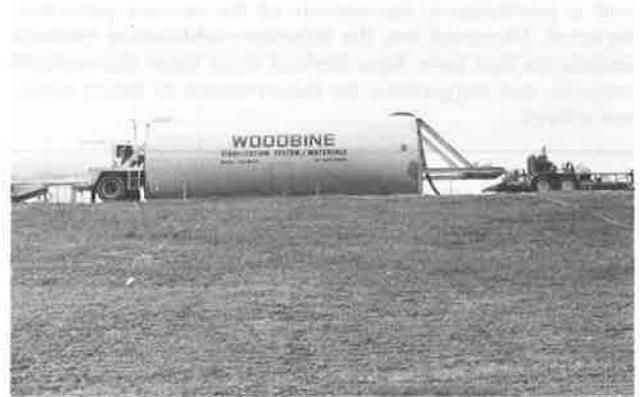
FIGURE 4 Slurry mixing tank on site in Arkansas.

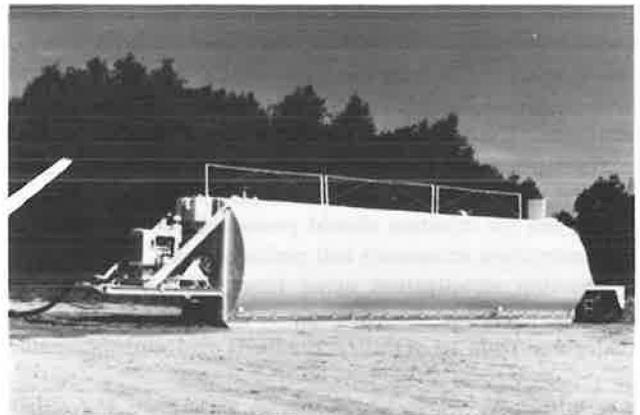
FIGURE 5 Porta batch high-capacity lime slaker.

The economy and convenience of jobsite lime slaking is now possible with new portable batch slakers, shown in Figure 5. Although these are relatively new to the marketplace, the system has been developed and proven over the past 5 years and is in daily use on stabilization projects. This portable batch slaker is a high-capacity lime slaker that can convert up to 25 tons of quicklime into 30 tons or more of hydrated lime slurry

in less than 1 hour. It is a totally enclosed, dust-free system that is simple and safe to operate.

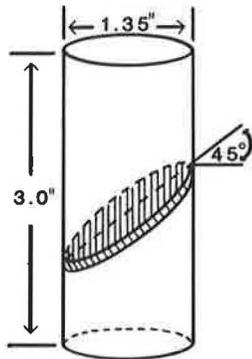
FIGURE 8 Angle split-seam-stabilized compression specimen, shear reinforcement.

The seam-stabilized compression specimens are of two types, straight seam (Figure 7) and angle seam (Figure 8). The straight-seam sample is designed for evaluation of the compression strength-reinforcement component of the stabilized seam, and the angle-seam sample is designed for evaluation of the shear-reinforcement component of the stabilized seam. Typically, the contribution of both compression and shear will be used in repairing cracks in embankment failures. These

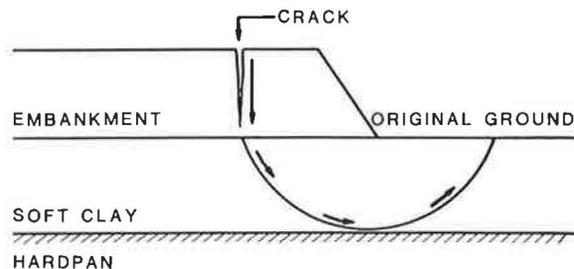
FIGURE 11 Failure surface passing through crack in embankment.

Embankment failures can be divided into two general groups, those occurring in embankments built on foundations of soft clay and silt, and those built on stiff soil foundations (5). Embankments built on foundations of soft clay and silt are typified by cracks originating in the vicinity of the bottom of the interface between the fill and the top of the foundation, as shown in Figure 11; whereas, those built on hard or stiff foundations are typified by surface failures originating with surface cracks, as shown in Figure 12. A study of the origination, location, and growth pattern of embankment cracks is paramount to understanding the need for different renovation techniques because the inherent soil strength may not contribute to the stability of the embankment slope if the embankment fill is substantially cracked. Therefore, crack mending can be critical to embankment renovation.

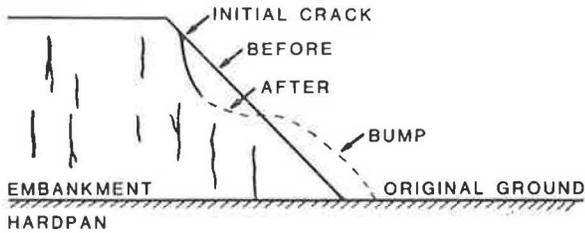
FIGURE 12 Failure surface passing through crack.

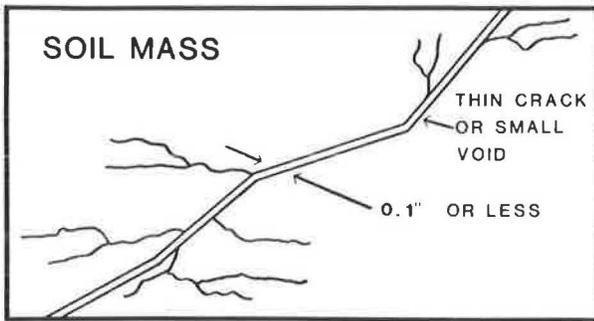
FIGURE 13 Soil crack before stabilization with lime slurry pressure injection.

There are certain characteristics of lime and L/FA seams that should be recognized. Figures 13–16 illustrate the concepts of how crack repair is made by LSPI and L/FA seams, respectively. These seam-stabilization concepts were given important consideration in the design of the seam- and glaze-stabilized laboratory evaluation tests previously discussed.

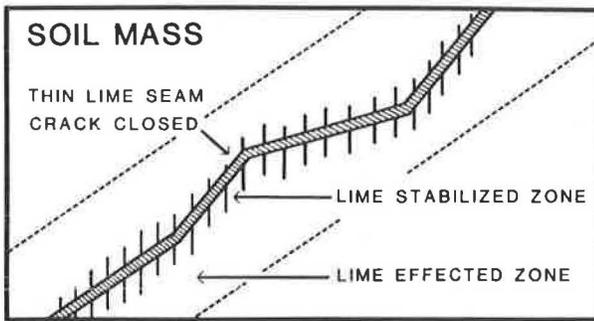
FIGURE 14 Soil crack after stabilization with lime slurry pressure injection.

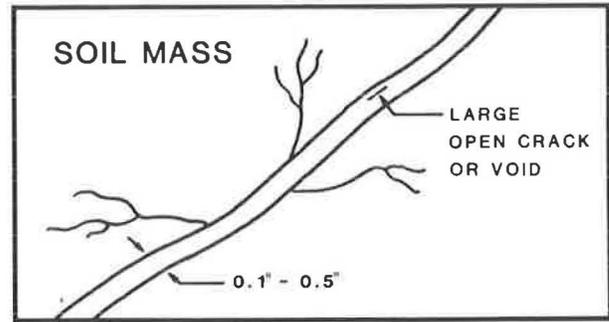
FIGURE 15 Large soil crack before stabilization with lime/fly ash injection.

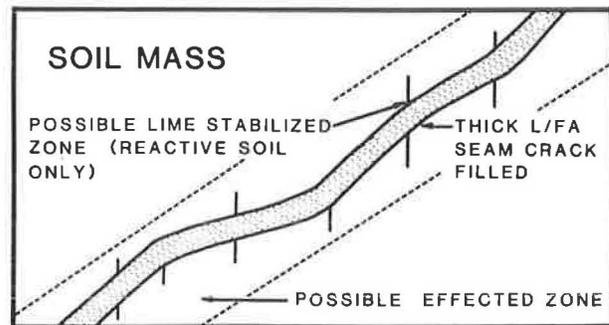
FIGURE 16 Large crack after stabilization with lime/fly ash injection.

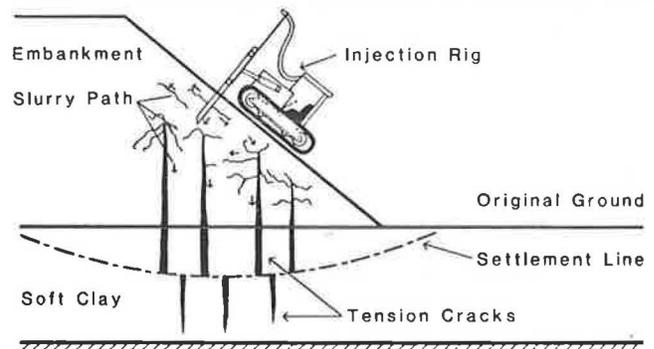
FIGURE 17 Tension cracks filling with lime/fly ash slurry.

Injection stabilization increases the strength of embankments by adding reinforcing strength and mending existing cracks, allowing peak strength of the embankment fill and the foundation subsoil to be mobilized simultaneously, thus reducing progressive failure effects. Cracks may develop in embankments because of excessive tensile stresses in the underlying fill due to differential settlements or because of shrinkage stresses due to drying. Many tension cracks frequently begin at the bottom of the fill, progress upward, and may not be detected until the embankment is seriously failing. The injection-stabilization method has been developed to treat cracks and planes of weakness in situ, even those cracks that are not visible from the surface (Figure 17). In general, cut and replace does not mend

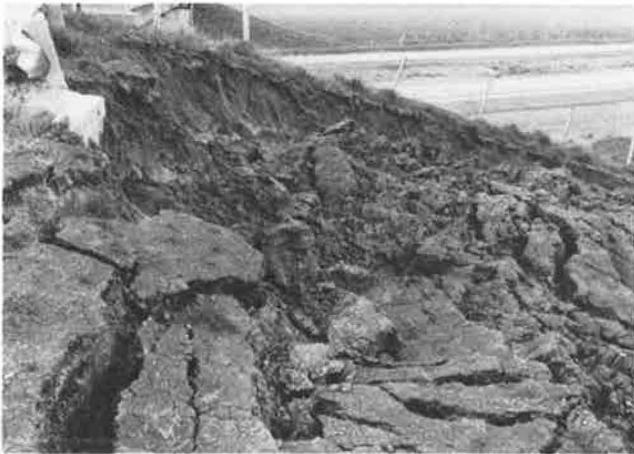
FIGURE 18 Slope failure on highway embankment.

1. The failed embankment, as shown in Figure 18, is bladed and compacted into shape and drainage is corrected.
2. The surface is proof rolled and compacted at prescribed limits of moisture and density, perpendicular to the face of the slope.

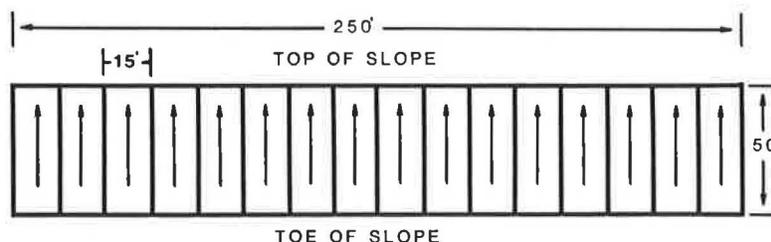
FIGURE 19 Injection equipment progress chart.

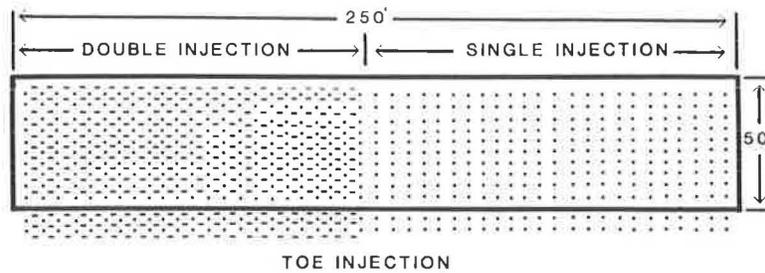
FIGURE 20 Embankment injection patterns.

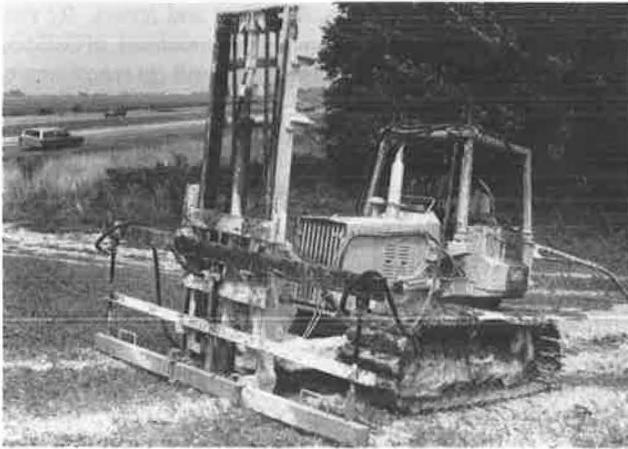
FIGURE 21 Injection rig advancing on injection pattern.

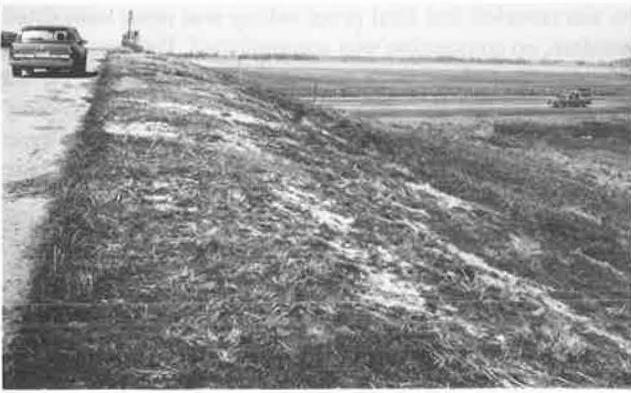
FIGURE 22 Bolling Road embankment: primary slide zone, 18 months after lime/fly ash stabilization.

The L/FA injection stabilization was performed in July 1983. On the first day the injection work was performed, a regional demonstration was held in West Memphis, Arkansas, and attended by personnel from state and federal agencies throughout the region. During the demonstration one of the maintenance engineers from Arkansas, who was familiar with the history of this slope, stated that if the slope was still standing after the next spring he would consider the job a success. The slope to be treated had failed twice in the spring before injection. Shortly after completion of the injection one of the slopes on the opposite side of the Interstate failed. This slope had been repaired at the same time the test slope and adjacent control were repaired. Early in December 1984, the control section failed. This was 18 months after injection of the test section. In January 1985, inspection of the test slope revealed that a shallow surface slough had occurred approximately 185 ft from the bridge end. The slough is 12 to 18 in. deep and extends for about 60 to 70 ft. Photographs of the treated slope showing the original area of failure before injec-

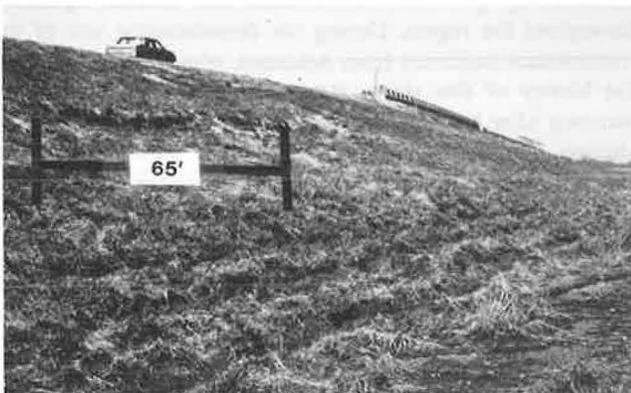
FIGURE 23 Bolling Road embankment: observed shallow surface slough, March 1985.

2. Immediately after injection the lime or L/FA slurry on the surface should be mixed into the top 6 in. and properly recompact. This was not done on this job.

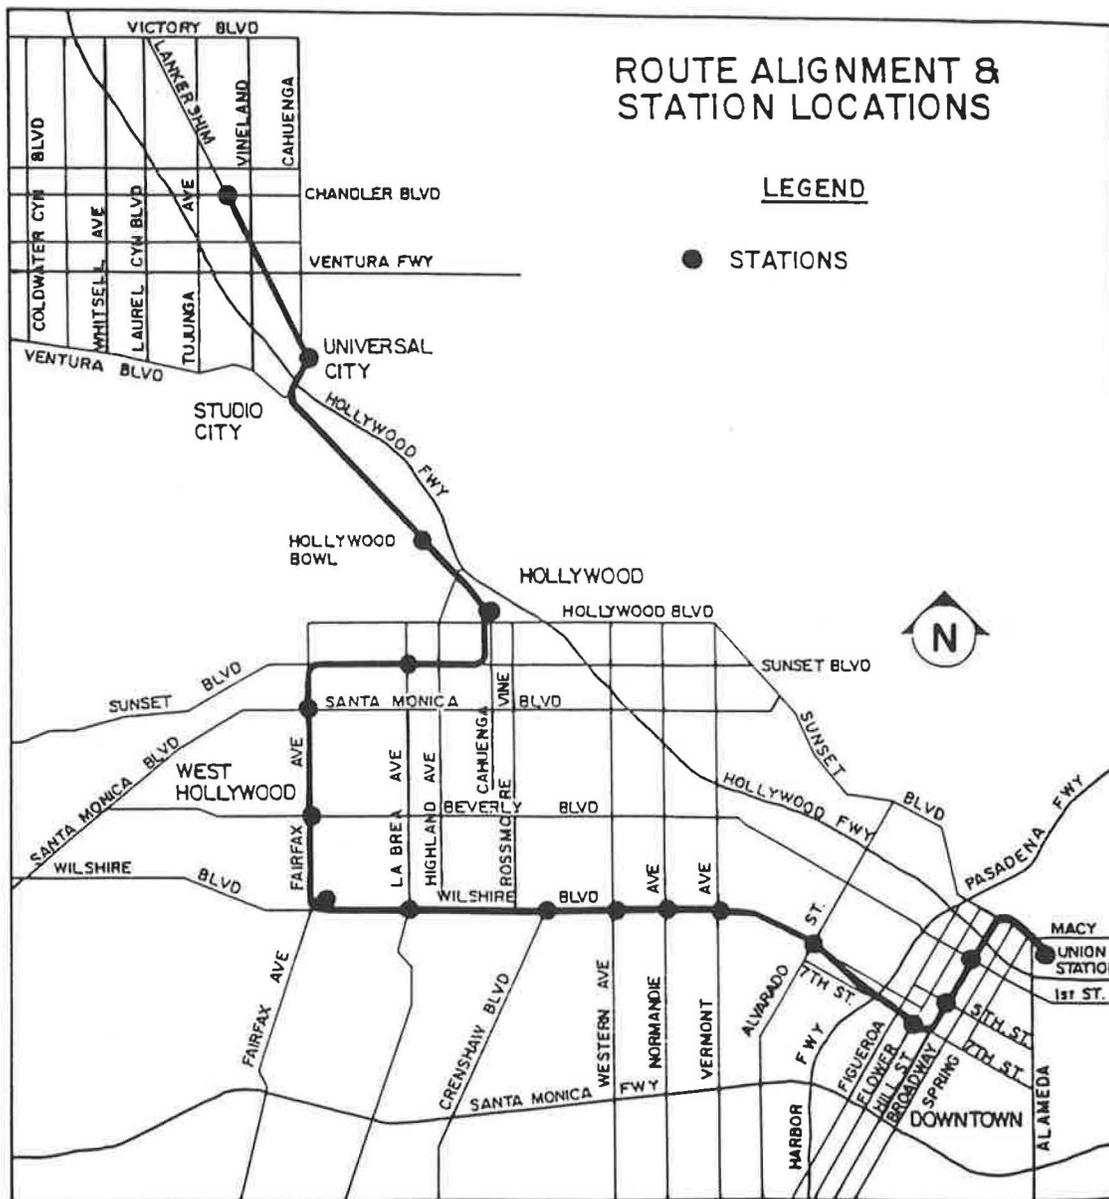
FIGURE 1 Schematic alignment.

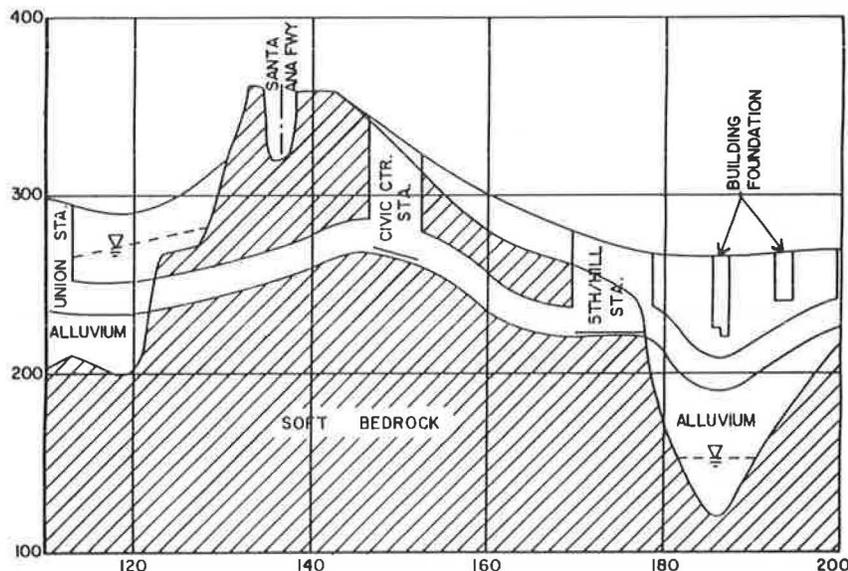
**FIGURE 2** General subsurface conditions.

In general terms, the subsurface conditions along Design Unit A-140 consist of alluvium over weak claystones and siltstones (1, 2). The general subsurface conditions are shown in Figure 2. The alluvium largely consists of clean sands and gravels, but may also contain some silt, clay, and boulders. The thickness of

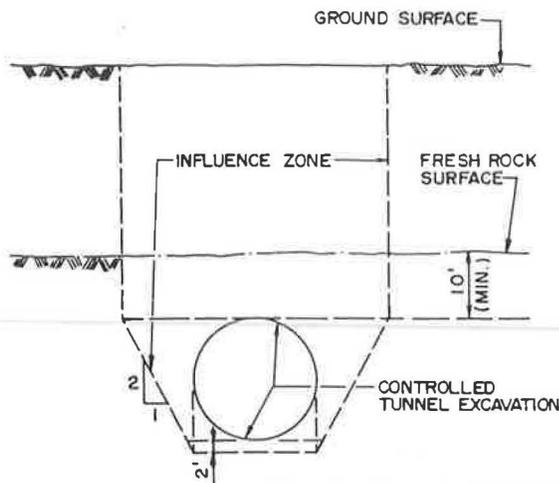
FIGURE 4 Underpinning guidelines for tunnel construction in rock.

Underpinning guidelines for tunnel construction are shown in Figures 4 and 5. Application of these guidelines resulted in more than 30 buildings deemed to be within the zone of influence of tunneling and, therefore, considered to be at risk from ground movement. The most economically important buildings located within the defined influence zone are given in Table 3. The necessity of protective measures for these struc-

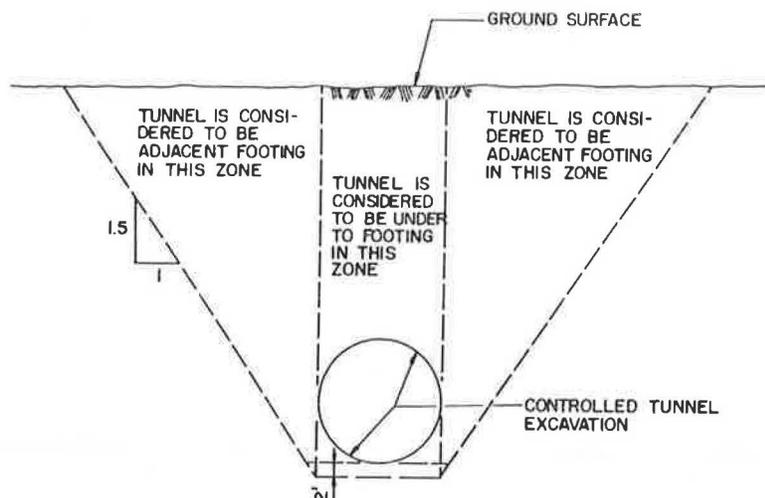
FIGURE 5 Underpinning guidelines for tunnel construction in soft ground.

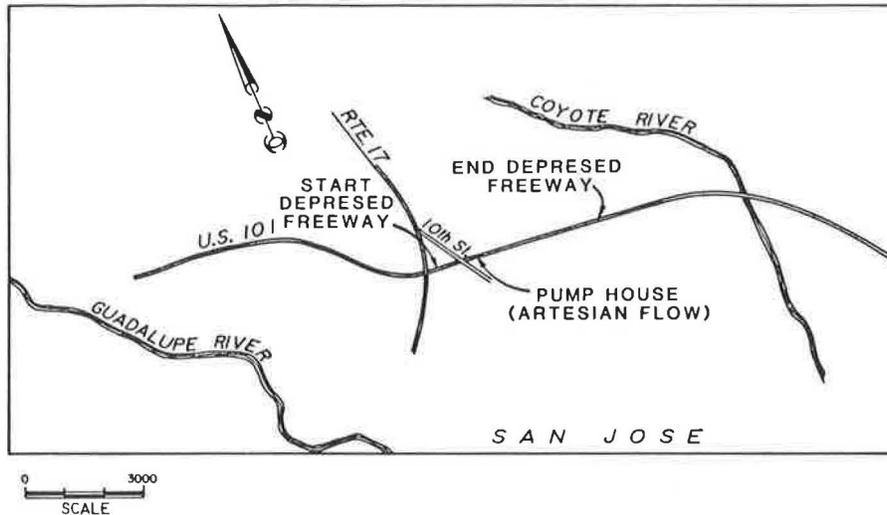
FIGURE 1 Plan map for a portion of U.S. 101 in San Jose showing location of artesian flow.

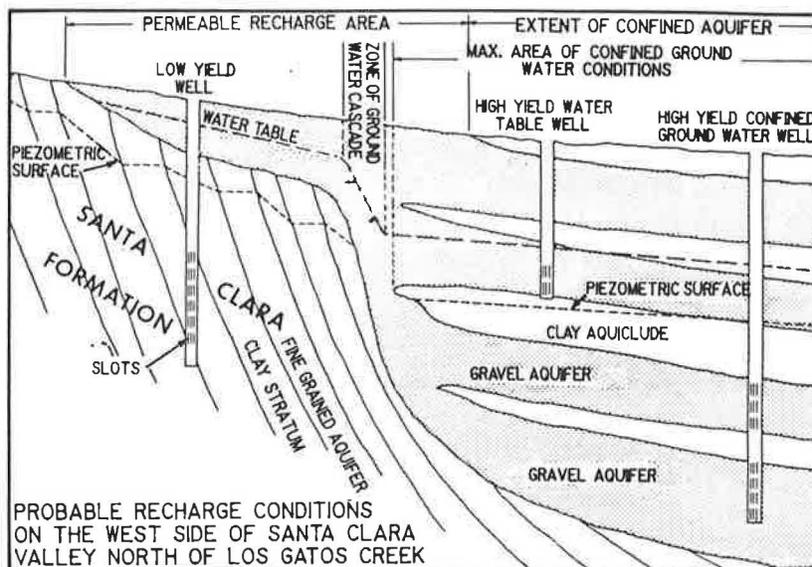
FIGURE 2 Generalized soil cross section of northwestern San Jose area showing aquifers and predominant method of natural recharge through the Santa Clara formation.

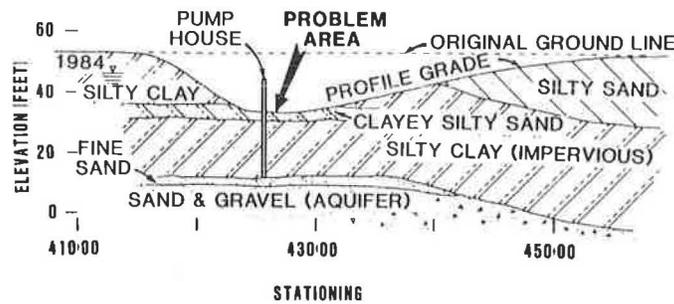
FIGURE 3 U.S. 101 profile of grade and soil types between Stations 410 and 460.

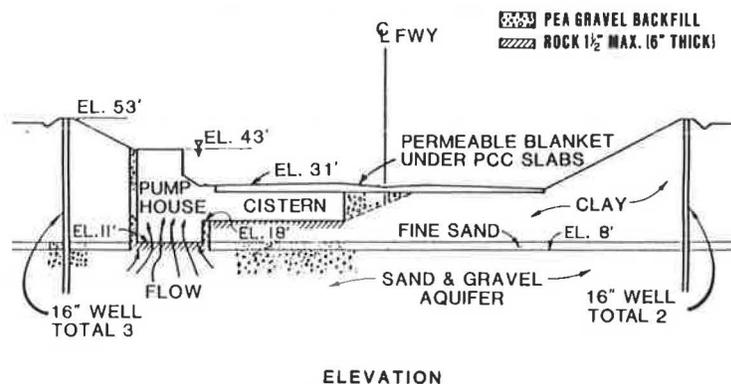
FIGURE 4 San Jose 10th Street Pump House, U.S. 101 (looking north).

Phase I grouting was to seal the perimeter of the pump house. This was accomplished from the sloping surface around the pump house using grout injection points driven to Elevation 10 (Figure 4) and staged up.

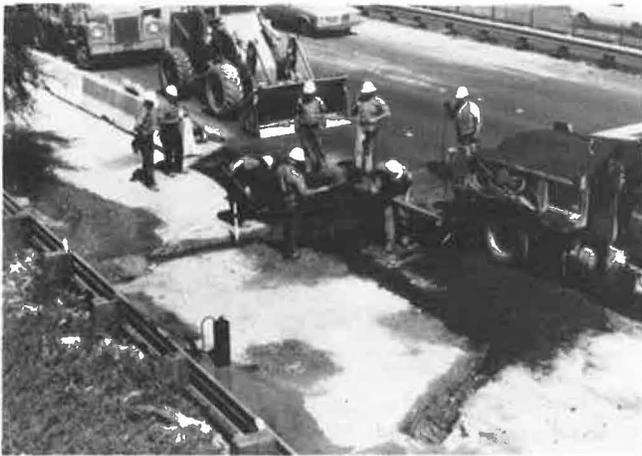
**FIGURE 5** Temporary repair of shoulder where a relief trench was cut to allow the water to flow from the highway subgrade.

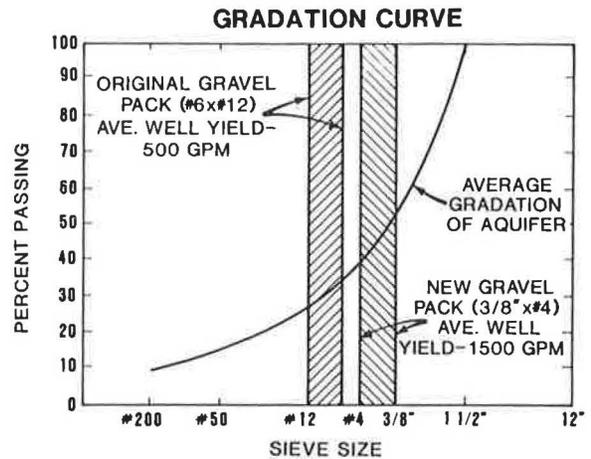
**FIGURE 6** Gradation averages of aquifer and gravel packs. Original gravel pack incorporated 0.045-in. slotted screen; new gravel pack incorporated 0.100-in. slotted screen.

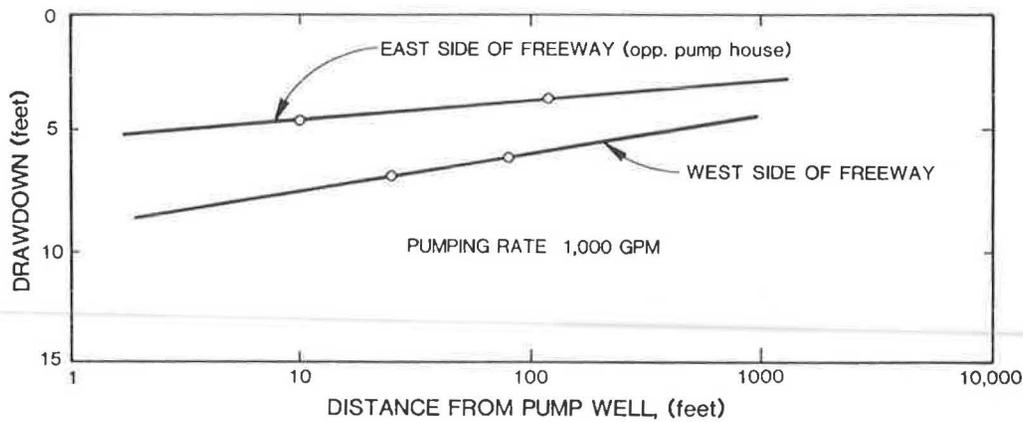
**FIGURE 7** Drawdown characteristics of aquifer on east and west side of freeway. East side curve typified area drawdown when full dewatering was implemented.

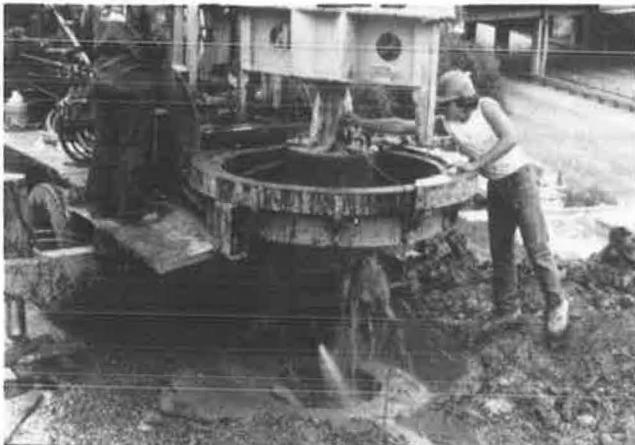
**FIGURE 8** Bucket rig used in drilling wells. Upper 40 ft lined with 30-in. corrugated metal pipe and concrete backfilled. Water jet spray used for cleaning.

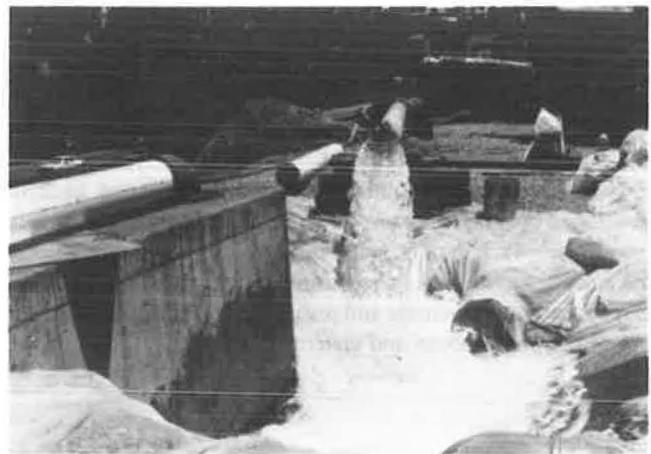
**FIGURE 9** Discharge from one of the wells during well development.

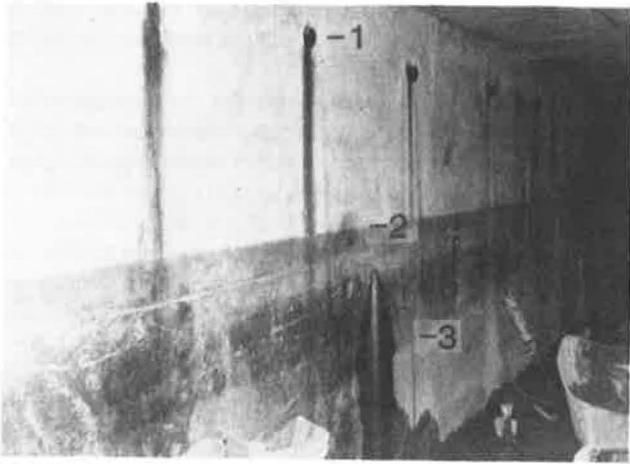
**FIGURE 10** Inside 8-ft tall cistern. Note (a) drilled water pressure relief holes, (b) high water line, and (c) silt line.

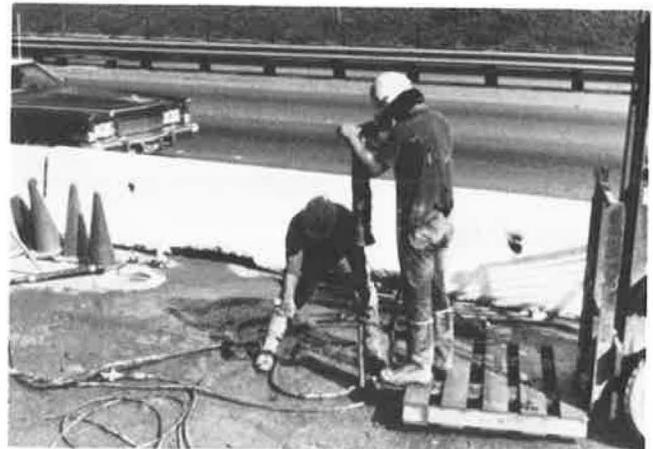
**FIGURE 11** Air hammer used in driving soil anchors to depth. Location where test soil anchor is driven.

To determine pile tip elevation and anchor pullout resistance, soil anchors were driven into the ground at freeway surface and load tested. Soil anchors consisted of perforated 2-in.-diameter Schedule 80 steel pipe in 5-ft lengths, coupled with steel pipe sleeves (40-kip rupture). The anchors were driven by a pneumatic 90-lb pavement breaker (Figure 11) to depths of 30, 40, and 50 ft into the sand and gravel and then grouted in place. A minimum holding capacity of 30 kips was necessary, which was developed with the 50-ft penetration depth. Figure 12 shows the loading and reaction-frame apparatus used for the pullout resistance tests.

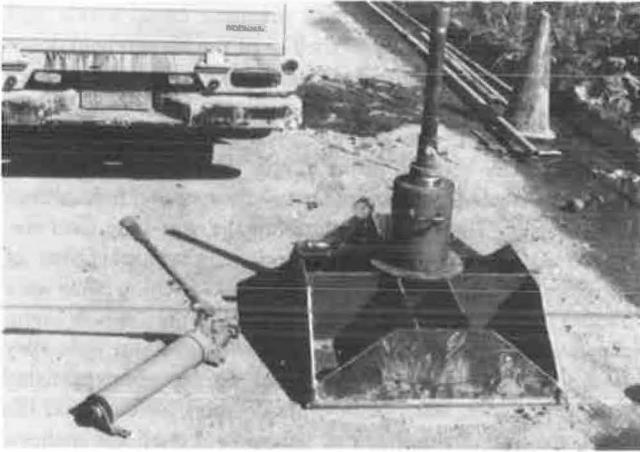
**FIGURE 12** Hydraulic jack and reaction frame used for testing pile anchor capacity.

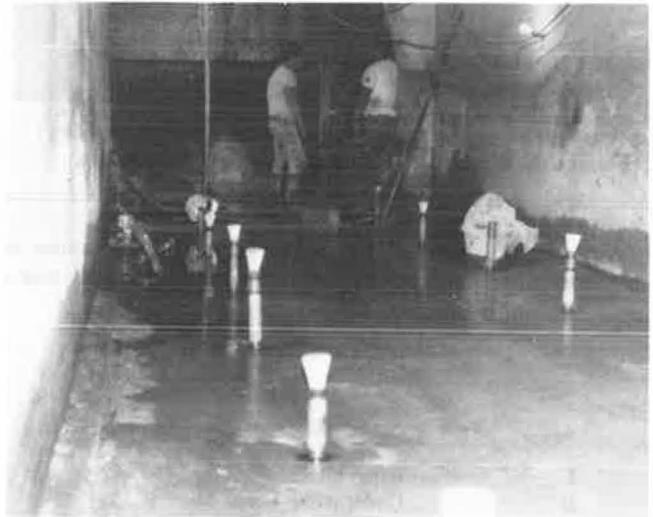
**FIGURE 13** Soil anchors installed in cistern before grouting and cutoff.

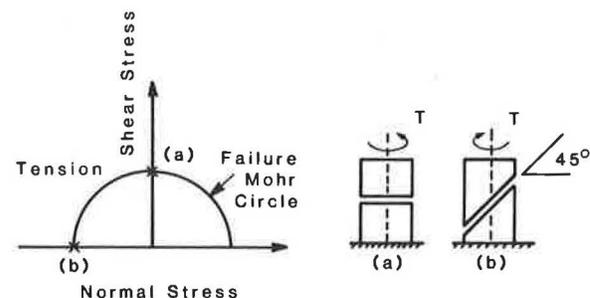
FIGURE 1 Critical modes of failure under pure torsional loading (a) shear failure and (b) tensile failure.

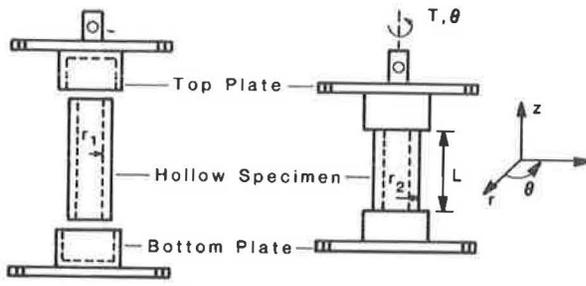
FIGURE 2 Torsional test configuration.

will depend on its material properties, specimen geometry (inner and outer radii and height), and end restraints ( $L$ ,  $2$ ). Because of the low strength and brittleness of the grout and grouted sand limitations associated with specimen preparation and handling, it was decided to adopt a ratio of inner to outer radius of 0.5. Figure 3 compares the selected dimensions with geometries used by other researchers (2). The length of the specimen should be as long as possible so that a large region will exist that will not be affected by the end restraints. In general, however, the stability of a specimen and experimental difficulties will govern its height. The effective height,  $L$ , of the specimens used in these tests varied between  $3.5r_2$  to  $4r_2$ .

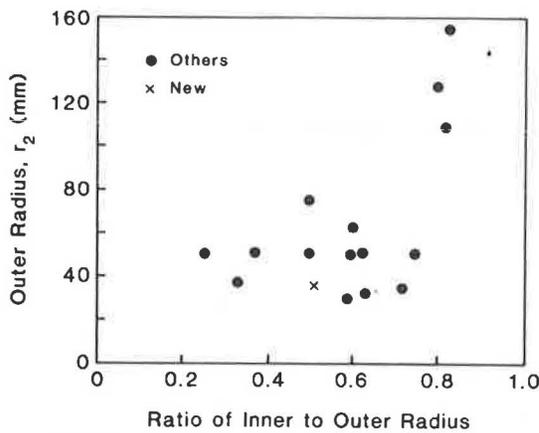
FIGURE 3 Geometries of specimen used in earlier hollow cylinder apparatuses.

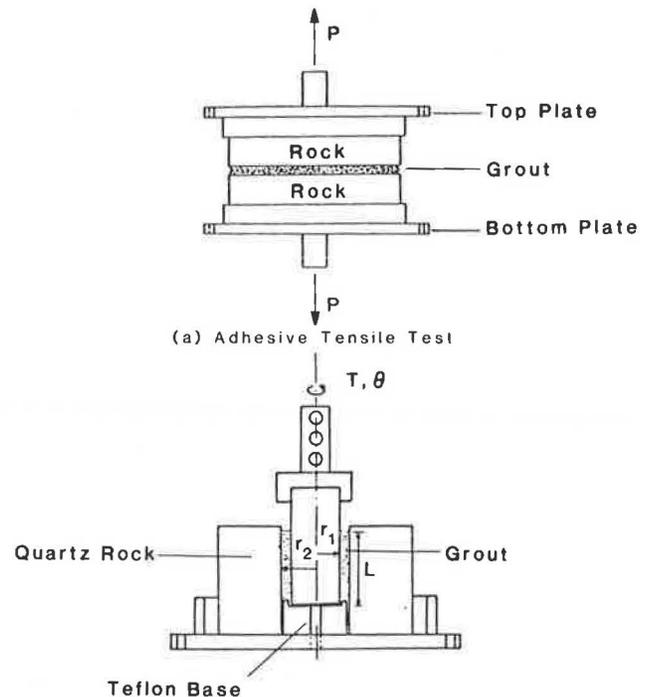
FIGURE 4 Adhesive test configurations.

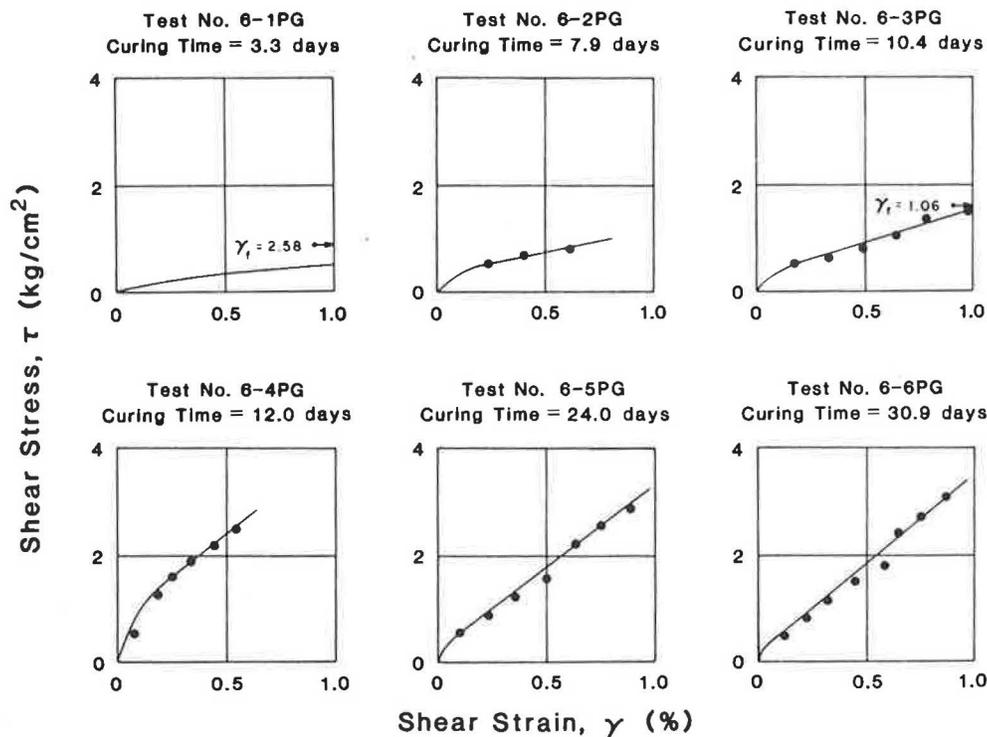
FIGURE 5 Shear stress-strain relationships for pure grout at different curing times.

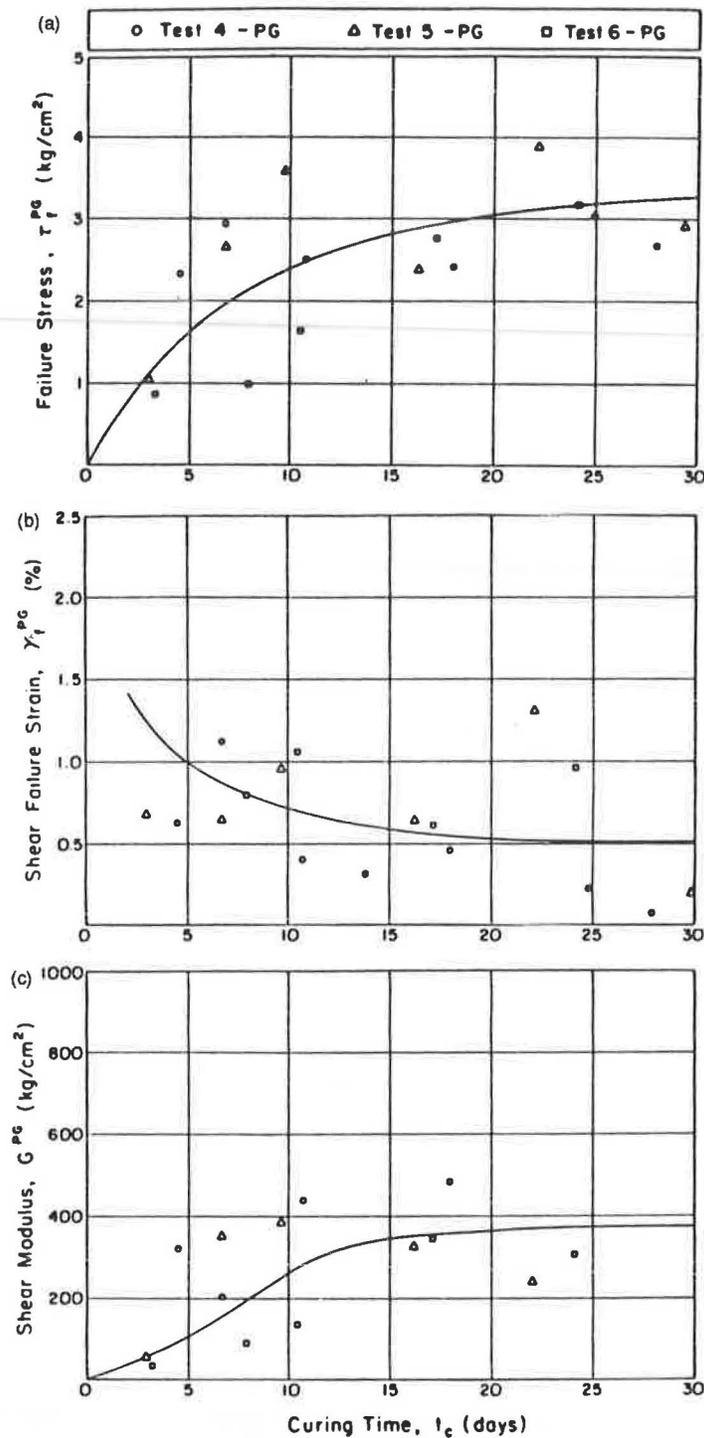
FIGURE 6 Variation of failure stress, shear failure strain, and shear modulus with curing time for pure grout.

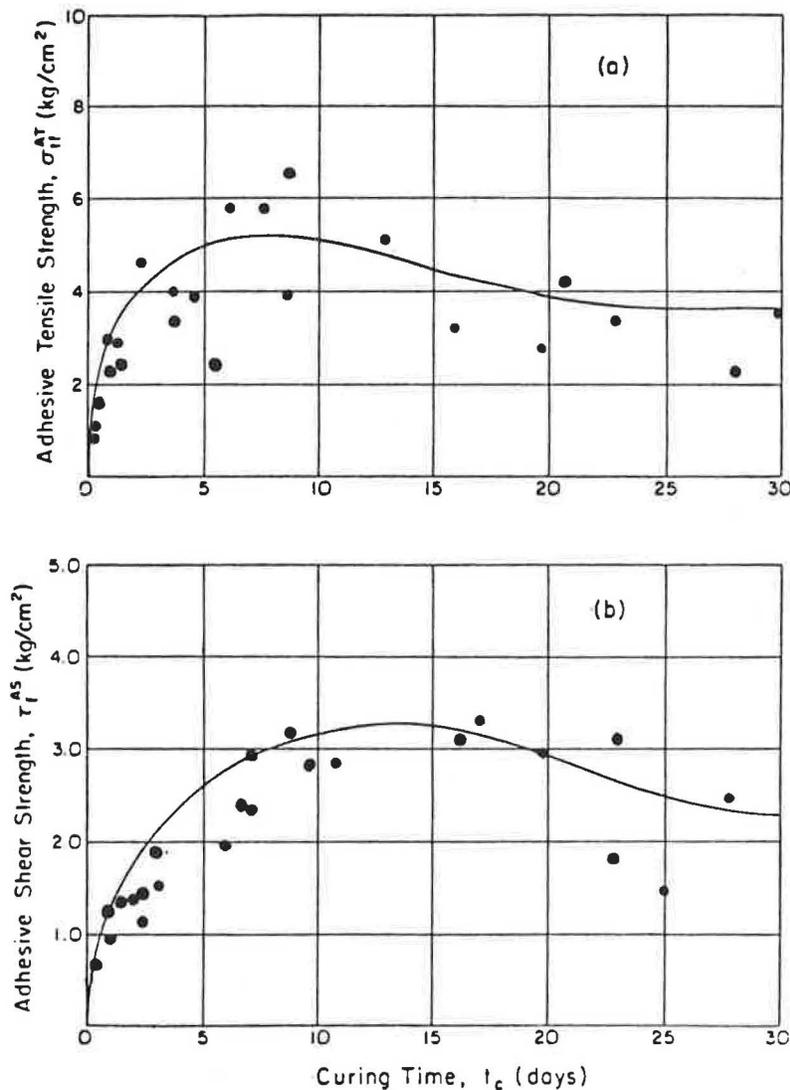
FIGURE 7 Variation of adhesive tensile and shear strengths with curing time.

The adhesive tensile strengths obtained from several tests are summarized in Figure 7a. The strength increased rapidly during the first 8 days of curing and reached a maximum value of 5.2 kg/cm<sup>2</sup> (0.51 MPa). However, with increased curing the strength reduced to less than 4 kg/cm<sup>2</sup> (0.39 MPa) on the 20th day and to almost 3.5 kg/cm<sup>2</sup> (0.34 MPa) on the 30th day of curing. The variation of adhesive shear strength with curing time is summarized in Figure 7b. The adhesive shear strength,  $\tau_f^{AS}$ , increased rapidly during the first few days, reaching a peak of 3.5 kg/cm<sup>2</sup> (0.34 MPa) around the second week. However, with increased curing, the strength reduced to 2.8 kg/cm<sup>2</sup> (0.27 MPa) after about 3 weeks and 2.5 kg/cm<sup>2</sup> (0.25 MPa) after about 4 weeks. A similar trend in the adhesive

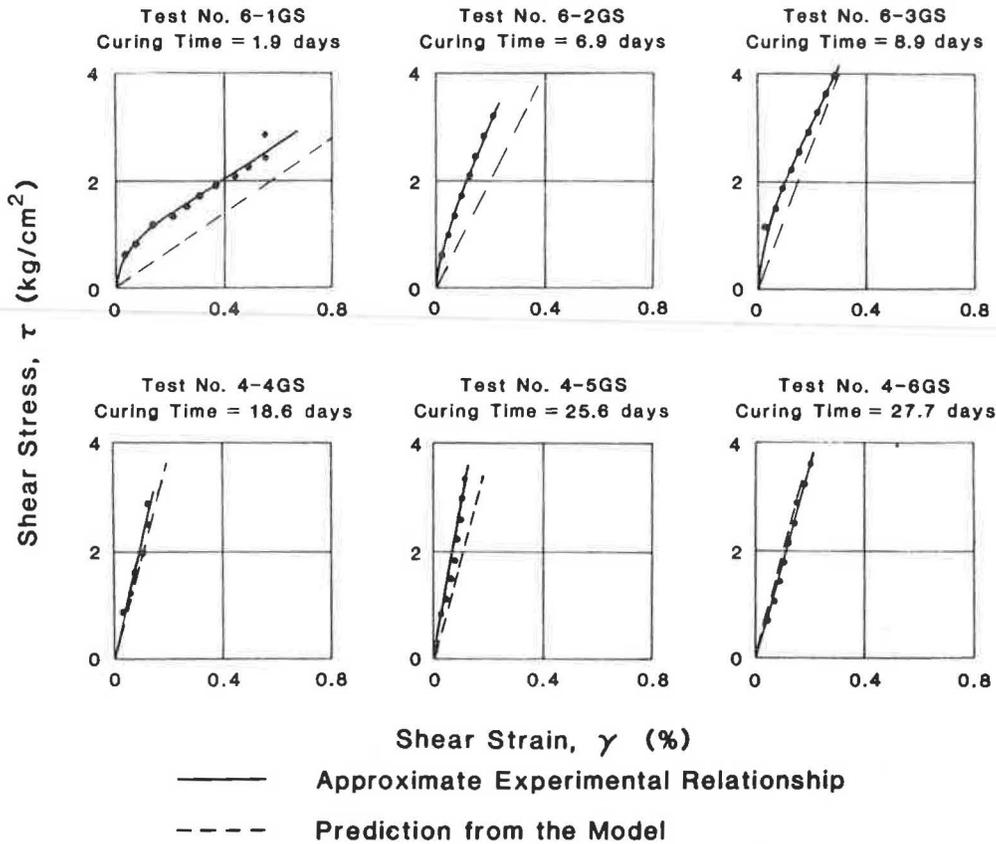
FIGURE 8 Shear stress-strain relationships for grouted sand at different curing times.

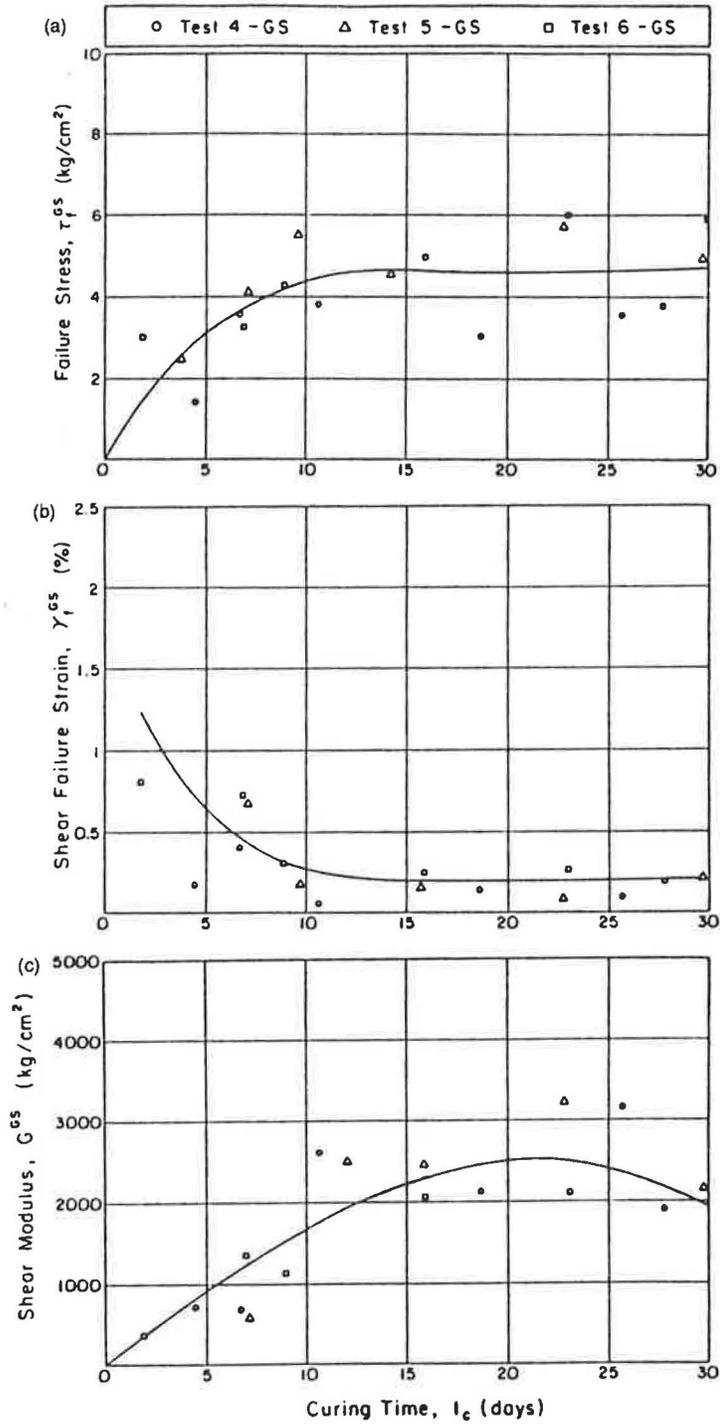
FIGURE 9 Variation of shear properties with curing time for grouted sand.

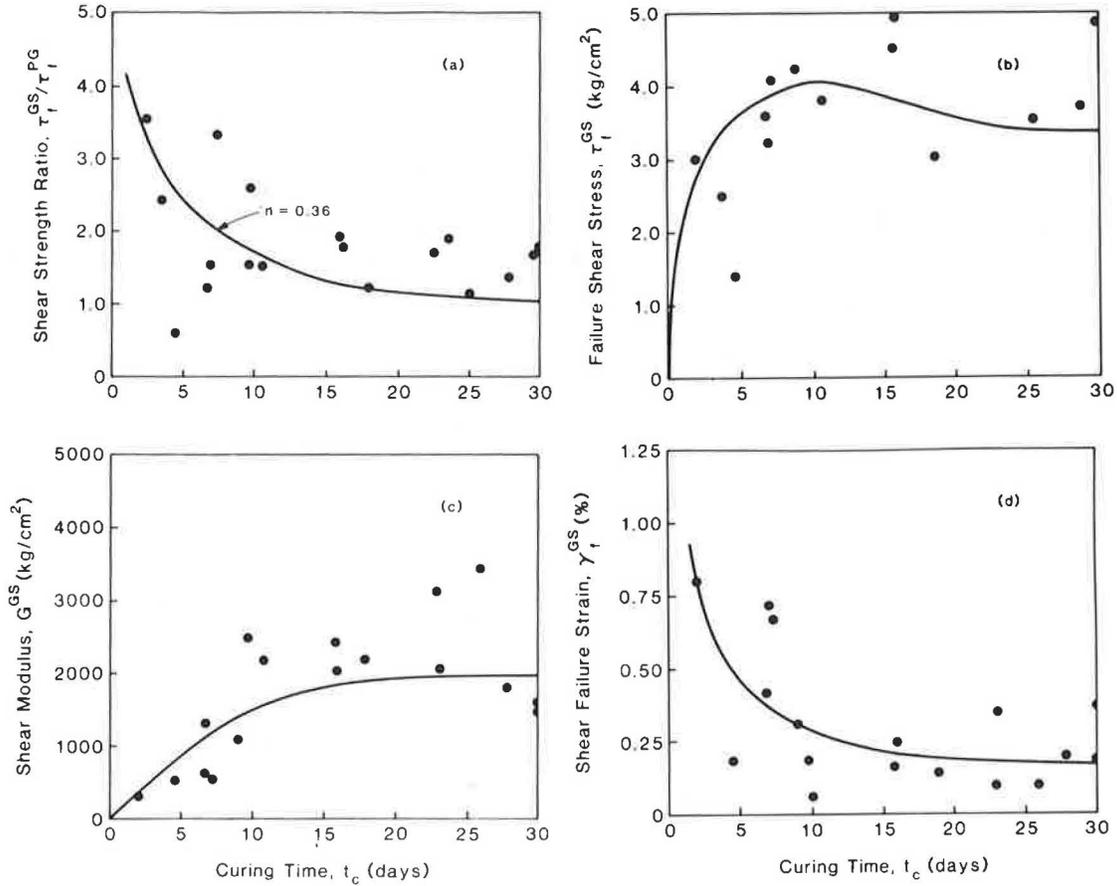
FIGURE 10 Comparison of predicted and measured results for grouted sand.
