Substructure Cathodic Protection in Ontario: Field Trials 1982 to 1986

D. G. MANNING AND H. C. SCHELL

In 1981, the Ontario Ministry of Transportation and Communications initiated a research program aimed at developing an effective method of repair for bridge substructures. Cathodic protection was identified as the most promising repair method available, and the emphasis of the program was placed on field testing. Eleven experimental systems, at two sites, were designed, installed, and monitored over the period 1982 to 1986. The effectiveness of the corrosion protection offered to the embedded steel, the cost and ease of installation, and the durability of the components were evaluated for each system. Anode materials used included conductive paints, conductive polymer, carbon fibers, zinc ribbon anodes and flame-sprayed zinc, and anode meshes of conductive polymer and of titanium. Updated in this paper is information on the Burlington Bay Skyway test site given in earlier publications and also described are installations at the Leslie Street test site. Installation of the first permanent substructure cathodic protection system covering one complete pier of the Burlington Bay Skyw

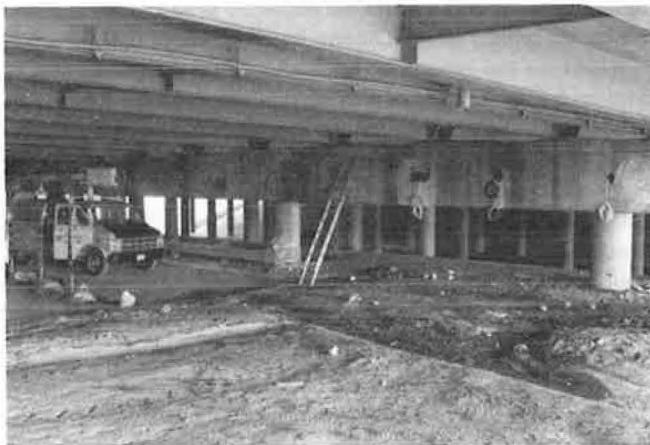
FIGURE 4 Leslie Street test site: One of the pier bents is shown, with instrumentation in place, before application of the conductive paint overcoat.

The site, which is shown in Figure 4, consists of several bridges carrying a freeway over a major urban, arterial road-

way. It was selected because the spirally reinforced columns and cap beams making up the pier bents are representative of many in Ontario, and access was convenient. In contrast to the Burlington site, the piers were sheltered from weathering. Like those at Burlington, however, they were subjected to surface run-off through leaking deck joints and exhibited active corrosion potentials and corrosion-induced damage.

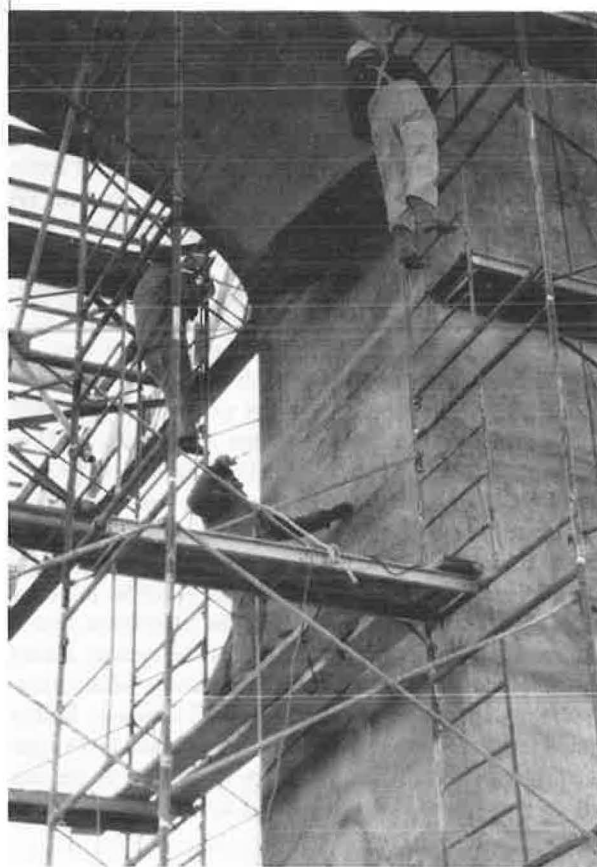
FIGURE 6 Pier S16, Burlington Bay Skyway: Attachment of the anode mesh (supplied in rolls 1.2 m wide x 61 m long) to the concrete surface.

The mesh anode was anchored in place with insulating fasteners. Figure 6 shows a roll of anode material being attached to the concrete surface. The anode material, which was designed for a lower current density than that installed the previous year, was flexible and tended to curl and stretch at the edges. This meant additional anchors were required to secure the anode tightly against the concrete, and the thickness of the overcoat was increased to cover the mesh. Both these items increased the cost of the installation considerably.

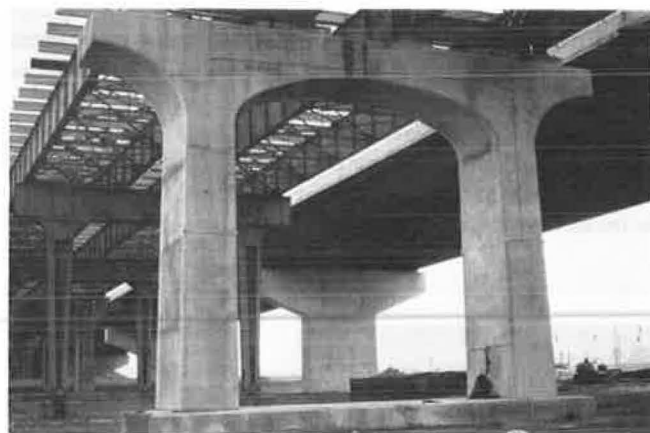
FIGURE 7 Pier S16, Burlington Bay Skyway: The pier is shown after installation of the anode system and overcoat. Surface-mounted conduit carried current supply wires to the anode.

Following the experience gained in the experimental installations, the system was designed so that the current supply wires and the connections to the anodes were outside the concrete. The wires were protected by polyvinyl chloride (PVC) conduit and the connections were made in junction boxes. Embedded instrumentation consisted of carbon reference cells with one cell for approximately each 18 m² of concrete surface. The rectifier specified was capable of constant current or voltage output, or could be programmed to maintain a constant potential on one of the reference cells. The system was divided into 10 anode zones, providing the capacity to control current flow to various areas of the structure. The completed installation is shown in Figure 7.
