Bridge Deck Expansion Joints

SABIR H. DAHIR AND DALE B. MELLOTT

In 1984, the Pennsylvania Department of Transportation (PennDOT) entered into a cooperative agreement with the Federal Highway Administration (FHWA) to conduct a comprehensive statewide evaluation of all types of bridge deck expansion joints used in Pennsylvania.

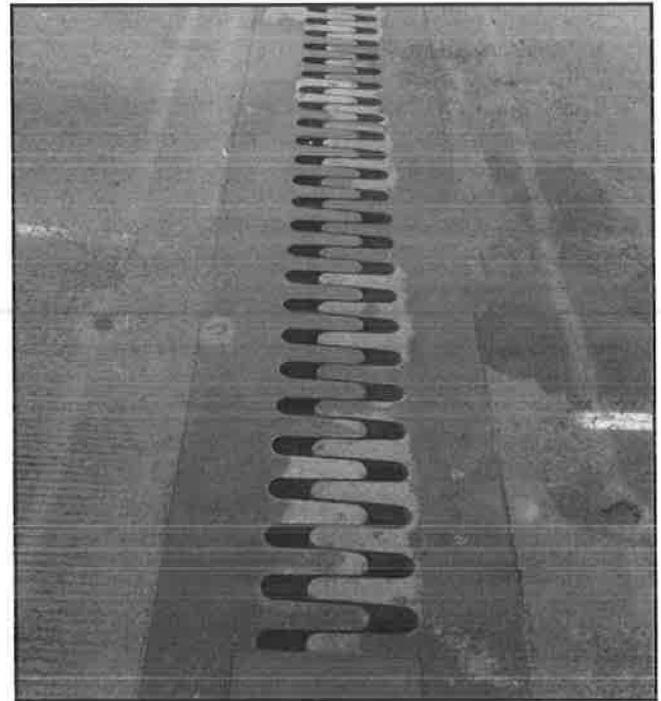
FIGURE 5 A typical finger dam.

show photographs of a finger dam system, an armored neoprene, and a preformed compression seal, respectively. Finger joints may be equipped with neoprene troughs to direct contaminated water away from the bridge abutments or piers, or they may allow water to fall directly into the area below the joint if the area is not adversely affected by the drainage water.

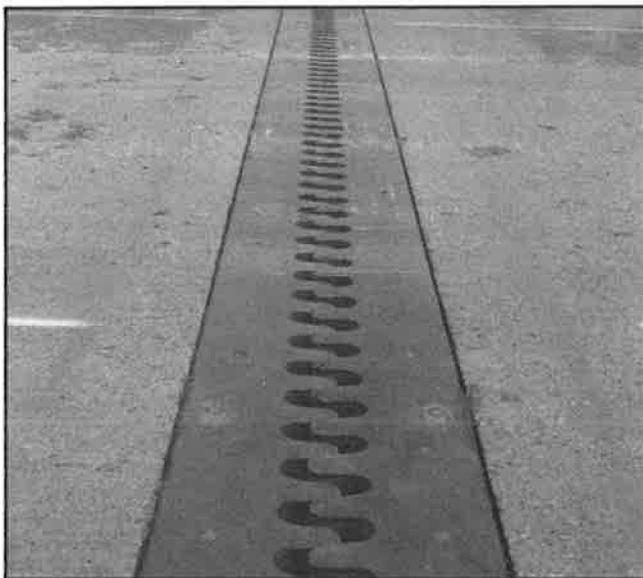
FIGURE 8 A finger dam with horizontal and vertical finger misalignment.

1. Misalignment during construction, especially in the finger dam systems. The misalignment can be either horizontal, causing the fingers to jam on expanding, or vertical, causing rough riding, noise, and sometimes bending or breaking of some fingers. Figure 8 shows a finger dam having both horizontal and vertical misalignment.

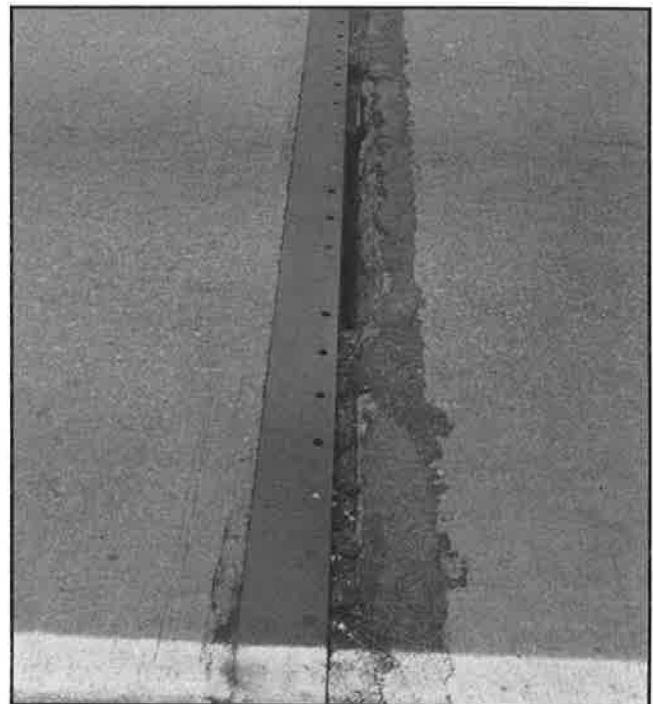
FIGURE 9 Damaged concrete adjacent to armored channels—concrete has not been well consolidated.

4. In the case of armored neoprene and preformed neoprene compression seals, problems may arise if the concrete around the armored channels is not adequately consolidated (Figure 9) or if the neoprene becomes twisted during construction (Figure 10). Obviously, these problems can be avoided if strict construction controls are applied. A problem that can be alleviated by maintenance is the rusting of the plates that occurs unless the plates are painted periodically.

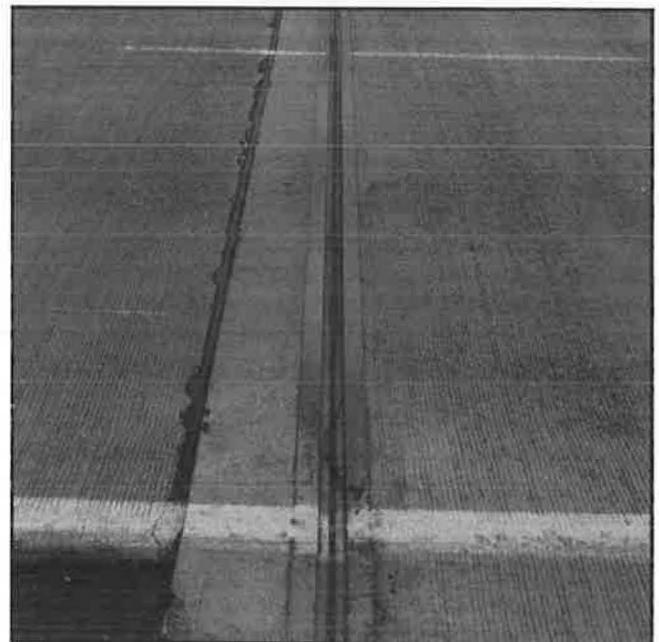
FIGURE 11 A typical strip seal dam.

These devices provide movements up to 4 in. (Figure 11). Several of these systems have been used in Pennsylvania on an experimental basis. They are listed at the beginning of this section in the grouping of the joint dam systems. Generally, their performance has ranged from fair to quite good, as may be seen in the summary of performance averages in Table 1.

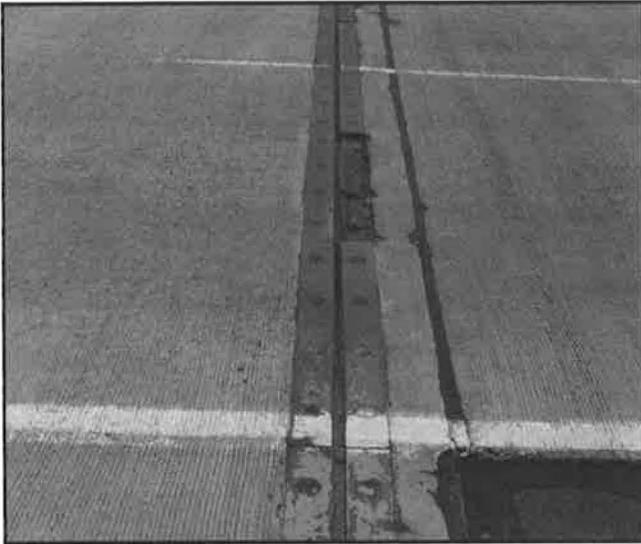
FIGURE 12 A strip seal dam having missing reinforcing strips and debris accumulation.

Some of the problems encountered when using these systems include debris accumulation, leakage, and noise under traffic (Figure 12).

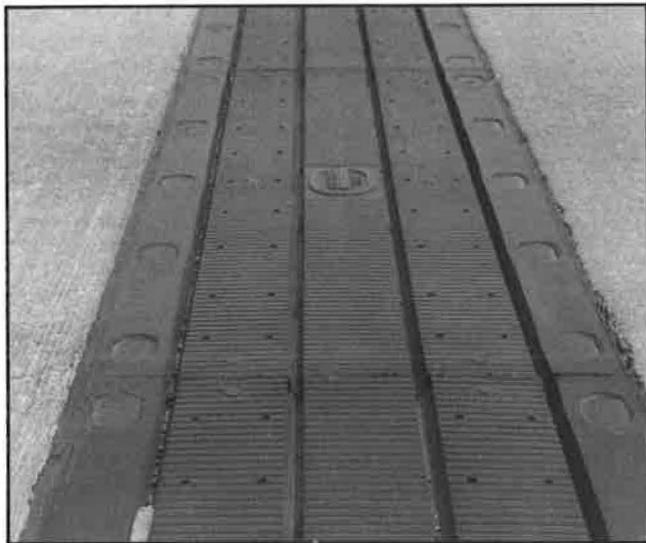
FIGURE 13 A typical Transflex dam.

Of the four systems in this group, the Transflex systems were generally most subject to tear and loosening of anchorage, followed by the Fel Span and Waboflex systems. The Unidam system generally performed better than the Transflex and other systems in this group; nevertheless, they were not completely satisfactory, as may be seen in Figure 14. The Fel Span dam system has since been modified to use a continuous belt anchored to the concrete deck by neoprene blocks or hold-down members that put it in the same group as the strip seal and gland type systems. The old version would leak where the segmented sections were joined in the field.

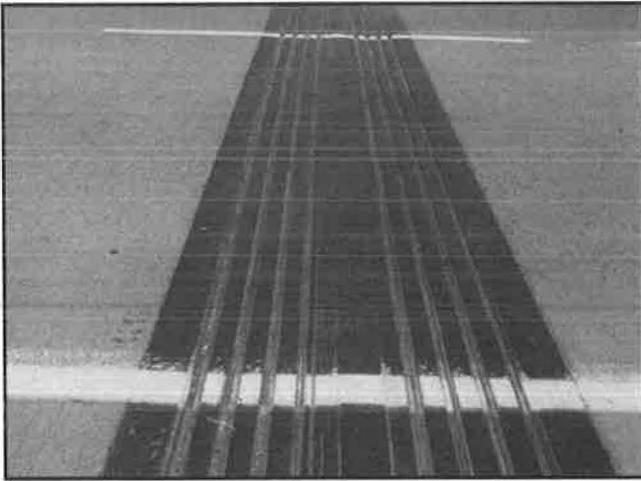
FIGURE 15 A typical modular dam.

more preformed neoprene elastomeric elements secured between contoured transverse load distribution members that bear on custom-designed support beams. The entire module is installed between end dams anchored into the concrete superstructure.

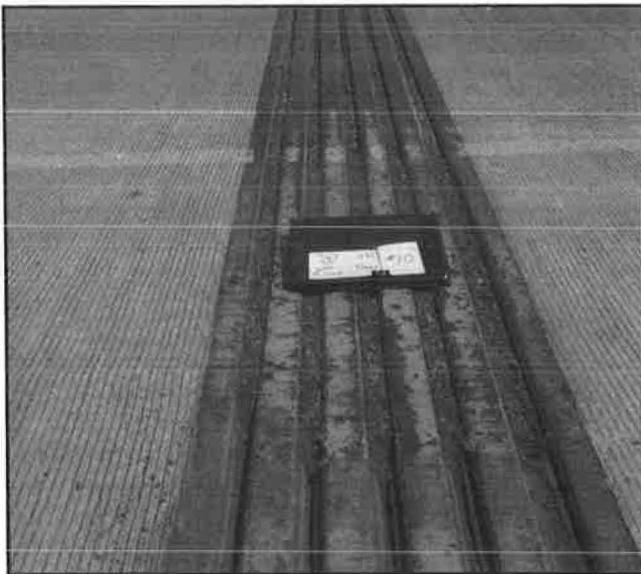
FIGURE 16 A modular joint showing debris accumulation.

Unfortunately, experience with these systems in Pennsylvania and elsewhere (6, 7) shows that although some of these expensive systems have performed fairly well, most have had problems, no less troublesome than those they were supposed to eliminate when using the conventional finger dam systems. Snow plow damage and debris accumulation are typical problems with the modular systems (Figure 16).
